# Site Assessment Summary & Variance Request

## Solaris Water Midstream, LLC Urraca Booster Pump

Lea County, New Mexico  
Unit Letter "B", Section 11, Township 23 South, Range 32 East  
Latitude 32.32348 North, Longitude 103.64382 West  
**NMOCD Reference No. nAPP2310130251**

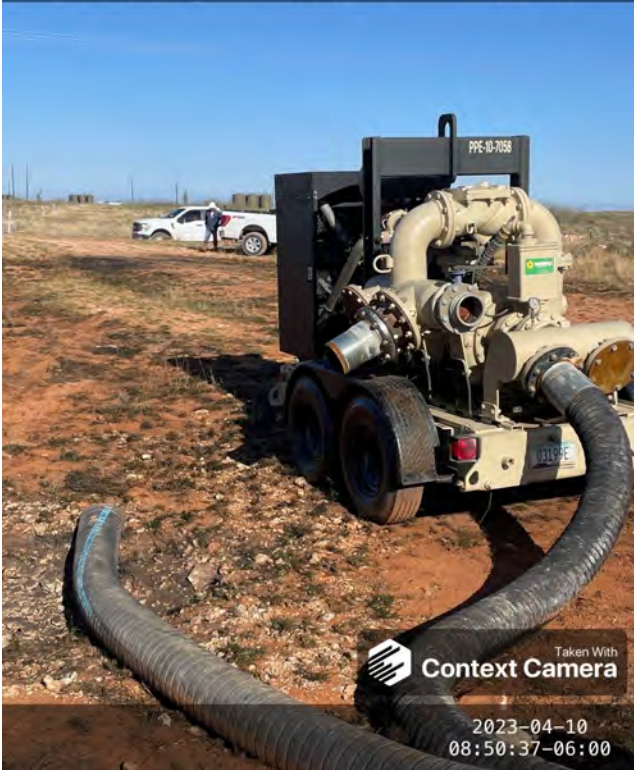
<b>Photo Number:</b> 1	<div><div><div>DIRECTION 287 deg(T)</div><div>32.32344°N 103.64369°W</div><div>ACCURACY 5 m DATUM WGS84</div></div>

</div>
<b>Photo Direction:</b> West-Northwest	
<b>Photo Description:</b>  Point of release.

A hose fastener on the booster pump failed. The pump was being monitored and was turned off. The pump was stopped and the hose replaced.

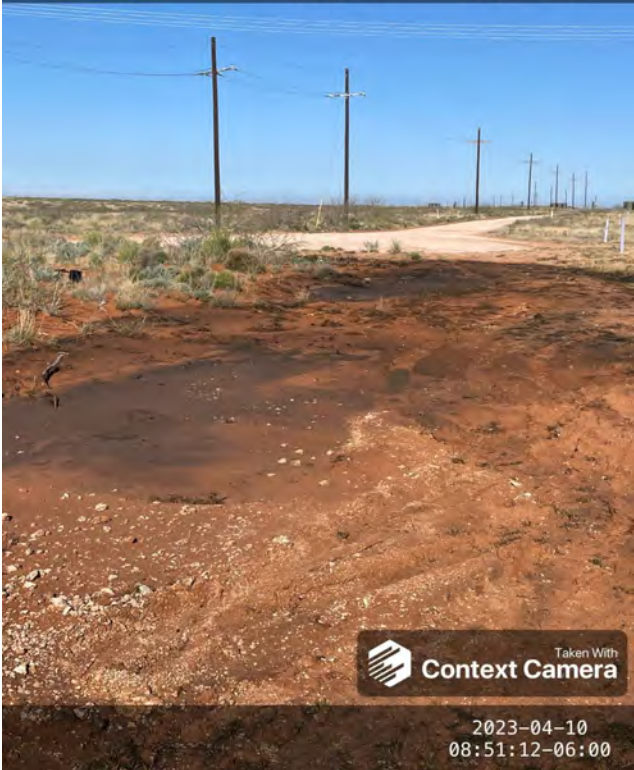
<b>Photo Number:</b> 2	<div><div><div>DIRECTION 254 deg(T)</div><div>32.32342°N 103.64374°W</div><div>ACCURACY 5 m DATUM WGS84</div></div>

</div>
<b>Photo Direction:</b> West-Southwest	
<b>Photo Description:</b>  View of the affected area.

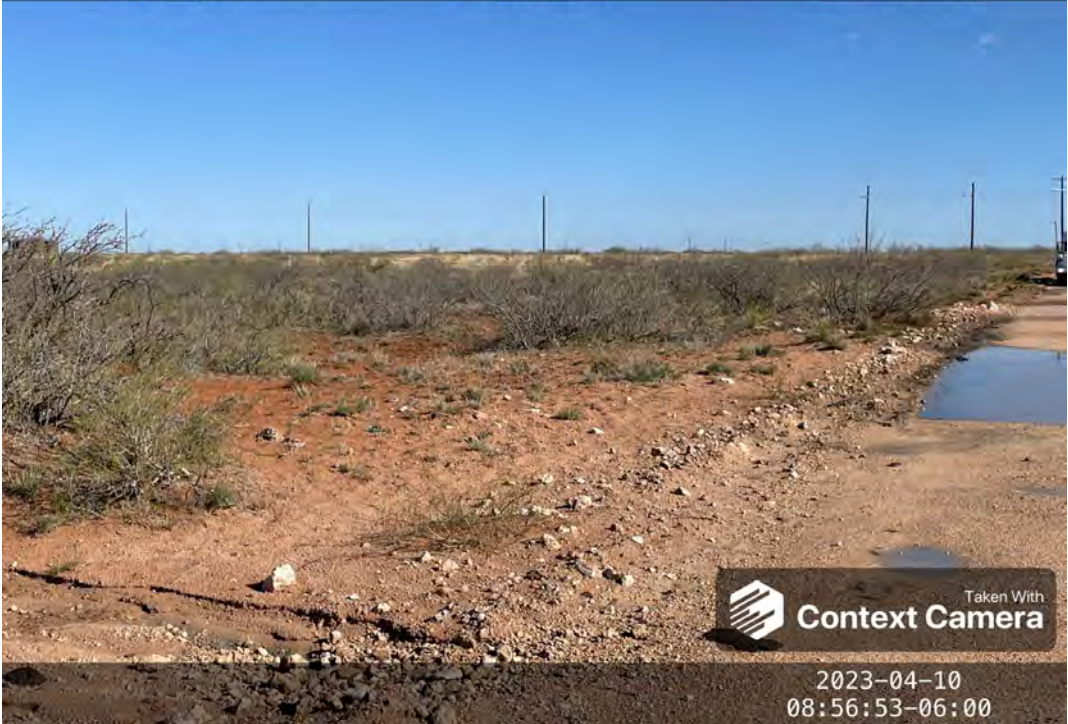
<b>Photo Number:</b> 5	<div><div>DIRECTION341 deg(T)32.32135°N103.64437°WACCURACY 5 mDATUM WGS84</div>

</div>
<b>Photo Direction:</b> North-Northwest	
<b>Photo Description:</b>  View of the affected area.

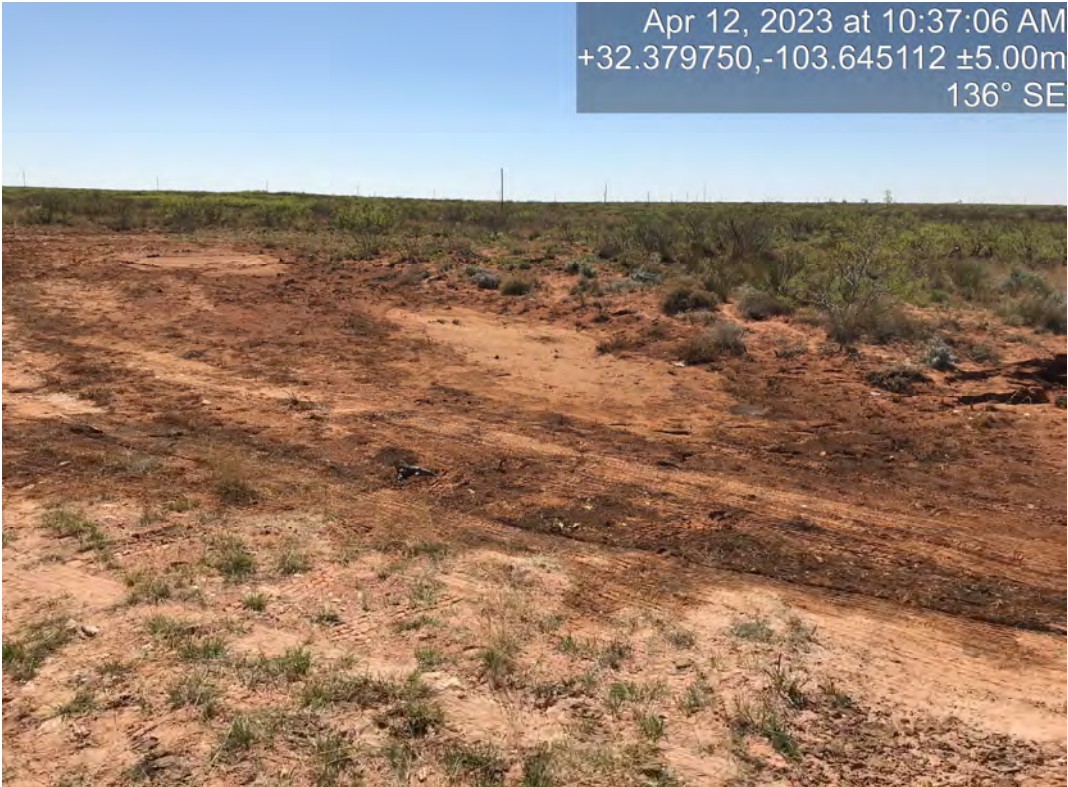
<b>Photo Number:</b> 6	<div><div>Apr 12, 2023 at 10:37:06 AM+32.379750,-103.645112 ±5.00m136° SE</div>

</div>
<b>Photo Direction:</b> Southeast	
<b>Photo Description:</b>  View of the affected area.

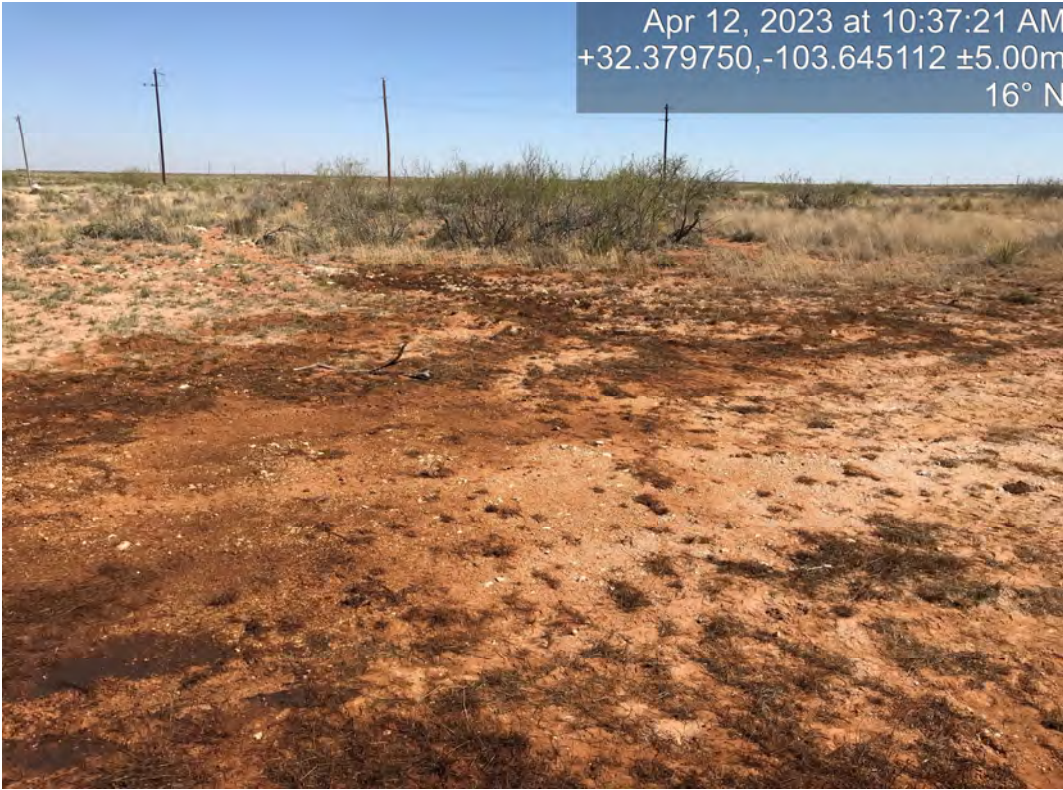
<b>Photo Number:</b> 8

<p>Apr 12, 2023 at 10:37:21 AM +32.379750,-103.645112 ±5.00m 16° N</p>
<b>Photo Direction:</b> North-Northeast	
<b>Photo Description:</b>  View of the affected area.

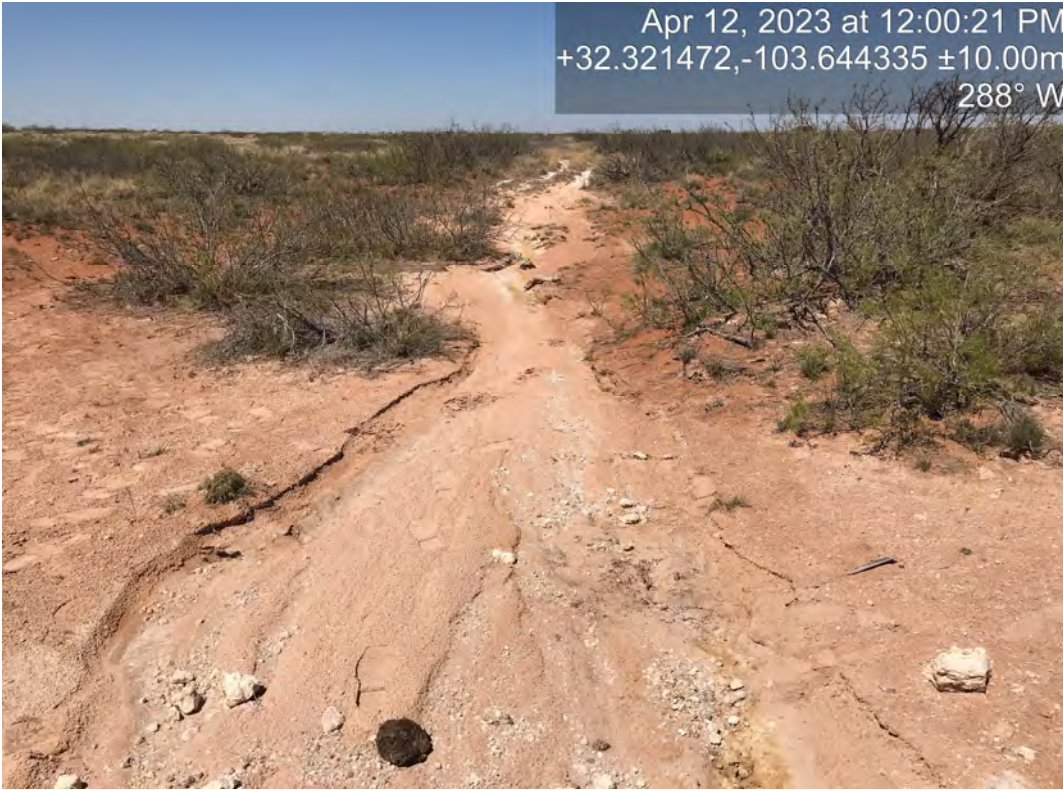
<b>Photo Number:</b> 9

<p>Apr 12, 2023 at 12:00:21 PM +32.321472,-103.644335 ±10.00m 288° W</p>
<b>Photo Direction:</b> West-Northwest	
<b>Photo Description:</b>  View of the affected area.

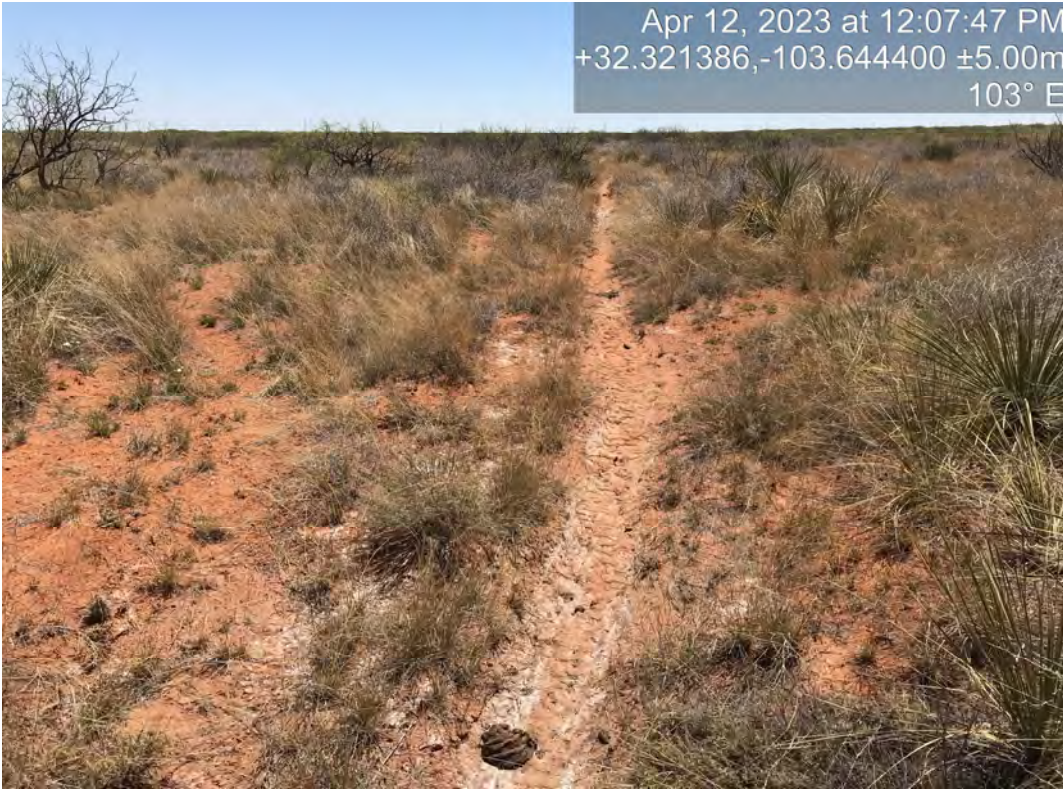
<b>Photo Number:</b> 10

<p>Apr 12, 2023 at 12:07:47 PM +32.321386,-103.644400 ±5.00m 103° E</p>
<b>Photo Direction:</b> East-Southeast	
<b>Photo Description:</b>  View of the affected area.

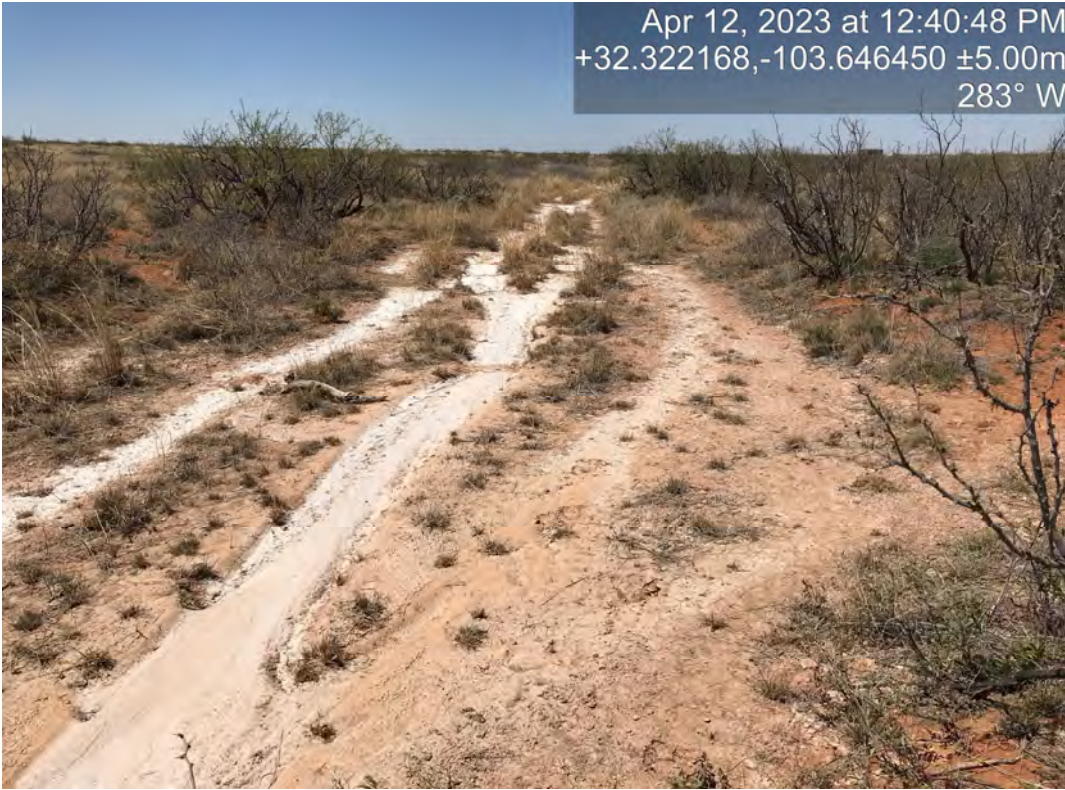
<b>Photo Number:</b> 11

<div>Apr 12, 2023 at 12:40:48 PM +32.322168,-103.646450 ±5.00m 283° W</div>
<b>Photo Direction:</b> West-Northwest	
<b>Photo Description:</b>  View of the affected area.

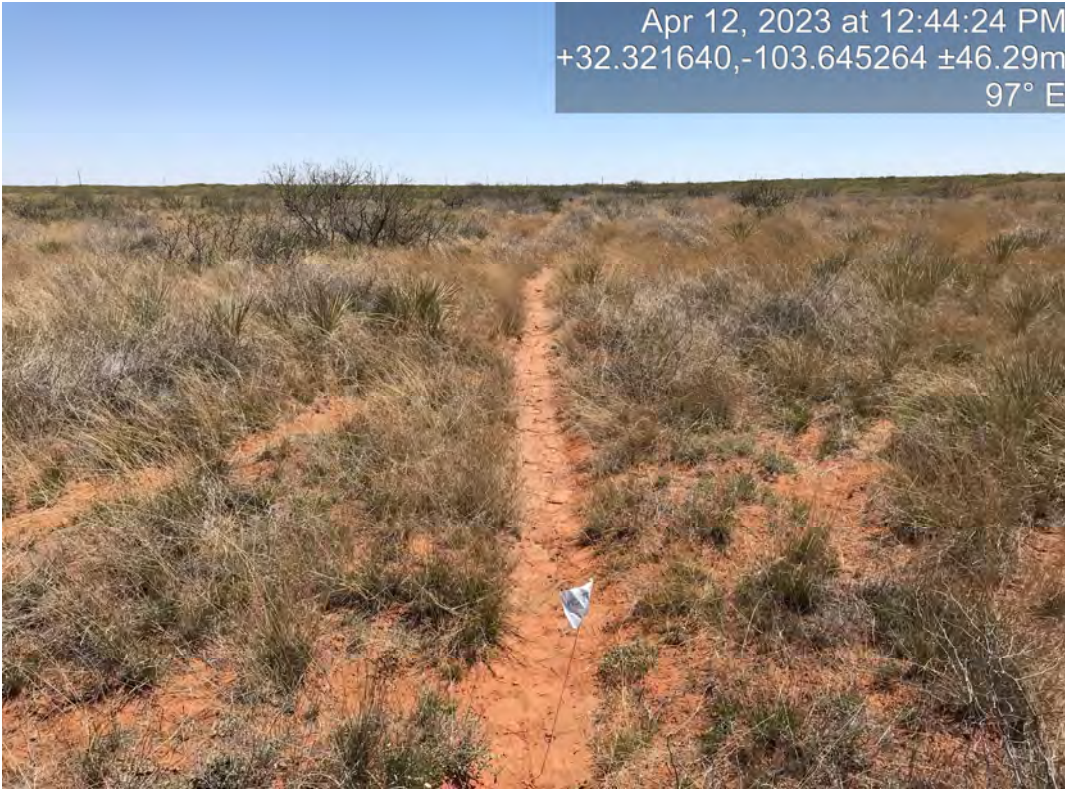
<b>Photo Number:</b> 12

<div>Apr 12, 2023 at 12:44:24 PM +32.321640,-103.645264 ±46.29m 97° E</div>
<b>Photo Direction:</b> East	
<b>Photo Description:</b>  View of the affected area.
