April 12, 2024

**RE: Closure Report
ConocoPhillips Company
Stampede Federal WC Com 34 #001H
Unit Letter E, Section 34, Township 26 South, Range 31 East
Eddy County, New Mexico
Incident ID# nAB1431639646**

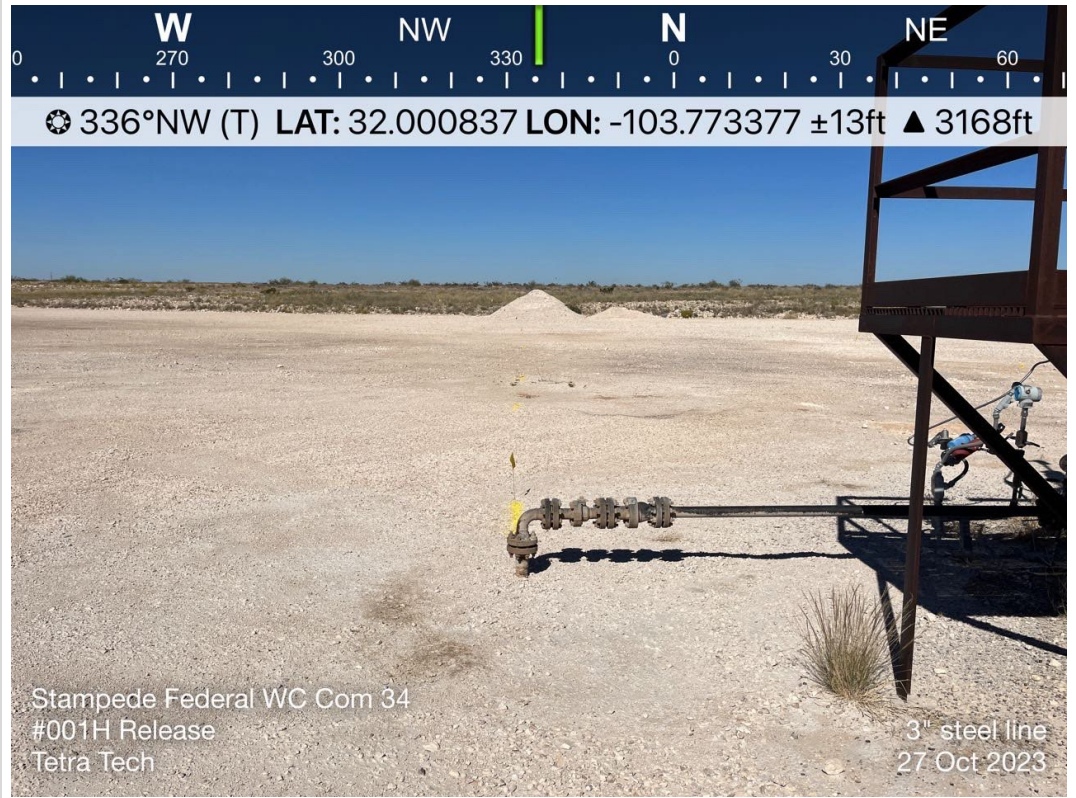
TETRA TECH, INC. PROJECT NO. 212C-MD-03248	DESCRIPTION	View north-northwest of 3" subsurface steel line. View of approximate release extent.	2
	SITE NAME	STAMPEDE FEDERAL WC COM #001 Release	10/27/2023

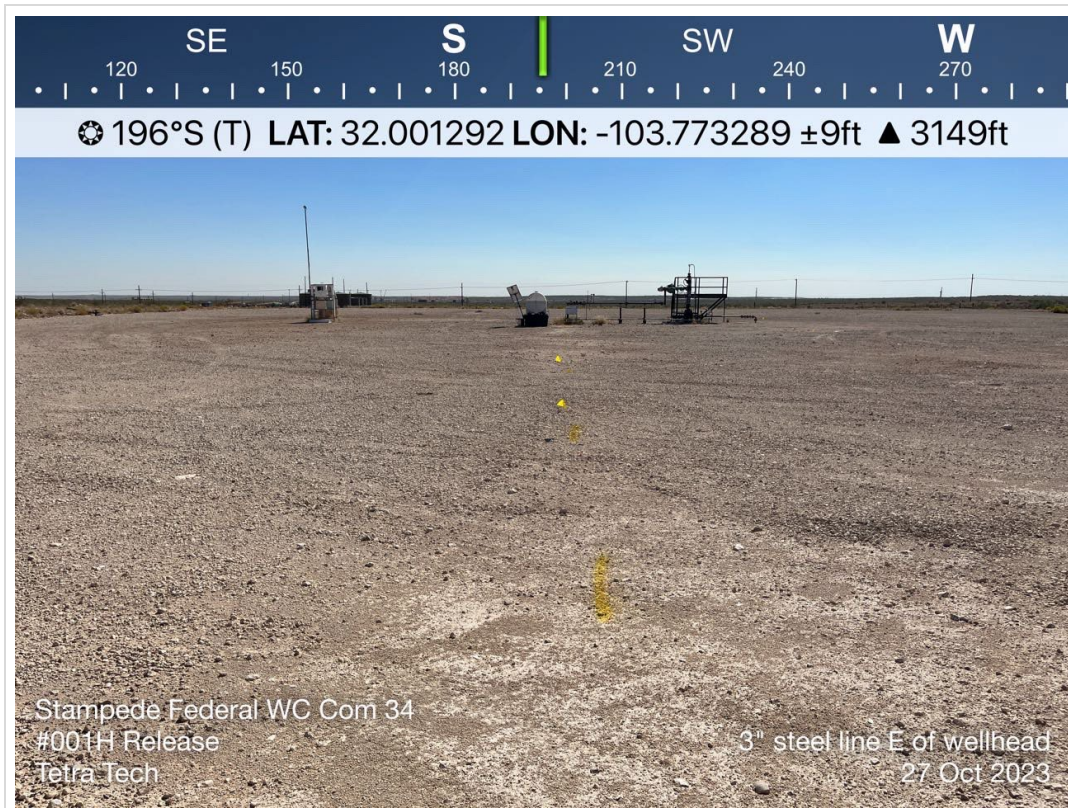
TETRA TECH, INC. PROJECT NO. 212C-MD-03248	DESCRIPTION	View south of 3" subsurface steel line east of wellhead. View of approximate release extent.	3
	SITE NAME	STAMPEDE FEDERAL WC COM #001 Release	10/27/2023

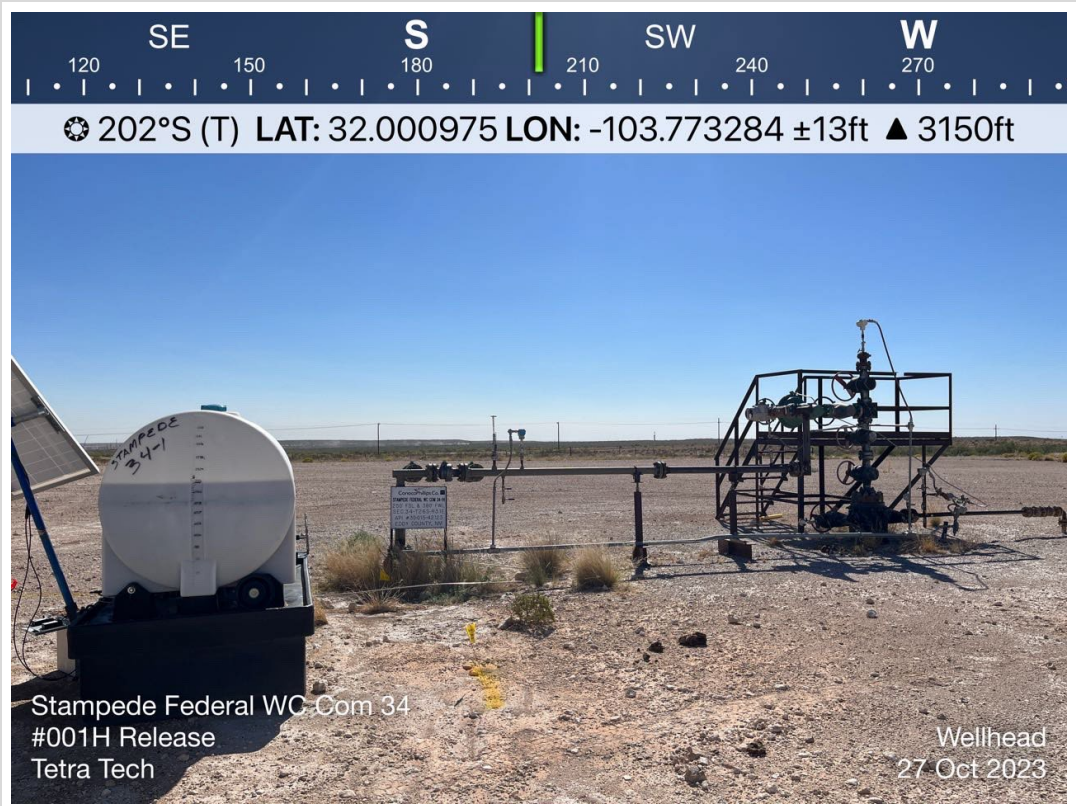
TETRA TECH, INC. PROJECT NO. 212C-MD-03248	DESCRIPTION	View south-southwest of wellhead and 3" subsurface steel line. View of approximate release Point.	5
	SITE NAME	STAMPEDE FEDERAL WC COM #001 Release	10/27/2023

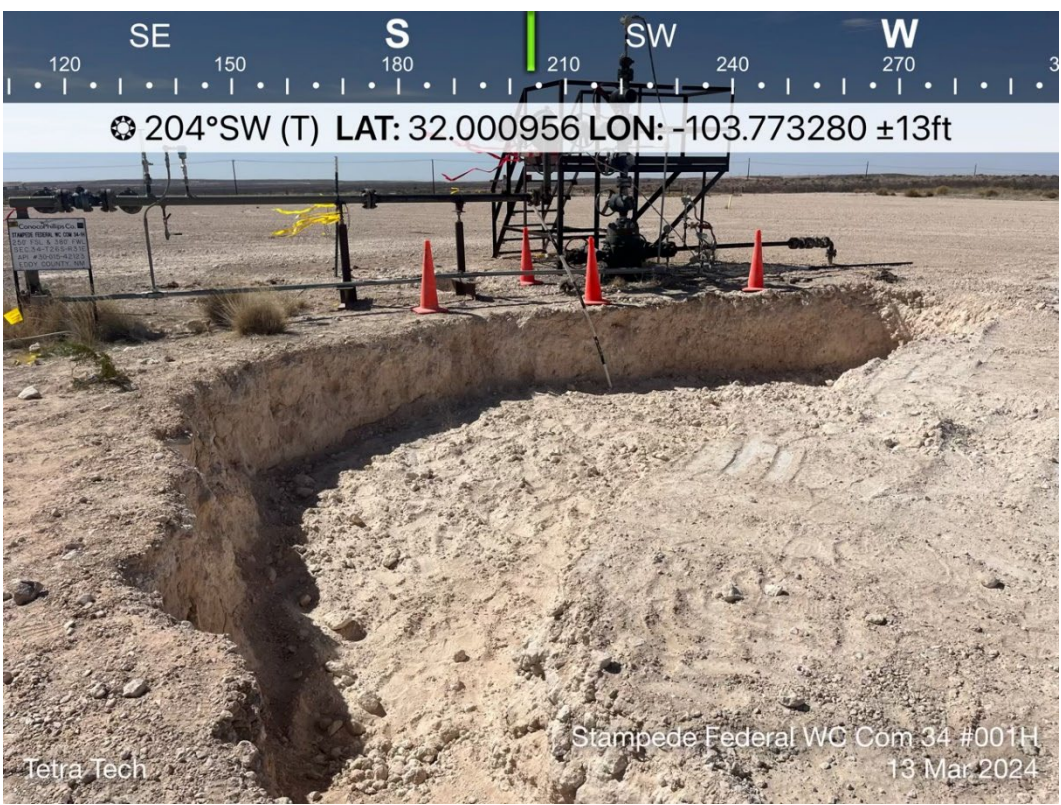
TETRA TECH, INC. PROJECT NO. 212C-MD-03248	DESCRIPTION	View south-southwest. View of excavation and production equipment.	8
	SITE NAME	STAMPEDE FEDERAL WC COM #001 Release	3/13/2024

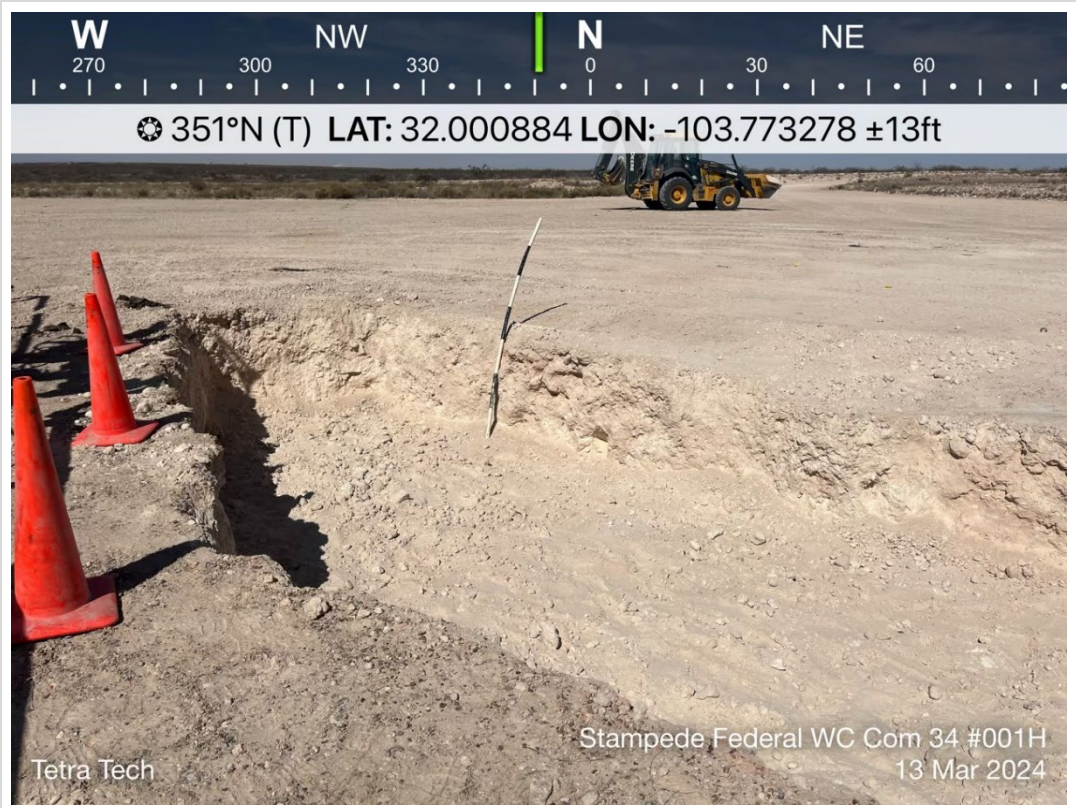
TETRA TECH, INC. PROJECT NO. 212C-MD-03248	DESCRIPTION	View north. View of 3 ft excavation.	9
	SITE NAME	STAMPEDE FEDERAL WC COM #001 Release	10/27/2023

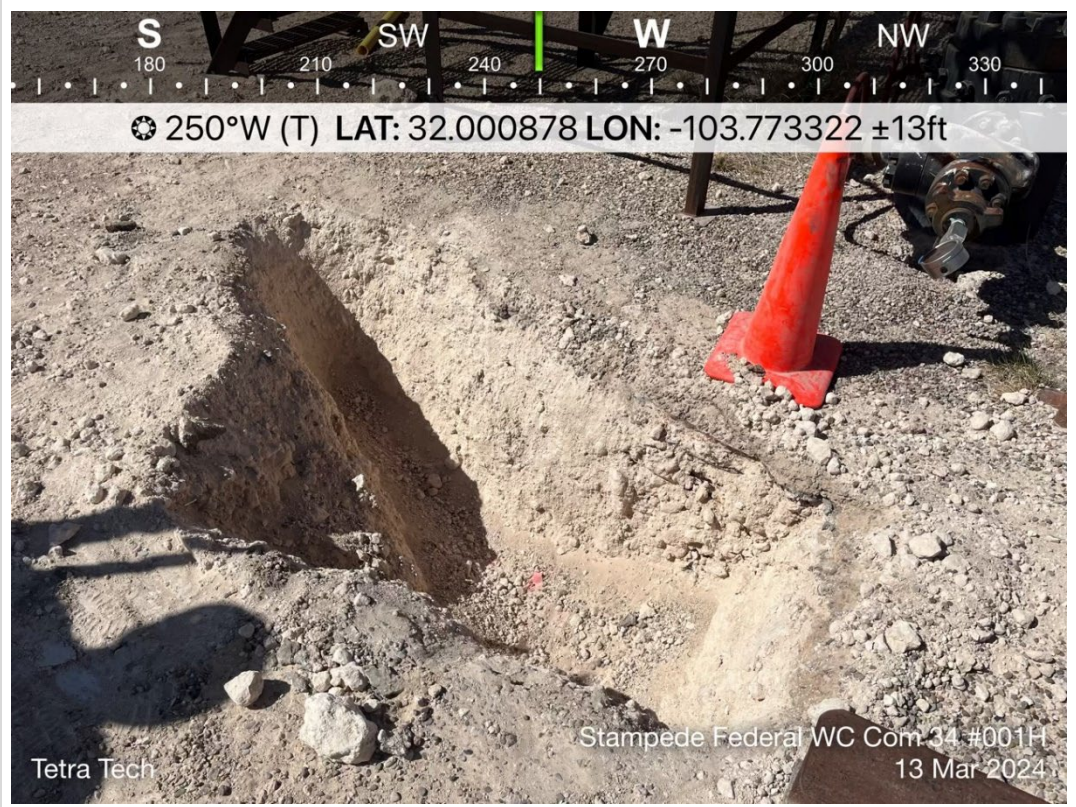
TETRA TECH, INC. PROJECT NO. 212C-MD-03248	DESCRIPTION	View south-southwest. View of southeast excavation to 3 ft bgs.	10
	SITE NAME	STAMPEDE FEDERAL WC COM #001 Release	10/27/2023

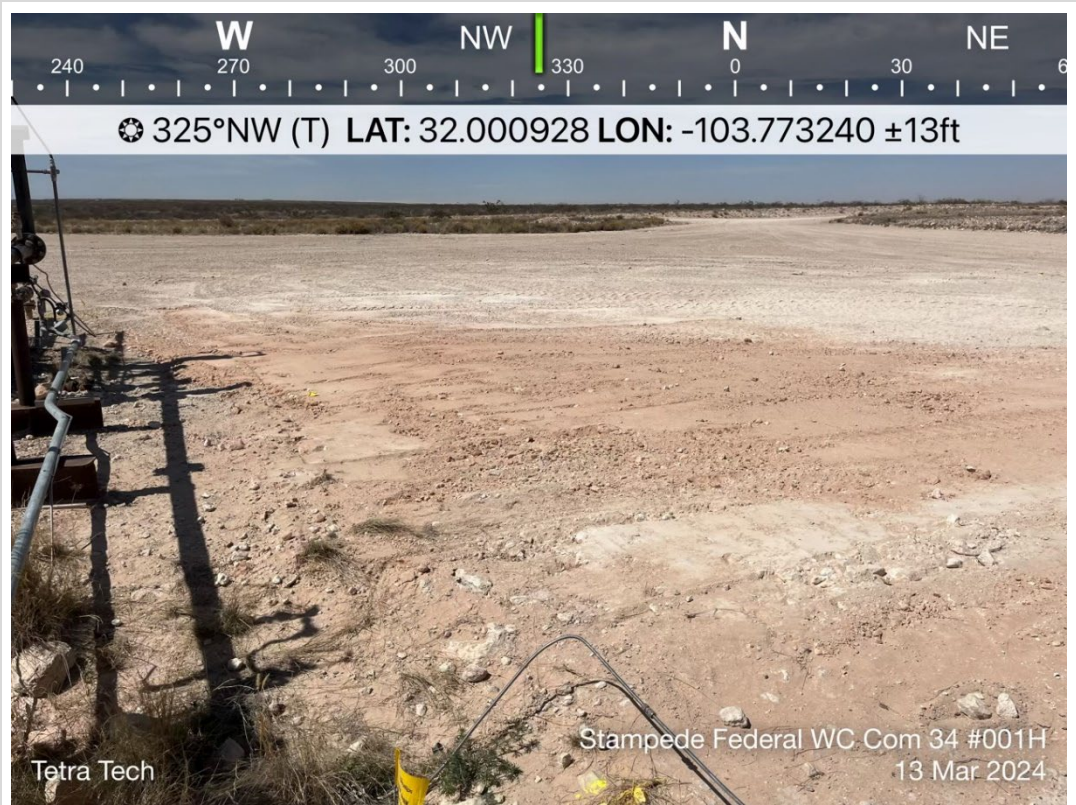
TETRA TECH, INC. PROJECT NO. 212C-MD-03248	DESCRIPTION	View northwest. View of backfilled area.	12
	SITE NAME	STAMPEDE FEDERAL WC COM #001 Release	10/27/2023

Backfilled areas were restored to the original condition or the final land use. As the release footprint was within an active pad, the release was not seeded. Copies of laboratory analysis and chain-of-custody documentation are included in Appendix C.

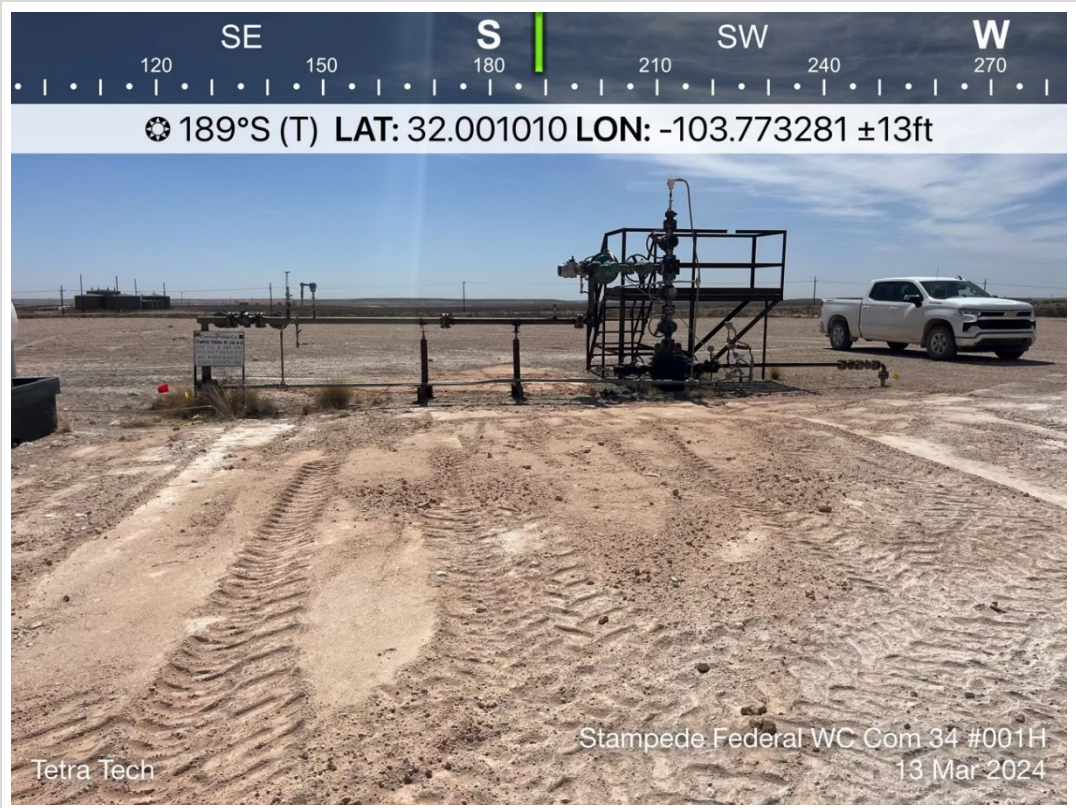
TETRA TECH, INC. PROJECT NO. 212C-MD-03248	DESCRIPTION	View south. View of backfilled excavation. View of production equipment.	13
	SITE NAME	STAMPEDE FEDERAL WC COM #001 Release	3/13/2024

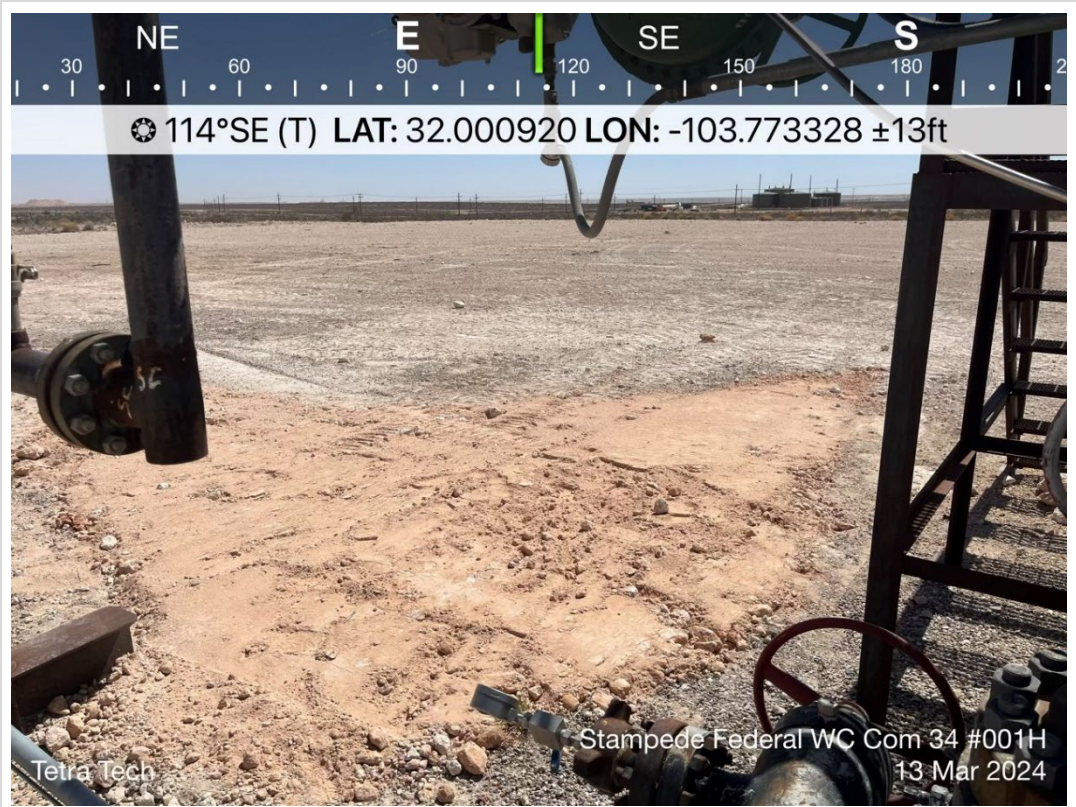
TETRA TECH, INC. PROJECT NO. 212C-MD-03248	DESCRIPTION	View east. View of backfilled excavation to the southeast.	14
	SITE NAME	STAMPEDE FEDERAL WC COM #001 Release	3/13/2024
