## Remediation Summary and Deferral Request

**Spur Energy Partners, LLC**

**Tarpan 33 Fee #004H Battery**

**NMOCD Reference No. nAPP2311043712**

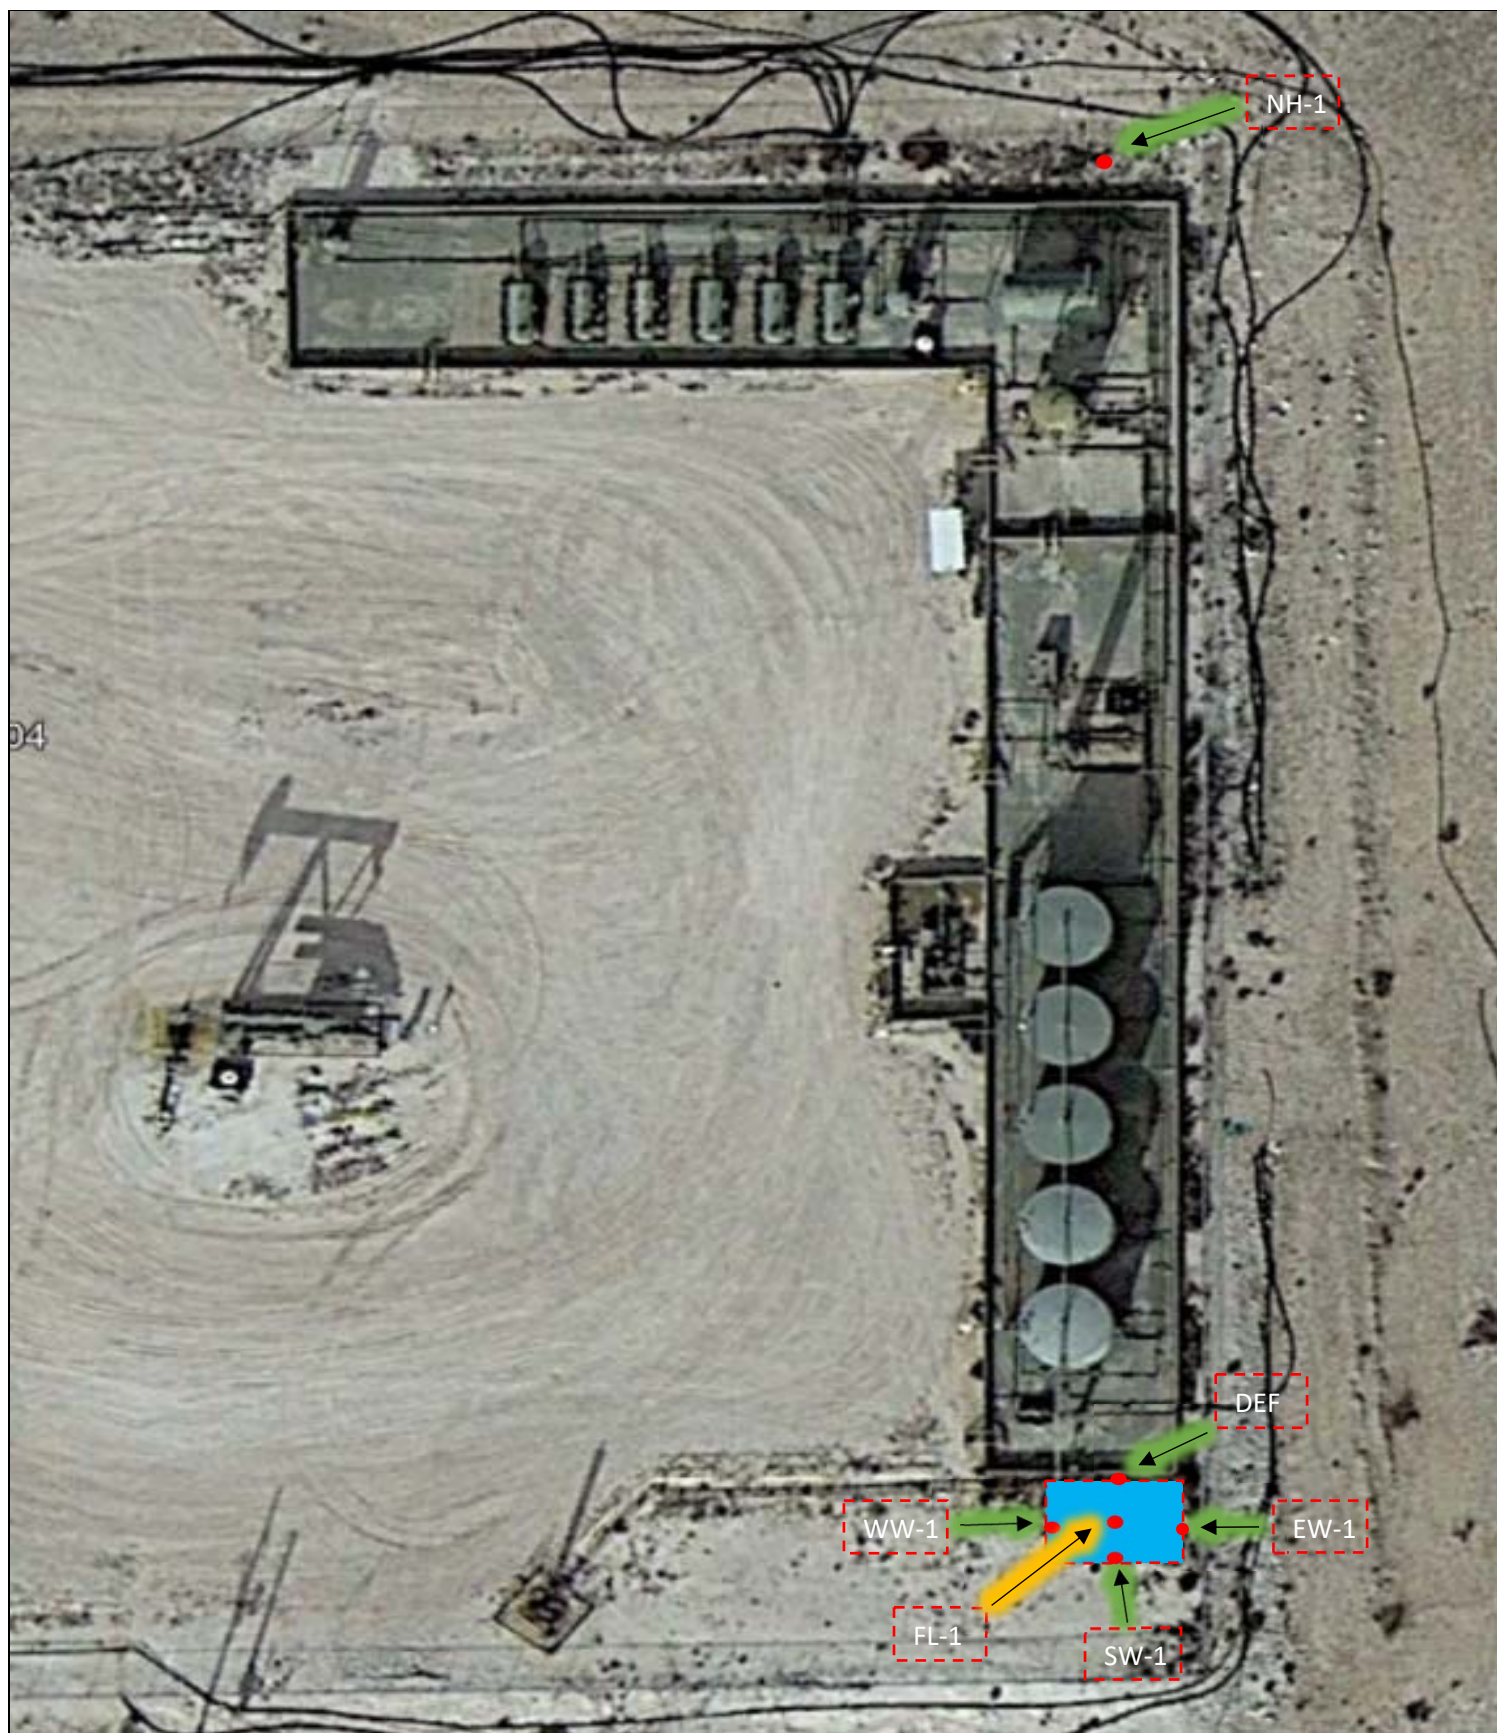
## **Figure 3**

### **Site and Sample Location Map**

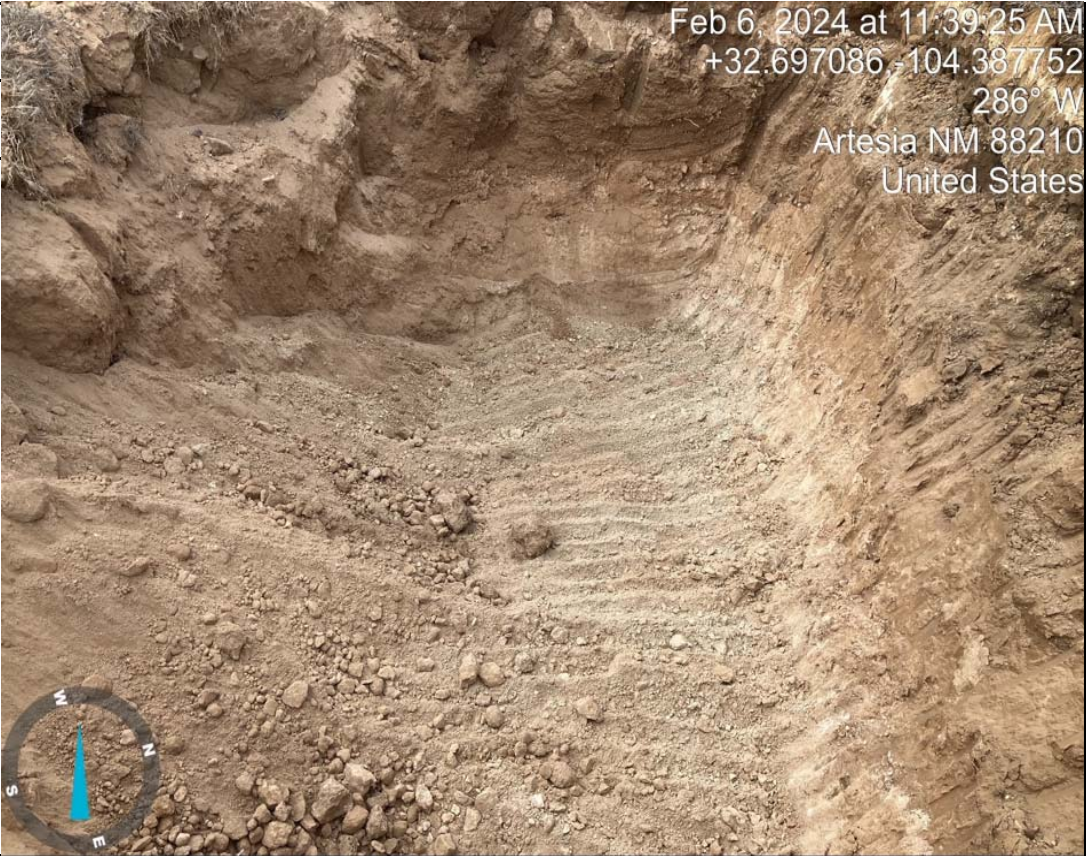
<b>Photo Number:</b> #3

Feb 6, 2024 at 11:39:25 AM +32.697086, -104.387752 286° W Artesia NM 88210 United States
<b>Photo Direction:</b> East		
<b>Photo Description:</b>  Excavation

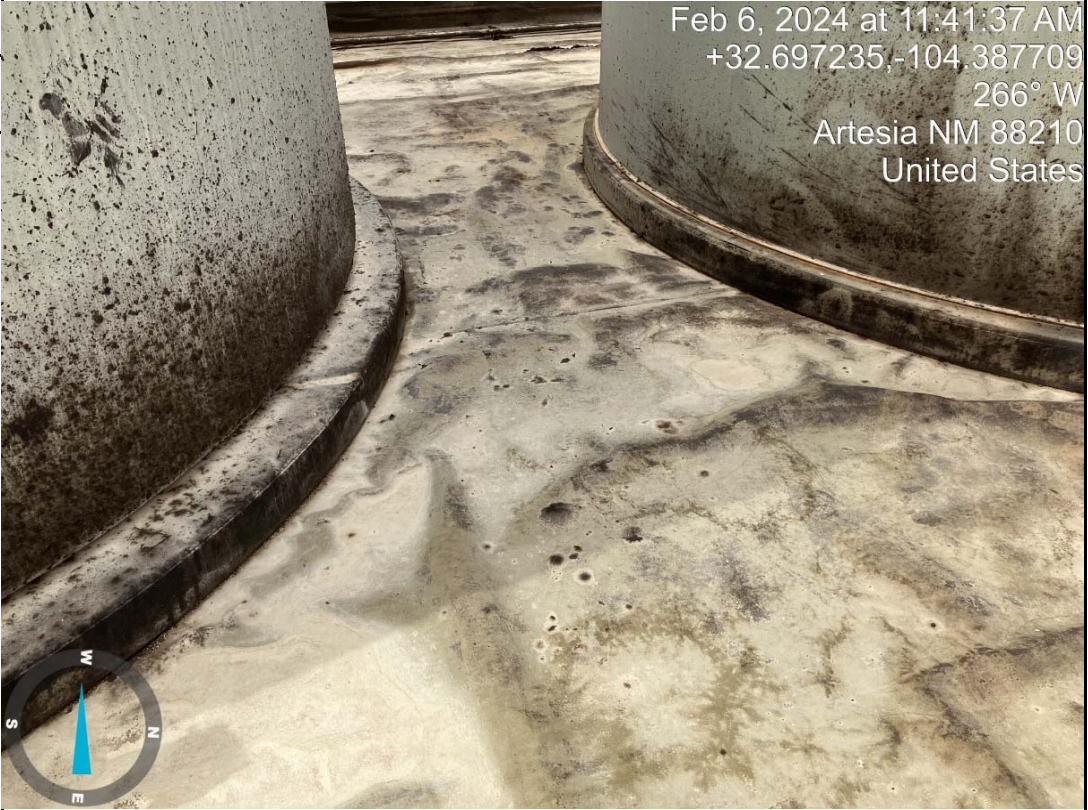
<b>Photo Number:</b> #3

<p>Feb 6, 2024 at 11:41:37 AM +32.697235,-104.387709 266° W Artesia NM 88210 United States</p>
<b>Photo Direction:</b> West	
<b>Photo Description:</b>  Liner not compromised
