Release Volume Estimate Ogden State 5H Release

Site Assessment and Remediation Work Plan

Murchison Oil & Gas, LLC

SITE PHOTOGRAPHS – OGDEN STATE 5H RELEASE

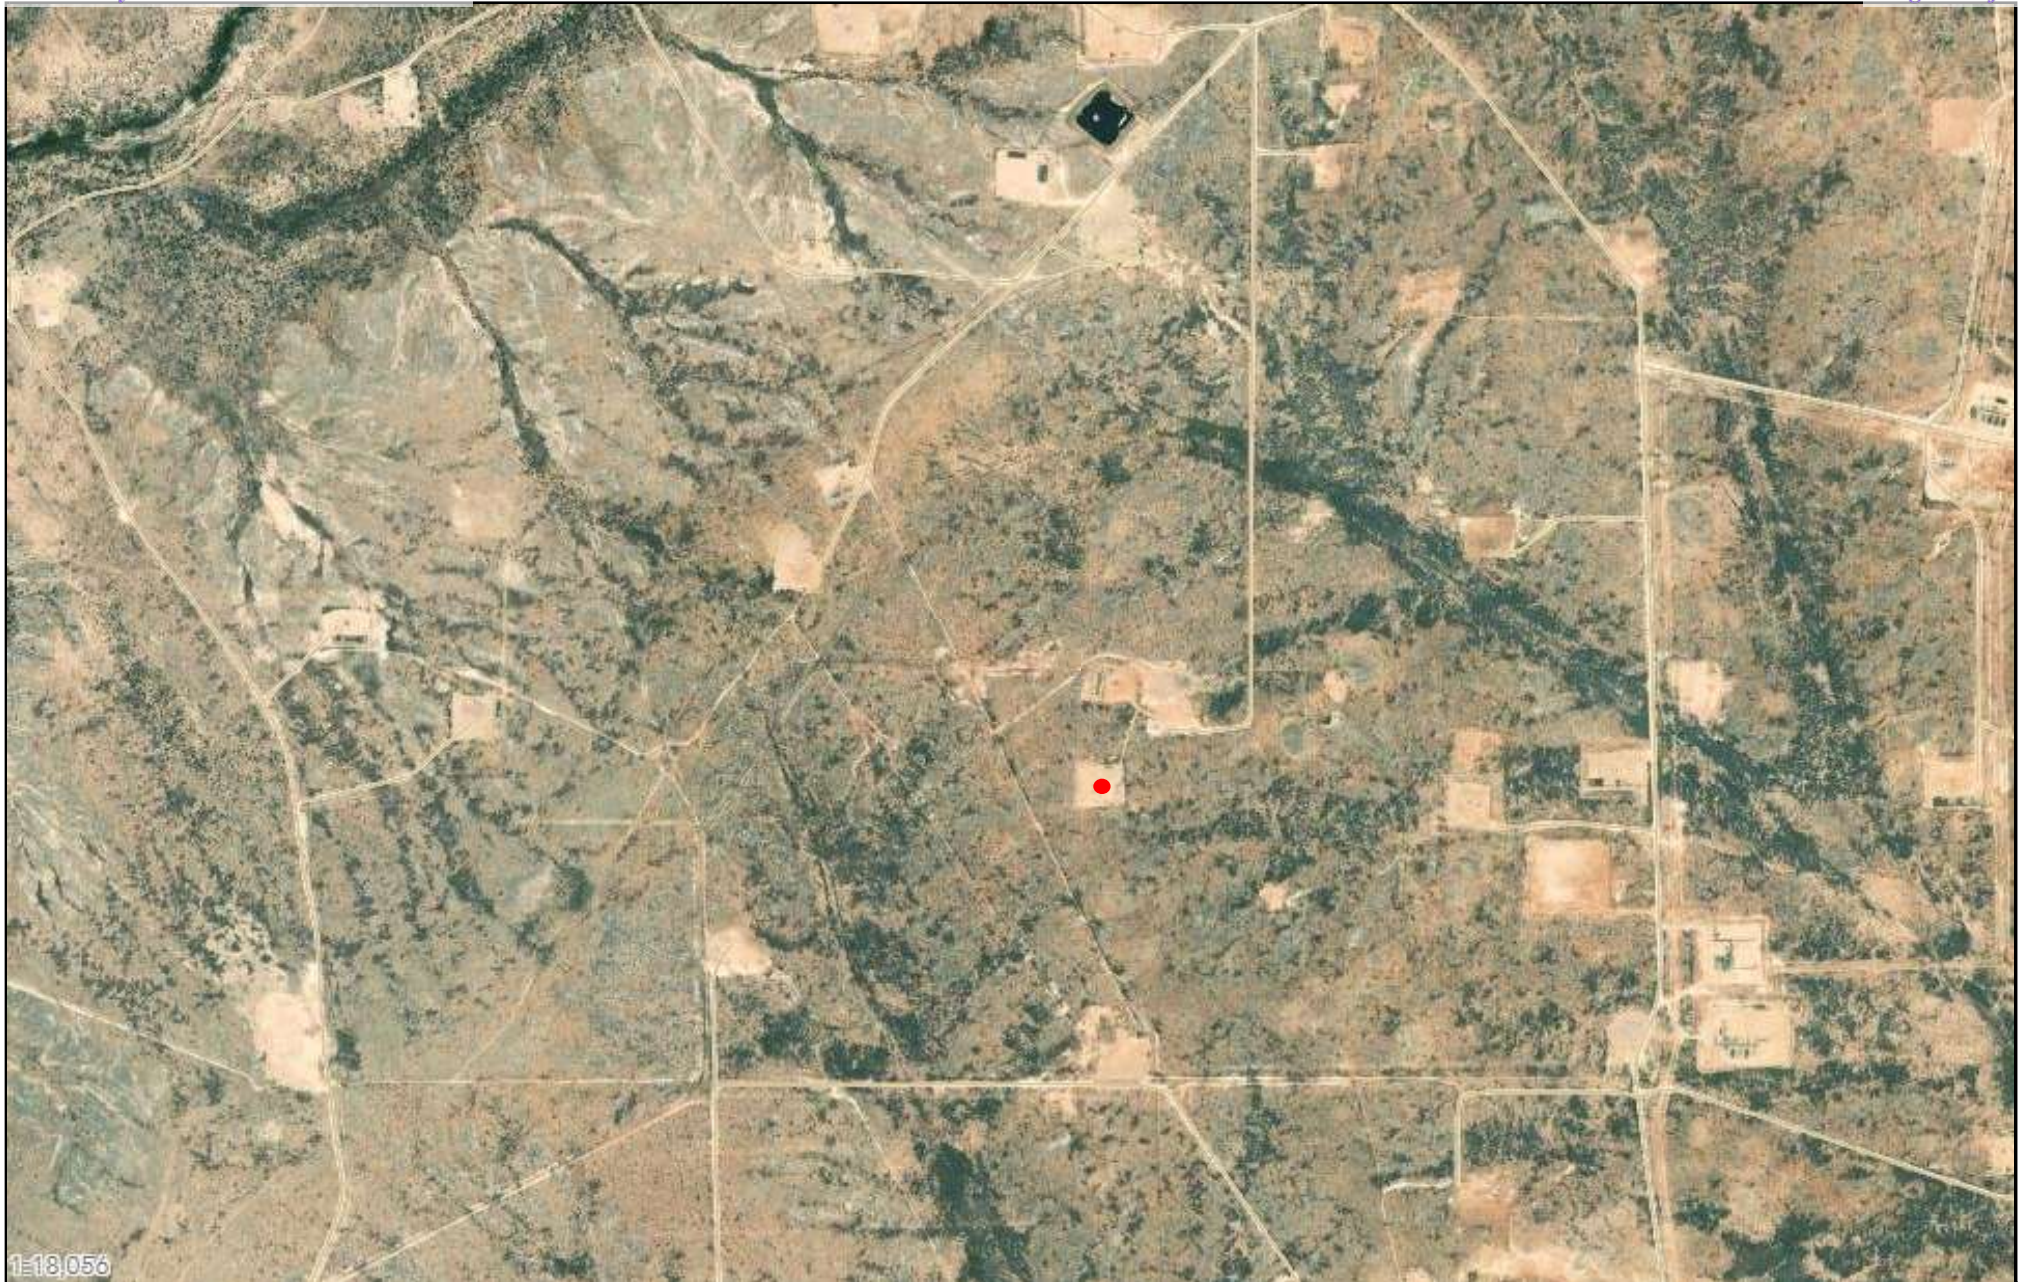
**Figure 2**

OSE POD Locations Map
Murchison Oil & Gas
Ogden State 5H
GPS: 32.152079, -104.260939
Eddy County

A search of the New Mexico Office of the State Engineer (NMOSE) and United States Geological Survey (USGS) groundwater databases was completed in an effort to determine the horizontal distance to known water sources within a half mile radius of the Release Site. Approximate depth to groundwater was determined using maintained and published water well data. Karst mapping indicates the site is located in a Gypsum Karst designated area. Depth to groundwater information is provided as Attachment II and the results are depicted on Figures 2 and 3.

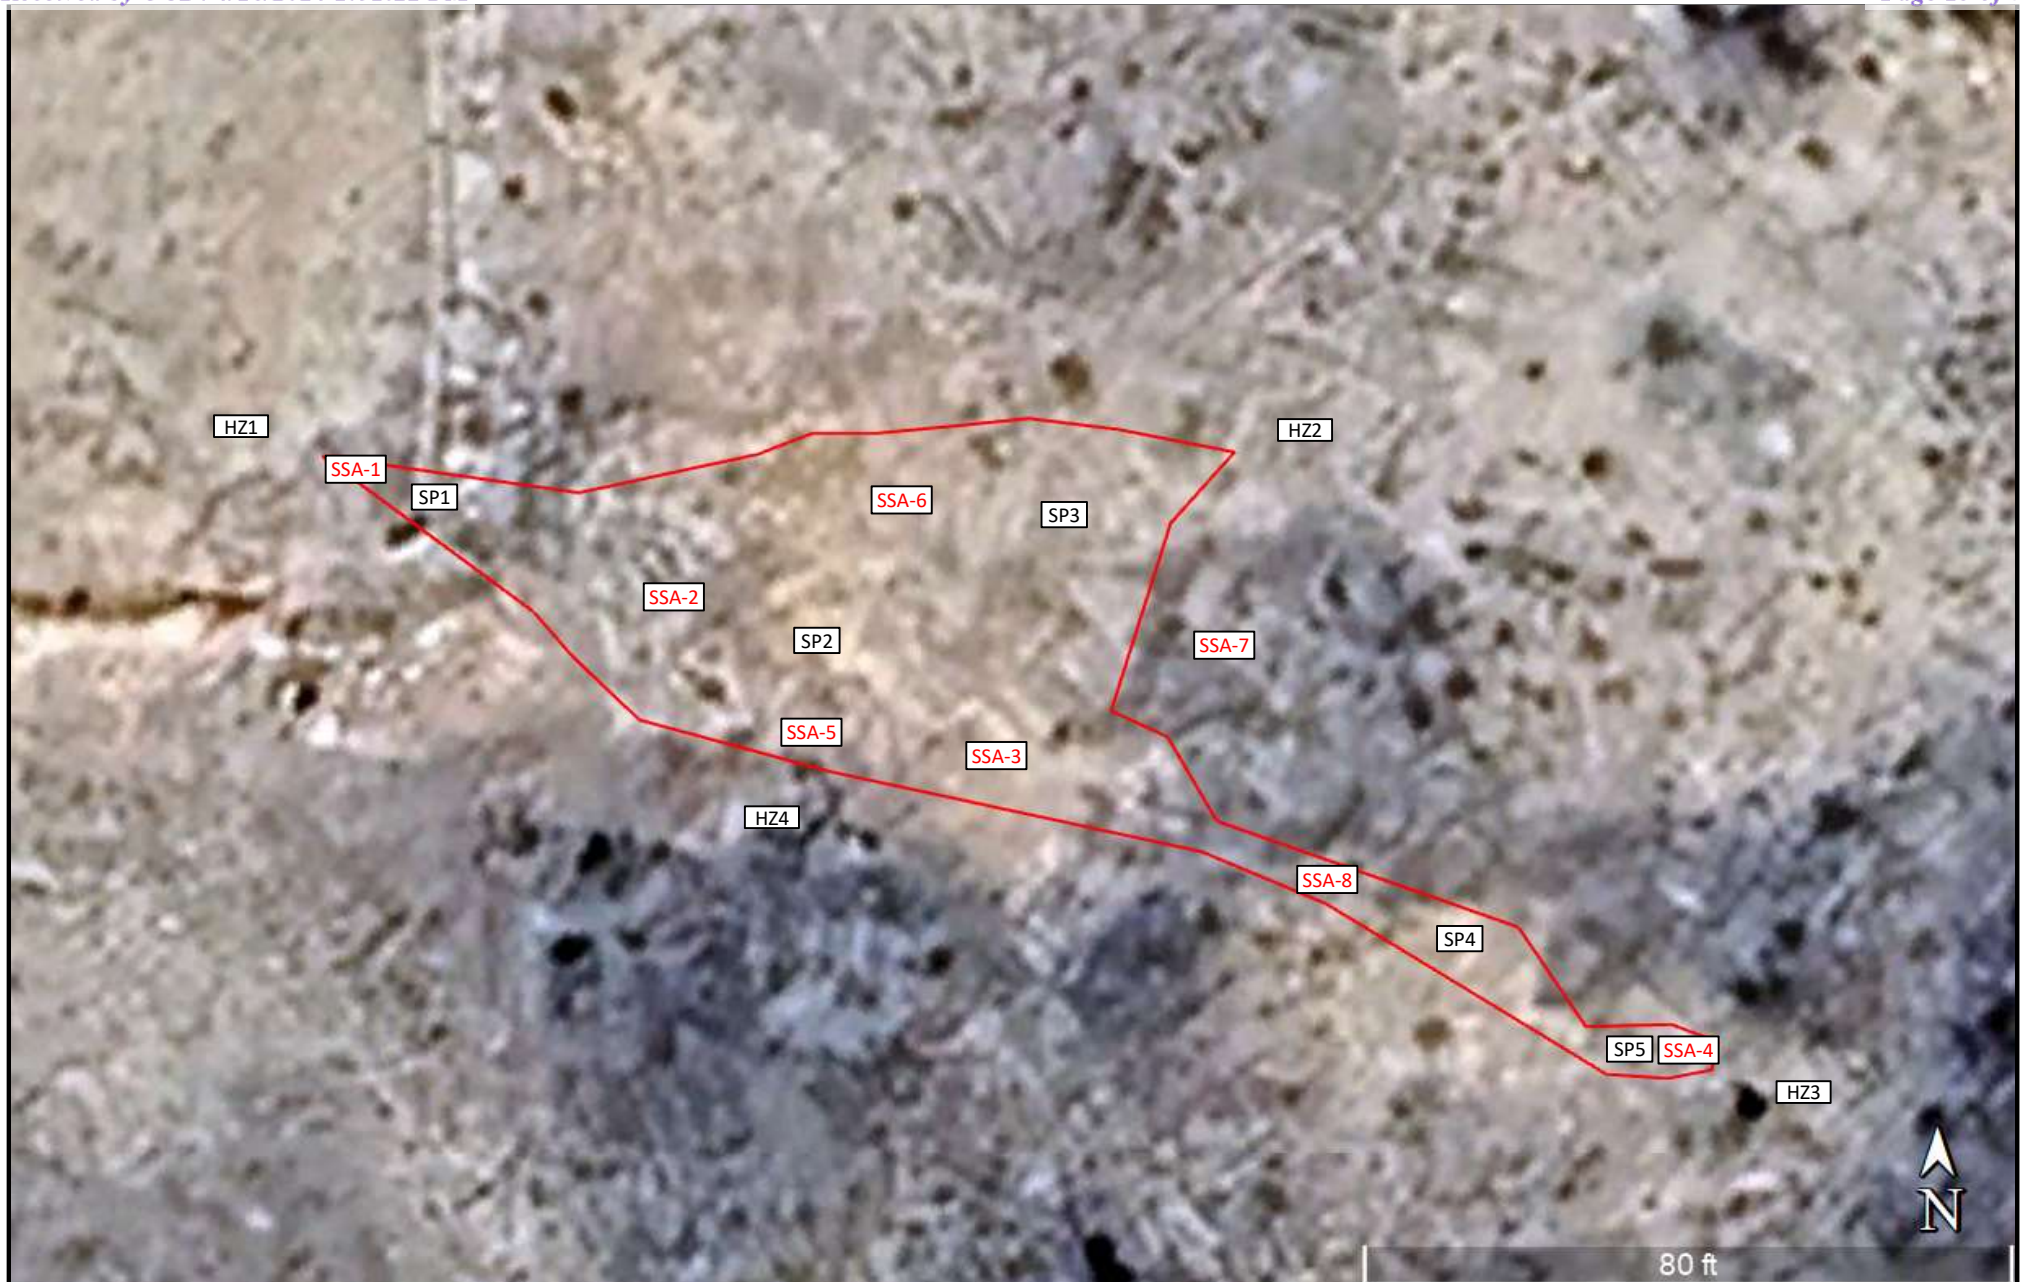
**Figure 4**

Proposed Delineation Sample Map
 Murchison Oil & Gas
 Ogden State 5H
 GPS: 32.152079, -104.260939
 Eddy County

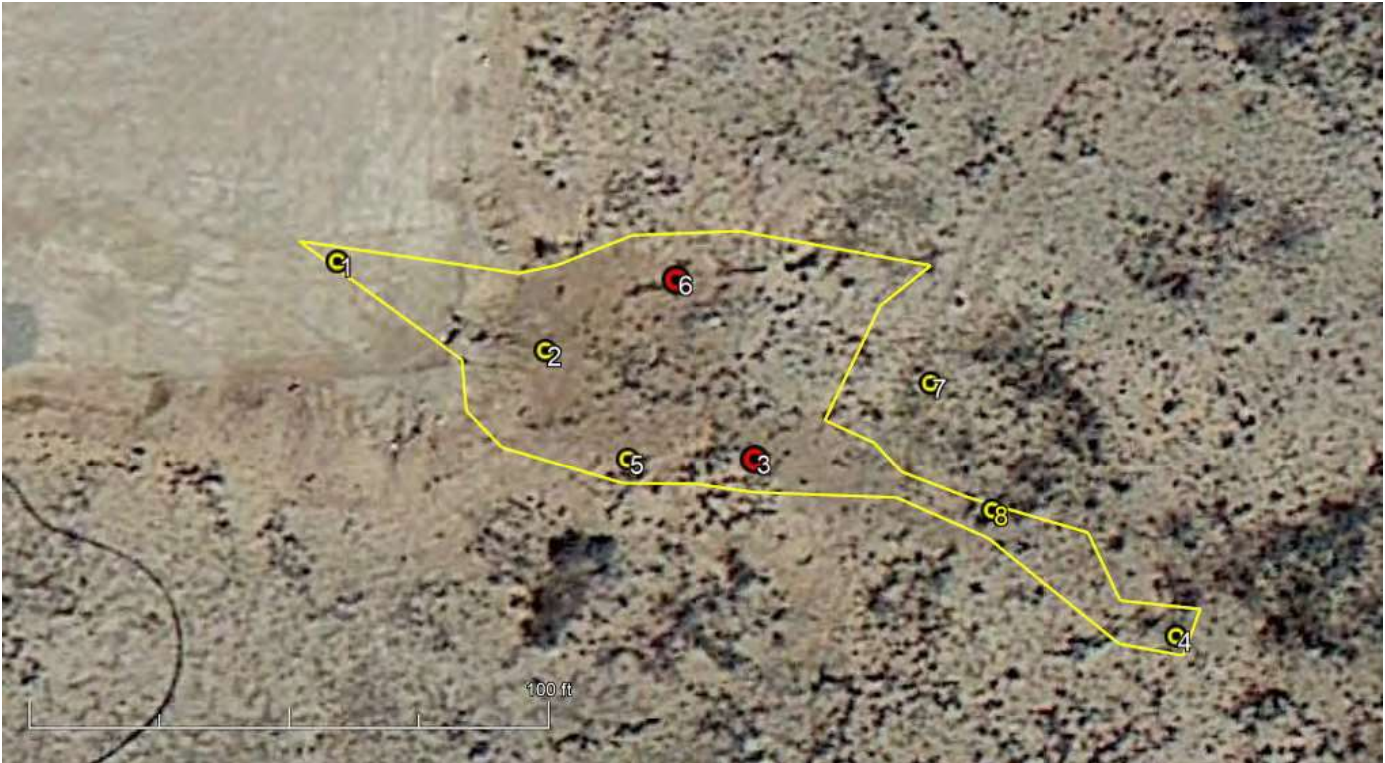
Above is the 4/6/2013 Google Earth Image that appears to show minor discoloration of the soil that may define the release footprint. Only sampling locations 6 and 3 exceed the Rule 29 reclamation limit (600 mg/kg) for chloride. The outline of the release is based upon this image, our 2023 field visit, and the laboratory results.

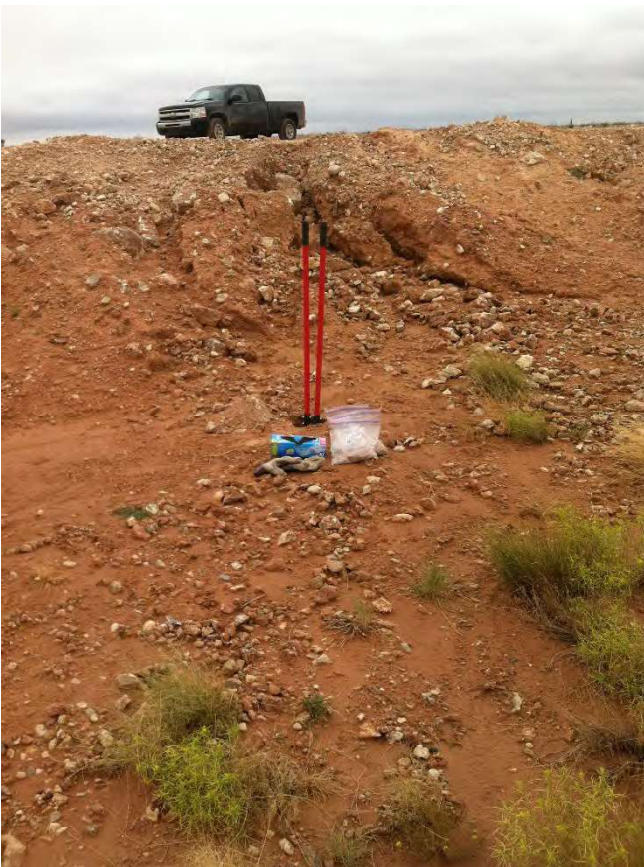
SP1 View northwest location of the October 2012 “base of delta” sample. A large rainfall event caused an overflow of the steel drilling pits on April 10, 2012. The released fluid drained to the southeast corner of the location, broke through the dirt berm, and caused erosion of the pad and deposition of a small alluvial fan (delta). This location is near the 2023 sample SSA-02.

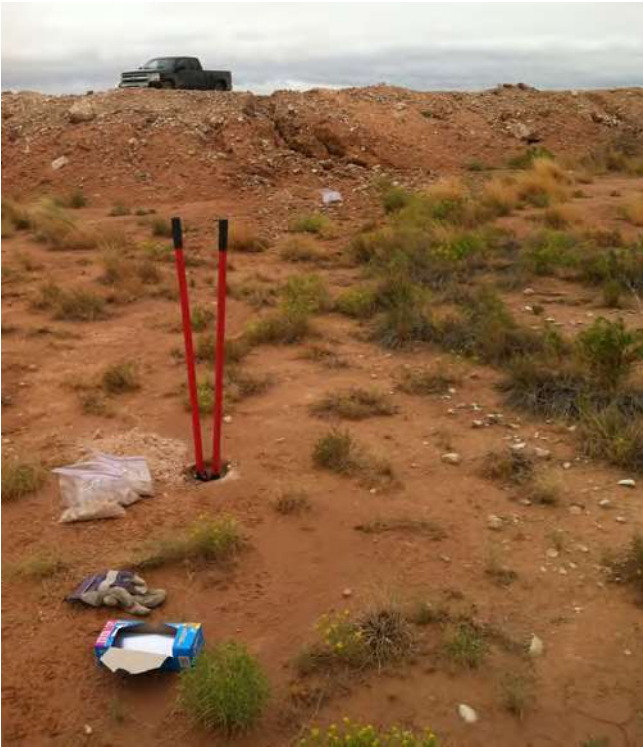
SP2 View northwest from sample "edge of delta", which is slightly uphill from the 2023 sample SSA-03

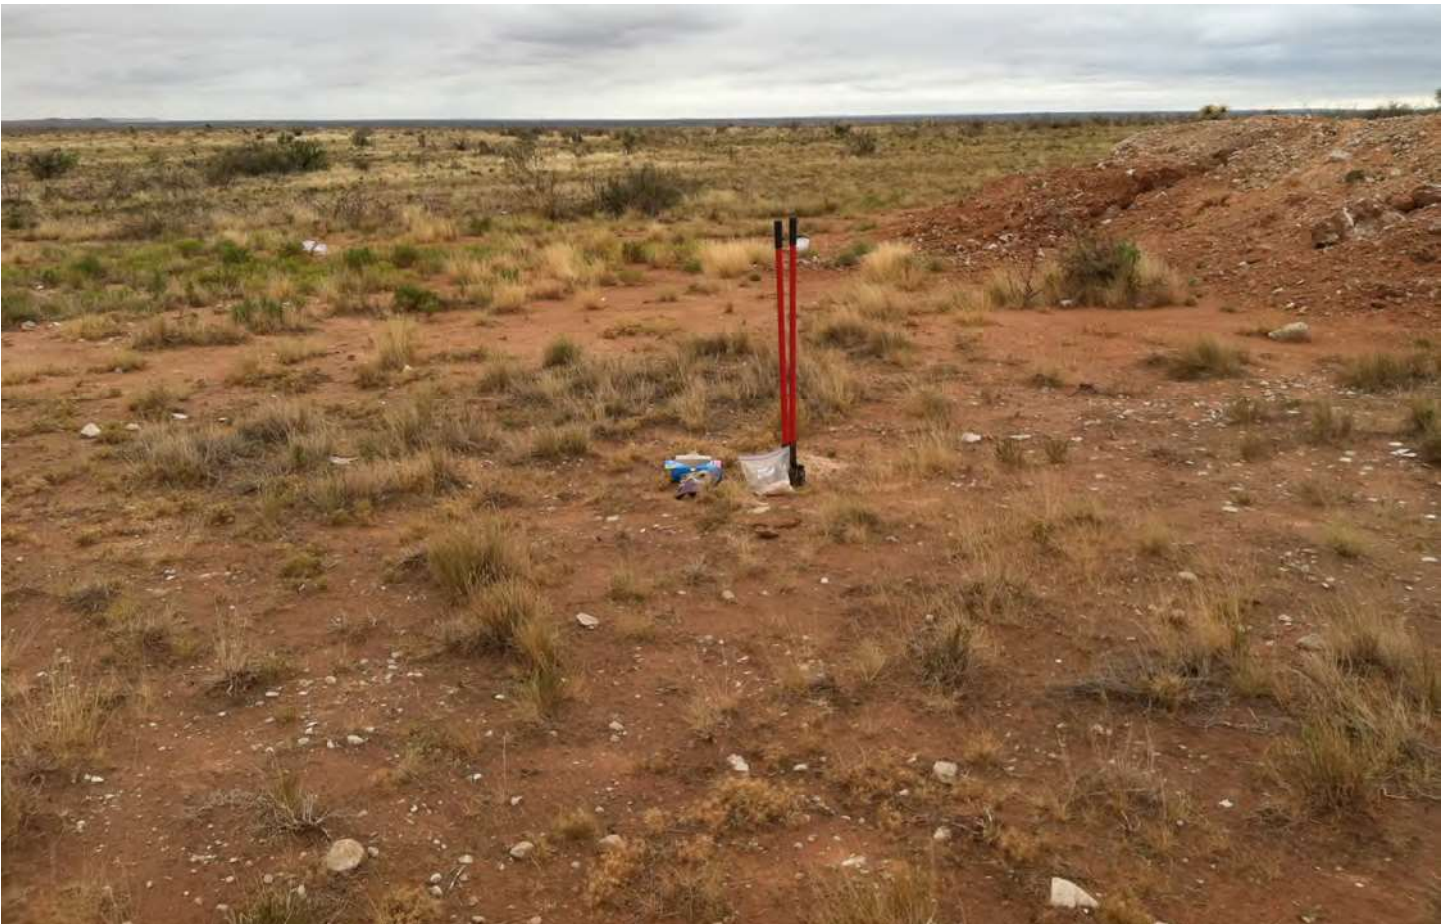
SP3 Looking south-southwest showing the post hole boring of the "background" sample of April 2012. The base of delta and edge of delta sample bags are visible.
