Remediation Summary & Soil Closure Request

Spur Energy Partners, LLC Skelly Unit #984

Eddy County, New Mexico
Unit Letter M, Section 14, Township 17 South, Range 31 East
Latitude 32.8282623 North, Longitude 103.8457184 West
NMOCD Reference No. NRM2010634337

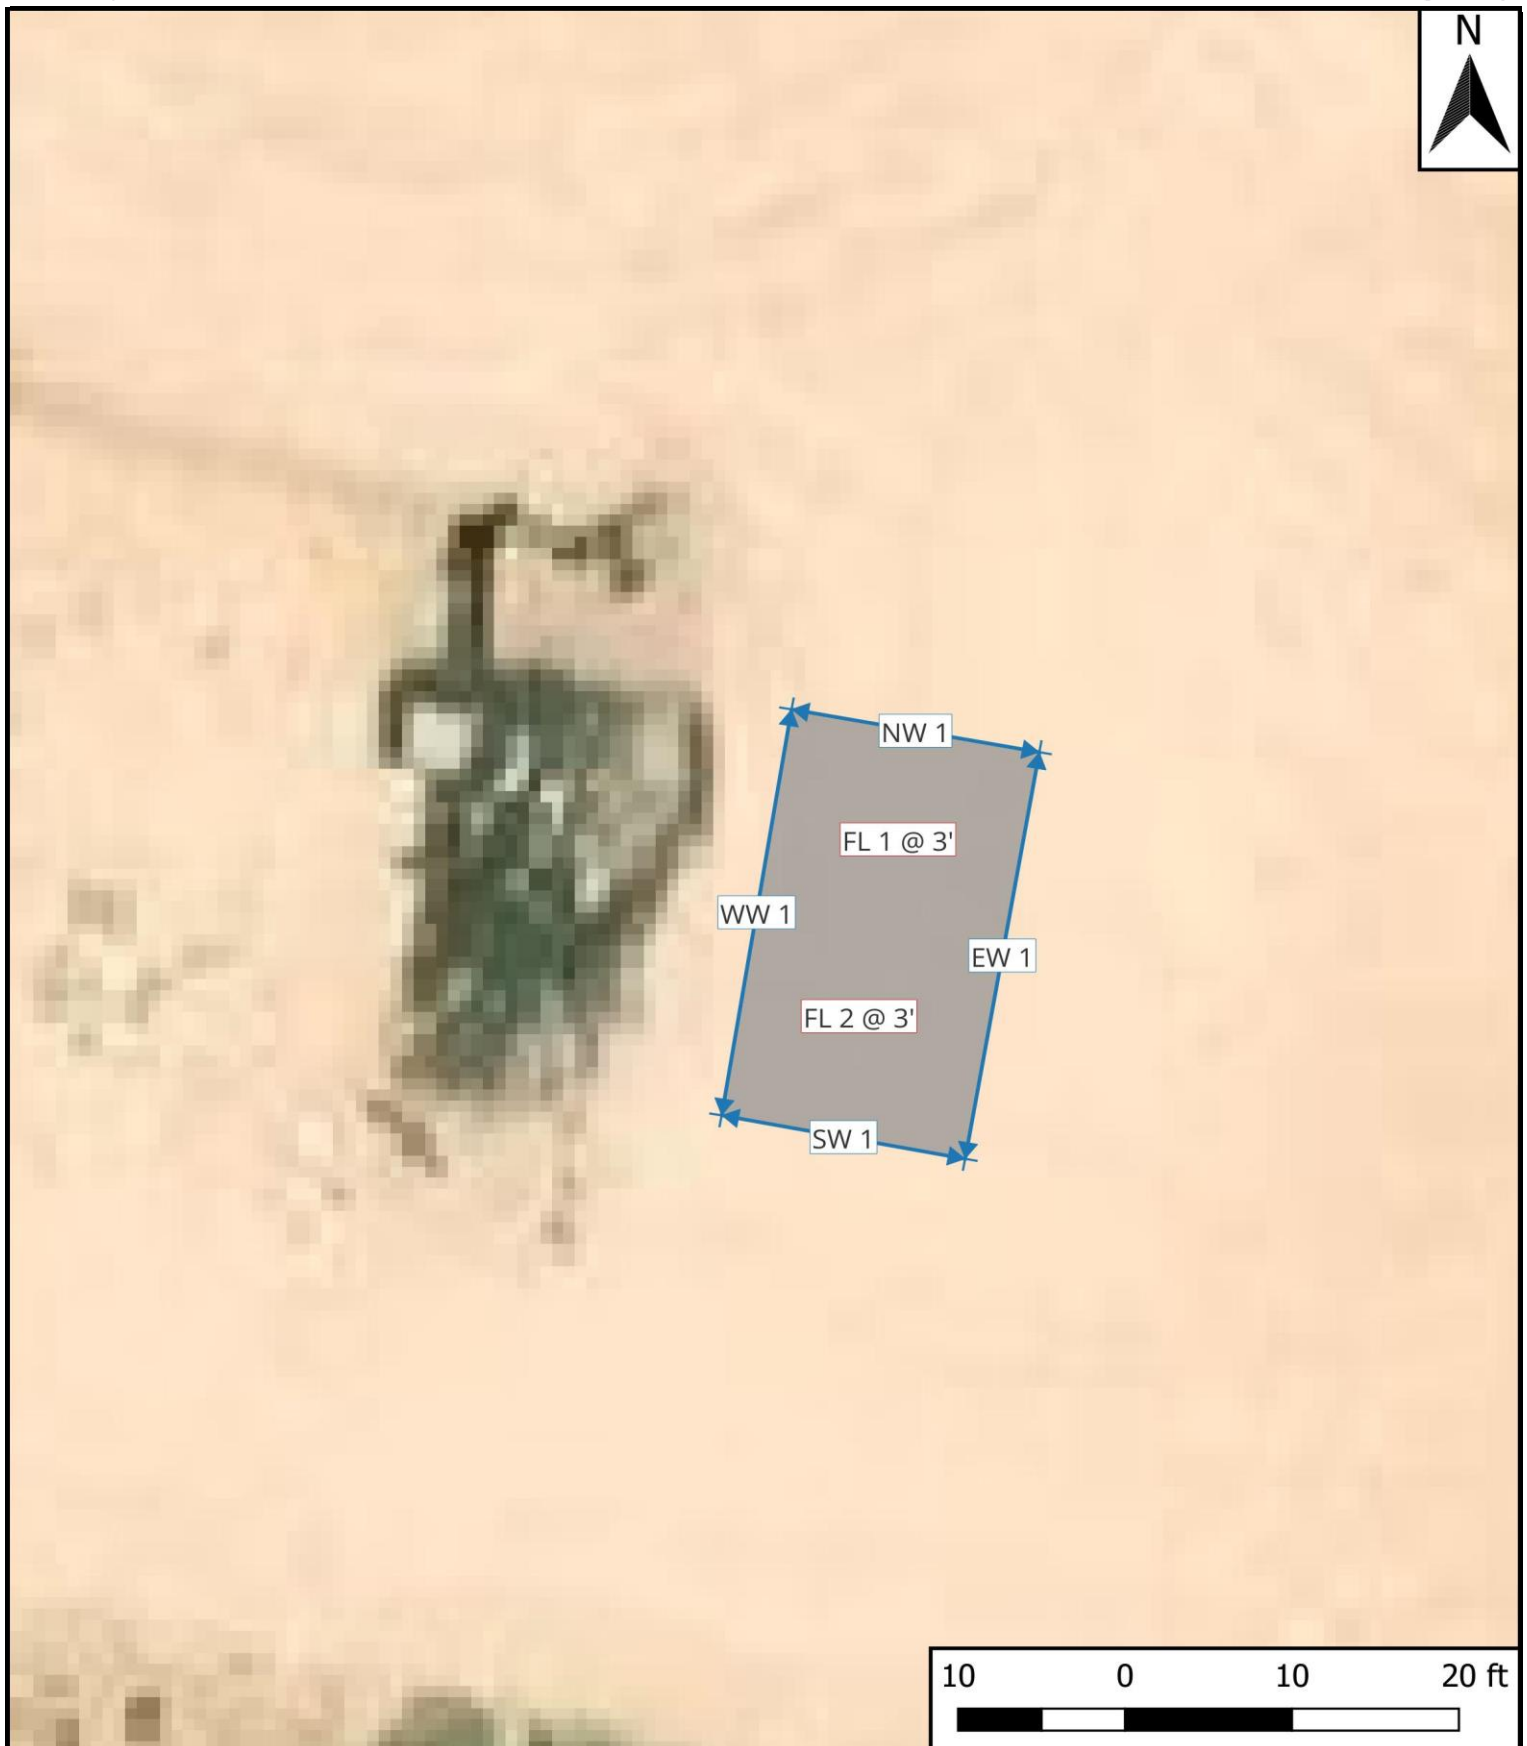
Figure 3

Etech collected six (6) confirmation soil samples (FL 1 @ 3', FL 2 @ 3', EW 1, NW 1, SW 1, and WW 1) from the sidewalls and floor of the excavated area. The soil samples were submitted to a certified, commercial laboratory (henceforth, "the laboratory") for analysis of BTEX, TPH, and chloride. Laboratory analytical results indicated that benzene, BTEX, GRO+DRO, TPH, and chloride concentrations were below the applicable NMOCD Closure Criteria and NMOCD Reclamation Standards in each of the submitted soil samples.

The final dimensions of the excavated area were approximately 25 feet in length, fifteen (15) feet in width, and three (3) feet in depth. During the course of remediation activities, Etech transported approximately sixty (60) cubic yards of impacted soil to an NMOCD-permitted surface waste facility for disposal and imported approximately sixty (60) cubic yards of locally sourced, non-impacted material to the Site for use as backfill.

Confirmation soil sample locations and the extent of the excavated area are depicted in Figure 3, "Site and Sample Location Map". A soil chemistry table is provided as Table 1. Field data is provided in Appendix B. A photographic log of remediation activities is provided in Appendix C. Laboratory analytical reports are provided in Appendix D. Regulatory correspondence is provided in Appendix E. Electronic C-141 supplemental Site characterization maps are provided in Appendix F.

Site and Sample Location Map

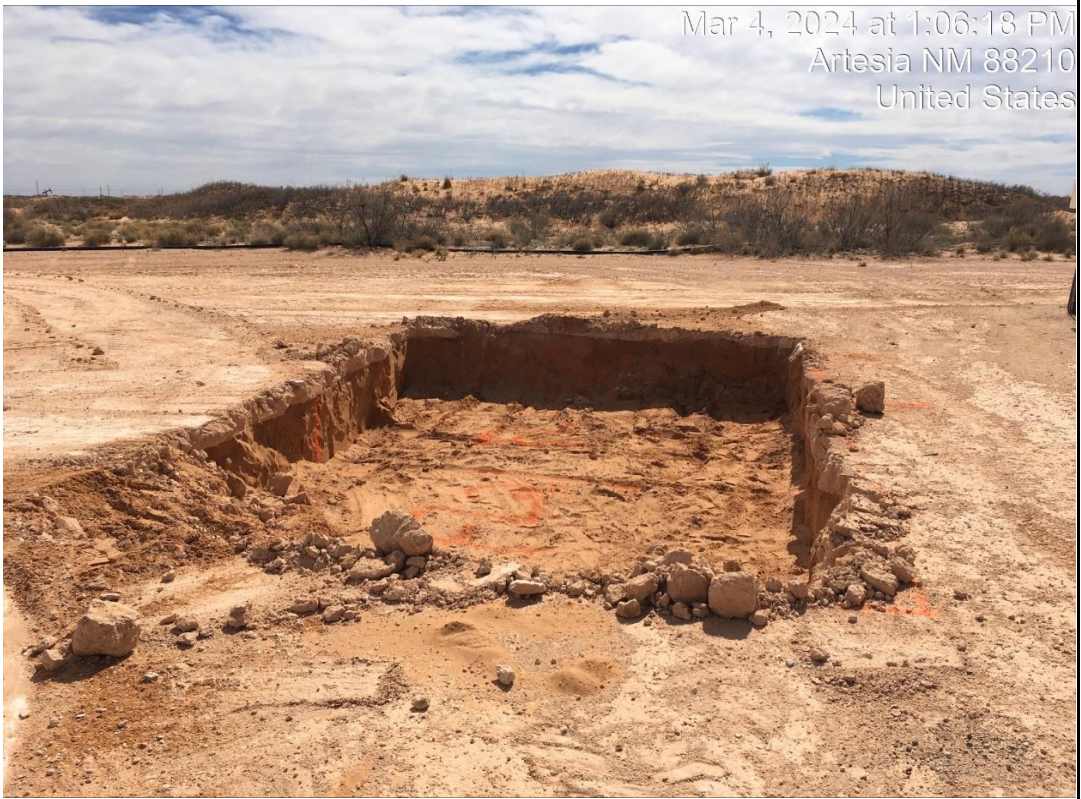
Photo Number: 1	<div>Mar 4, 2024 at 1:06:18 PM Artesia NM 88210 United States</div>

Photo Direction: South	
GPS Coordinates: 32.82829, -103.84557	
Photo Description: View of open excavation.

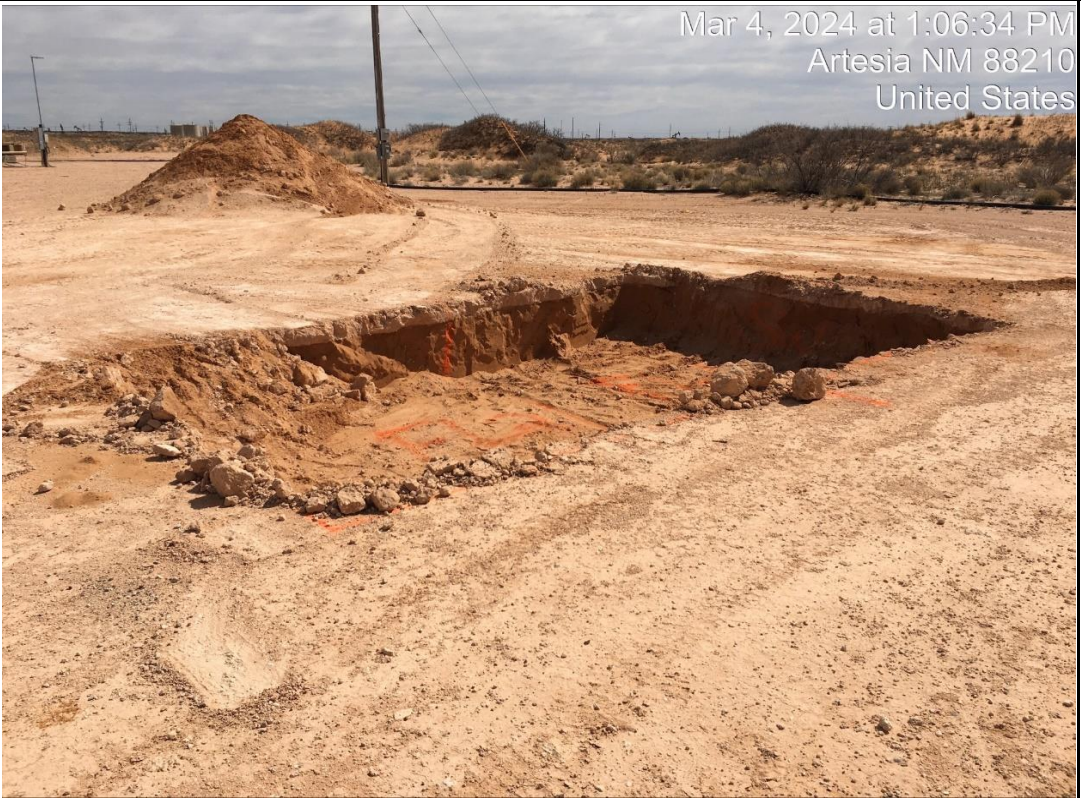
Photo Number: 2	<div>Mar 4, 2024 at 1:06:34 PM Artesia NM 88210 United States</div>

Photo Direction: Southeast	
GPS Coordinates: 32.82831, -103.84562	
Photo Description: View of open excavation.

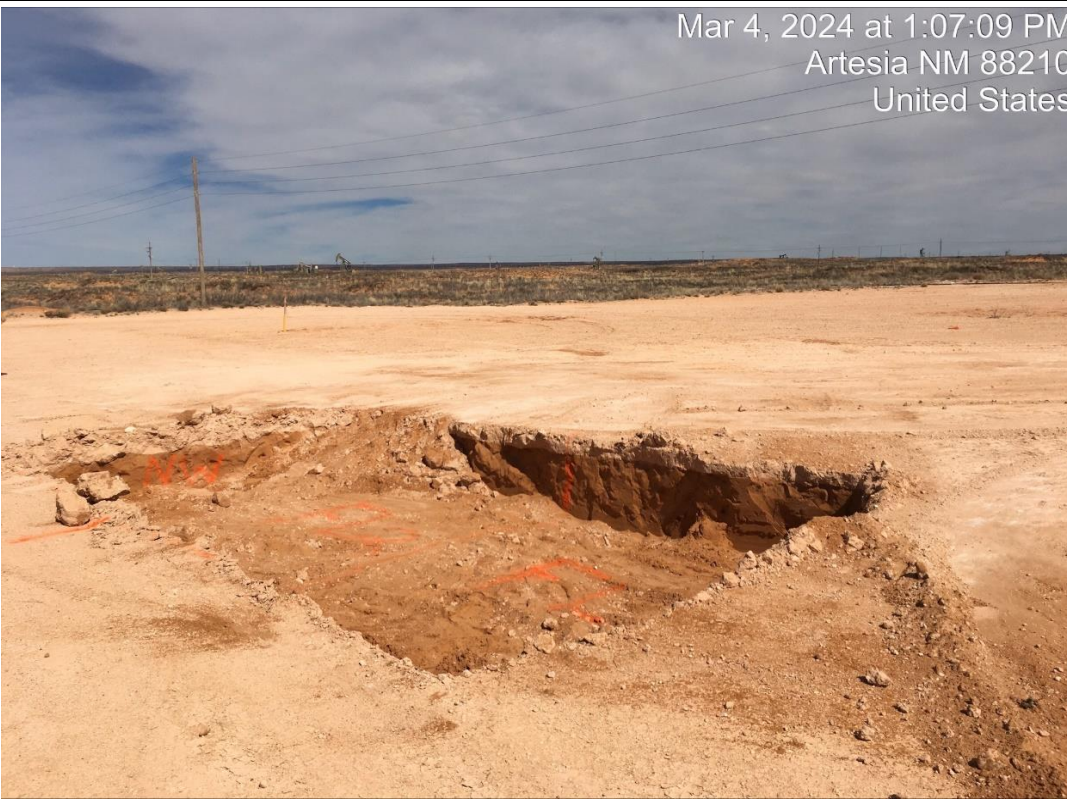
Photo Number: 3	<div>Mar 4, 2024 at 1:07:09 PM Artesia NM 88210 United States</div>

Photo Direction: Northeast	
GPS Coordinates: 32.82817, -103.84566	
Photo Description: View of open excavation.

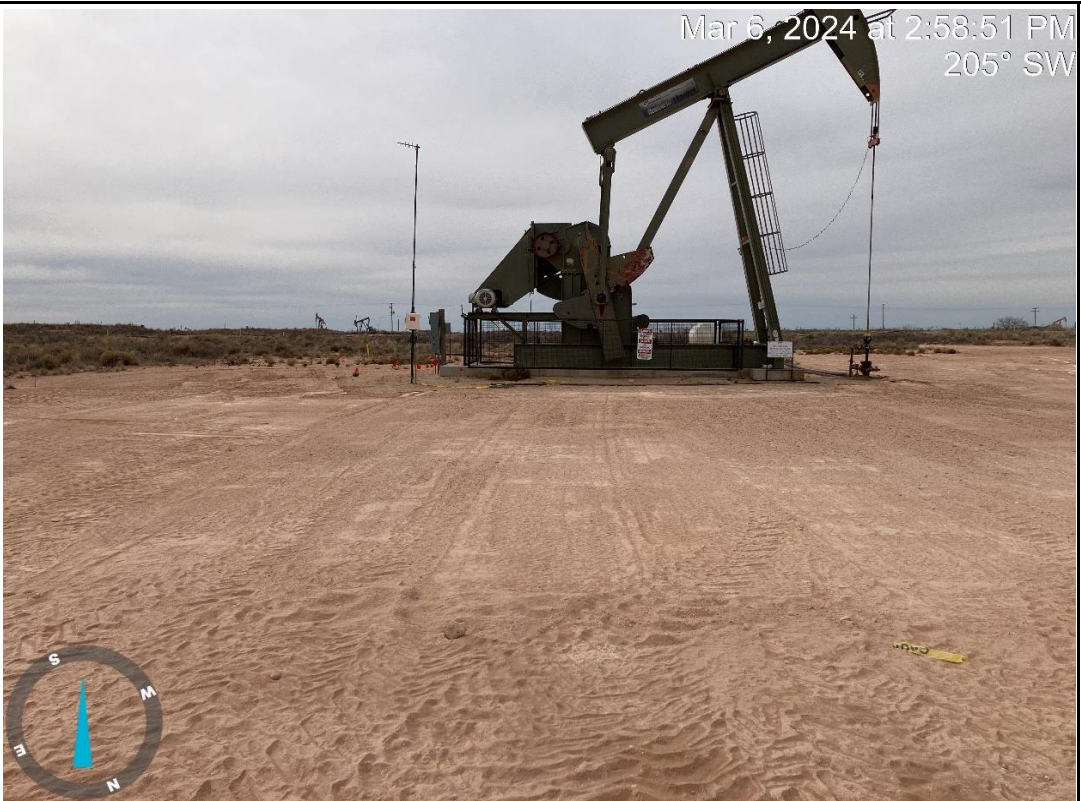
Photo Number: 5	<div>Mar 6, 2024 at 2:58:51 PM 205° SW</div>

<div>View of remediated area after backfill and grading.</div>
Photo Direction: West	
GPS Coordinates: 32.82820, -103.84547	
Photo Description:
