Interim Characterization Report and Remediation Plan

**2D-1 Well Tie/Bruce R Sullivan #2 (7/29/21)
Unit Letter I, S23 T28N R10W
San Juan County, New Mexico**

NM EMNRD OCD Incident ID No. NAPP2121054964

February 9, 2022
Ensolum Project No. 05A1226149

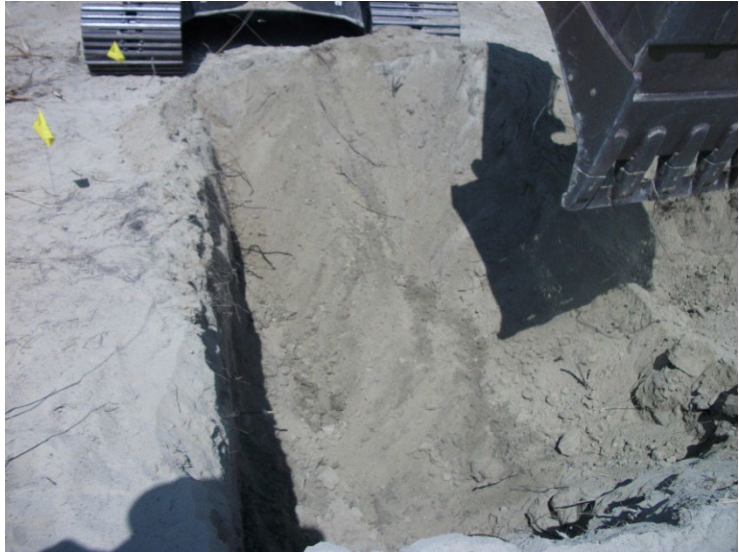
**Photograph 1**

Photograph Description: View of the initial excavation activities.

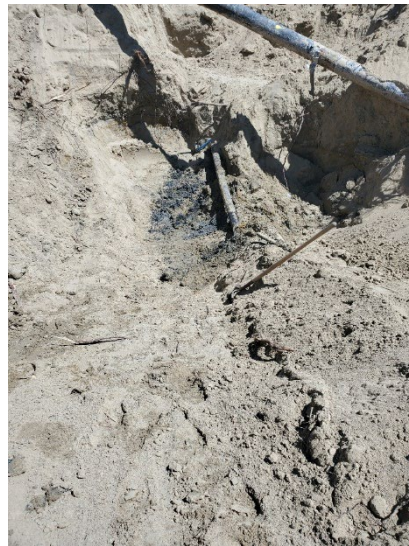
**Photograph 2**

Photograph Description: View of in-process excavation activities.

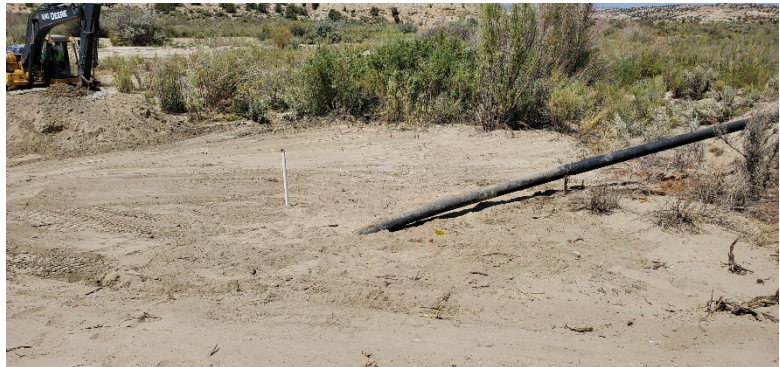
**Photograph 5**

Photograph Description: View of the site after restoration.
