# Durango Midstream

## **EOG 6" PVC**

### Closure Report

Unit Letter: M, Section 36, T19S, R24E  
Eddy County, New Mexico  
nAPP2319434216

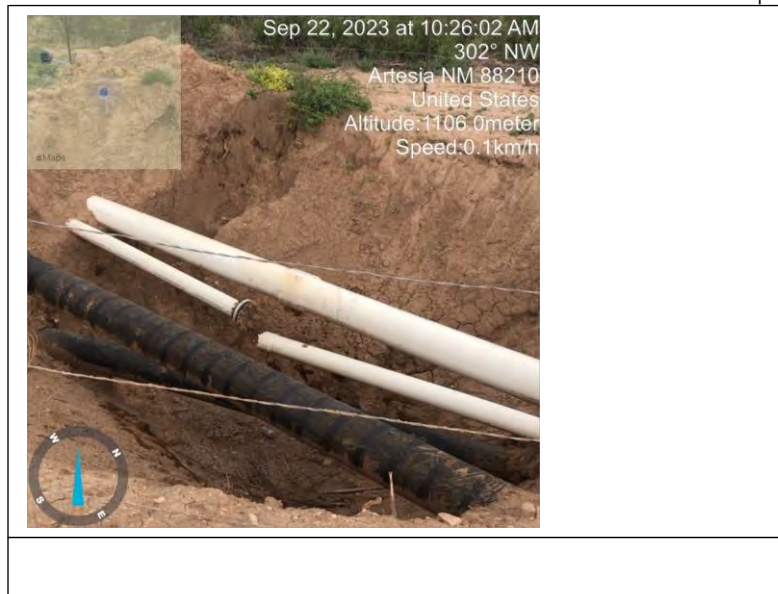
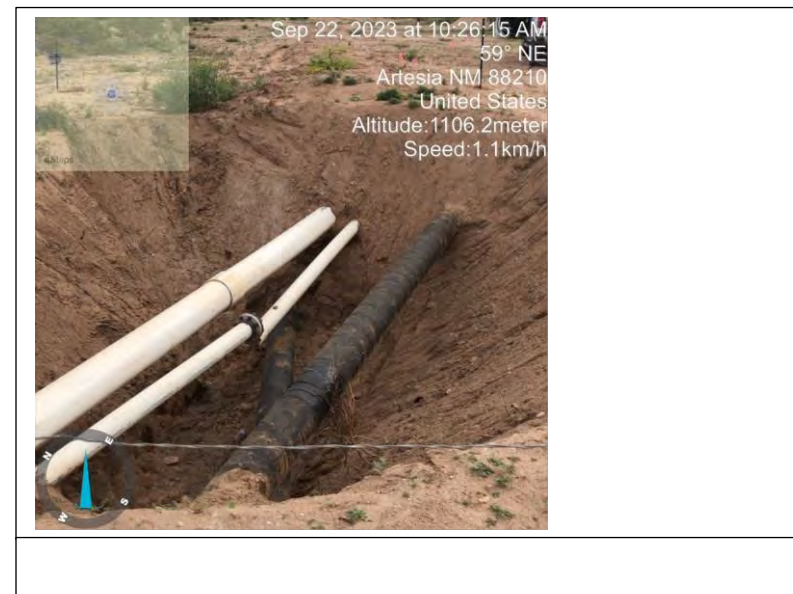
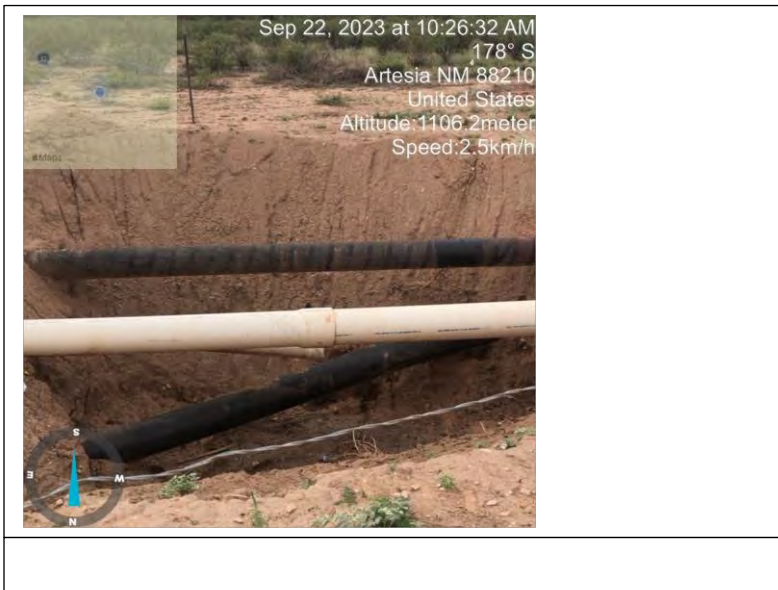
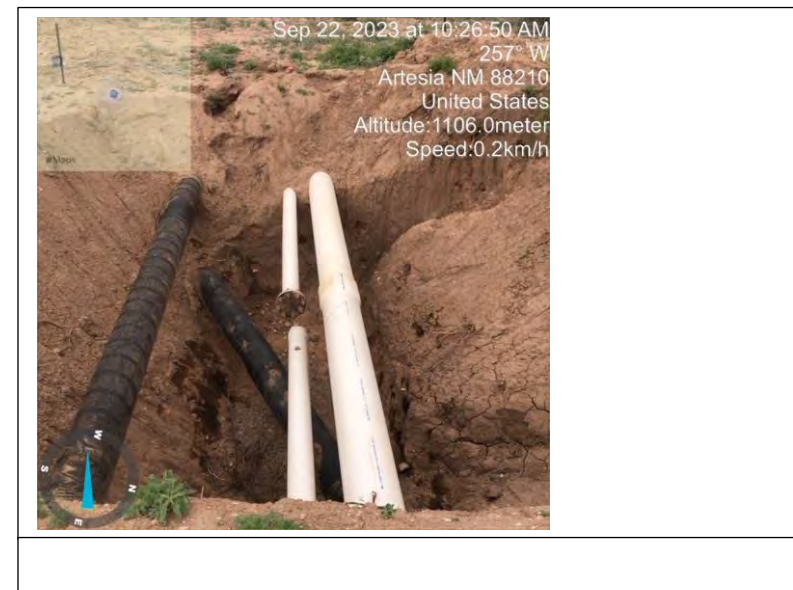
# Watson Spill September 22, 2023

SESI personnel arrived at the site on September 22, 2023, and collected four (4) composite samples of soil from the walls and a bottom hole sample which was taken at the SP 12 at a depth of 10 ft. referenced above. All soil samples were appropriately packaged, preserved, and transported to Cardinal Laboratories using a Chain of Custody for analysis of the following: Chloride (Method SM4500Cl-B), Benzene, Toluene, Ethylbenzene, and Xylenes (BTEX Method 8021B) and TPH 8015M. The sampling results are summarized in the table below:

Remedial actions at this site have all been performed in accordance with all New Mexico Oil Conservation Division (NMOCD) requirements. The affected areas were excavated and then backfilled with clean material from an offsite facility. Approximately 112 yards of contaminated soil was transported to J-Dan LandFarm.

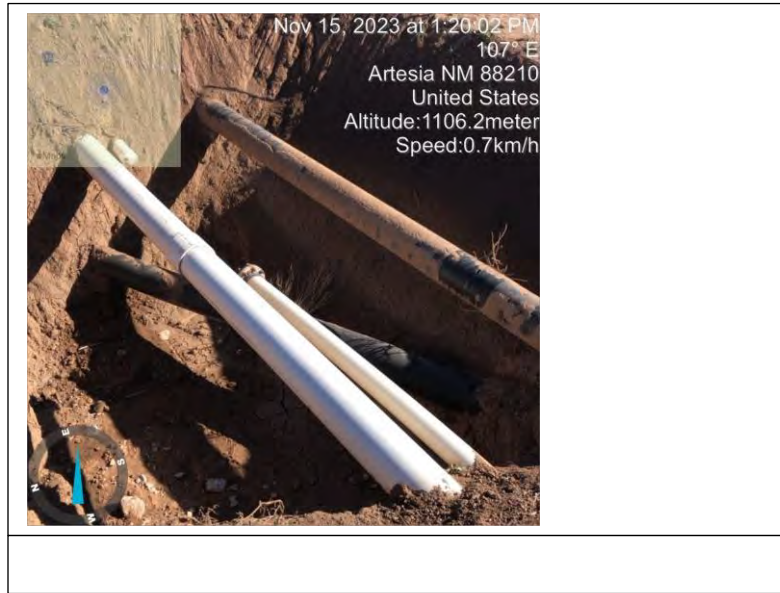
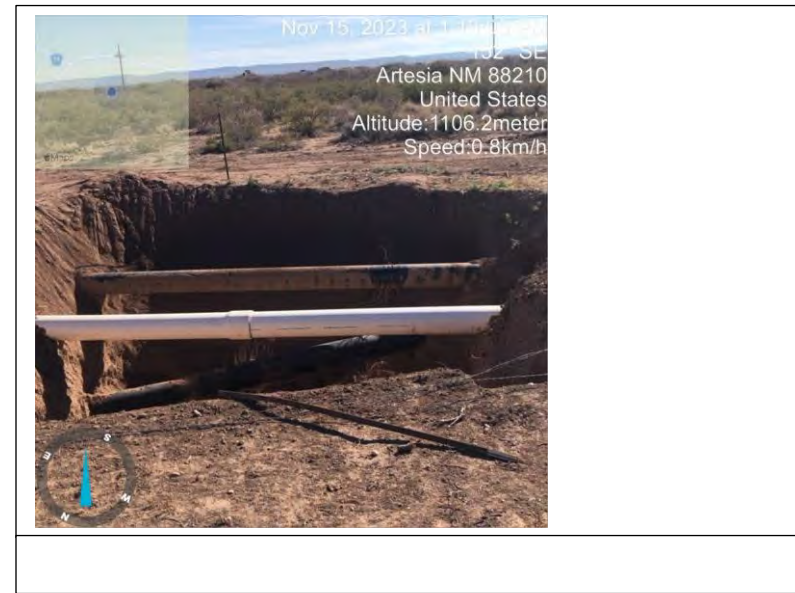
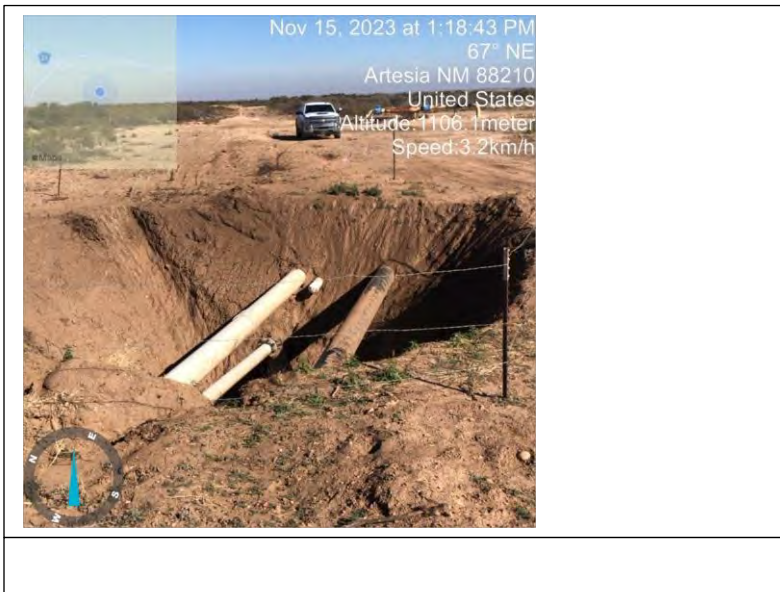
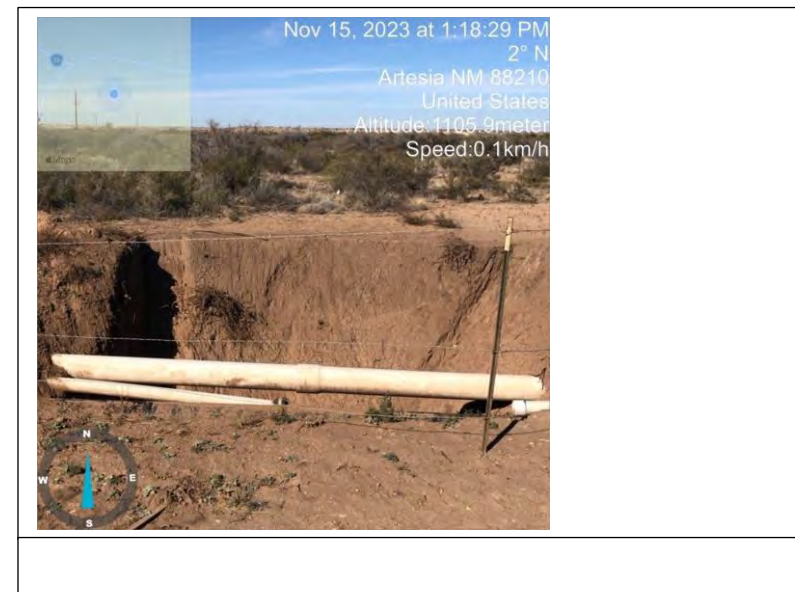
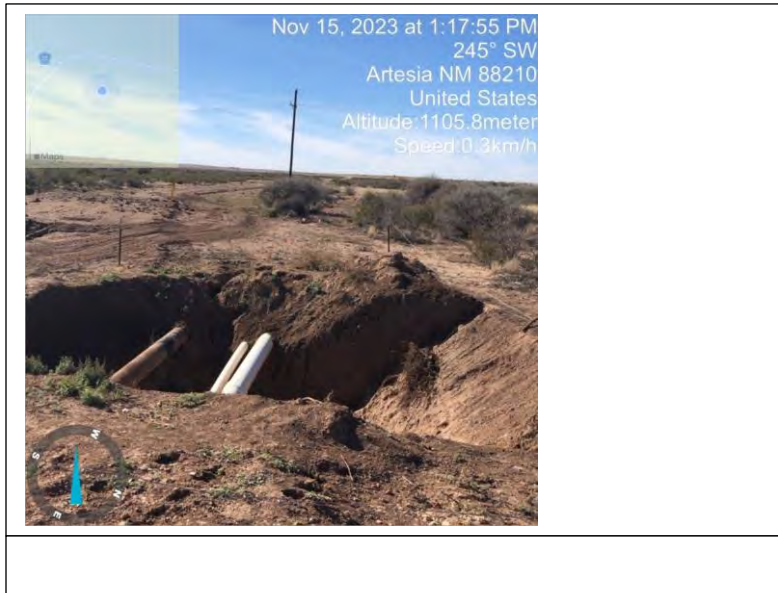
# Watson Spill November 15, 2023

SESI personnel arrived at the site on November 15, 2023, and collected one north wall composite sample. The soil sample was properly packaged, preserved, and transported to Cardinal Laboratories via Chain of Custody for analyses of the following: Chloride (Method SM4500Cl-B), Benzene, Toluene, Ethylbenzene, and Xylenes (BTEX Method 8021B) and TPH 8015M. The sampling results are summarized in the table below:
