Re: Remediation Work Plan

San Juan 28-6 Unit 102N
Rio Arriba County, New Mexico
Hilcorp Energy Company
NMOCD Incident Number: nAPP2403034973

Site Receptor Map
Hilcorp Energy Company
San Juan 28-6 Unit 102N
Incident Number: nAPP2403034973
Unit I, Sec. 26, T028N, R006W
Rio Arriba County, New Mexico, United States

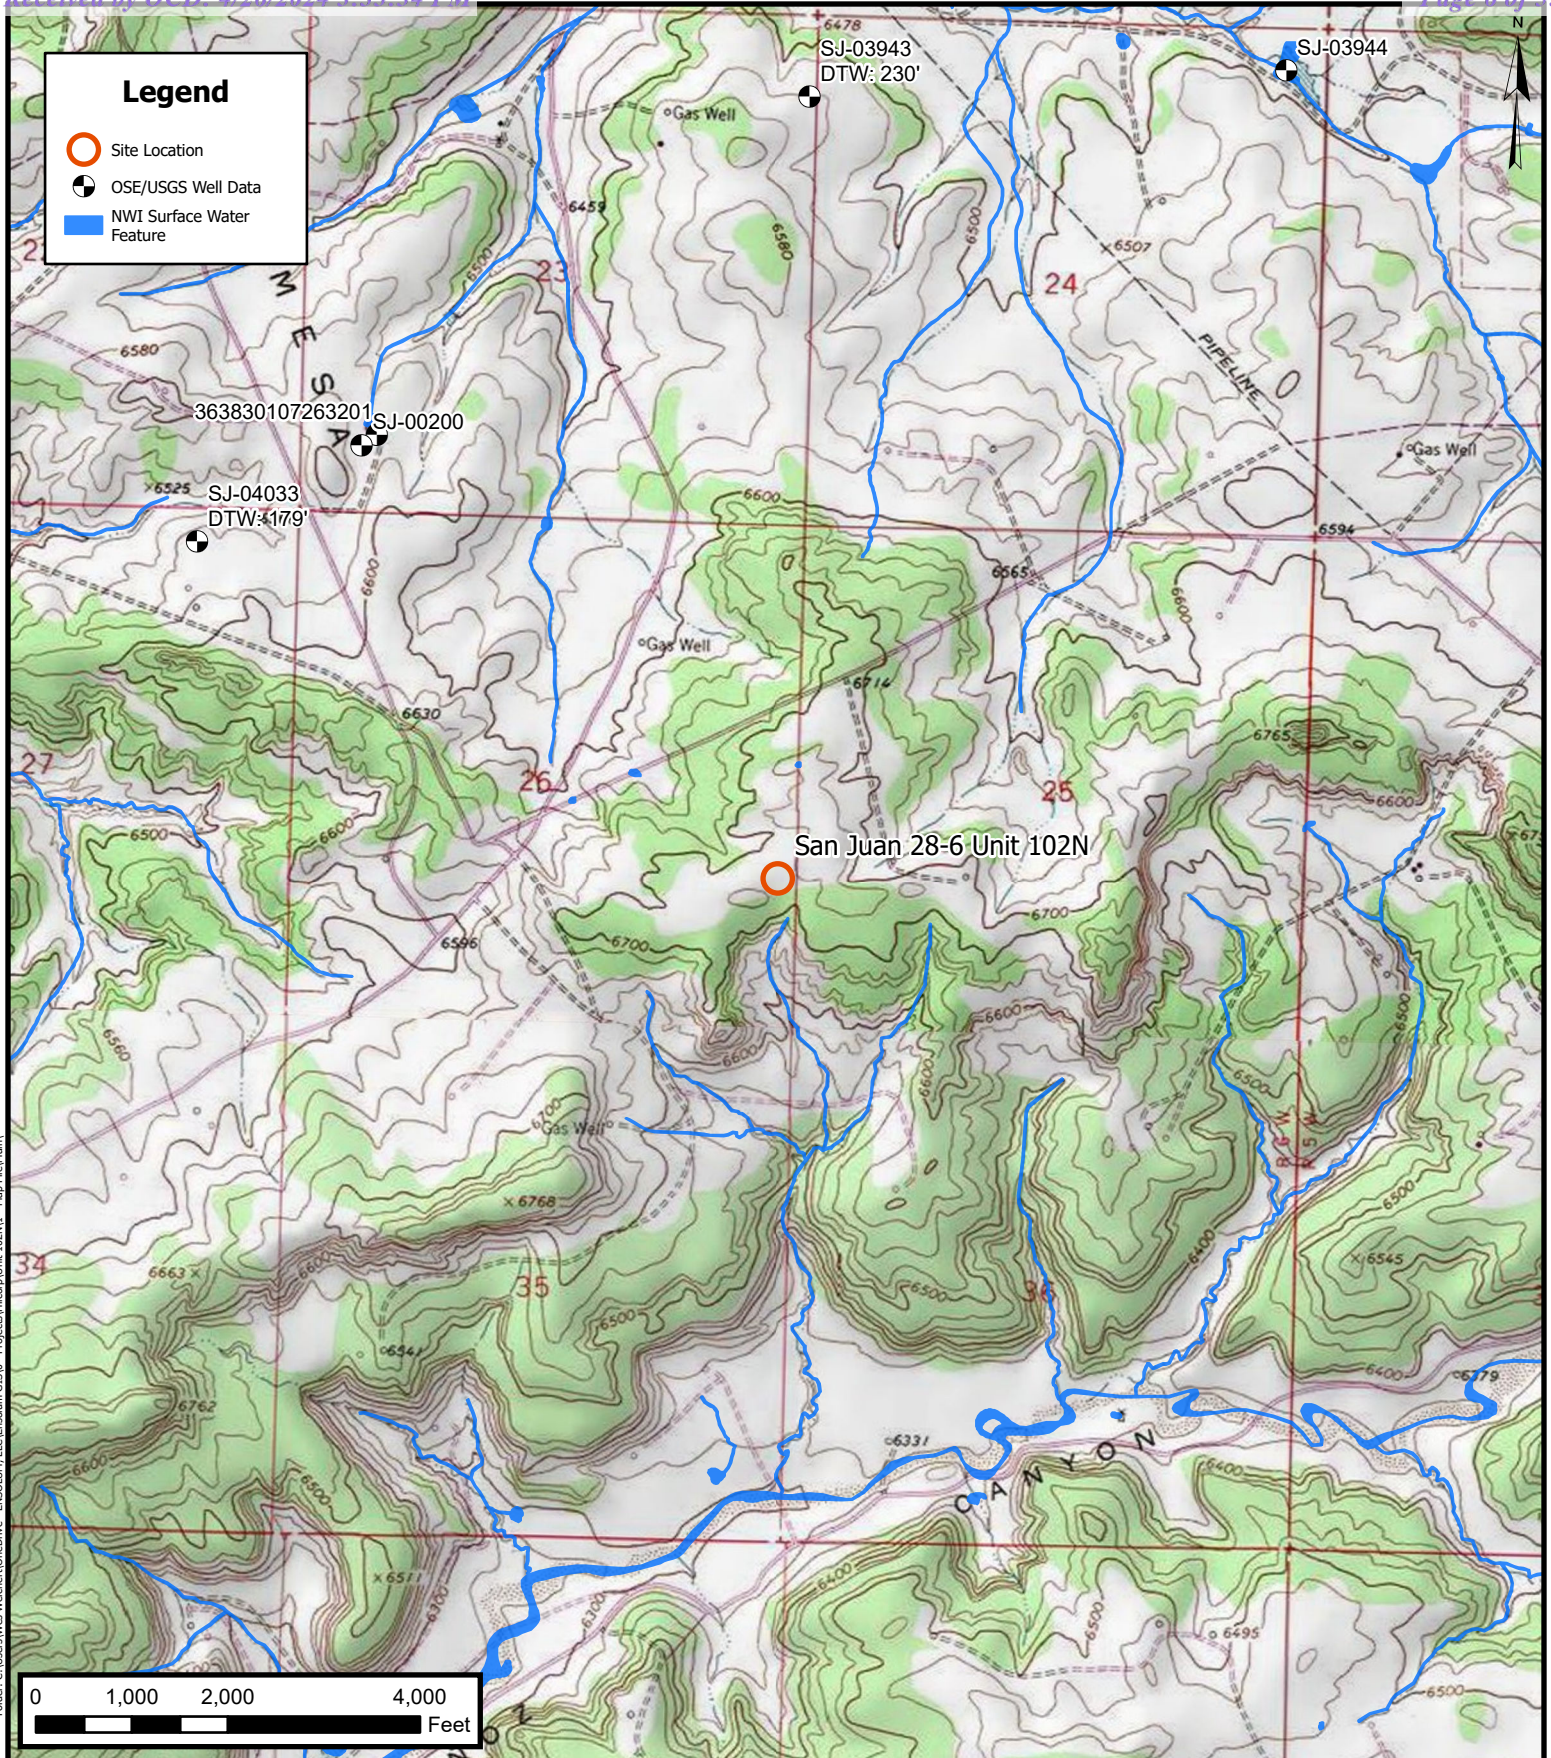
FIGURE
1

The Site is greater than 200 feet from any lakebed, sinkhole, or playa lake, and greater than 300 feet from any wetland. Wellhead protection areas, springs, or domestic/stock wells are not located within a ½-mile from the Site. The Site is not within a 100-year floodplain, overlying a subsurface mine, or located within an area underlain by unstable geology (area not designated as high potential karst by the BLM). Schools, hospitals, institutions, churches, and/or other occupied permanent residence or structures are not located within 300 feet of the Site. A Site receptor map is shown on Figure 1.

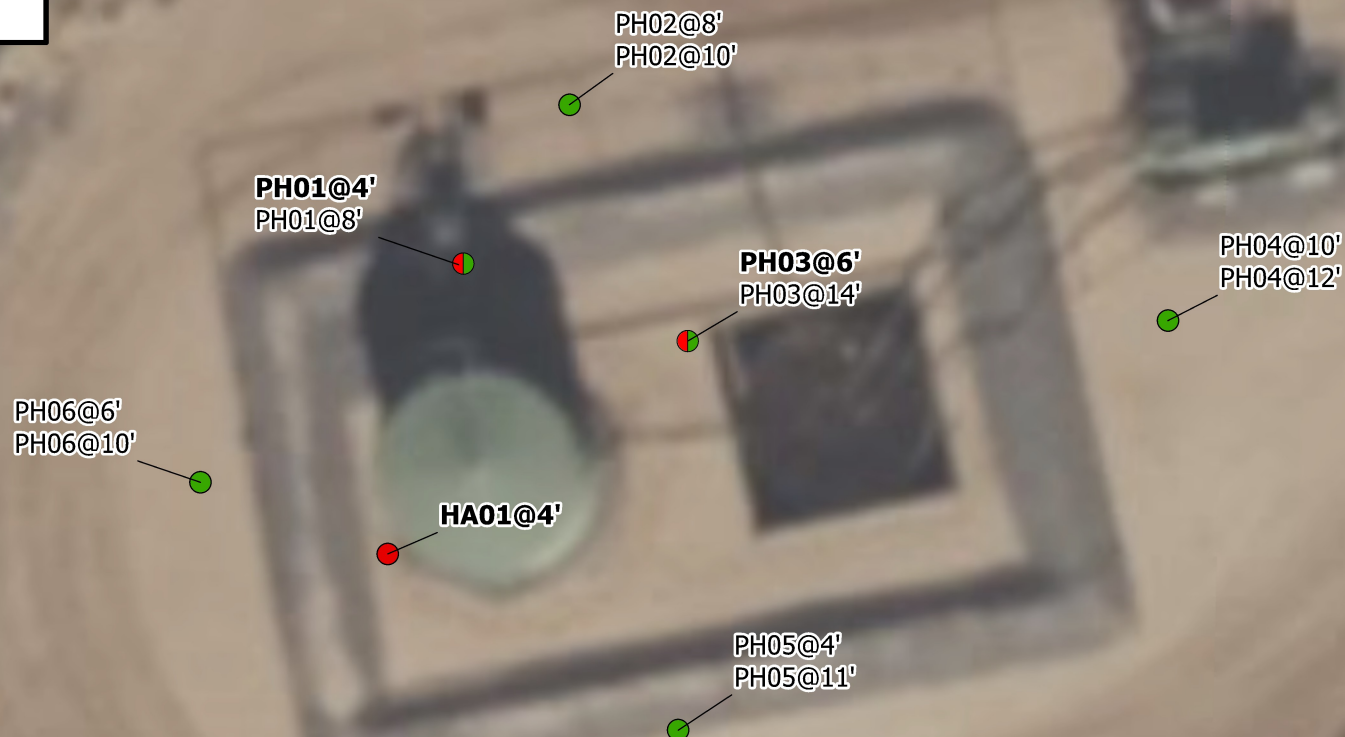
FIGURE

Concentrations of total BTEX and total TPH exceeding the NMOCD Table I Closure Criteria were detected in samples collected from borings/potholes HA01, PH01, and PH03. Containment of Concern (COC) concentrations were compliant with the NMOCD Table I Closure Criteria in all other analyzed samples. A summary of the January and February 2024 analytical results is presented on Table 1 and is depicted on Figure 2. Complete laboratory reports are attached in Appendix C. Photographs collected during Site work are included in Appendix D.

Notes:
 Sample ID @ Depth Below Ground Surface.
 Samples in bold indicate sample exceeded applicable
 Closure Criteria.

Delineation Soil Sample Locations

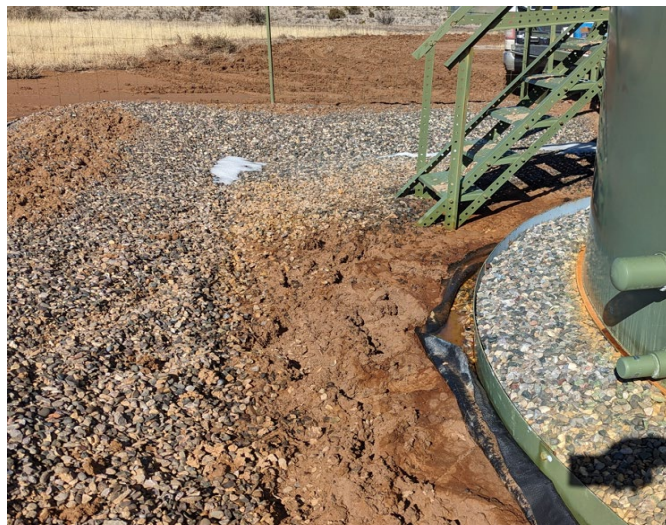
Photograph: 1 Date: 1/29/2024
Description: Surface Staining
View: Northwest

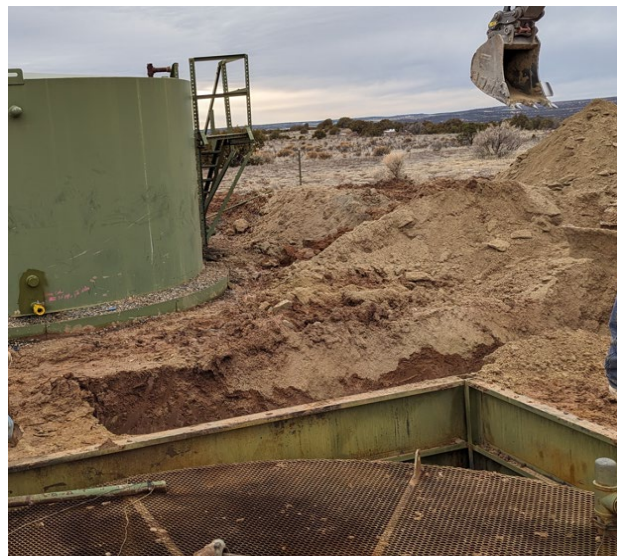
Photograph: 2 Date: 2/6/2024
Description: PH03 Adjacent to BGT
View: West

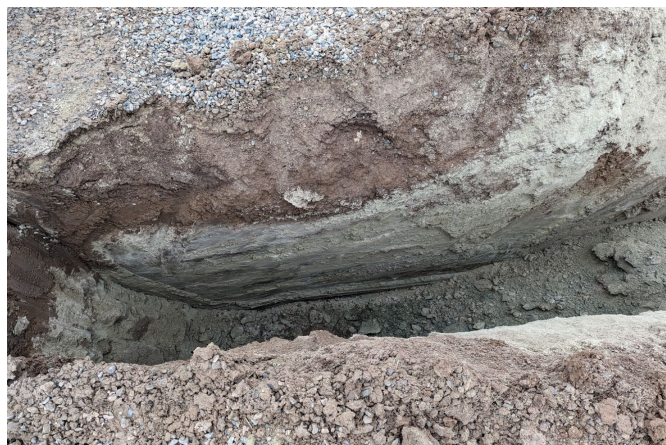
In general, unconsolidated clay and silt overlie soft, silty sandstone that grades to hard sandstone at depths of approximately 10 to 12 bgs. Refusal with the backhoe was encountered at depths between 10 to 14 feet bgs. Field indications of petroleum hydrocarbons, including staining, odors, and/or elevated PID readings, were noted in potholes PH01 and PH03. Groundwater was not encountered in any of the potholes.

Photograph: 3 Date: 2/6/2024
Description: Staining in Pothole PH01
View: Northeast

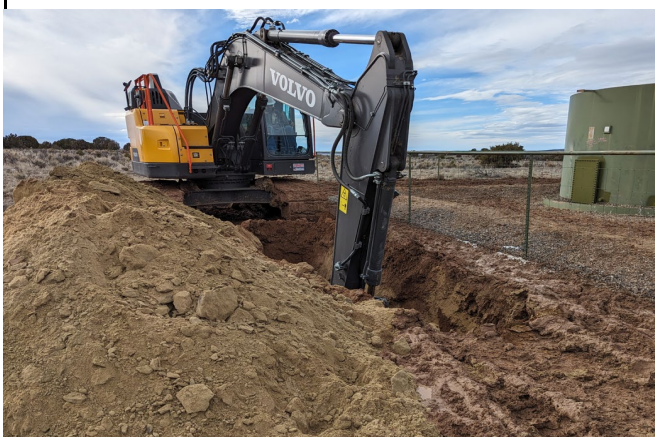
Photograph: 4 Date: 2/6/2024
Description: Potholing activities
View: West
