Rio Blanco 4 CTB 2

OCD Incident nAPP2330725341

Re: Closure Report
Devon Energy Production Company
Rio Blanco 4 CTB 2
Unit F, Section 4, Township 23S, Range 34E
Site Coordinates: 32.3361266°, -103.4753081°
Lea County, New Mexico
Incident ID: nAPP2330725341

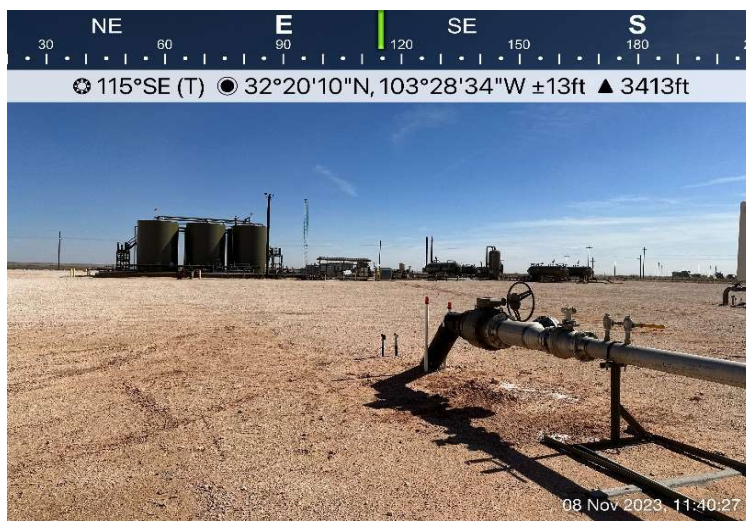
**Photograph No. 2**

Description:
Area of excavation.

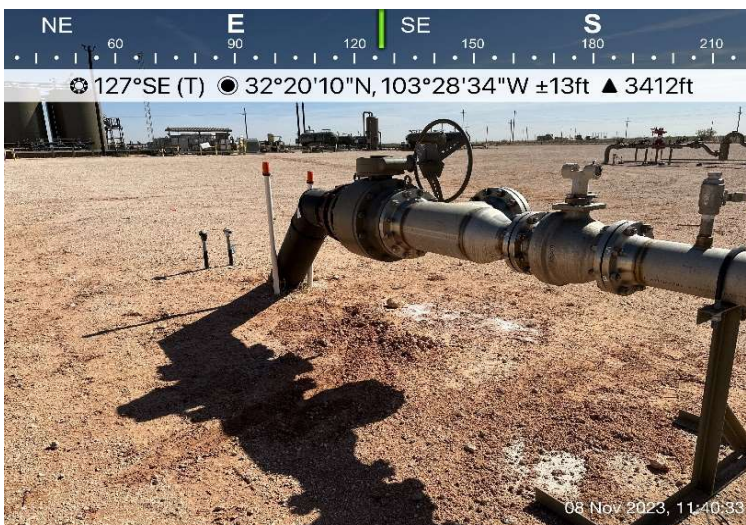
**Photograph No. 3**

Description:
Area of excavation.

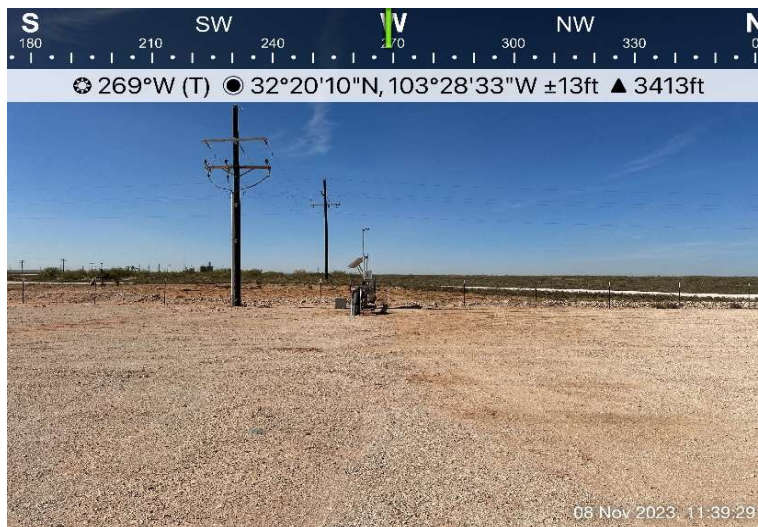
Photograph No. 4

Description:
View of excavation

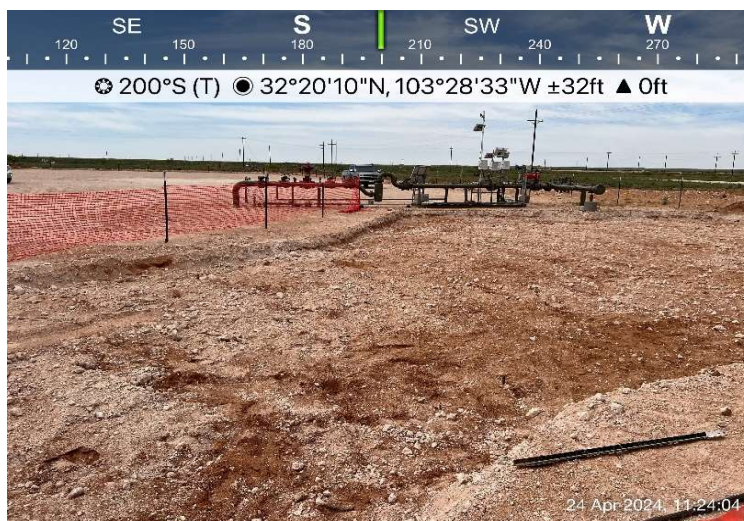
**Photograph No. 5**

Description:
View of excavation

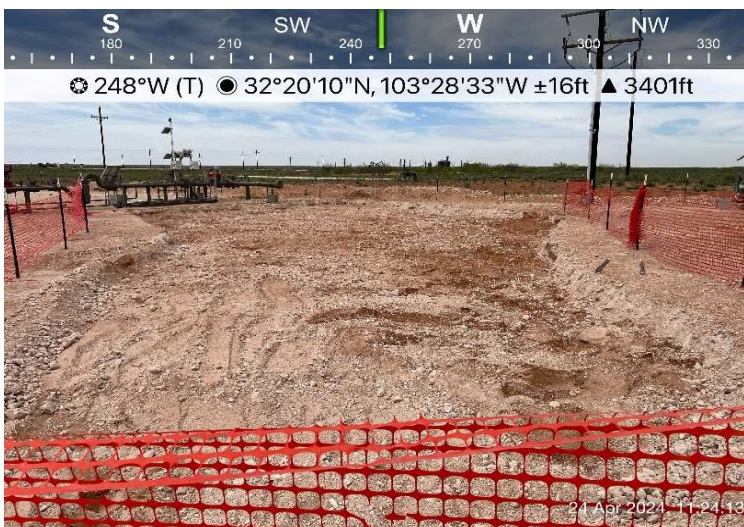
**Photograph No. 6**

Description:
View of excavation
