Remediation Summary and Closure Request

FAE II Operating, LLC

Federal F #4

NMOCD Incident # nAPP2313546854

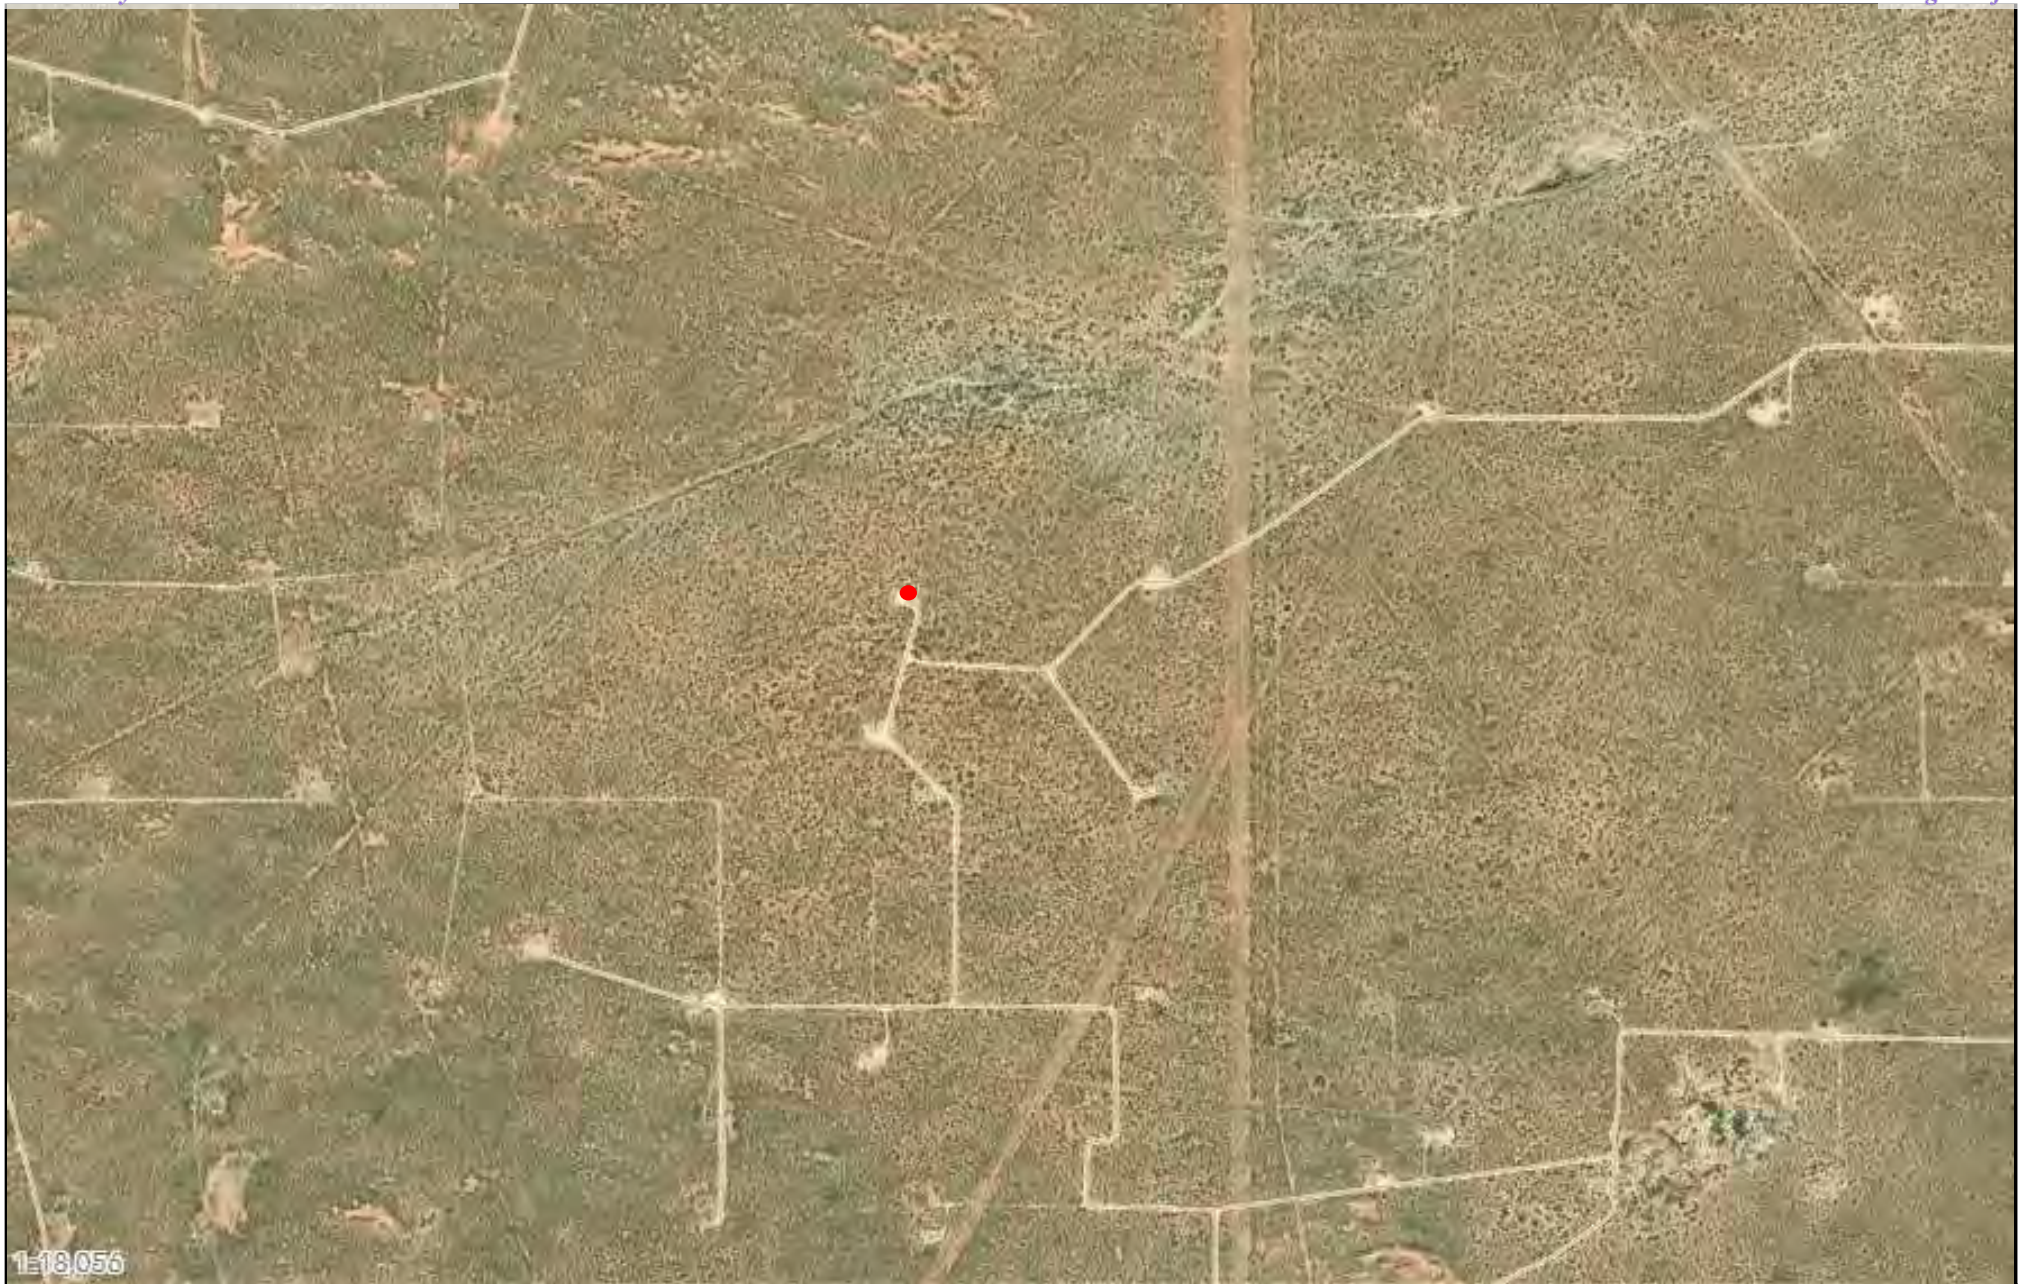
**Figure 2**

OSE POD Locations Map
FAE II Operating, LLC
Federal F #4
GPS: 32.012016, -103.183159
Lea County

A search of the New Mexico Office of the State Engineer (NMOSE) and United States Geological Survey (USGS) groundwater databases was completed in an effort to determine the horizontal distance to known water sources within a half mile radius of the Release Site. Approximate depth to groundwater was determined using maintained and published water well data. Karst mapping indicates the site is located in a Karst designated area. Karst and Wetland Maps are provided as Attachment I. Depth to groundwater information is provided as Attachment V and the results are depicted on Figures 2 & 3.

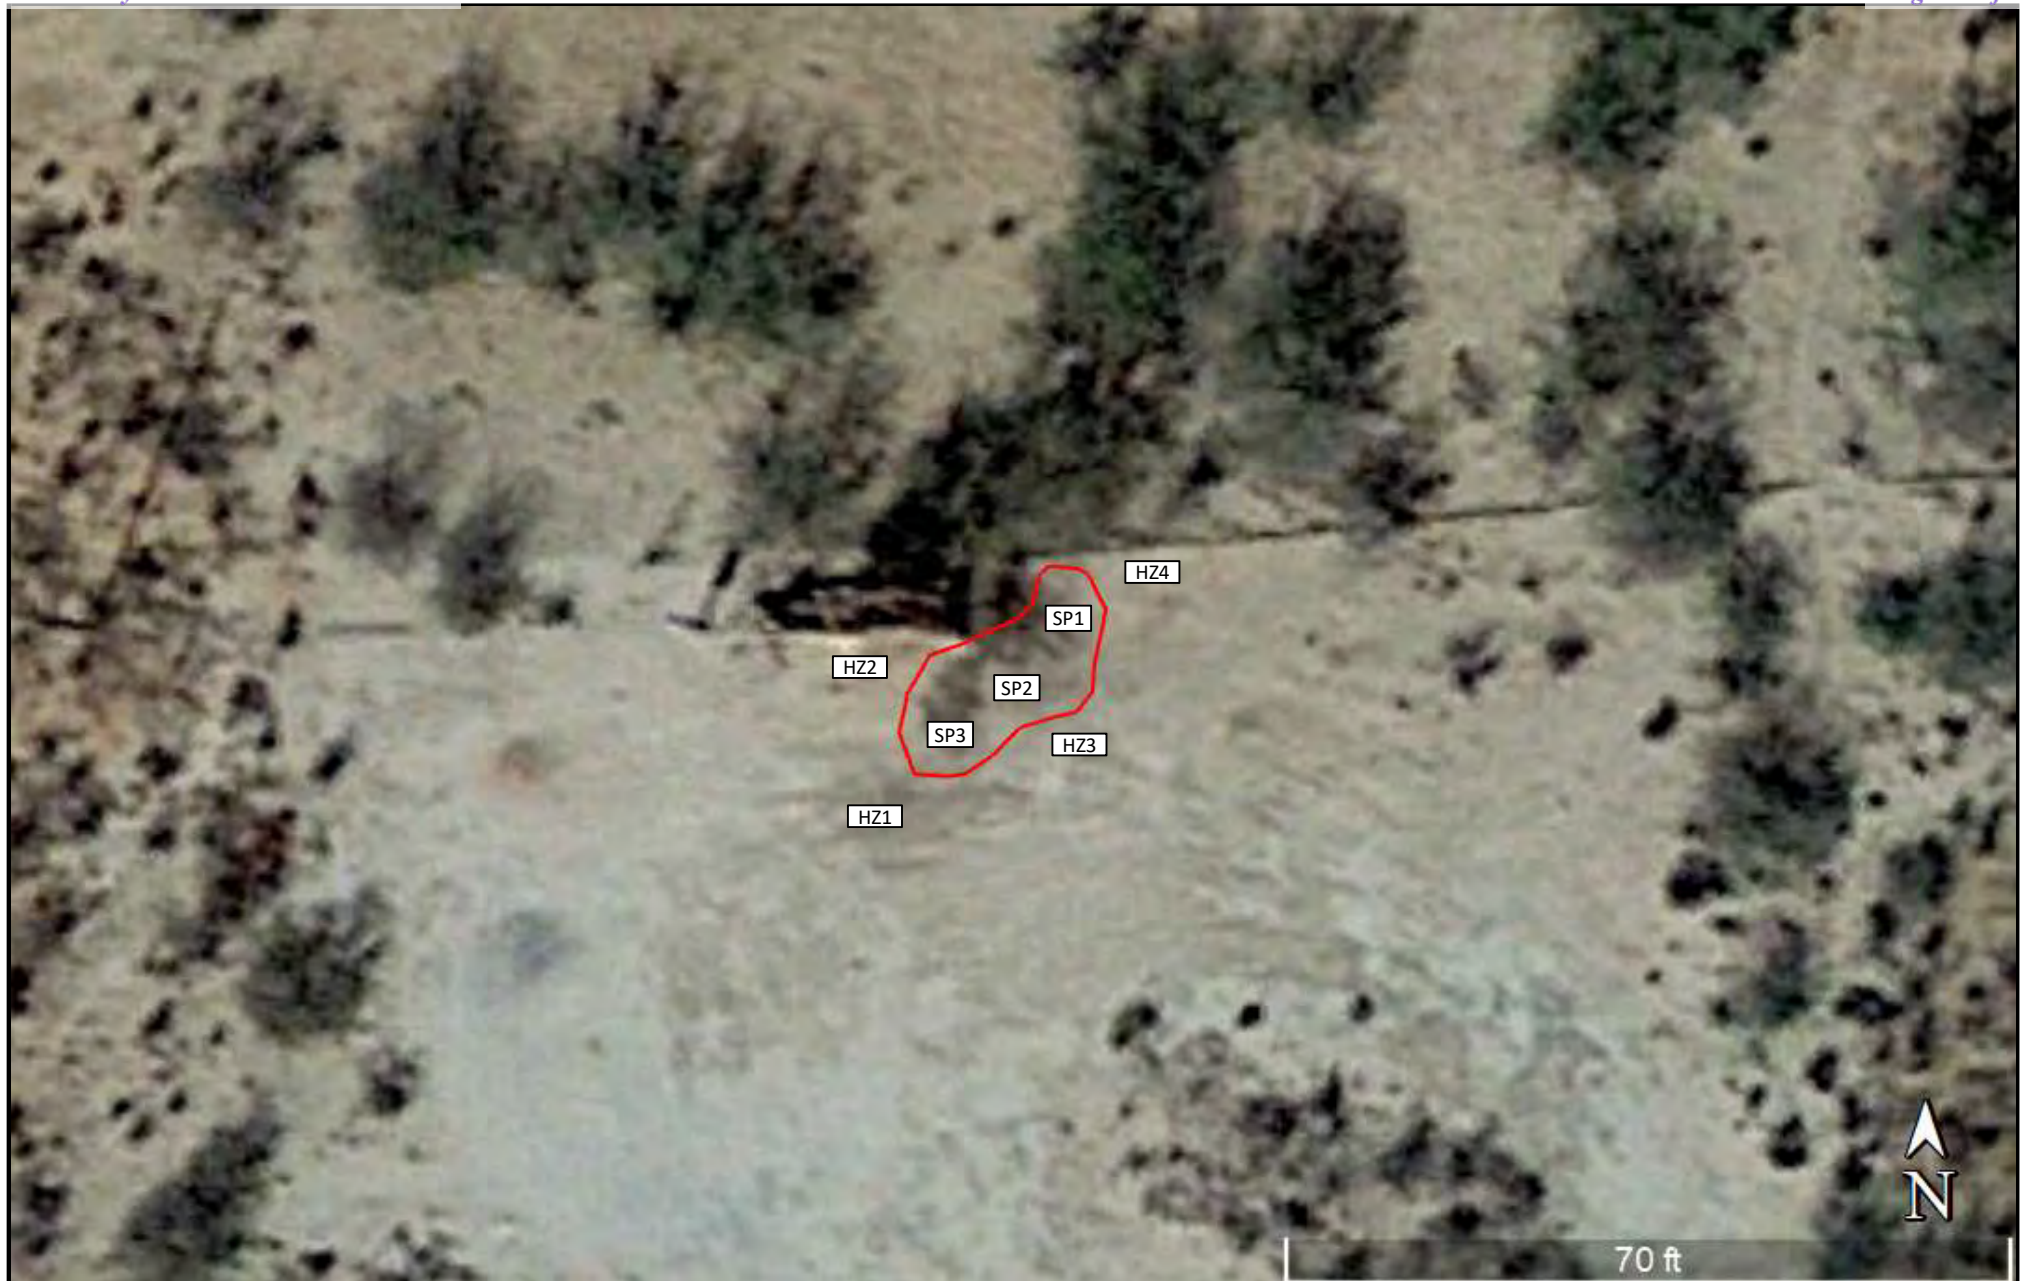
**Figure 4**

Delineation Sample Map
FAE II Operating, LLC
Federal F #4
GPS: 32.012016, -103.183159
Lea County

On October 12, 2023, Hungry Horse conducted an initial site assessment consisting of photographing, mapping, and sampling the release area. During sampling, hand augered test bores were advanced throughout the affected area in an effort to determine the vertical extent of contamination. These sample locations are identified by SP designation. On October 19, 2023, hand augered sample bores were advanced along the outside edges of the affected area in an effort to determine the horizontal extent of contamination. These sample locations are identified by HZ designation. During the advancement of the hand augered sample bores, soil samples were collected and field screened for the presence of chloride concentrations utilizing a Hach Quantab® chloride test kit.

Based on field observations and field test data noted above and provided in Attachment IV, fourteen representative soil samples were selected for laboratory analysis. Delineation soil samples SP1 through SP3, HZ1 through HZ4, were submitted to the laboratory for analysis of BTEX, TPH, and chloride. Laboratory analytical results indicated contaminant concentrations were below the NMOCD Closure Criteria in each of the submitted samples, with the exception of SP3 at Surface, which exhibited TPH concentrations in excess of NMOCD Closure Criteria.

A Delineation Sample Map and Excavation Sample Map are provided as Figure 4 and Figure 5, respectively. A Summary of Soil Sample Laboratory Analytical Results is provided as Table 1 and Laboratory Analytical Reports are provided as Attachment VI.

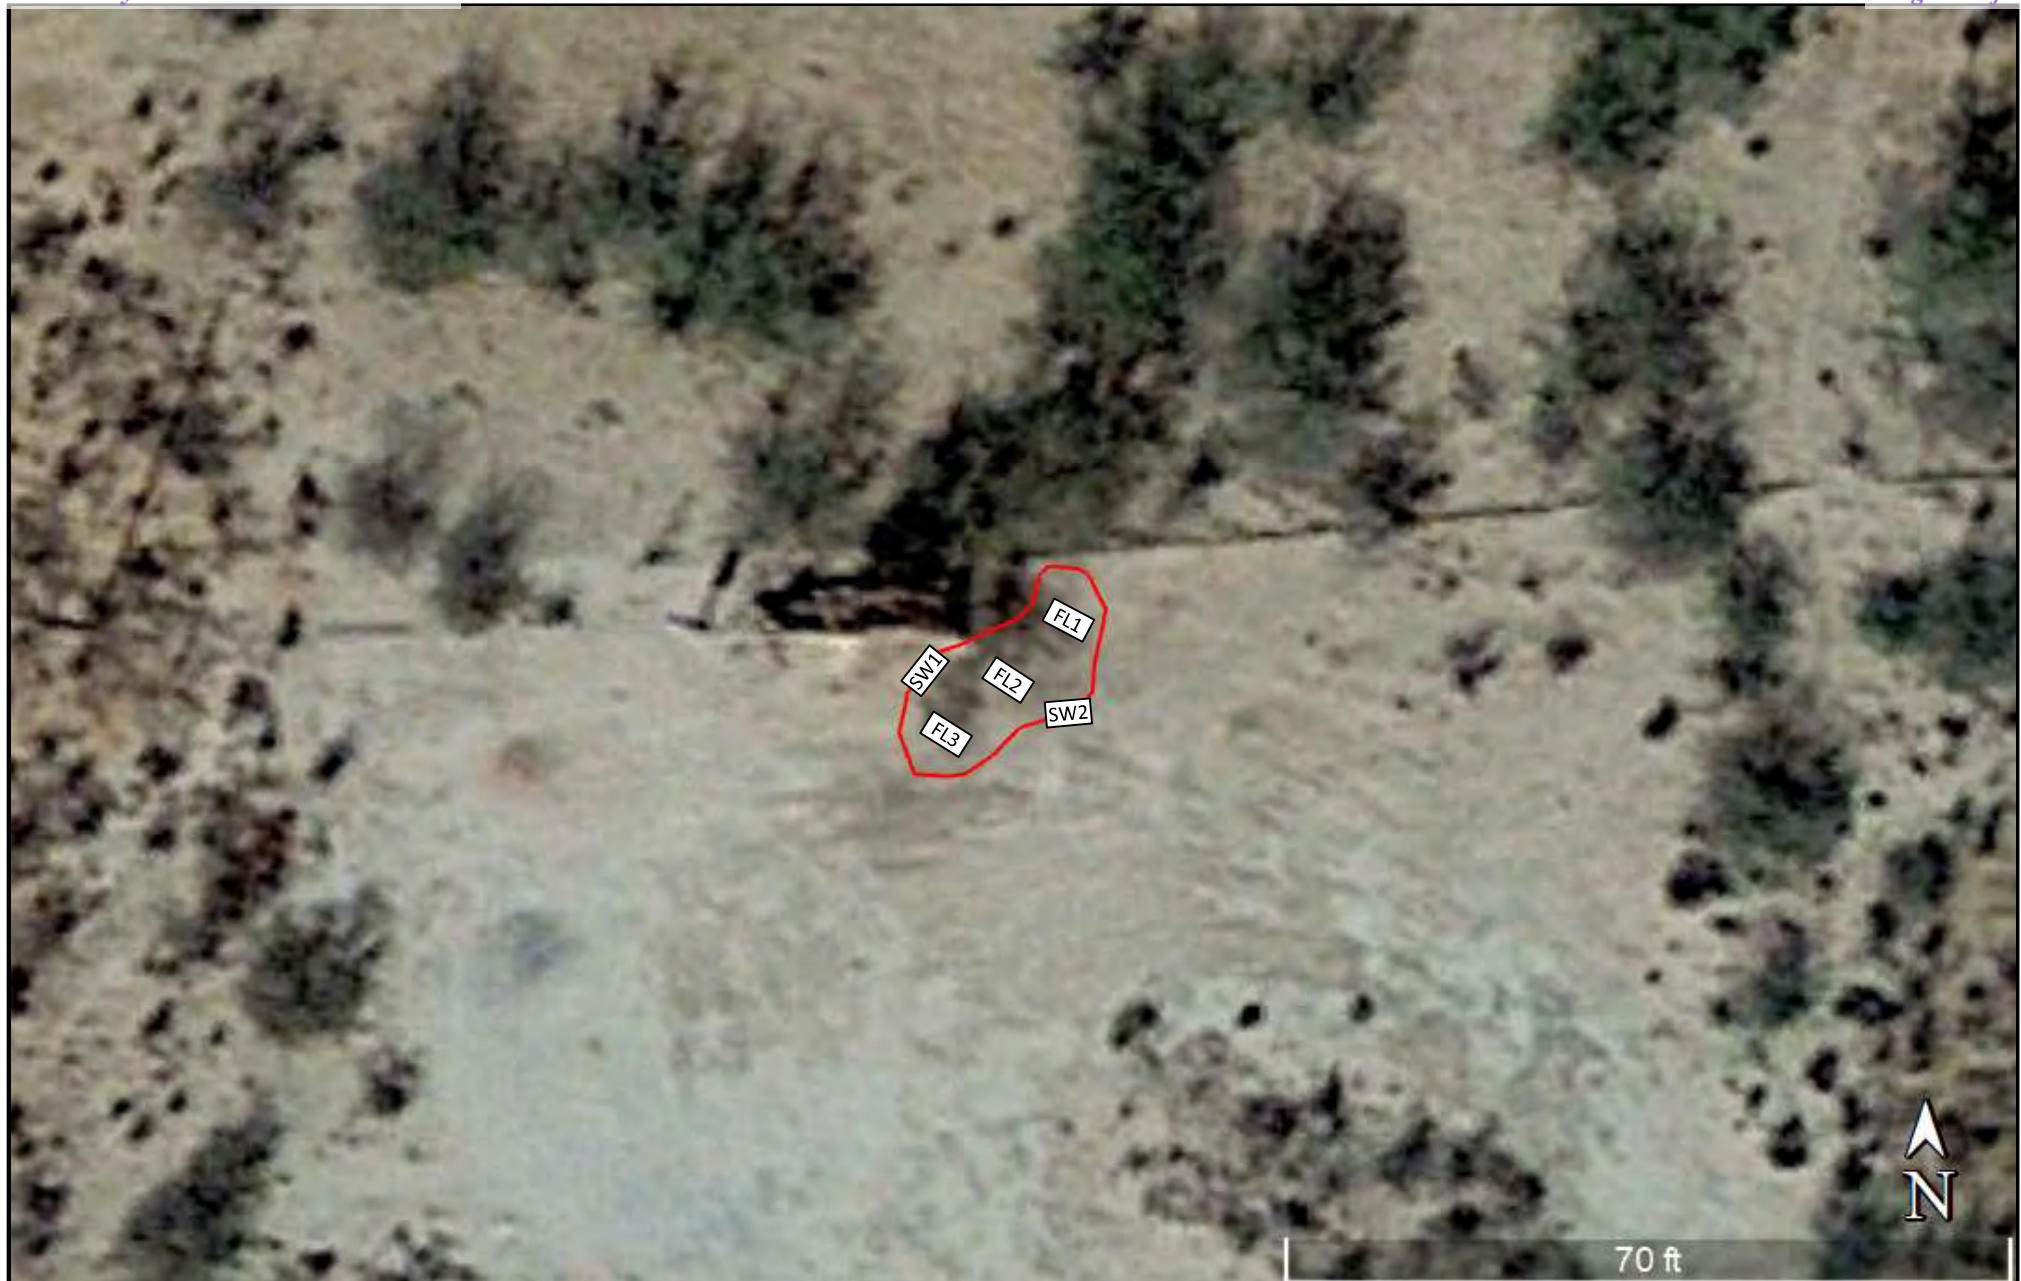
**Figure 5**

Excavation Sample Map
FAE II Operating, LLC
Federal F #4
GPS: 32.012016, -103.183159
Lea County

On November 3, 2023, the release area was excavated to a depth of two feet bgs. Excavated contaminated soil was temporarily stockpiled onsite, atop plastic, before transport to an NMOCD approved disposal facility.

On December 1, 2023, five composite confirmation soil samples were collected from the excavation floor and sidewalls, every 200 square feet and every 50 linear feet, respectively. Soil samples FL1 through FL3 and SW1 through SW2, were submitted to the laboratory for analysis of BTEX, TPH, and chloride. Laboratory analytical results indicated contaminant concentrations were below the NMOCD Closure Criteria in each of the submitted samples.

The excavated area measured approximately six hundred square feet. During remediation activities approximately 50 cubic yards of impacted soil were excavated and hauled to an NMOCD approved disposal facility.
