Remediation Summary and Closure Request

FAE II Operating, LLC

Federal F #3

NMOCD Incident # nAPP2313543757

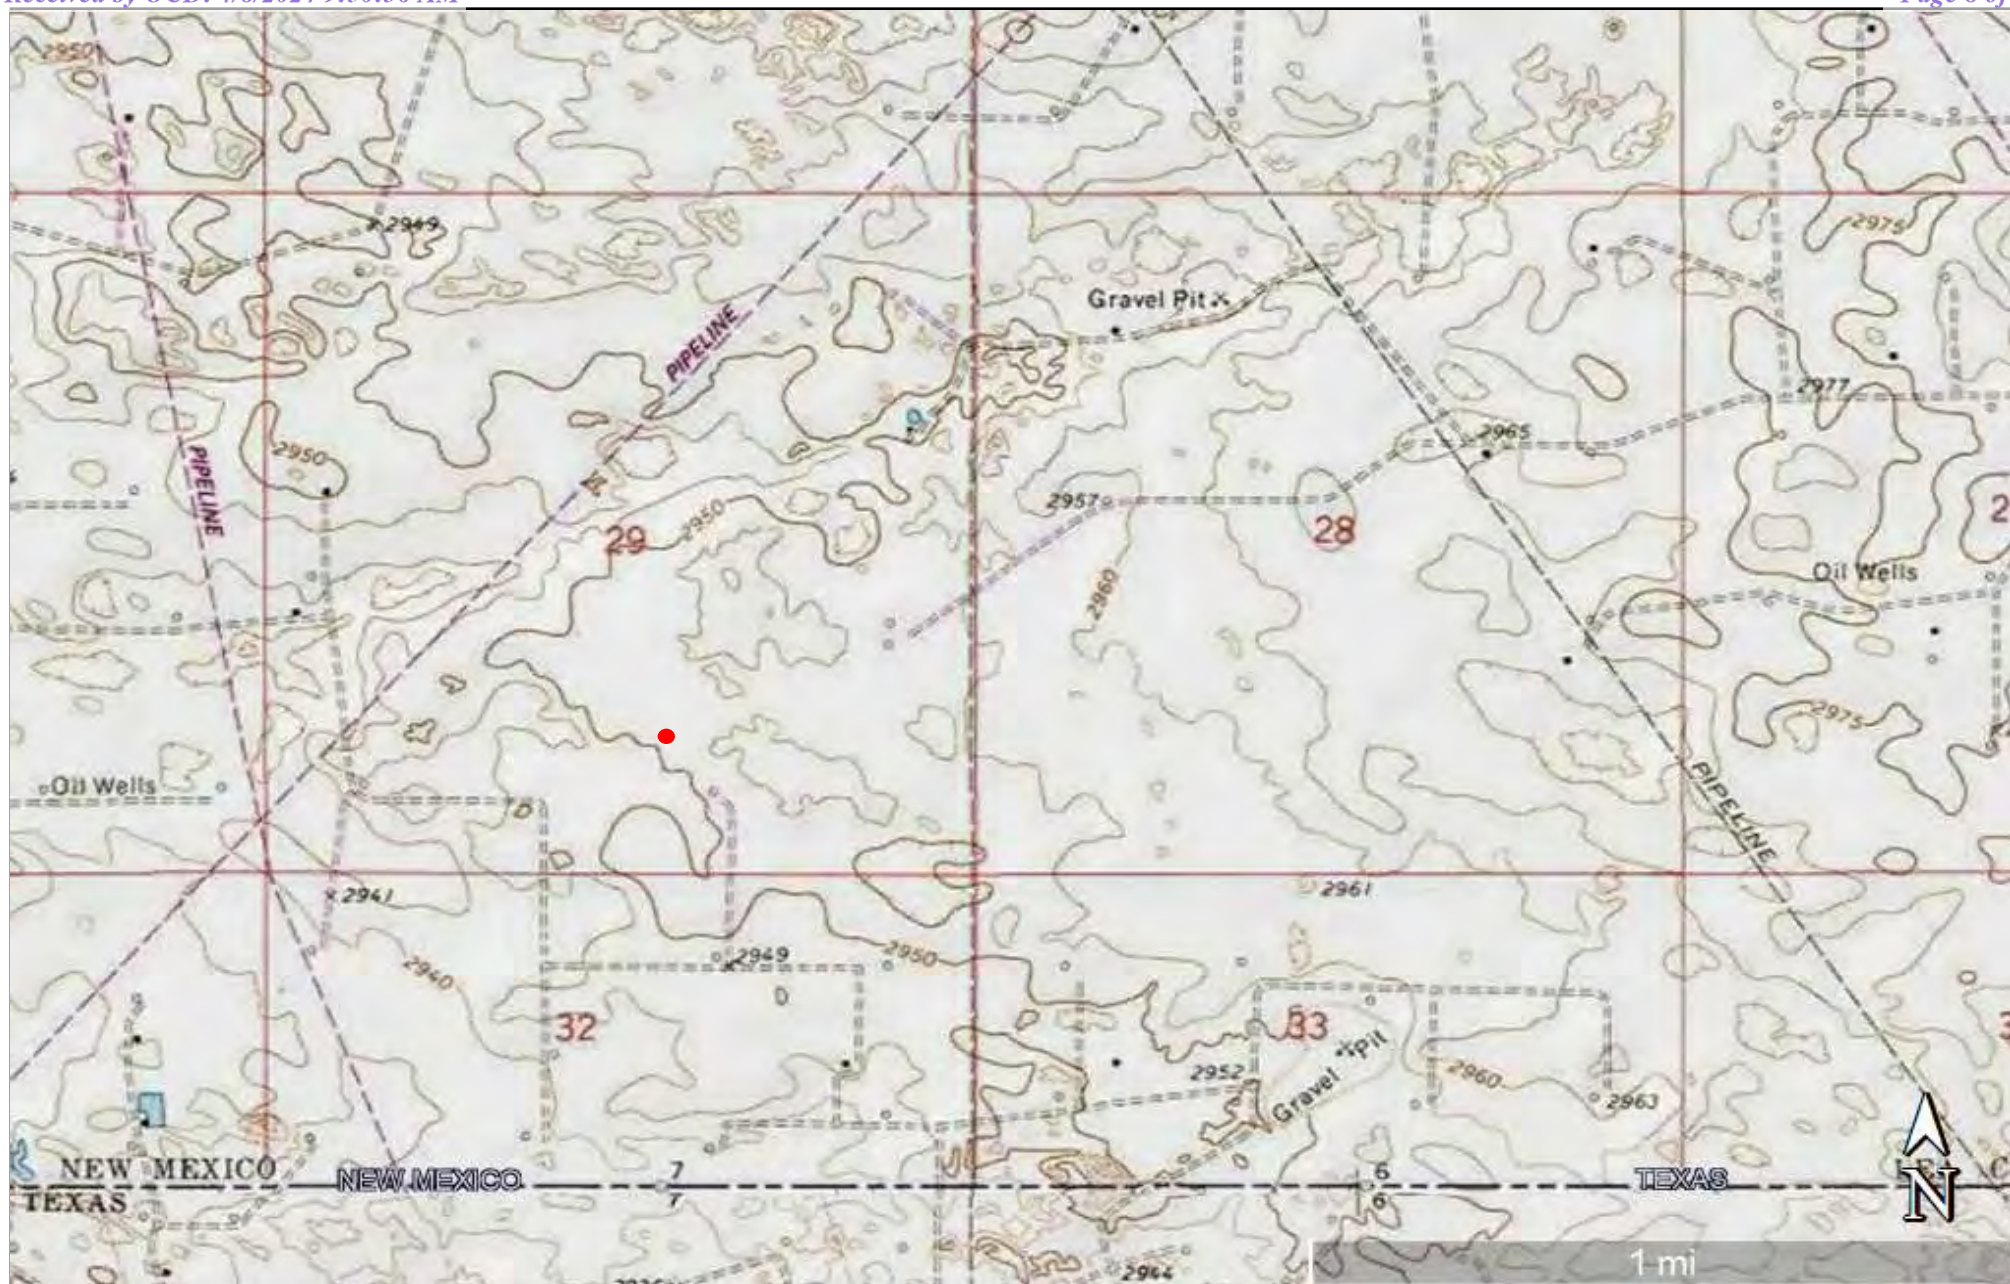
**Figure 1**

Topographic Map

The site is located in Unit Letter O (SW/SE), Section 29, Township 26 South, Range 37 East, approximately seven miles south of Jal, in Lea County, New Mexico. The site is located on private land. Topographic Map, OSE POD Locations Map, and USGS Well Locations Map are included as Figure 1, Figure 2, and Figure 3, respectively.

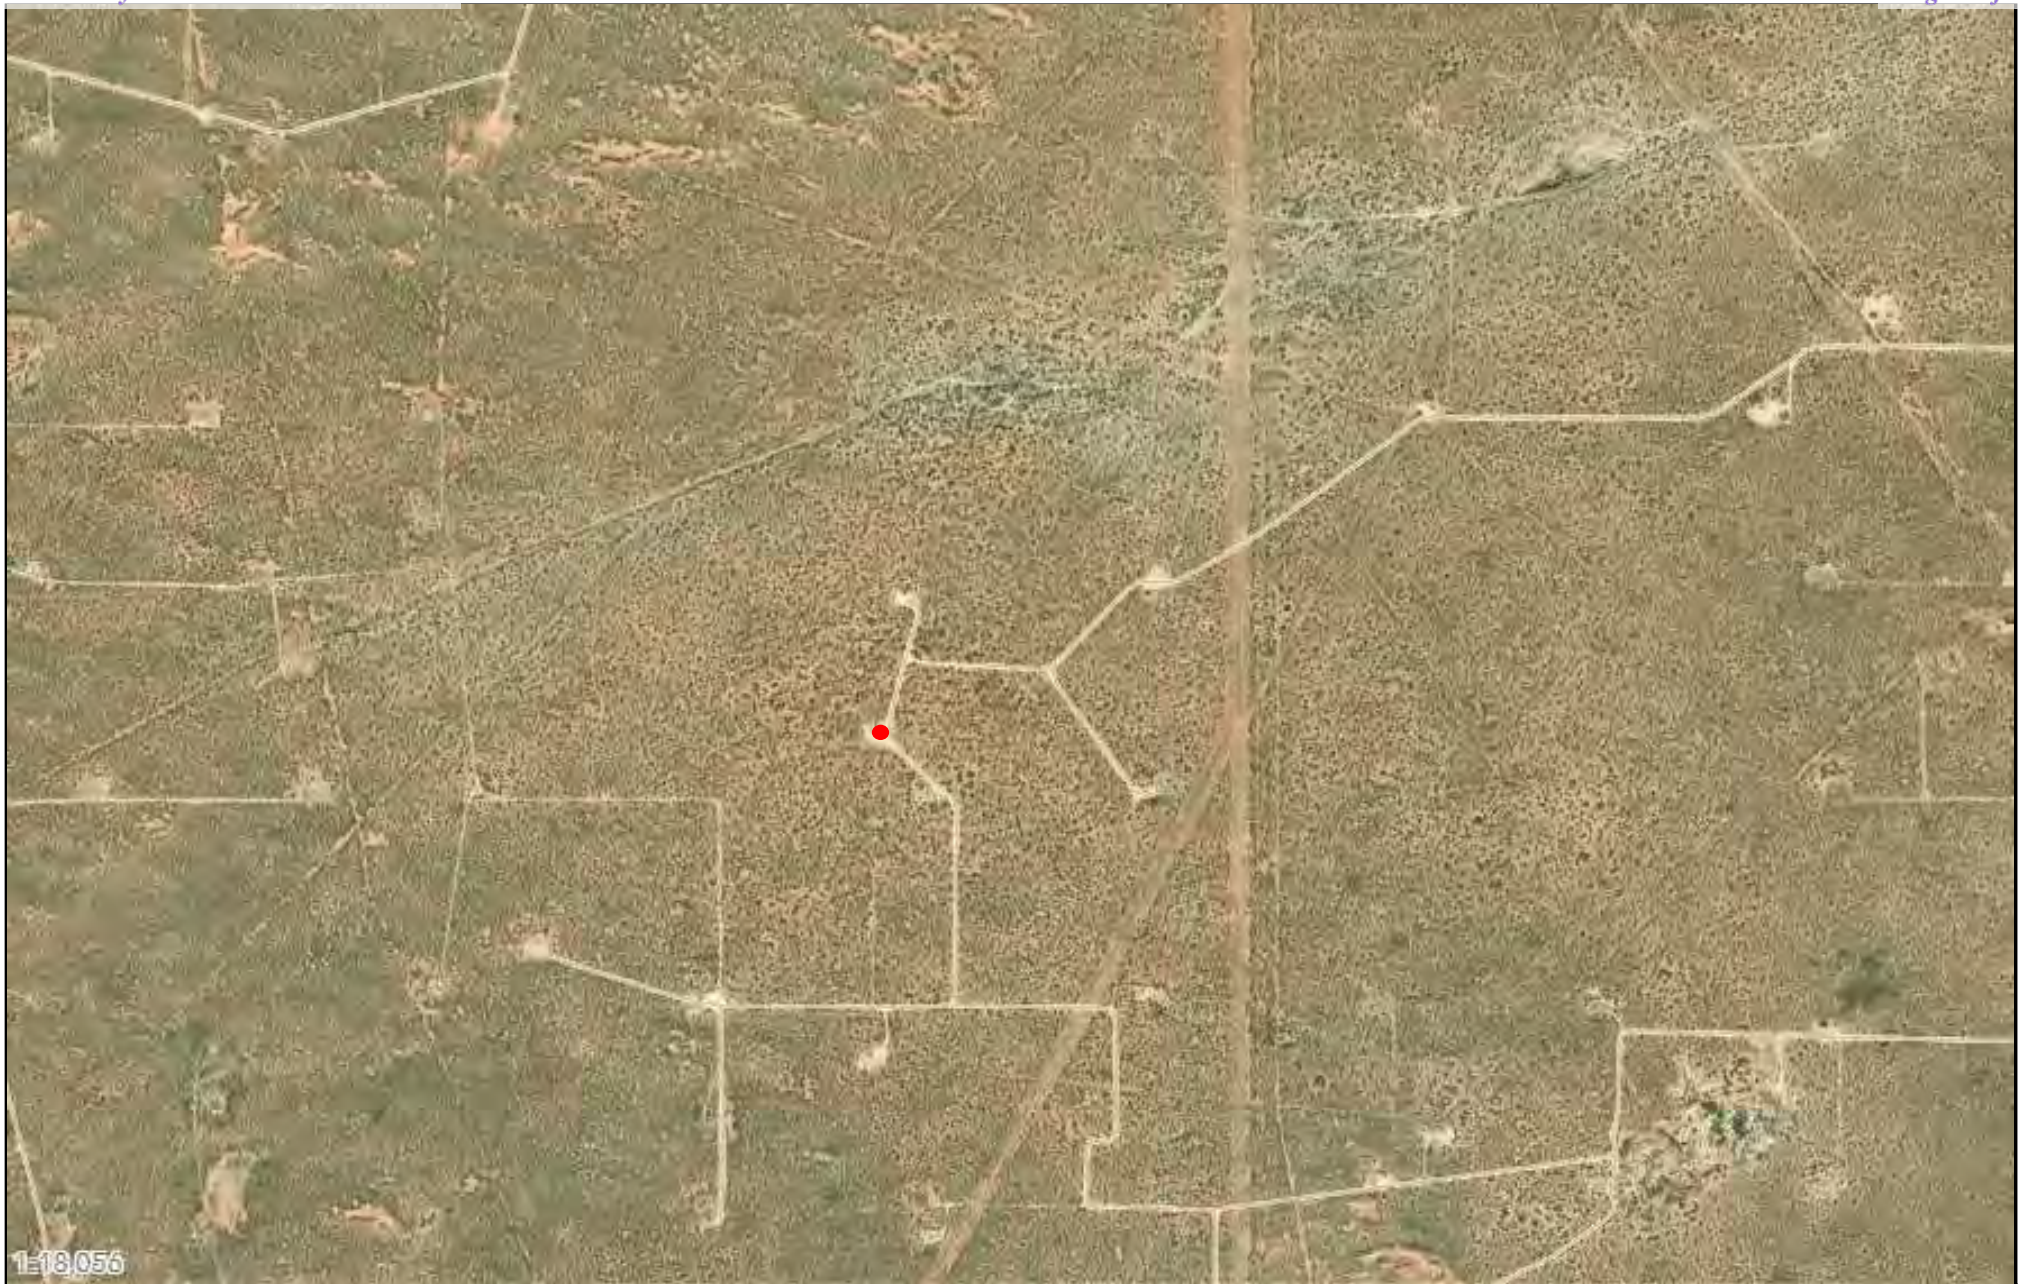
**Figure 2**

OSE POD Locations Map
FAE II Operating, LLC
Federal F #3
GPS: 32.00969, -103.183752
Lea County

A search of the New Mexico Office of the State Engineer (NMOSE) and United States Geological Survey (USGS) groundwater databases was completed in an effort to determine the horizontal distance to known water sources within a half mile radius of the Release Site. Approximate depth to groundwater was determined using maintained and published water well data. Karst mapping indicates the site is located in a Karst designated area. Karst and Wetland Maps are provided as Attachment I. Depth to groundwater information is provided as Attachment V and the results are depicted on Figures 2 & 3.

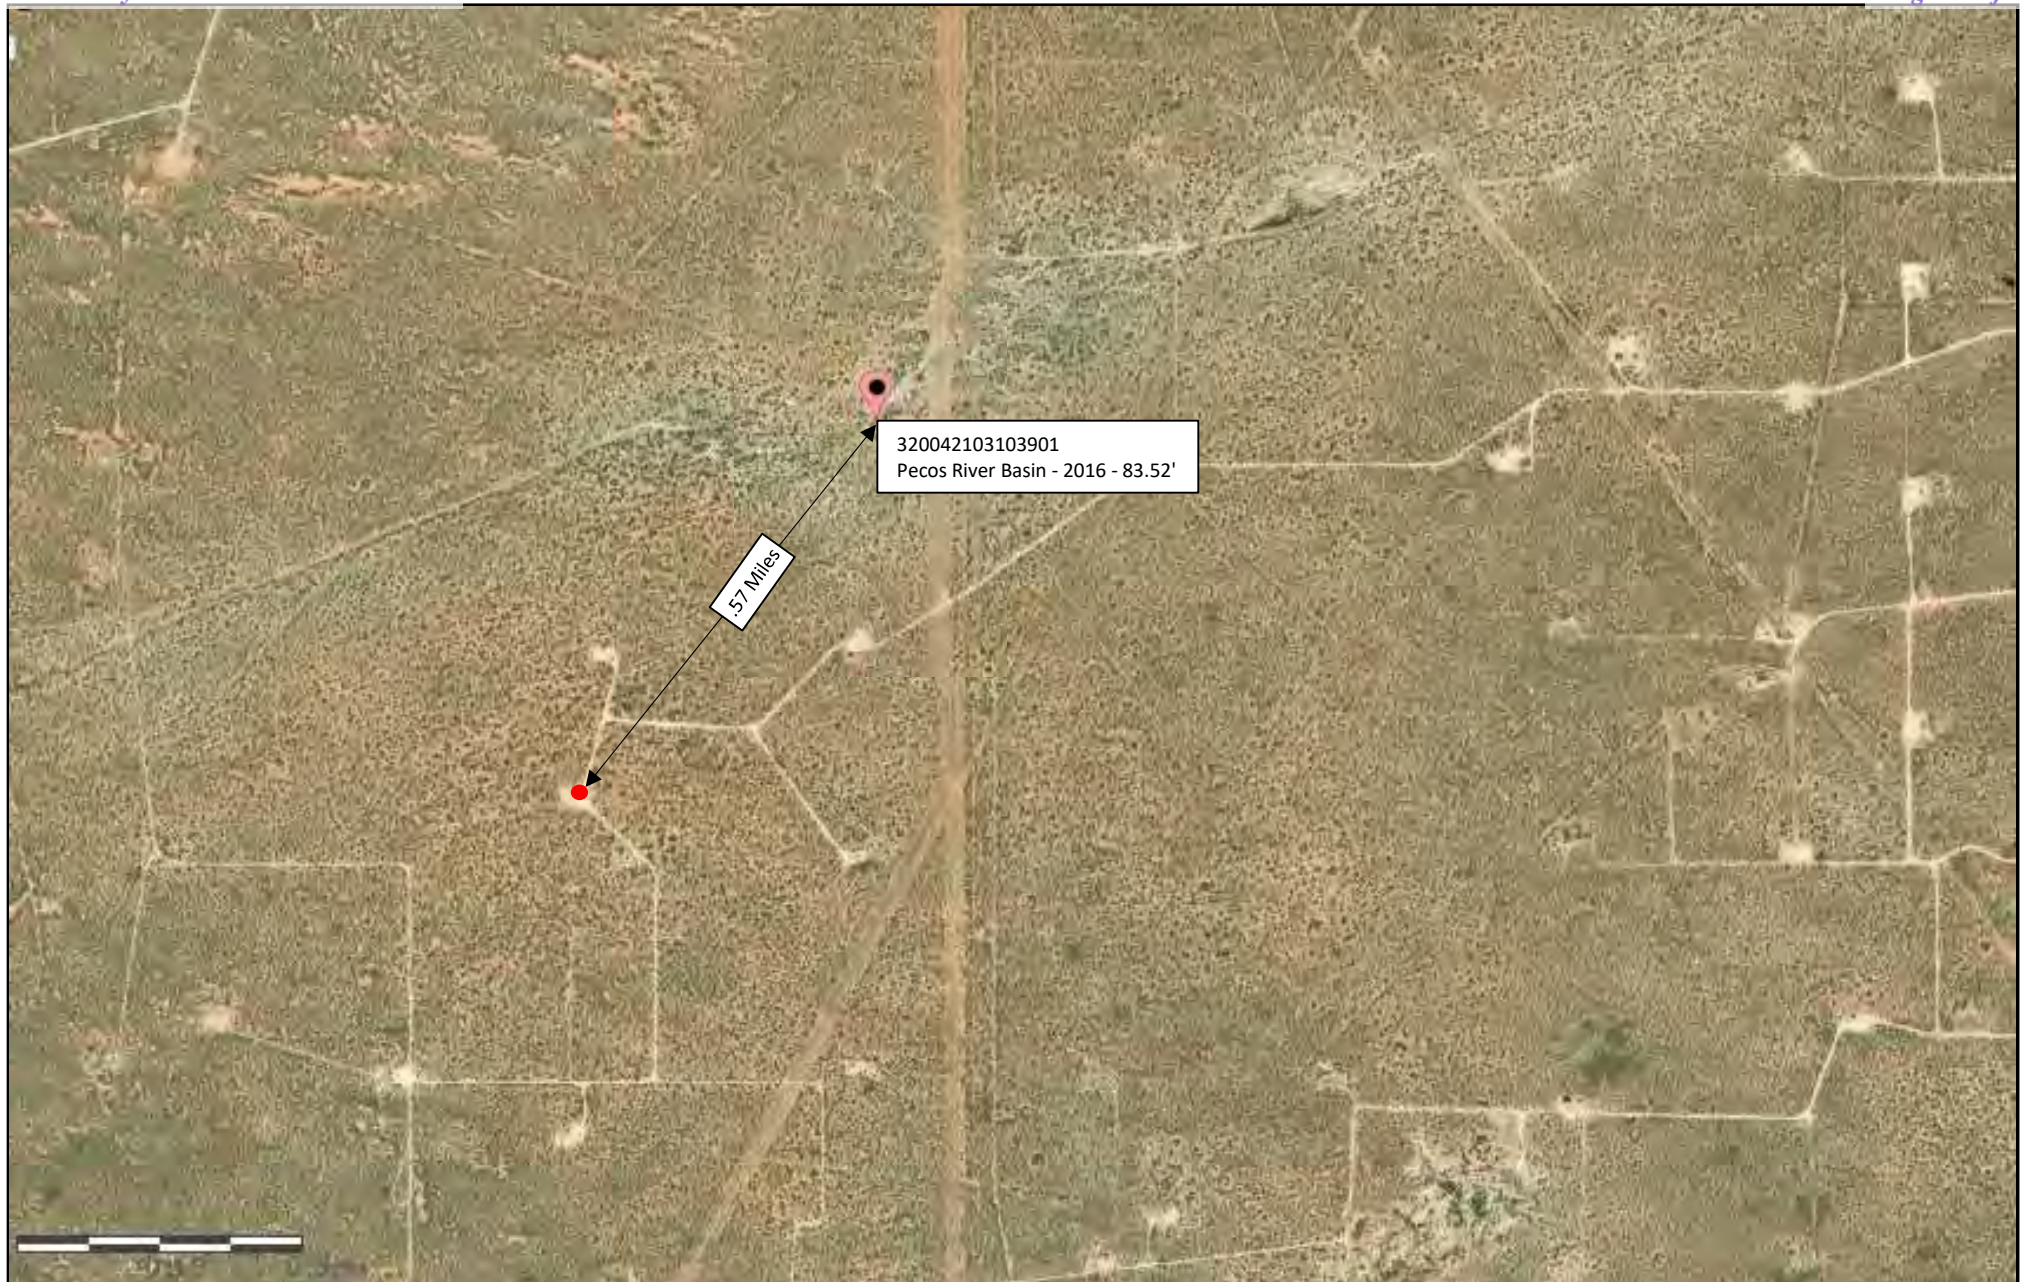
**Figure 3**

USGS Well Locations Map
FAE II Operating, LLC
Federal F #3
GPS: 32.00969, -103.183752
Lea County

One water well was located in the vicinity of the release area. USGS well 320042103103901 was located .57 miles northeast of the location. Gauging in 2016 indicated depth to water of approximately 83.52 feet bgs. However, as the release occurred within a Karst designated area, the site was remediated according to the strictest NMOCD Closure Criteria. Utilizing this information, the NMOCD Closure Criteria for the Site were determined as follows:

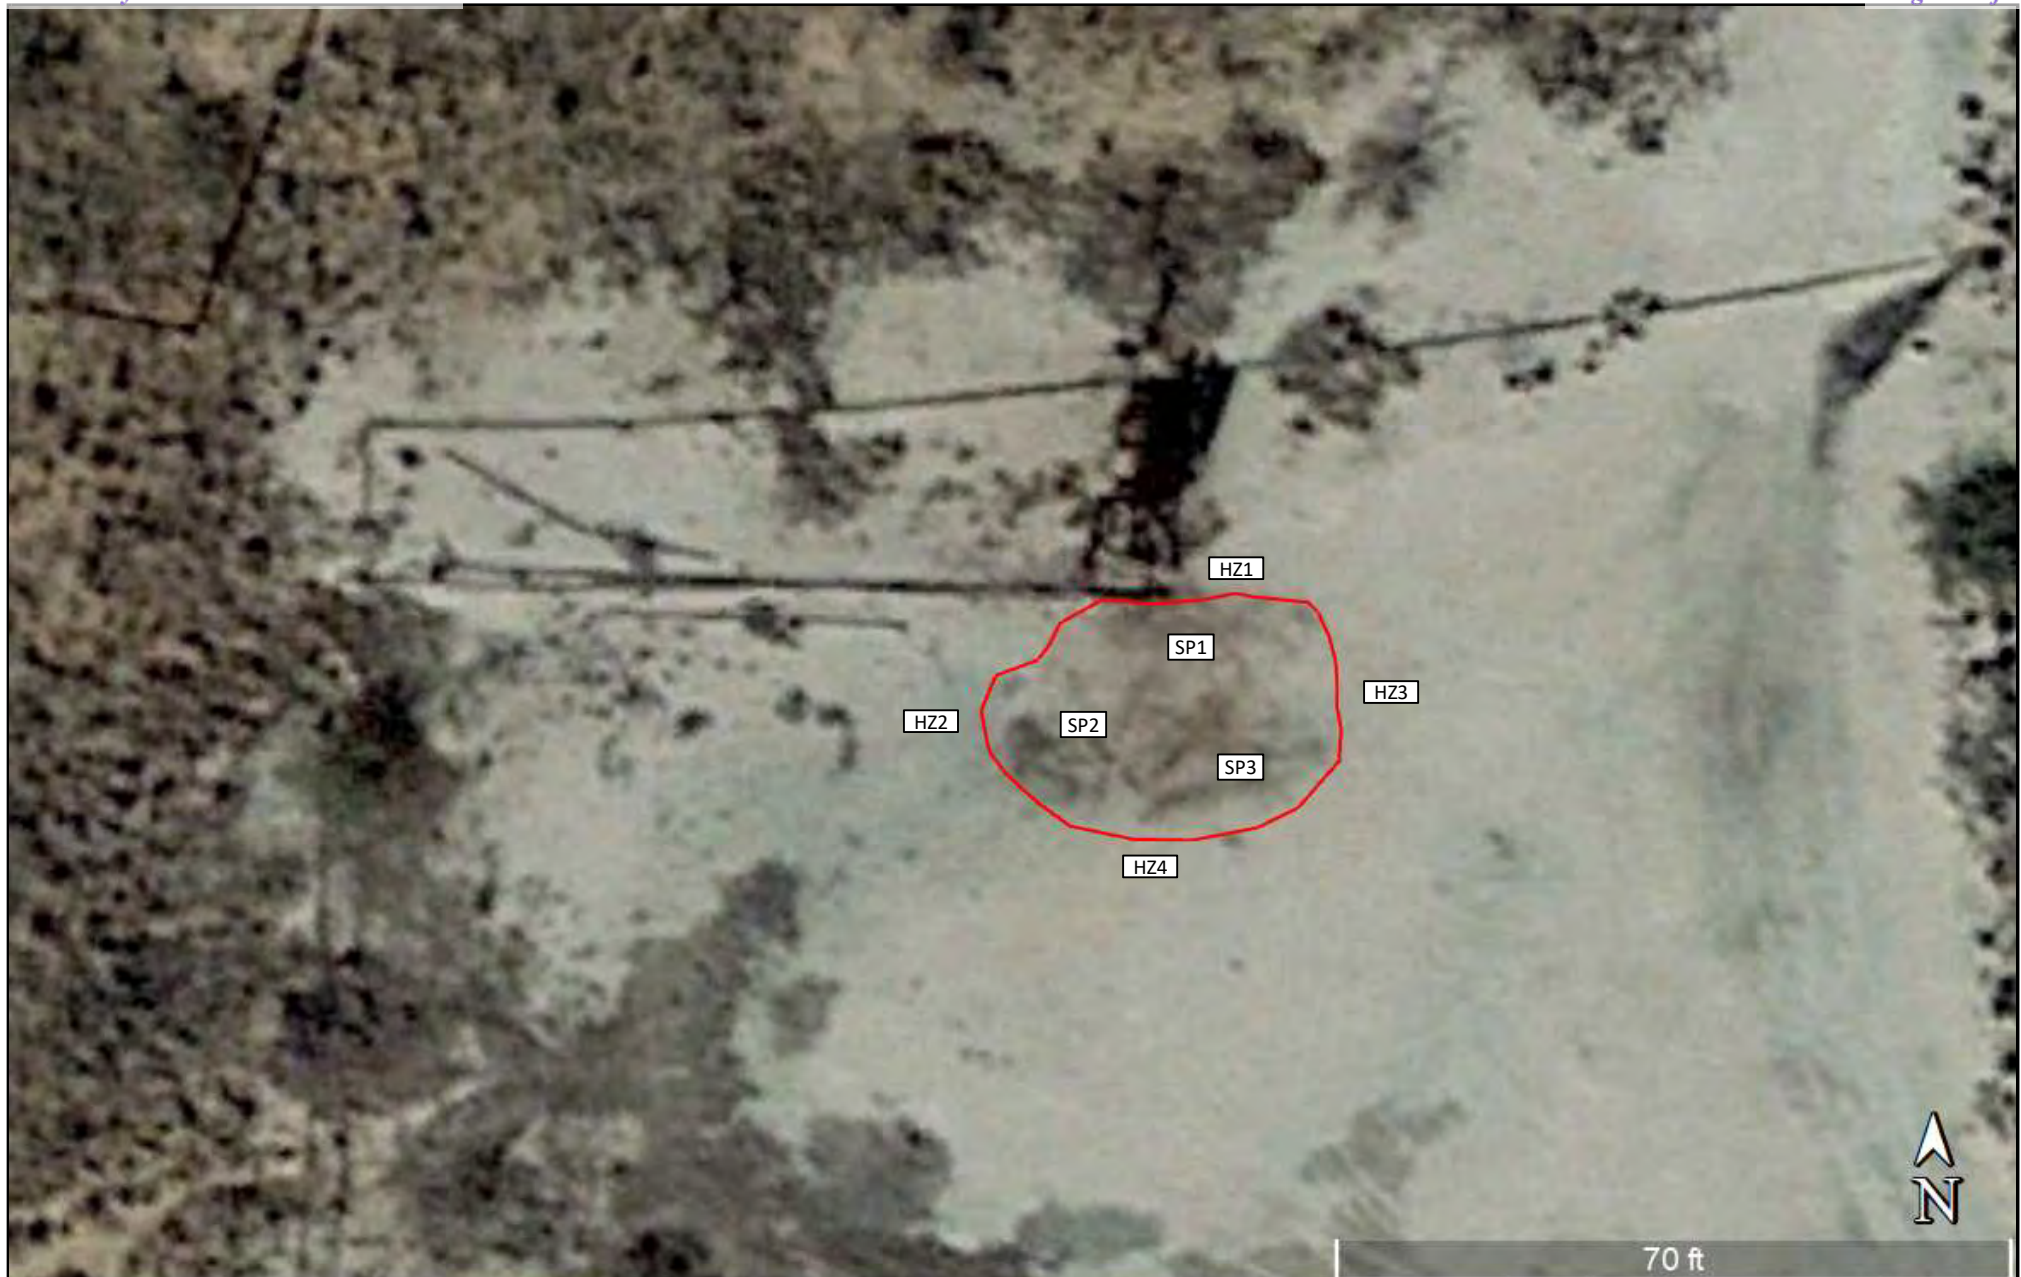
**Figure 4**

Delineation Sample Map
FAE II Operating, LLC
Federal F #3
GPS: 32.00969, -103.183752
Lea County

Based on field observations and field test data noted above and provided in Attachment IV, fourteen representative soil samples were selected for laboratory analysis. Delineation soil samples SP1 through SP3, HZ1 through HZ4, were submitted to the laboratory for analysis of BTEX, TPH, and chloride. Laboratory analytical results indicated contaminant concentrations were below the NMOCD Closure Criteria in each of the submitted samples, with the exception of SP1 at one foot, SP2 and SP3 at Surface, which exhibited TPH concentrations in excess of NMOCD Closure Criteria.

A Delineation Sample Map and Excavation Sample Map are provided as Figure 4 and Figure 5, respectively. A Summary of Soil Sample Laboratory Analytical Results is provided as Table 1 and Laboratory Analytical Reports are provided as Attachment VI.

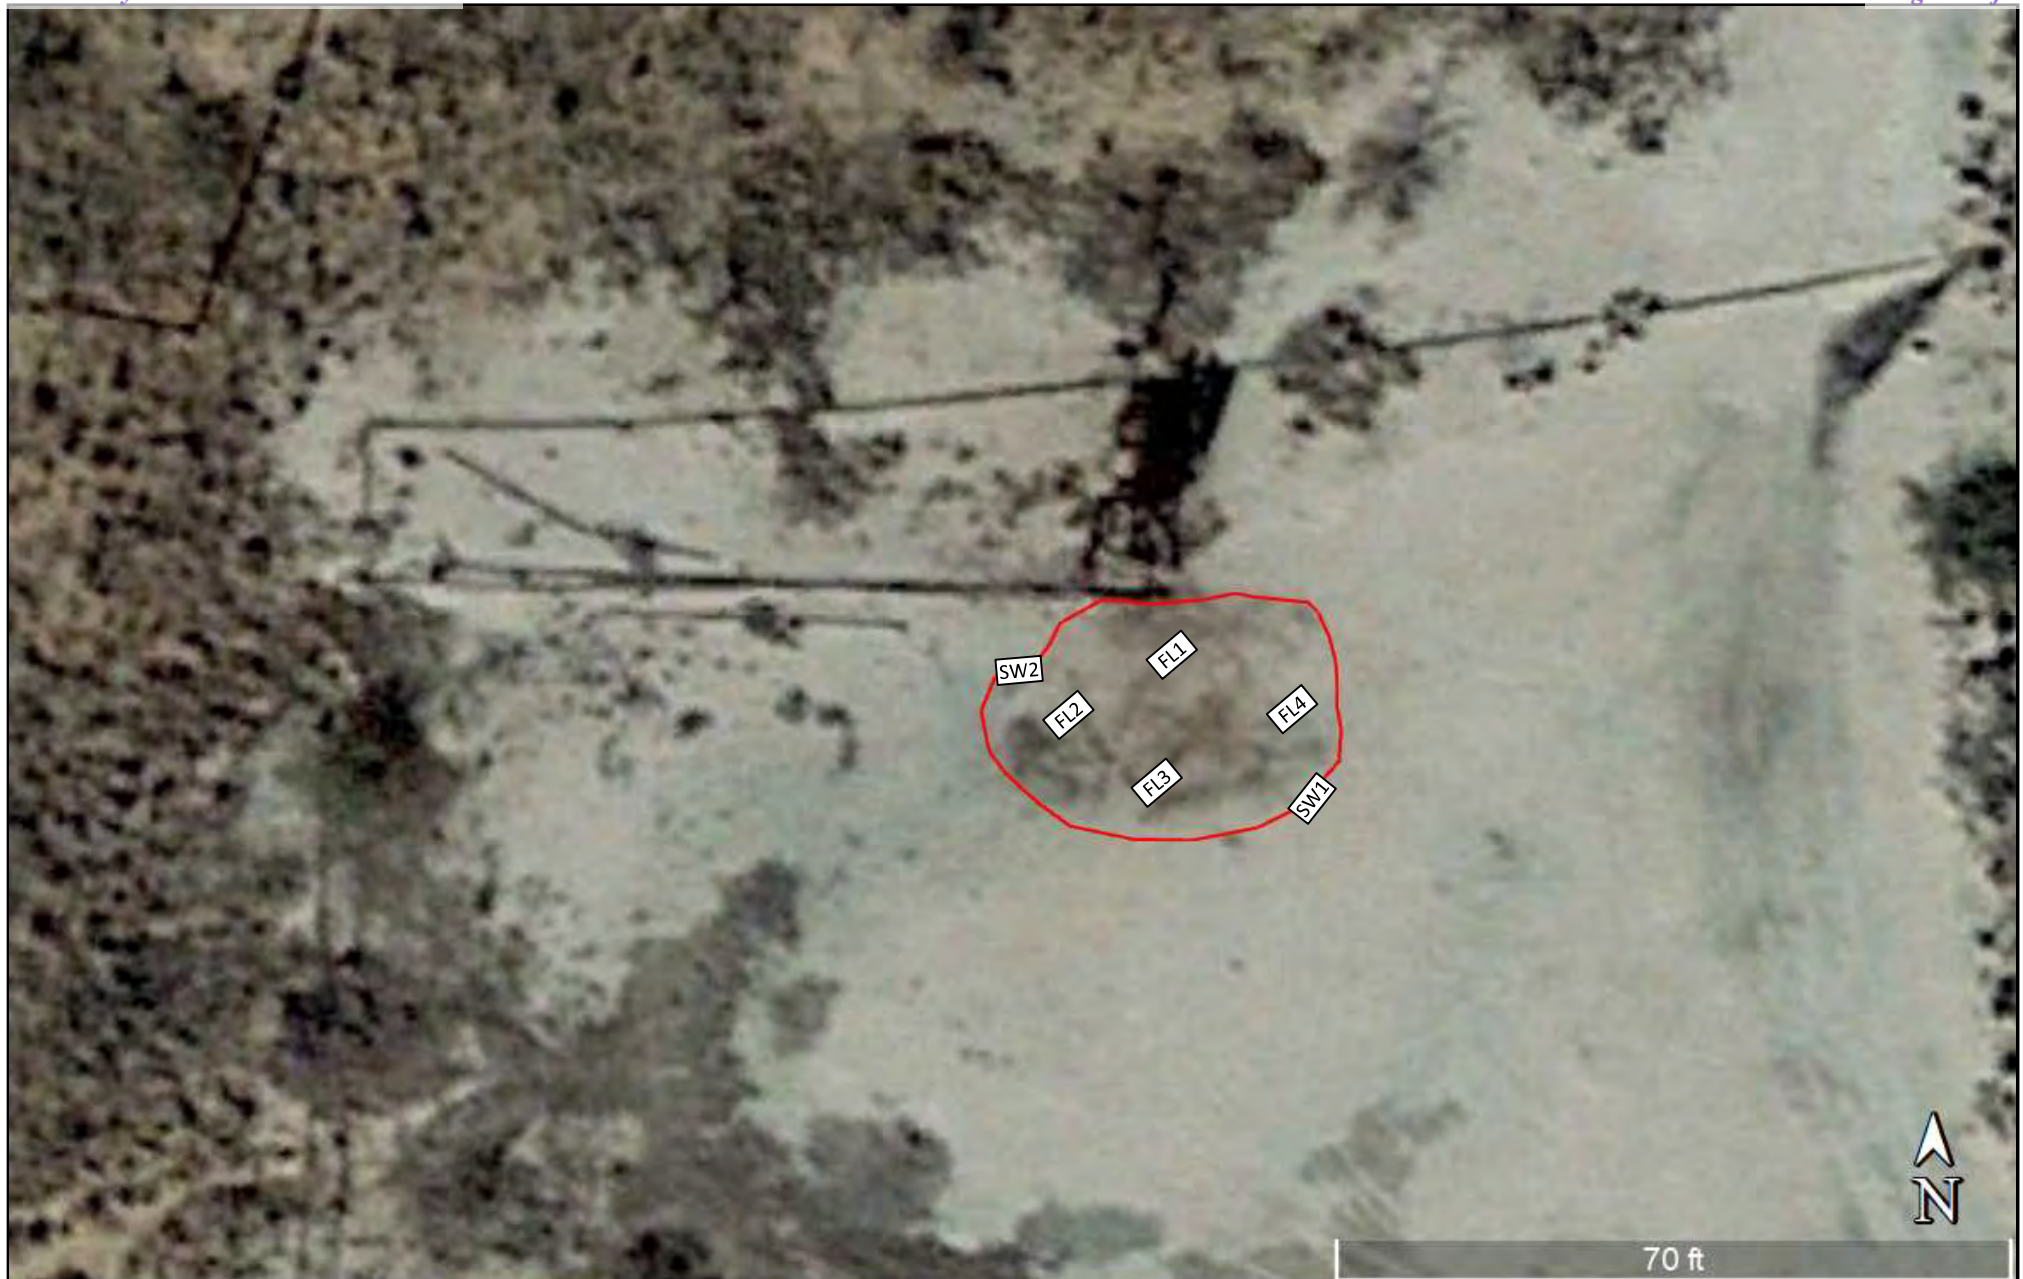
**Figure 5**

Excavation Sample Map
FAE II Operating, LLC
Federal F #3
GPS: 32.00969, -103.183752
Lea County

On November 3, 2023, the release area was excavated to a depth ranging from one and half to four feet bgs. Excavated contaminated soil was temporarily stockpiled onsite, atop plastic, before transport to an NMOCD approved disposal facility.

On December 1, 2023, six composite confirmation soil samples were collected from the excavation floor and sidewalls, every 200 square feet and every 50 linear feet, respectively. Soil samples FL1 through FL4 and SW1 through SW2, were submitted to the laboratory for analysis of BTEX, TPH, and chloride. Laboratory analytical results indicated contaminant concentrations were below the NMOCD Closure Criteria in each of the submitted samples.

The excavated area measured approximately eight hundred square feet. During remediation activities approximately 70 cubic yards of impacted soil were excavated and hauled to an NMOCD approved disposal facility.
