RE: Liner Inspection and Closure Report
Maracas 22 State Tank Battery
API No. N/A
GPS: Latitude 32.82148 Longitude -104.15637
UL- H, Section 22, Township 17S, Range 28E
NMOCD Reference No. nAPP2316451217

Spur Energy Partners (Spur) has contracted Pima Environmental Services, LLC (Pima) to perform a liner inspection and prepare the following closure report for the release of produced water that occurred on the Maracas 22 State Tank Battery (Maracas). This incident was assigned Incident ID. nAPP2316451217, by the New Mexico Oil Conservation Division (NMOCD).

SITE PHOTOGRAPHS
SPUR ENERGY PARTNERS
MARACAS 22 STATE TANK BATTERY

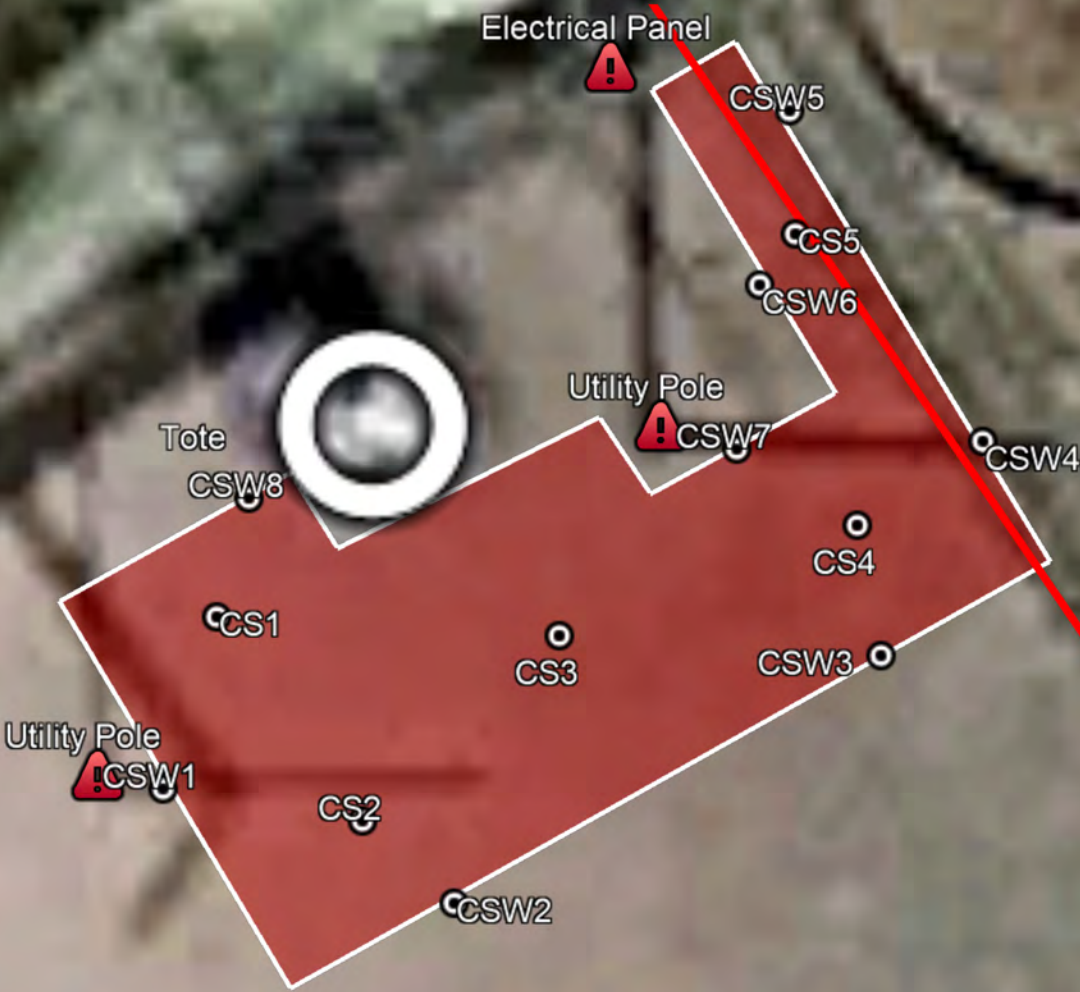
Spur Energy
API # N/A
Eddy County, NM
Confirmation Sampling Map

On March 12, 2024, a Pima field technician was dispatched to Maracas to conduct a confirmation sampling event. They gathered a total of five bottom samples (CS1-CS5) from the base of the excavation, each taken at a depth of 3 feet below ground surface (bgs). Additionally, eight side wall samples (SW1-SW8) were collected from the bottom to the top of the excavation's side walls. Each soil sample comprises a 5-point composite sample. Notably, each bottom sample covered an area not exceeding 200 square feet of the excavated zone, while each side wall sample did not surpass 50 feet of the perimeter of the excavation. The specific areas for each side wall sample are indicated on our site map, with detailed illustrations provided in Figure 5 depicting the confirmation sampling event and the excavated zone. The results of this sampling event are presented in the subsequent data table.

- Confirmation Sample
- Excavated Area ~353 ft2
- Pipe
- Tote
- Utility Pole

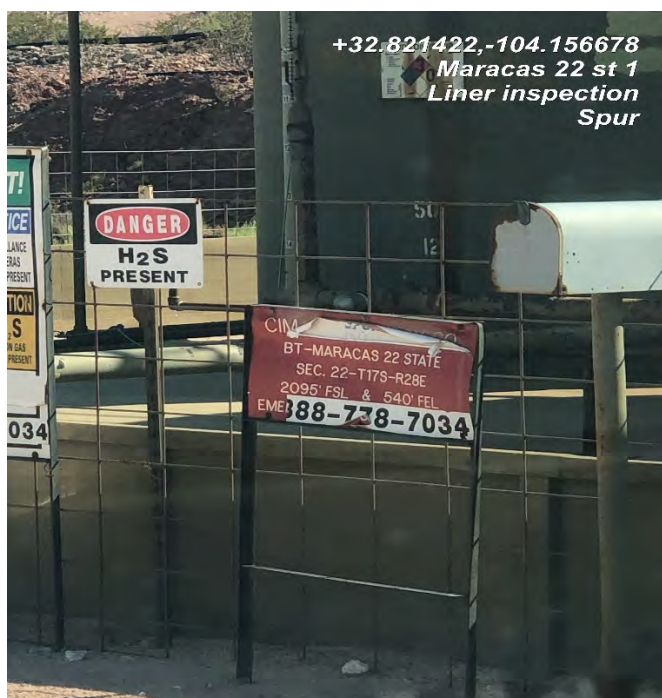
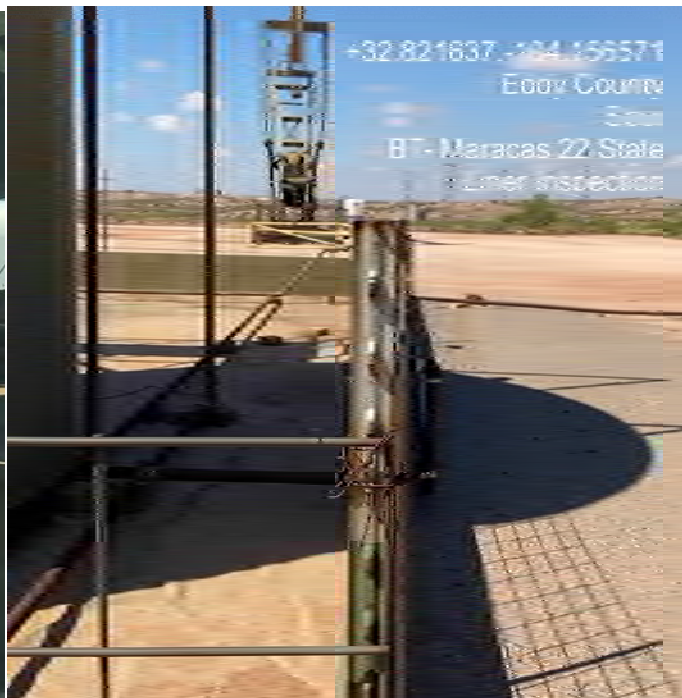
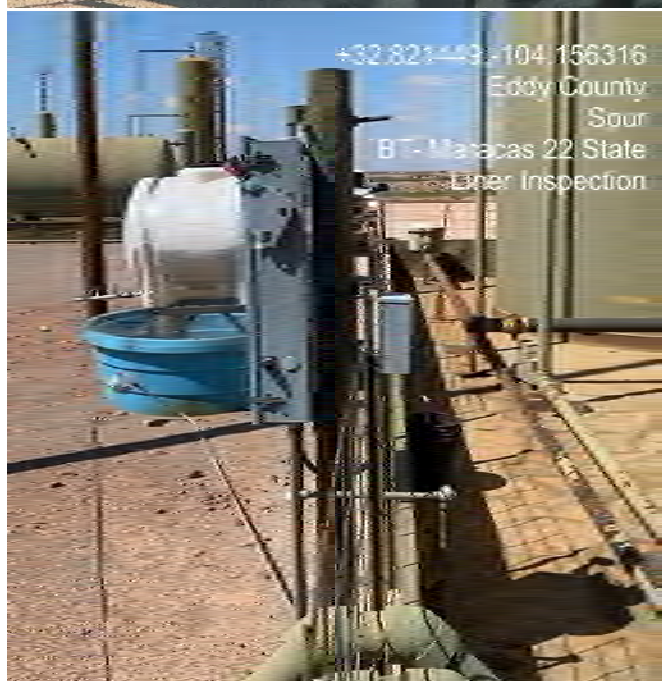
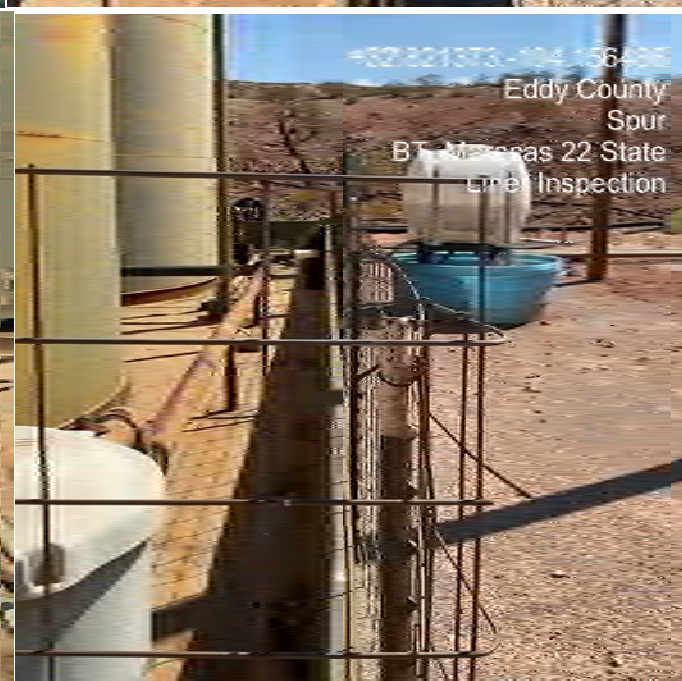
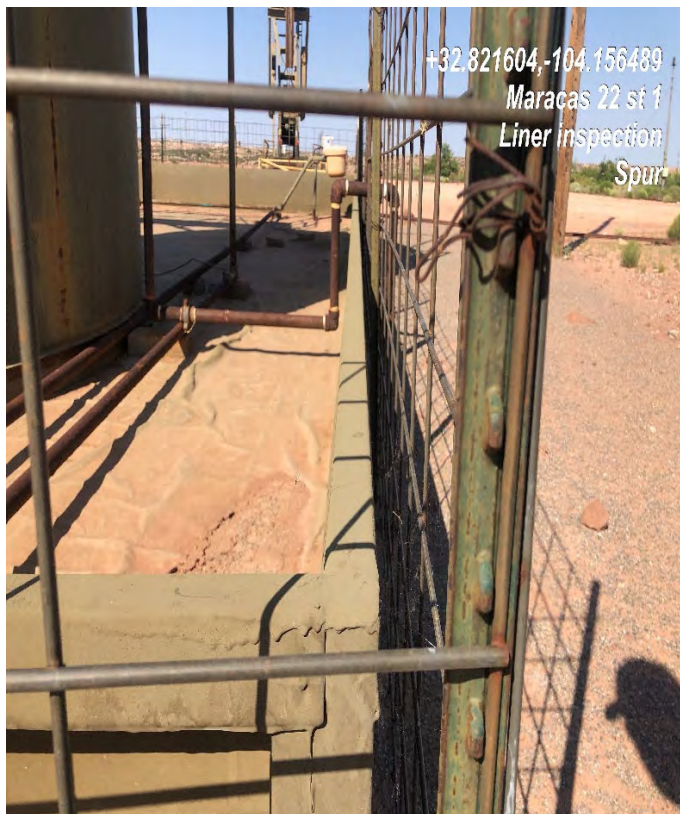
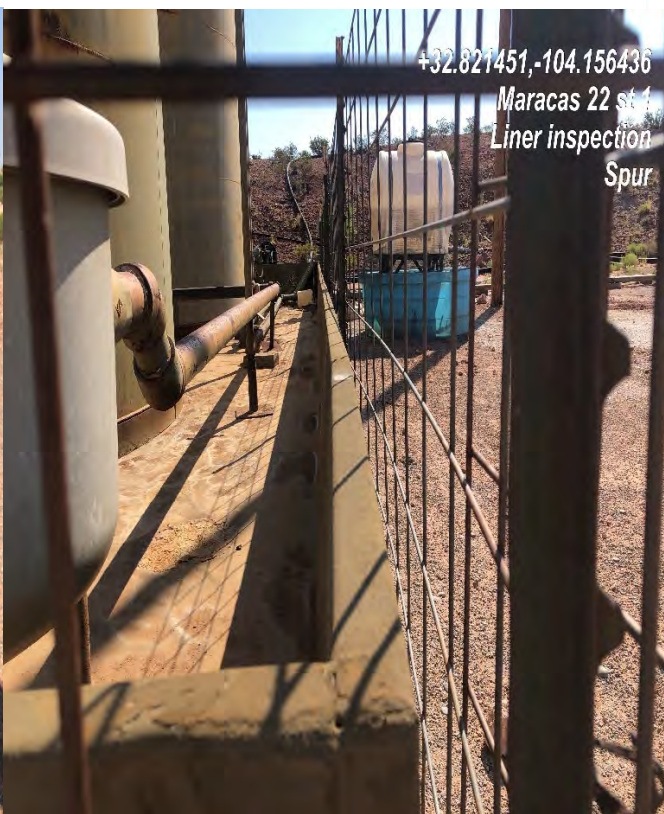
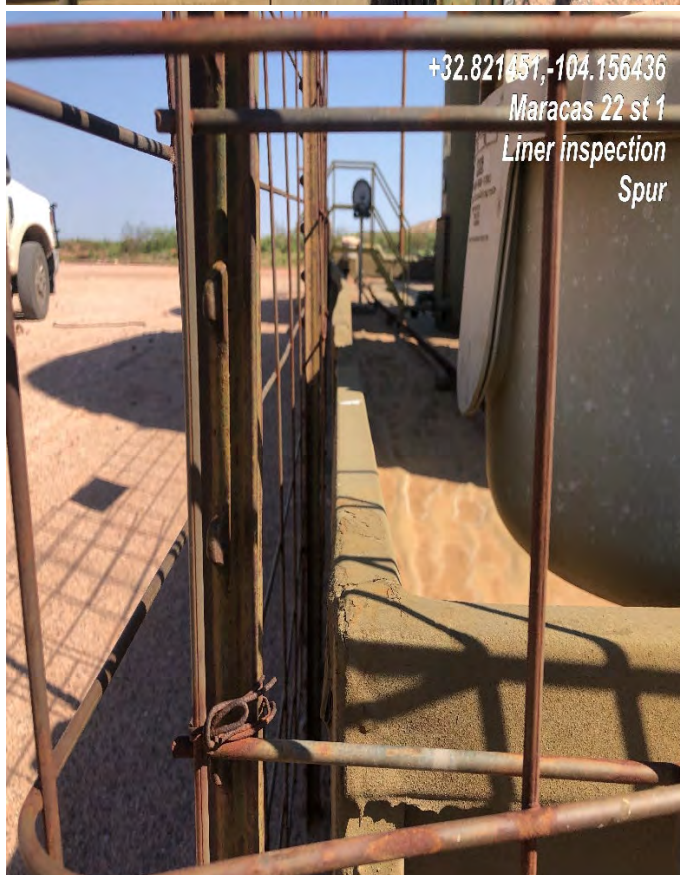
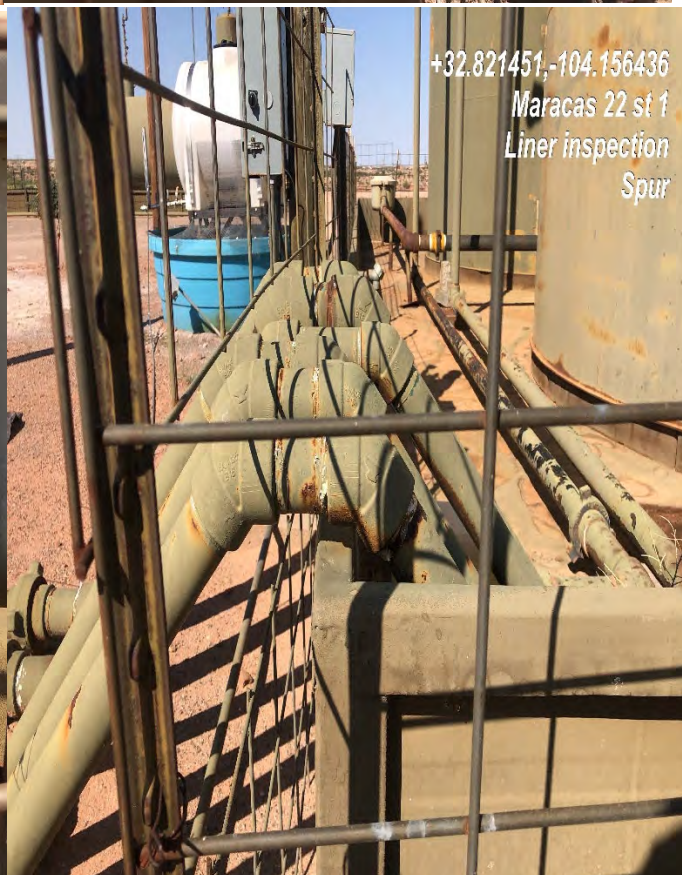
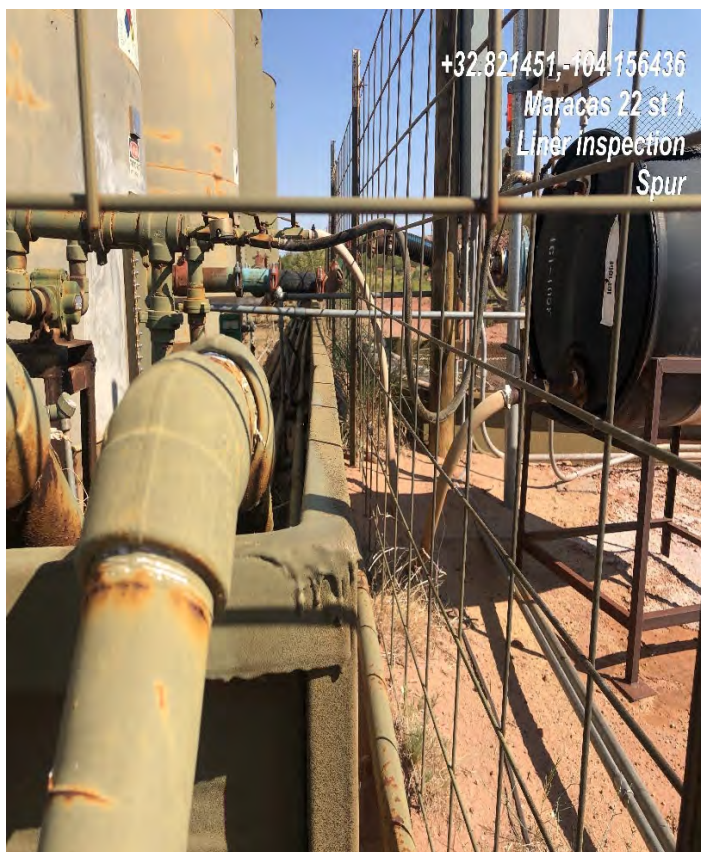
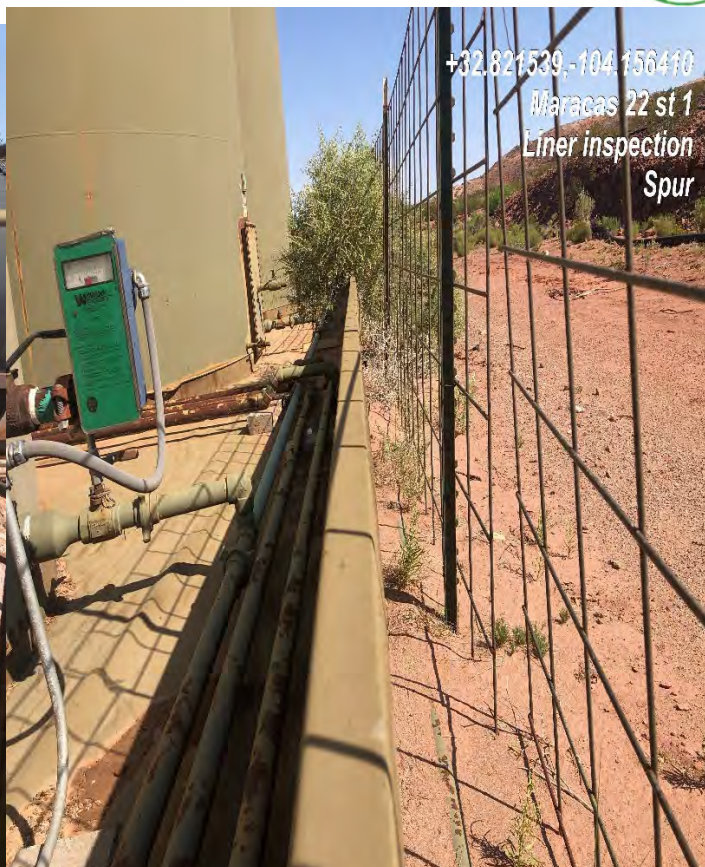
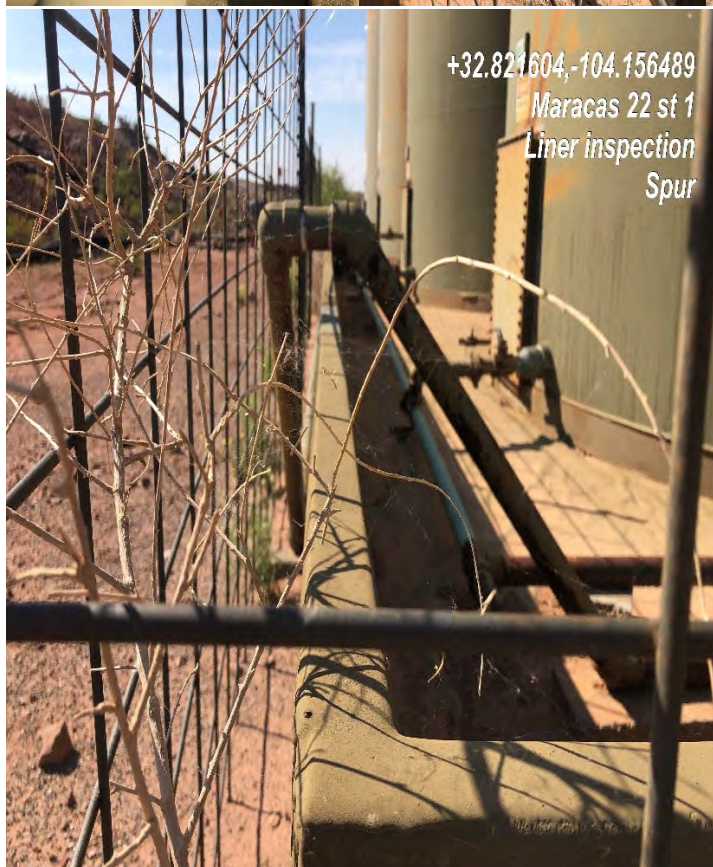
Liner Inspection:

On August 25, 2023, after sending the 48-hour notification via email, Pima Environmental conducted a liner inspection at the Maracas. We concluded that this liner and containment maintained its integrity and was able to retain the fluids. The liner inspection form and photographic documentation can be found in Appendix D.

Visualization	Yes	No	Comments
Is there a tear in the liner?		X	
Are there holes in the liner?		X	
Is the liner retaining any fluids?		X	
Does the liner have integrity to contain a leak?	X

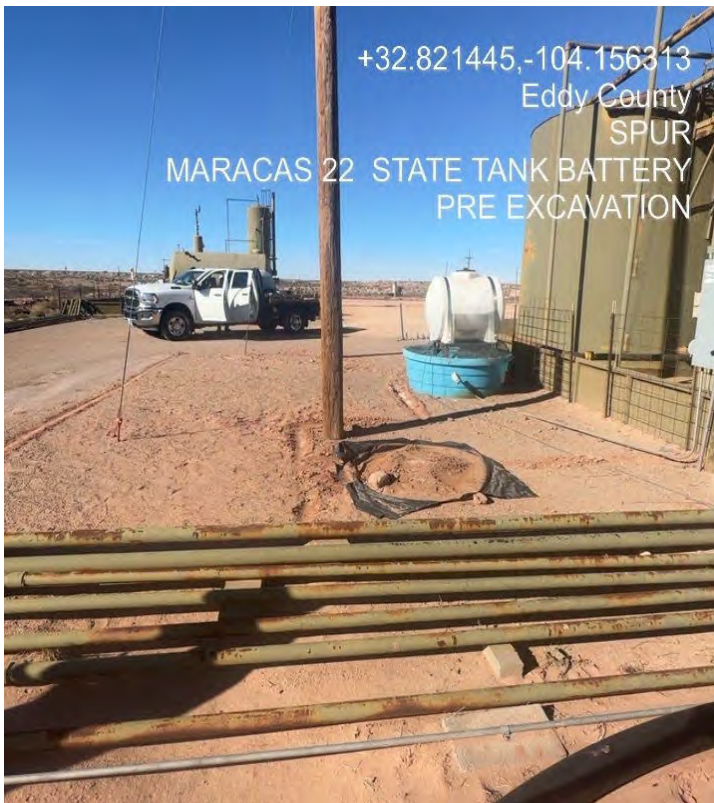
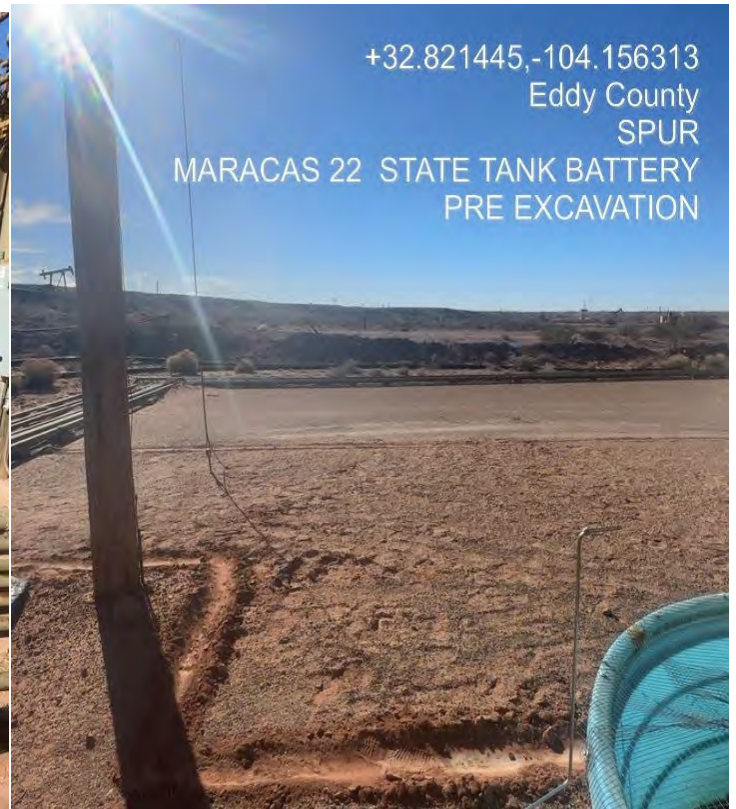
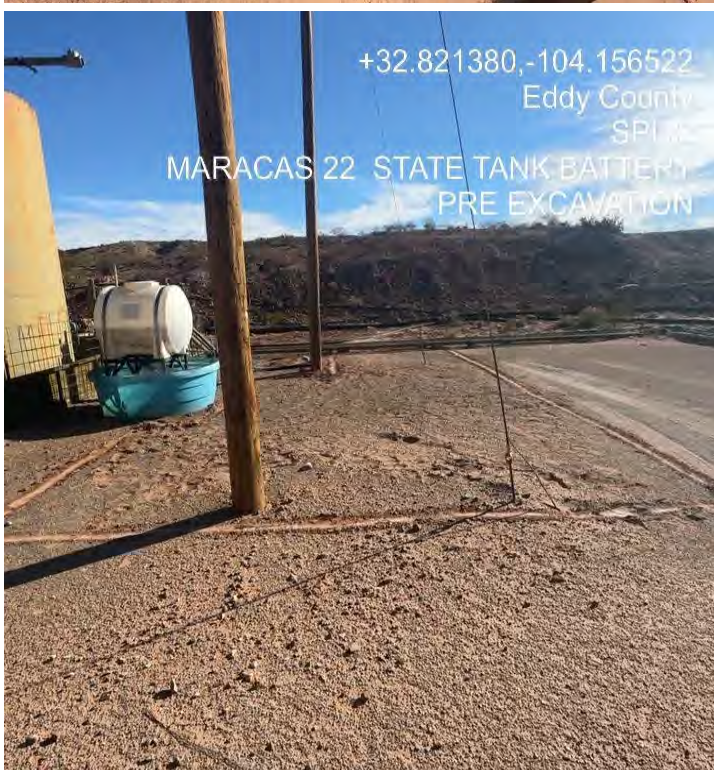
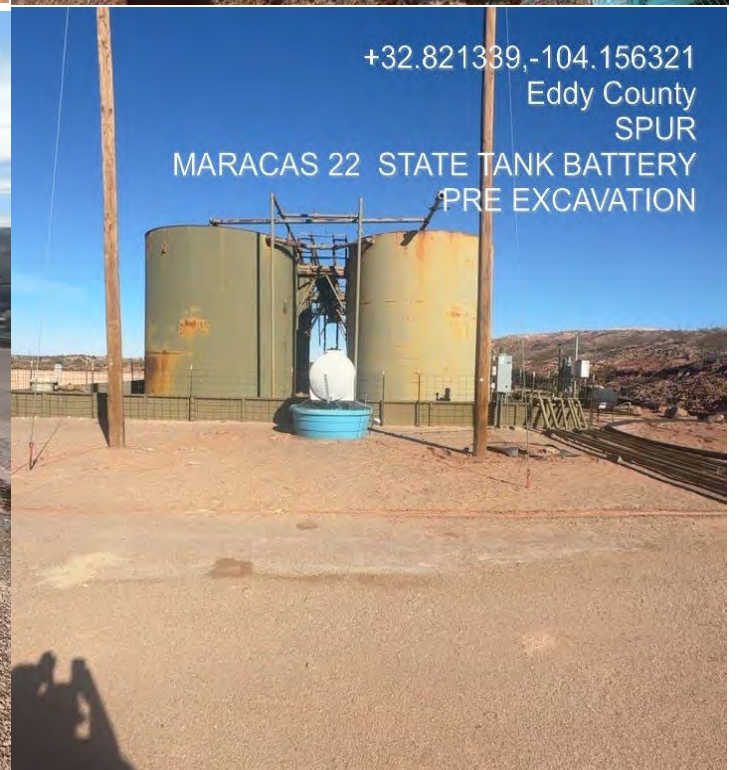
PRE-EXCAVATION-

nAPP2316451217: On June 13th, 2023, A seal on the water transfer pump failed causing a produced water release inside the lined containment with a small amount spilling onto the engineered pad. The release area measured approximately 287 square feet. All contamination remained on location.

On June 14th, 2023, Pima Environmental mobilized personnel to the site to assess the impacted area located adjacent to the lined containment. Pima sampled the area between the point of release and the southeastern extent of the tank battery containment, the impacted area measured approximately 287 square feet. A total of four sample points (S1-S4) were collected at depths of 1-4 feet to achieve vertical delineation. Similarly soil samples (SW1-SW4) were collected at a depth of 6 inches to achieve horizontal delineation, each side wall sample consists of 5-point composite samples of the impacted area. One background sample (BG1) was collected in the pasture to the northeast of the impacted area. Laboratory results of this sampling event can be found in the following data table.

On February 13, 2024, the closure submission made previously was rejected, citing the proximity of the release area to a wetland zone within 300 feet. In response, Pima Environmental mobilized its workforce to Maracas once more, focusing on excavating the affected section situated at the southern extremity of the tank battery. Beginning from March 1 to March 11, 2024, Pima deployed a manual shoveling crew to excavate the area, encompassing soil samples S1-S4, to a depth of 3 feet below ground surface (bgs). The excavated zone measured approximately 353 square feet, and roughly 32 cubic yards of contaminated soil were extracted. All contaminated materials were safely transported to Lea Land, an NMOCD-approved disposal facility.

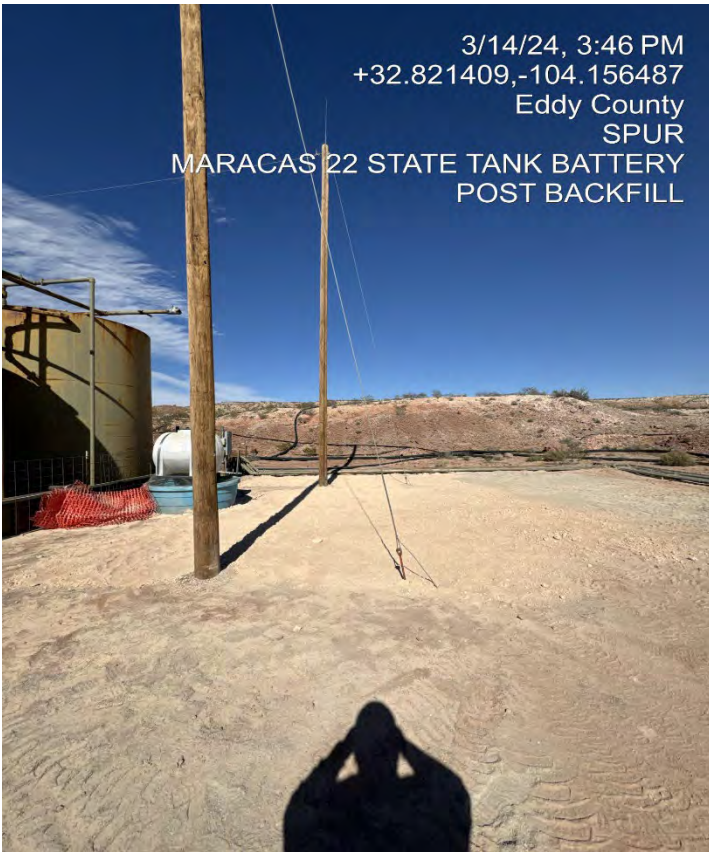
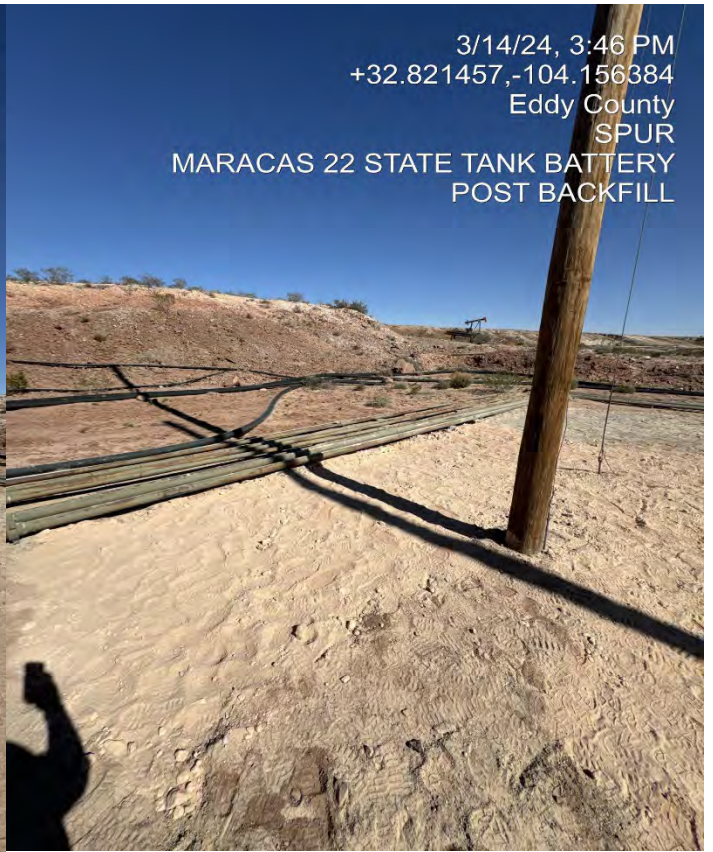
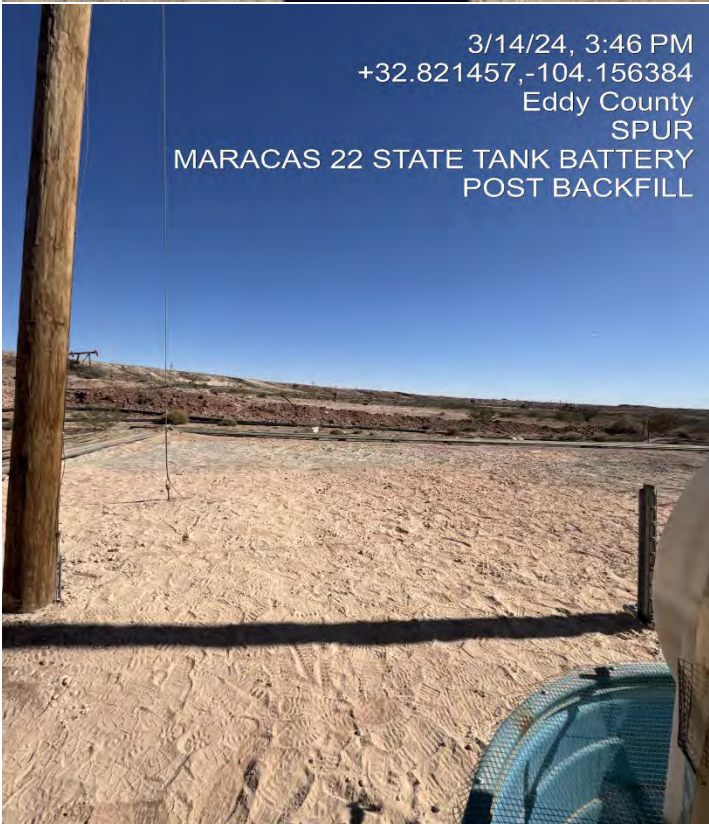
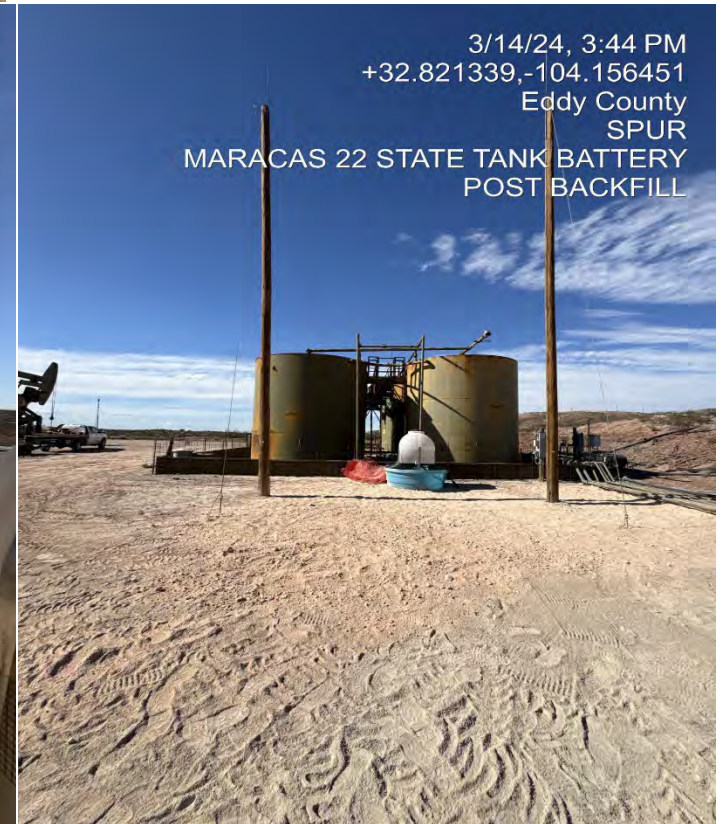
BACKFILL-

Upon confirmation that all soil samples met the closure standards set by the New Mexico Oil Conservation Division (NMOCD), clean backfill material was brought in and utilized to restore the excavated area, returning it to its original state.
