April 15, 2024

Vertex Project #: 23E-03658

Spill Closure Report: Siebert #1 Production Facility (Section 15, Township 23 South, Range 28 East)
API: 30-015-26322
County: Eddy
Incident Report: nAPP2111646040

Prepared For: **BTA Oil Producers, LLC**
104 S. Pecos Street
Midland, Texas 79701

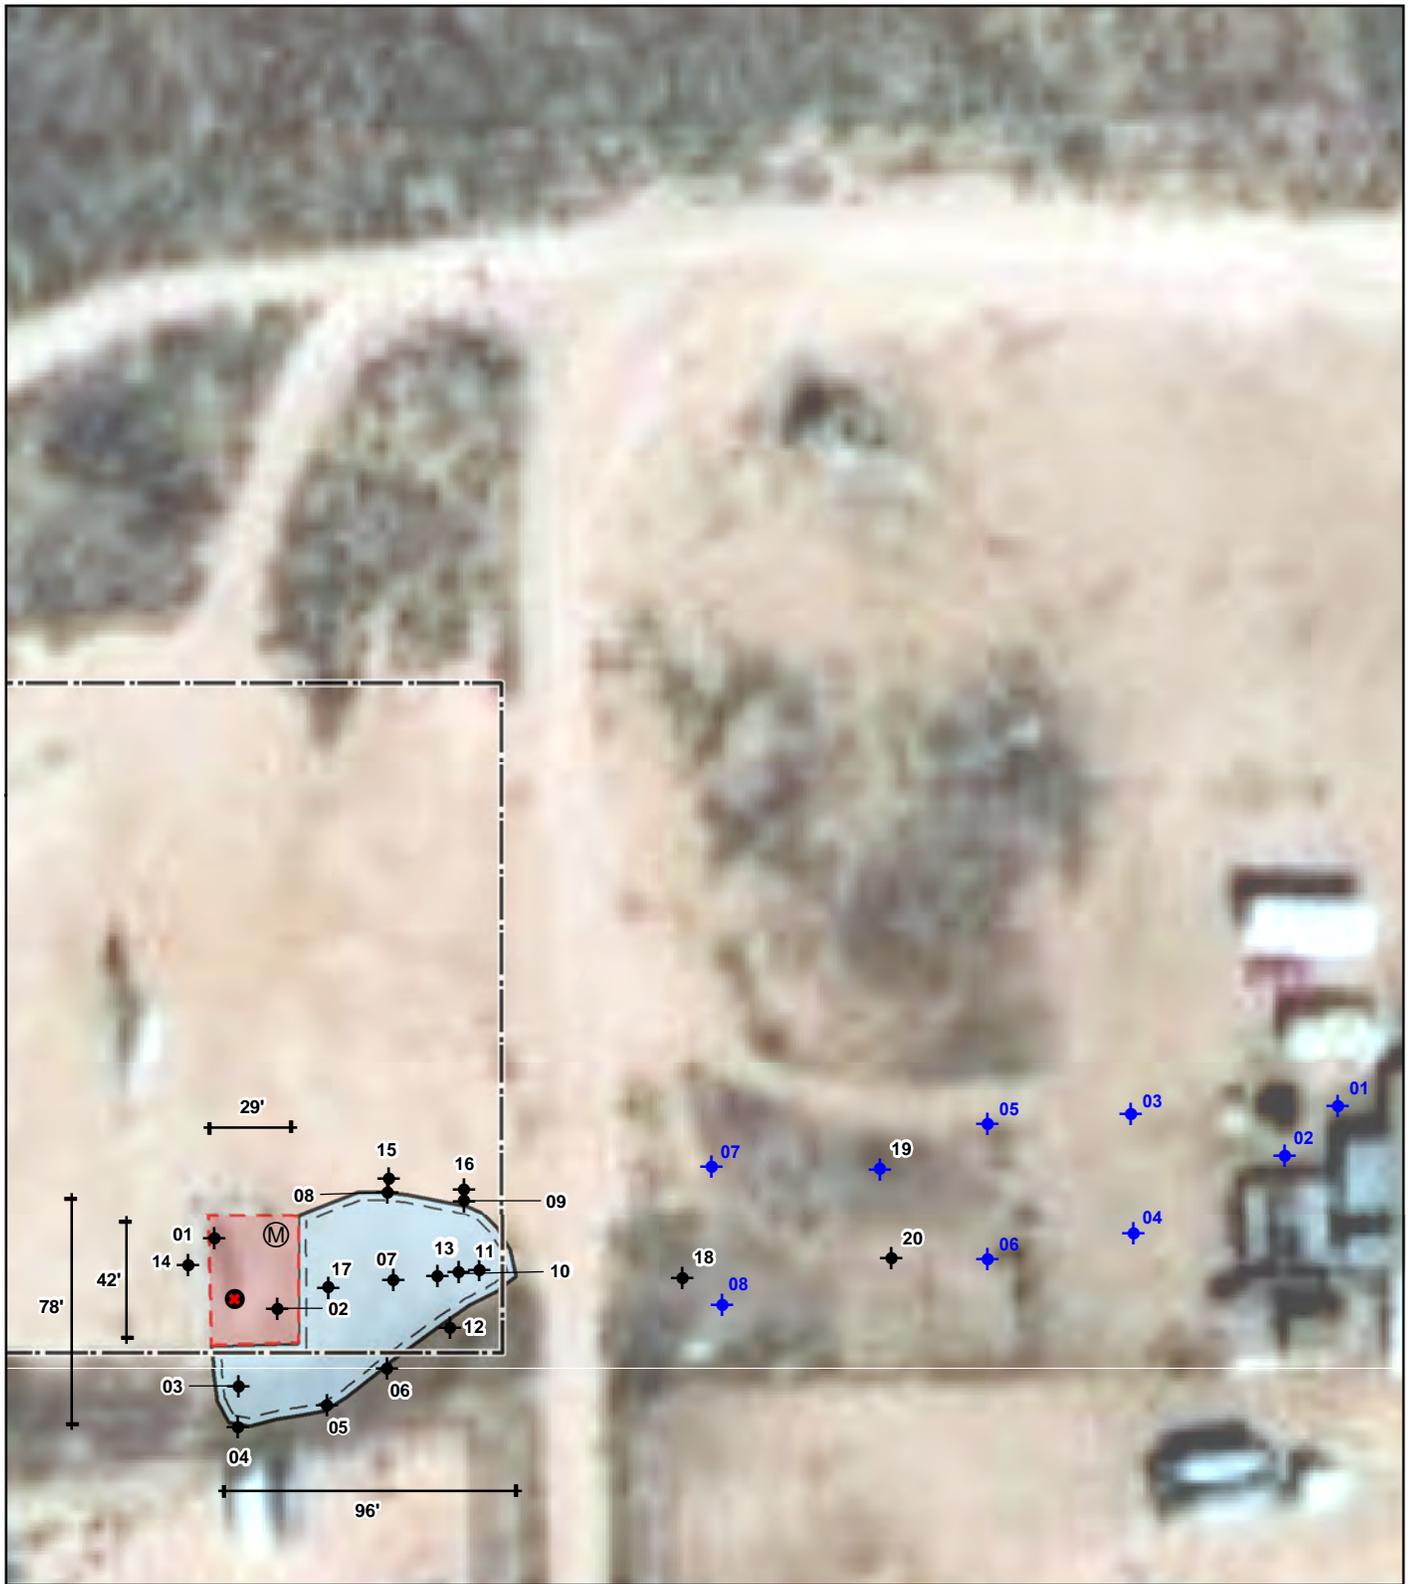
- Background Sample (Prefixed by "BG21-") (M) Meter Run
- ◆ Borehole (Prefixed by "BH21-") Excavated ● Point of Release
- ◆ Borehole (Prefixed by "BH24-")
- ⎓ Approximate Lease Boundary
- ⎓ Approximate Release Area Outside Containment (~4,008 sq. ft.)
- ⎓ Approximate Release Area Inside Containment (~1,214 sq. ft.)

The site is typical of oil and gas exploration and production sites on the western portion of the Permian Basin and is currently used for oil and gas production and storage. The following sections specifically describe the release area on the south edge of the constructed pad where the heater treater is located (Attachment 2 – Figure 1).

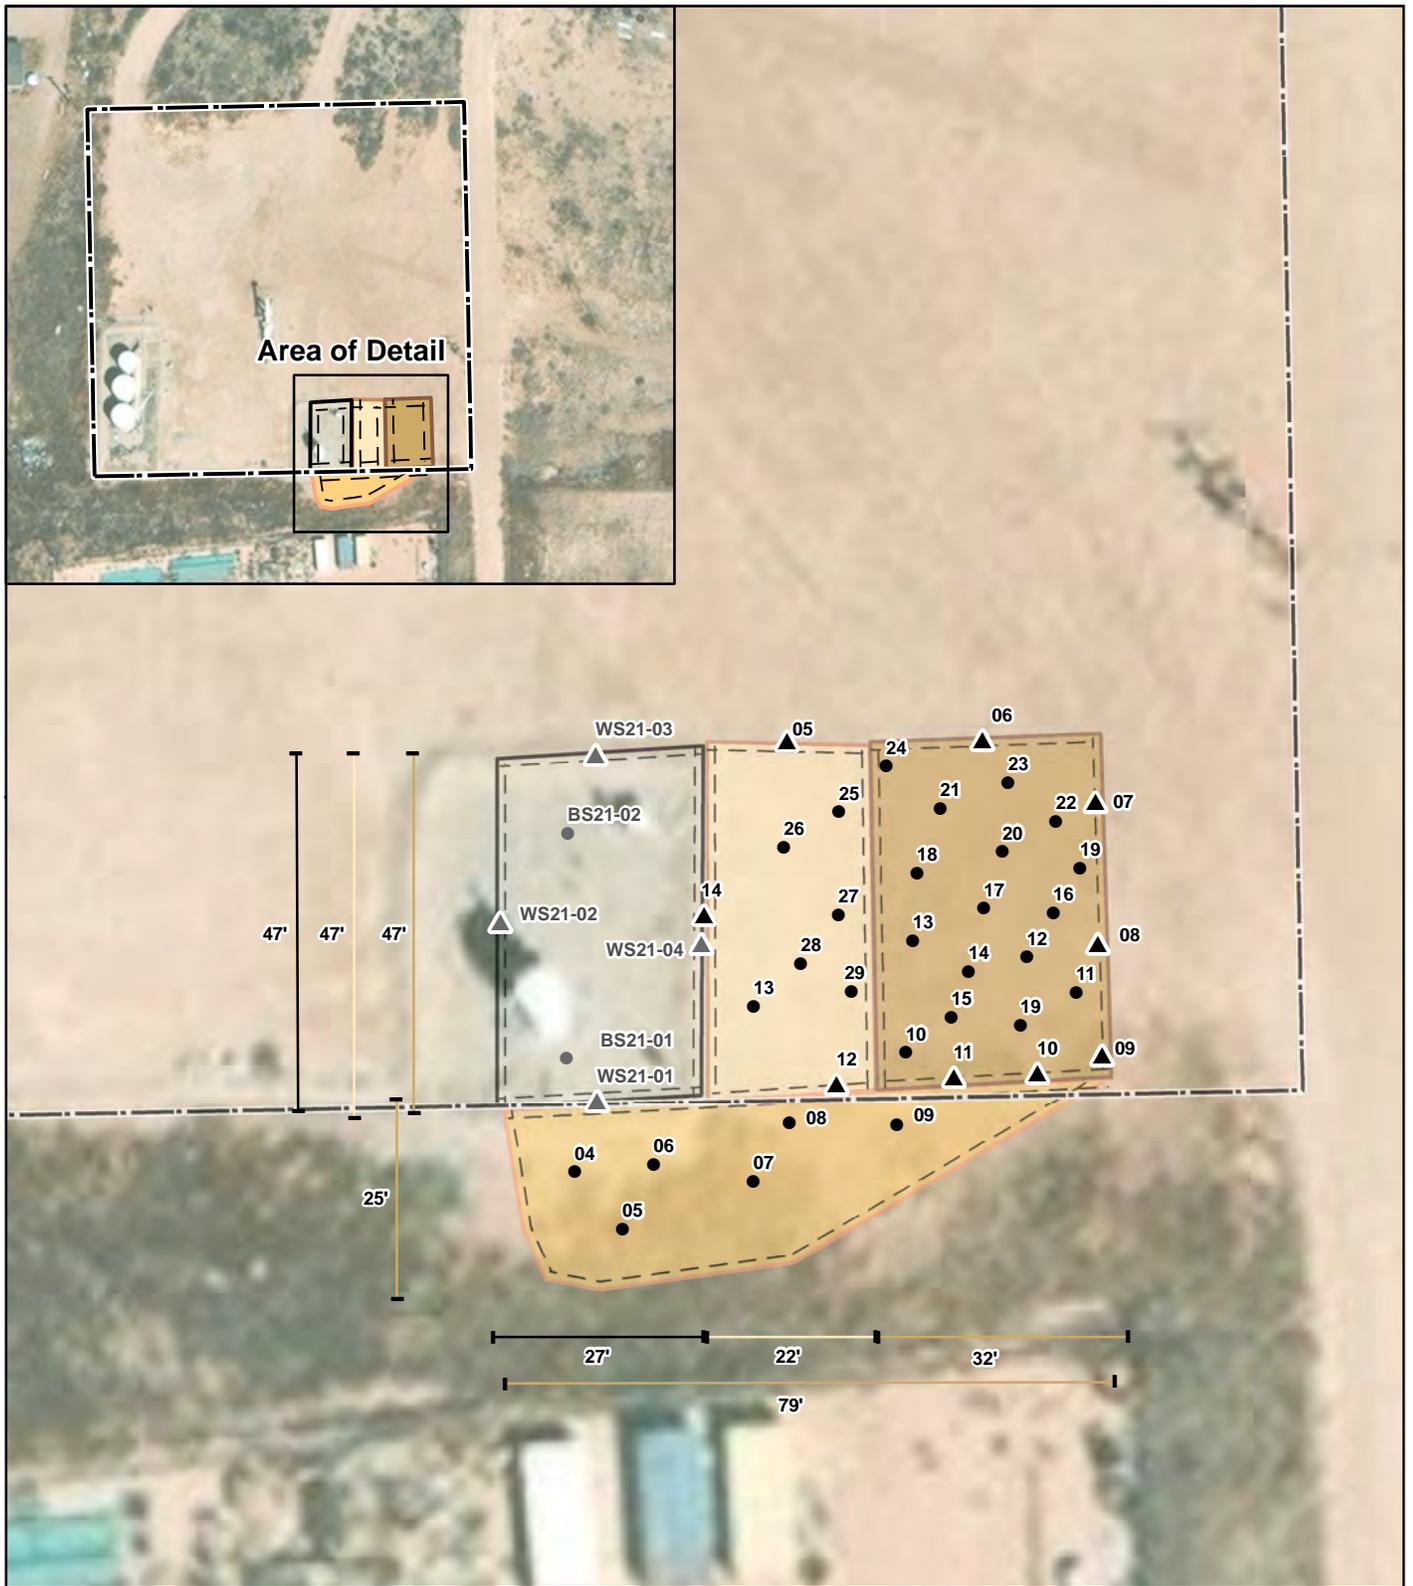
- Base Sample (Prefixed by "BS23-")
- Historical Base Sample
- ▲ Historical Wall Sample
- ▲ Wall Sample (Prefixed by "WS23-")
- Approximate Lease Boundary
- ▭ Excavation to 0.5' bgs (~997 sq.ft.)
- ▭ Containment Excavation to 4' bgs (~1,224 sq.ft.)
- ▭ Pad Excavation to 0.5' bgs (~1,271 sq.ft.)
- ▭ Pad Excavation to 1.5' (~1,378 sq.ft.)

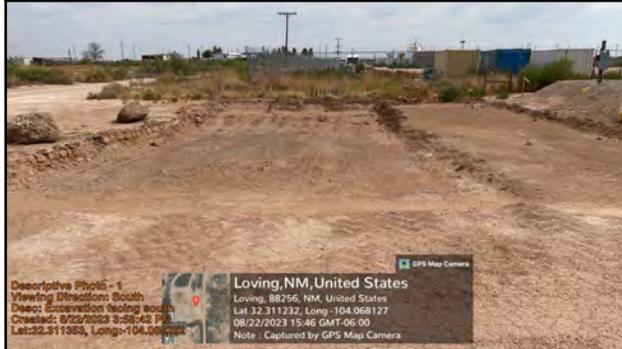
Viewing Direction: South

Excavation facing south

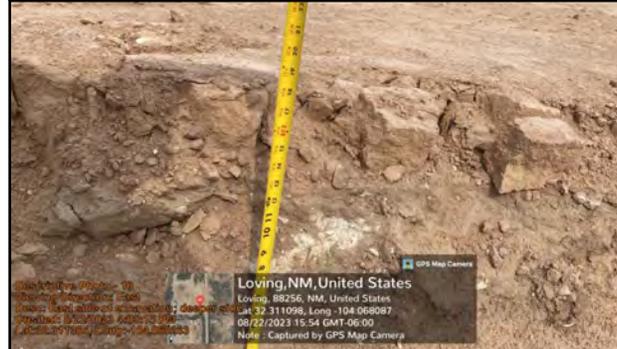
Viewing Direction: East

East side of excavation; deeper side

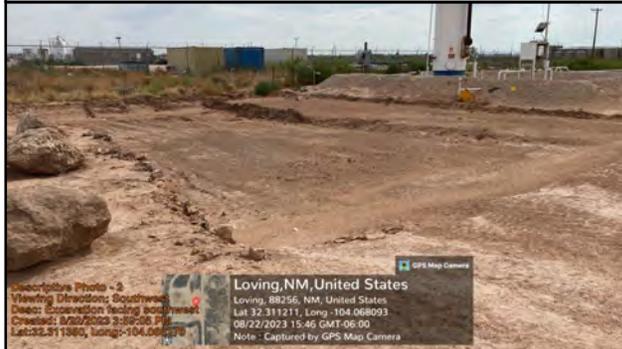
Viewing Direction: Southwest

Excavation facing southwest

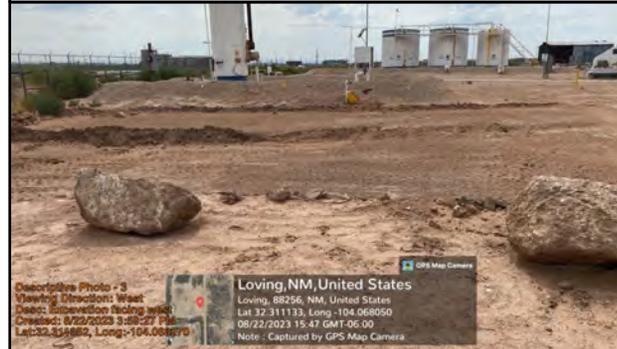
Viewing Direction: West

Excavation facing west

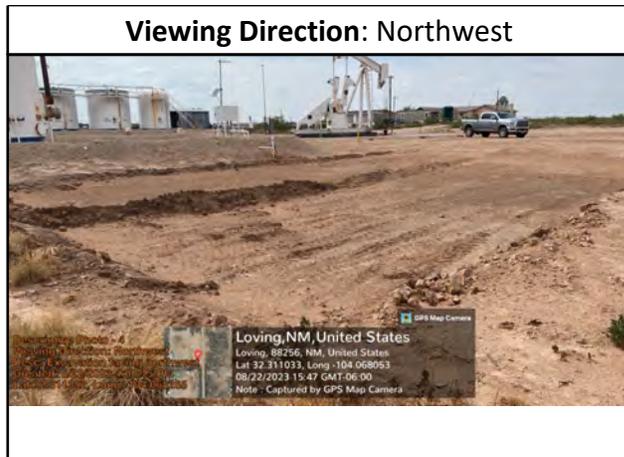
Excavation facing northwest

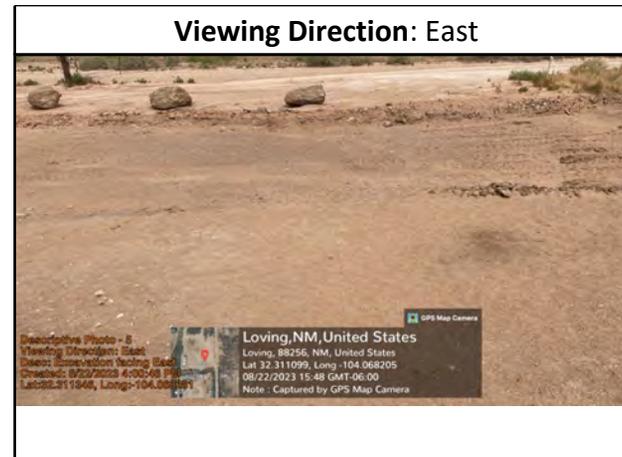
Excavation facing East

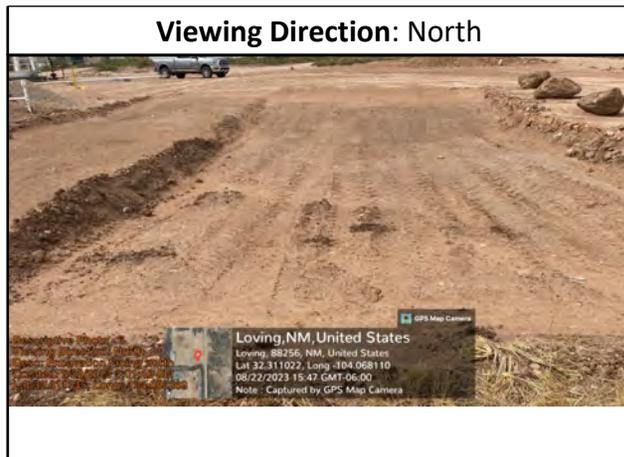
Excavation facing north

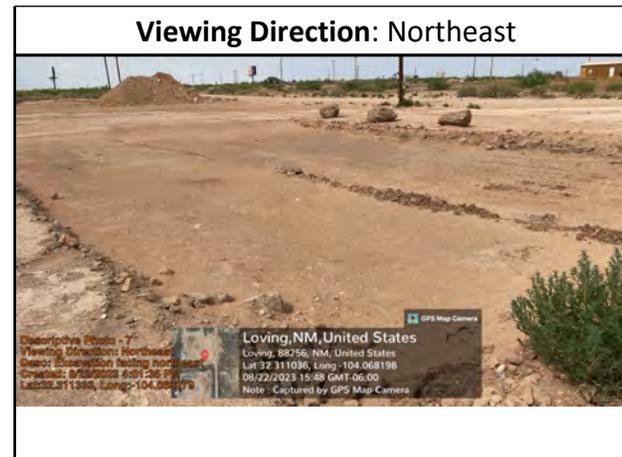
Excavation facing northeast

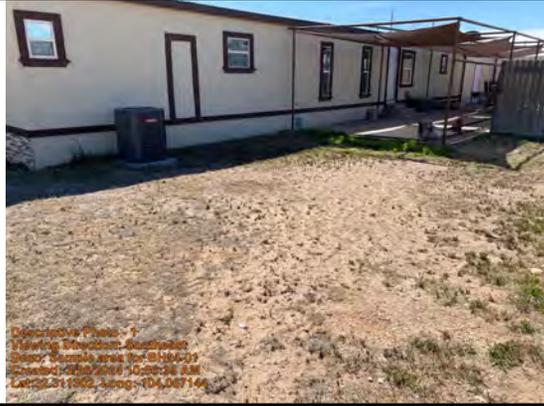
Descriptive Photo - 1
Viewing Direction: Southeast
Date: Sample area for BH24-01
Created: 3/25/2024 10:58:36 AM
Lat:32.311932, Long:-104.067144

Sample area for BH24-01

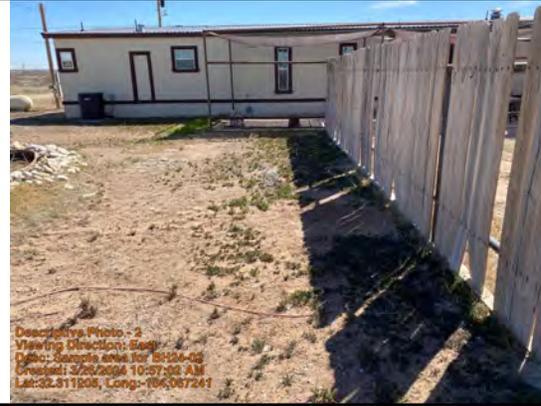
Descriptive Photo - 2
Viewing Direction: East
Date: Sample area for BH24-02
Created: 3/25/2024 10:57:02 AM
Lat:32.311935, Long:-104.067241

Sample area for BH24-02

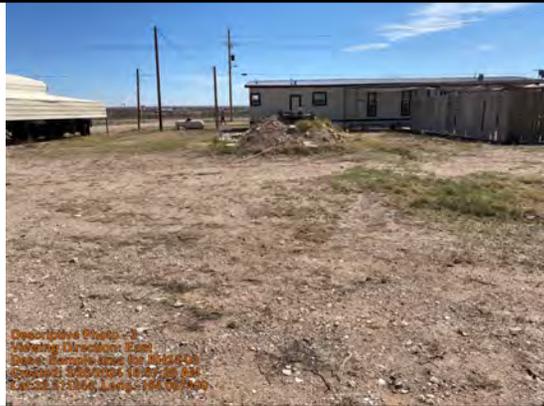
Descriptive Photo - 3
Viewing Direction: East
Date: Sample area for BH24-03
Created: 3/25/2024 10:57:35 AM
Lat:32.311936, Long:-104.067169

Sample area for BH24-03

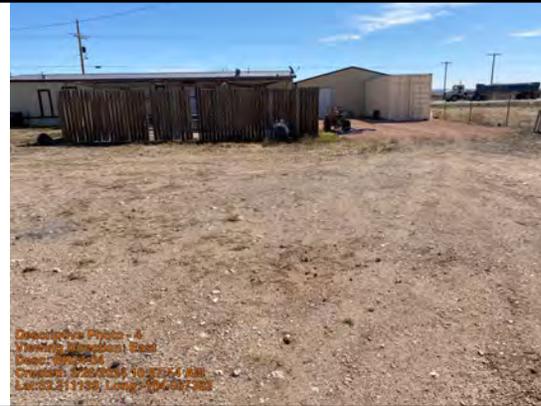
Descriptive Photo - 4
Viewing Direction: East
Date: Sample area for BH24-04
Created: 3/25/2024 10:57:54 AM
Lat:32.311938, Long:-104.067353
