RE: Closure Request Letter
Devon Energy Production Co. LP
Todd 22B Fed 2
nAB1609941598
Eddy County, New Mexico

Devon Energy Production Co LP Todd 22B Fed 2 Closure Report

2RP-1671
2RP-3640

**Unit Letter B, Section 22, T23S, R31E
Eddy County, New Mexico**

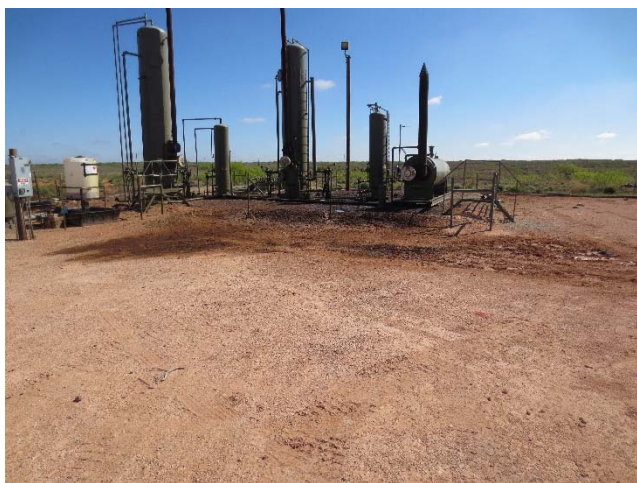
Looking North at impacted pad area

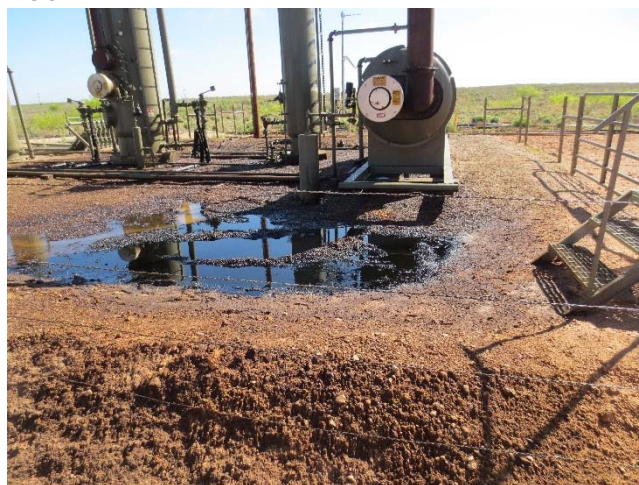
Standing fluid inside berm from SE corner

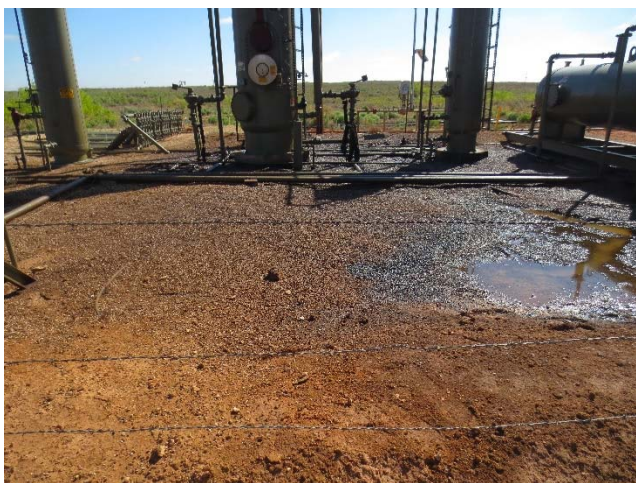
Standing Fluid inside berm SW corner

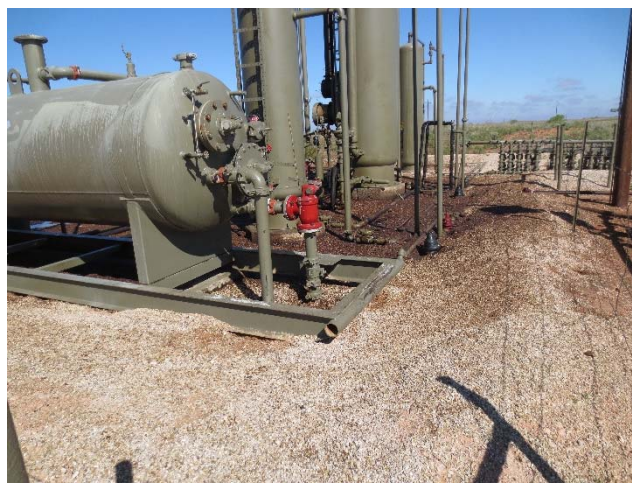
Impacted area inside berm NE Corner

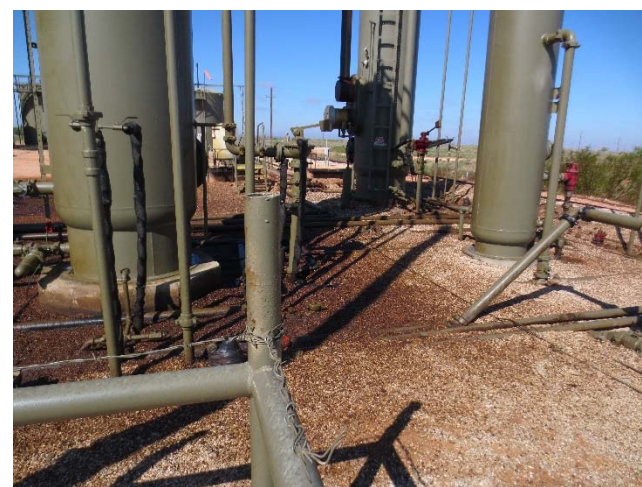
Looking SW from NE corner of bermed area

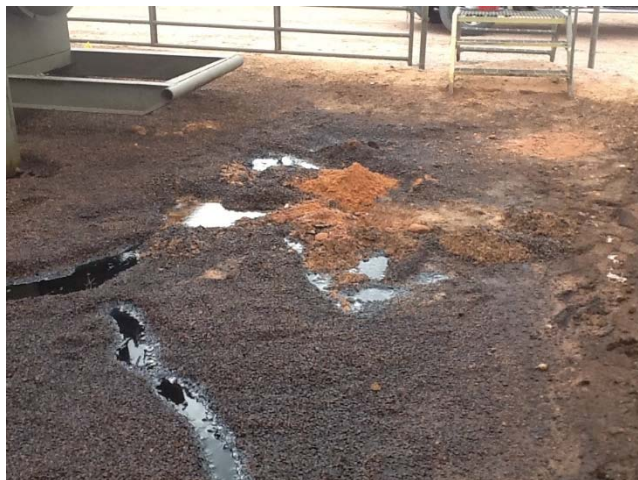
Area of Auger hole 1

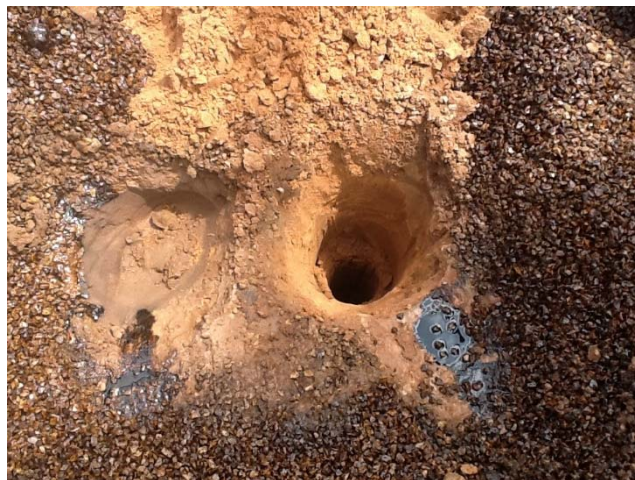
Auger hole 2

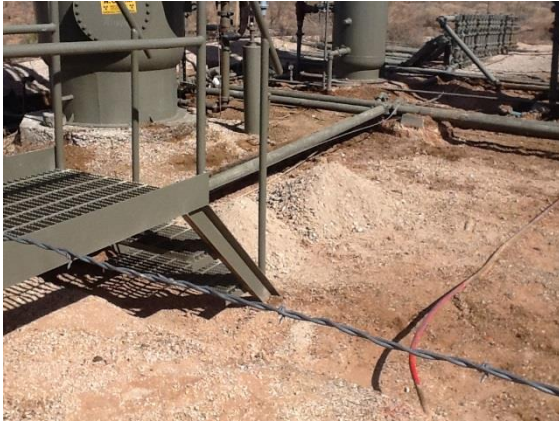
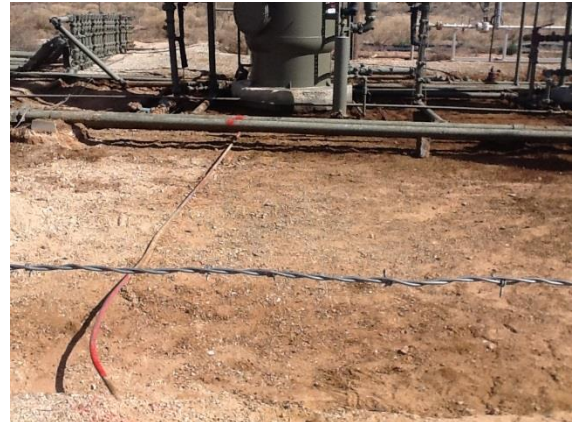
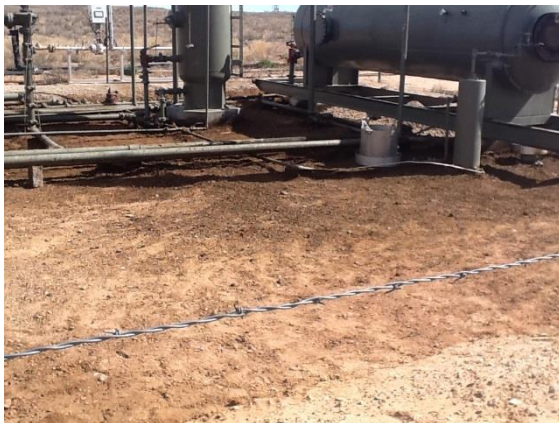
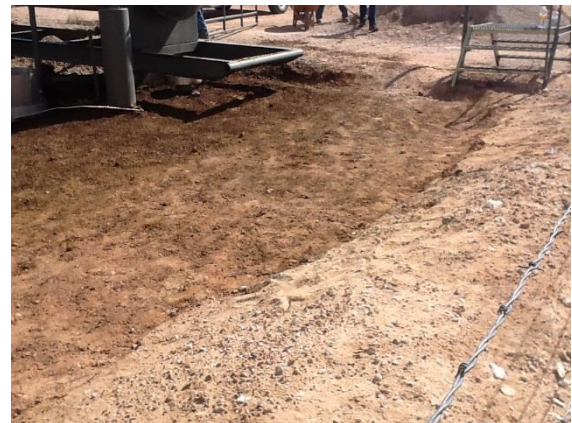
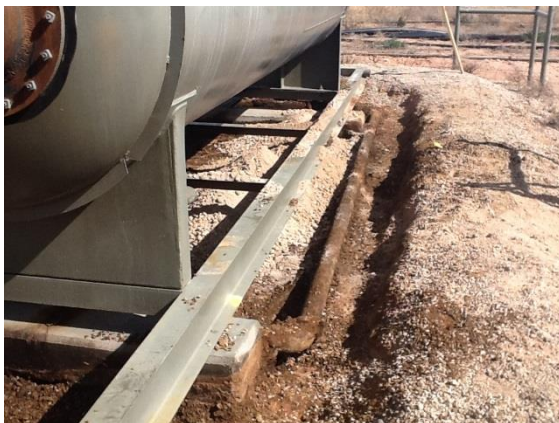
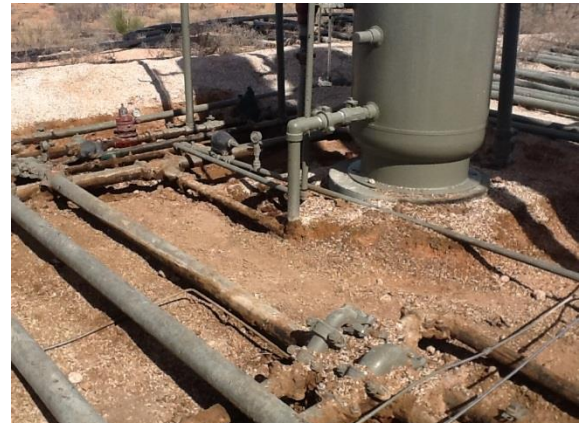
Bermed Area Excavated

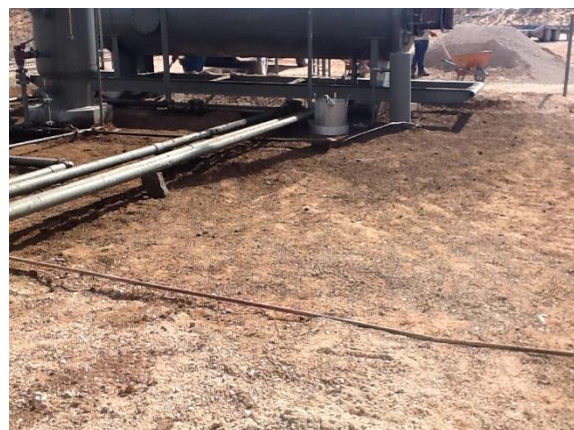
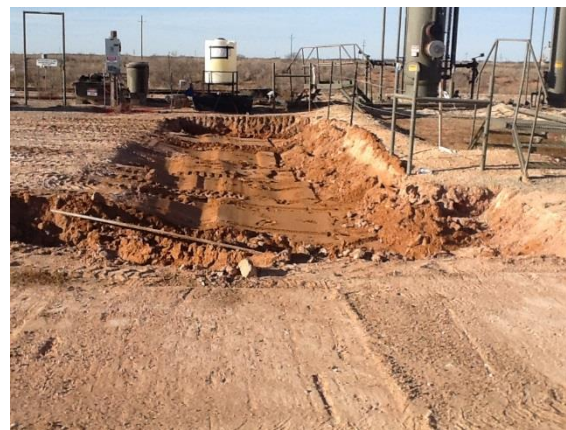
Bermed Area Excavated

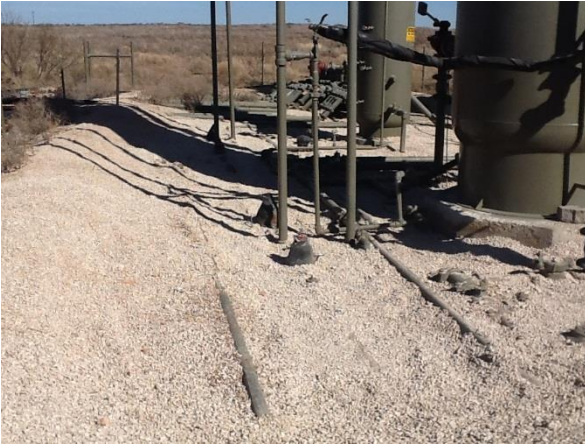
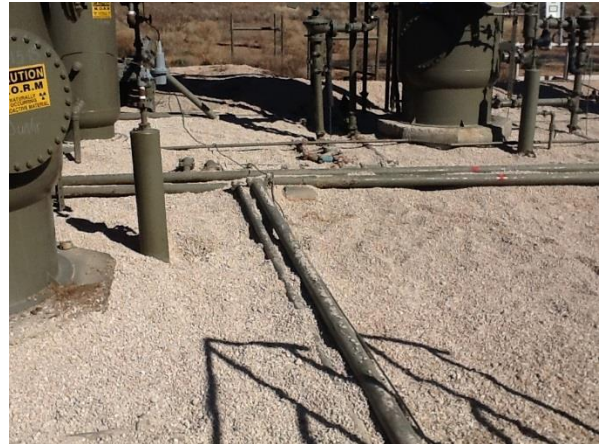
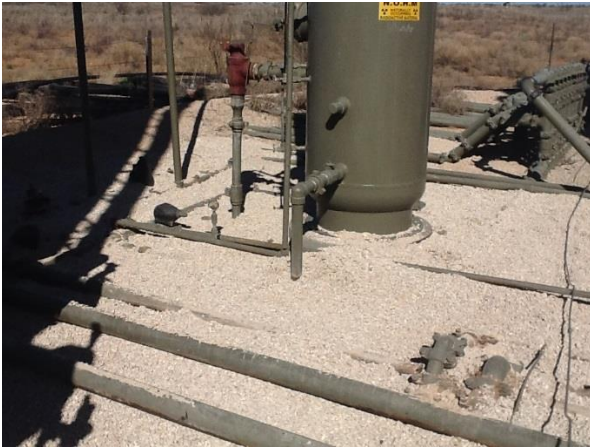
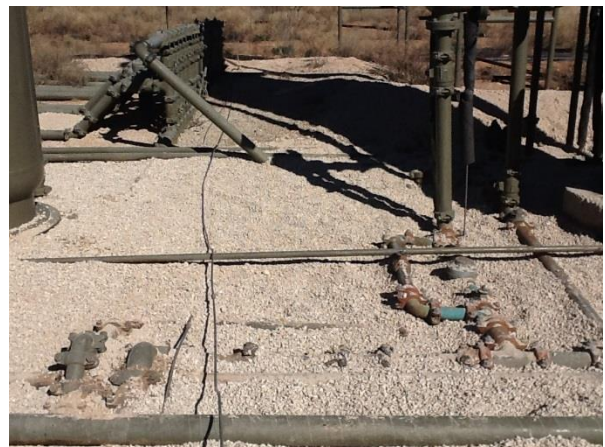
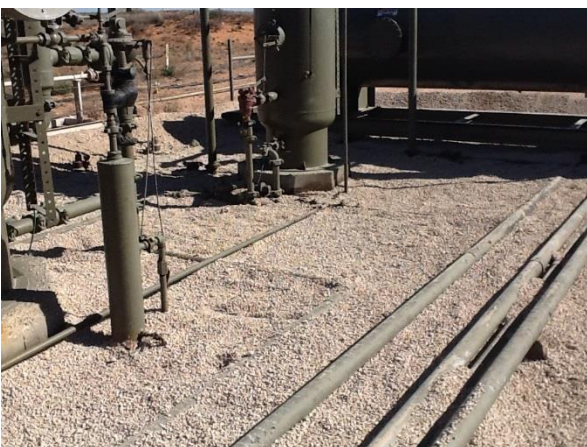
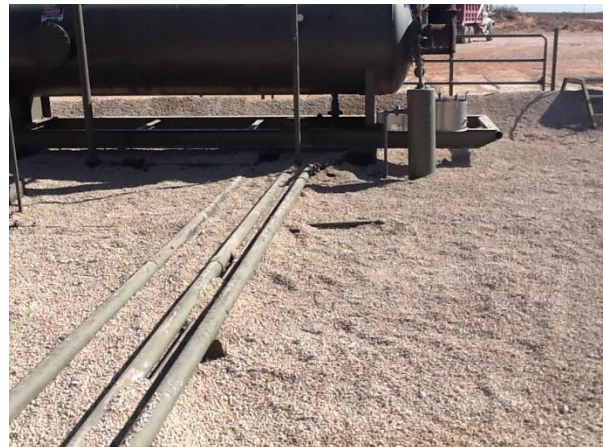
Bermed Area Backfilled

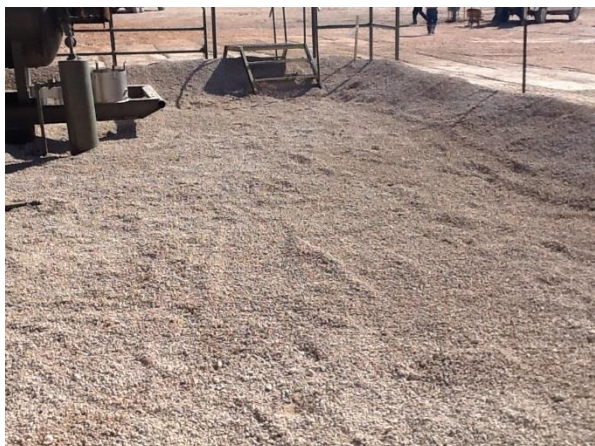
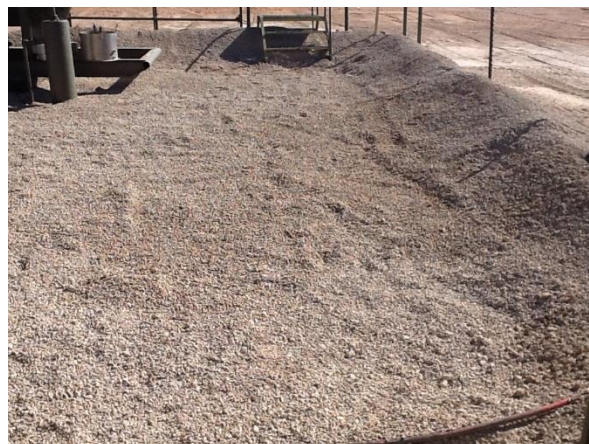
Bermed Area Backfilled

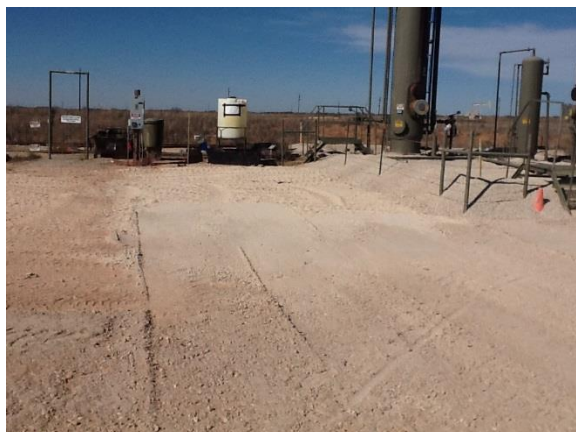
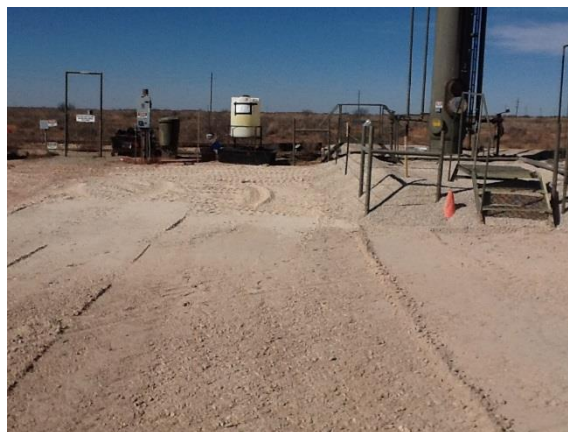
Outside Pad Area Backfilled
