## Remediation Summary & Soil Closure Request

### Spur Energy Partners, LLC Bone Yard 11 Fee #016H

Eddy County, New Mexico  
Unit Letter B, Section 1, Township 20 South, Range 25 East  
Latitude 32.606454 North, Longitude 104.438028 West  
NMOCD Reference No. nAPP2317146882

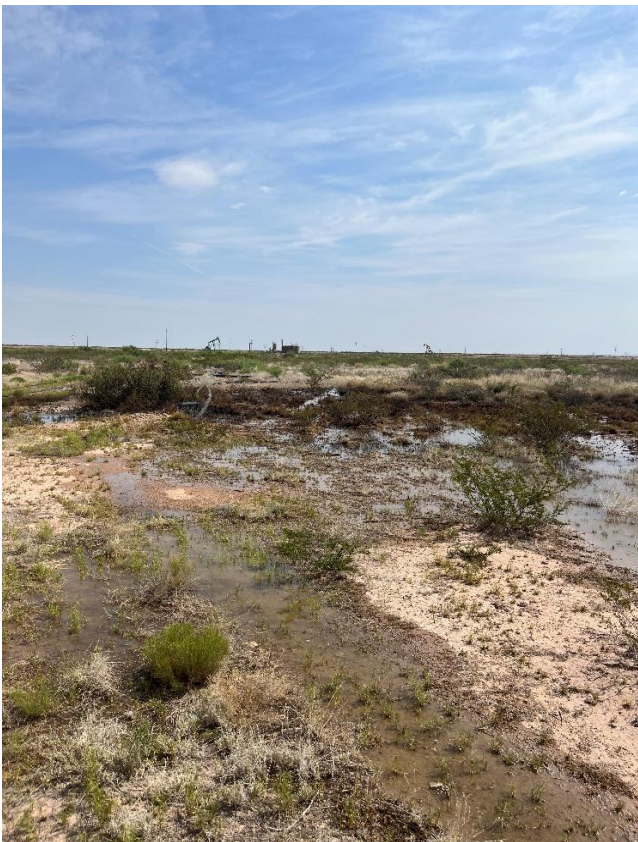
<b>Photo Number:</b> 1

<b>Photo Direction:</b> East	
<b>Photo Date/Time:</b> 6/20/2023 10:16 AM	
<b>Photo GPS:</b> 32.60646, -104.43815	
<b>Photo Description:</b>  View of release and impacted area.

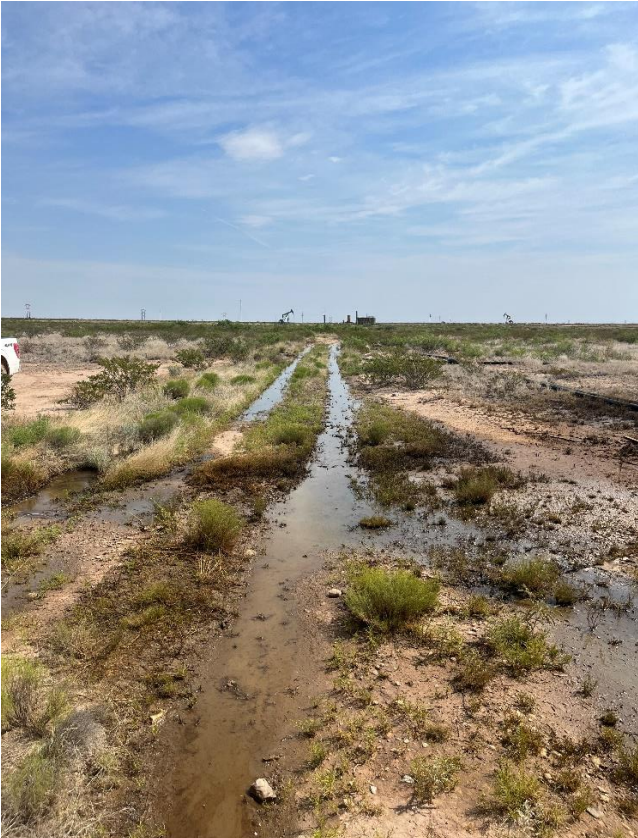
<b>Photo Number:</b> 2

<b>Photo Direction:</b> North	
<b>Photo Date/Time:</b> 6/20/2023 10:16 AM	
<b>Photo GPS:</b> 32.60646, -104.43815	
<b>Photo Description:</b>  View of release and impacted area.

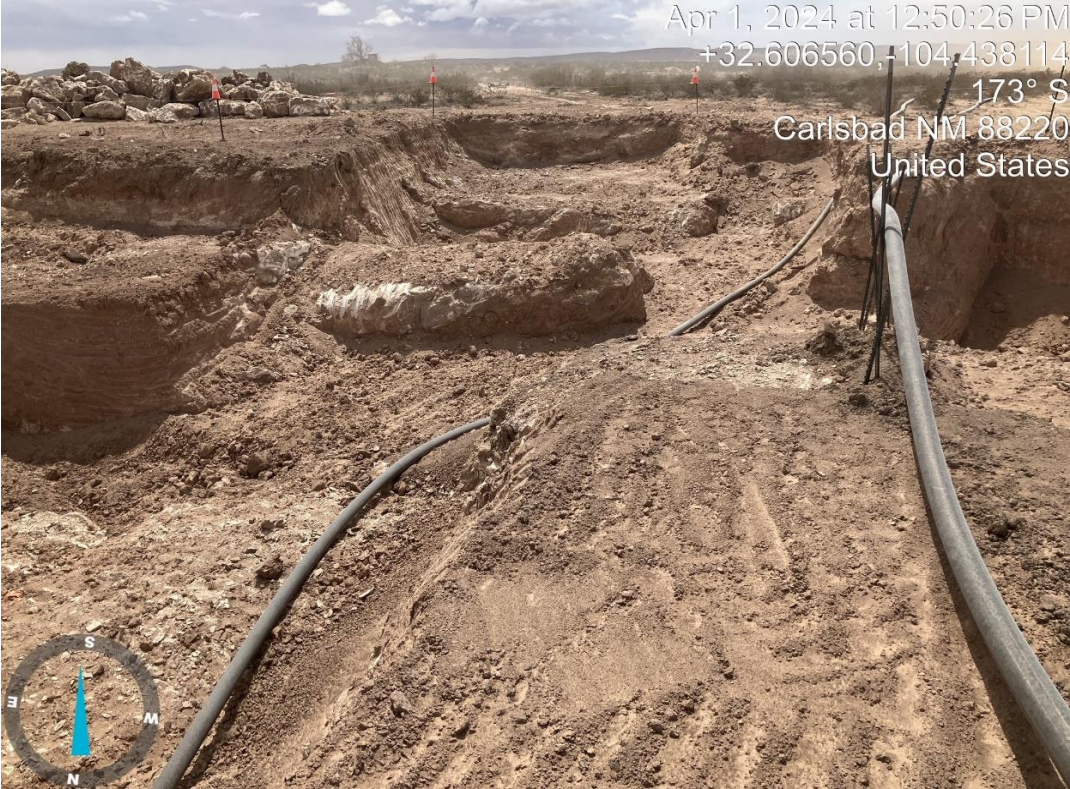
<b>Photo Number:</b> 4

<div>Apr 1, 2024 at 12:50:26 PM +32.606560, -104.438114 173° S Carlsbad NM 88220 United States</div>
<b>Photo Direction:</b> South	
<b>Photo Description:</b>  View of open excavation.

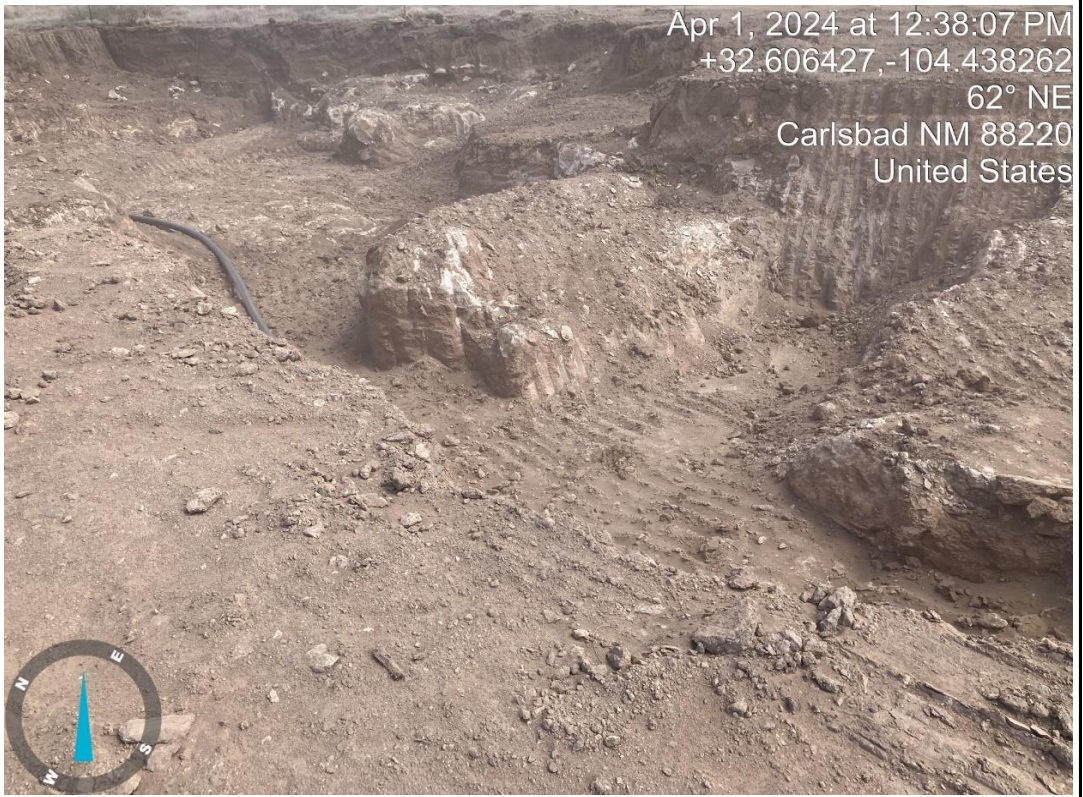
<b>Photo Number:</b> 7	<div>Apr 1, 2024 at 12:38:07 PM +32.606427,-104.438262 62° NE Carlsbad NM 88220 United States</div>

<b>Photo Direction:</b> Northeast	
<b>Photo Description:</b>  View of open excavation.

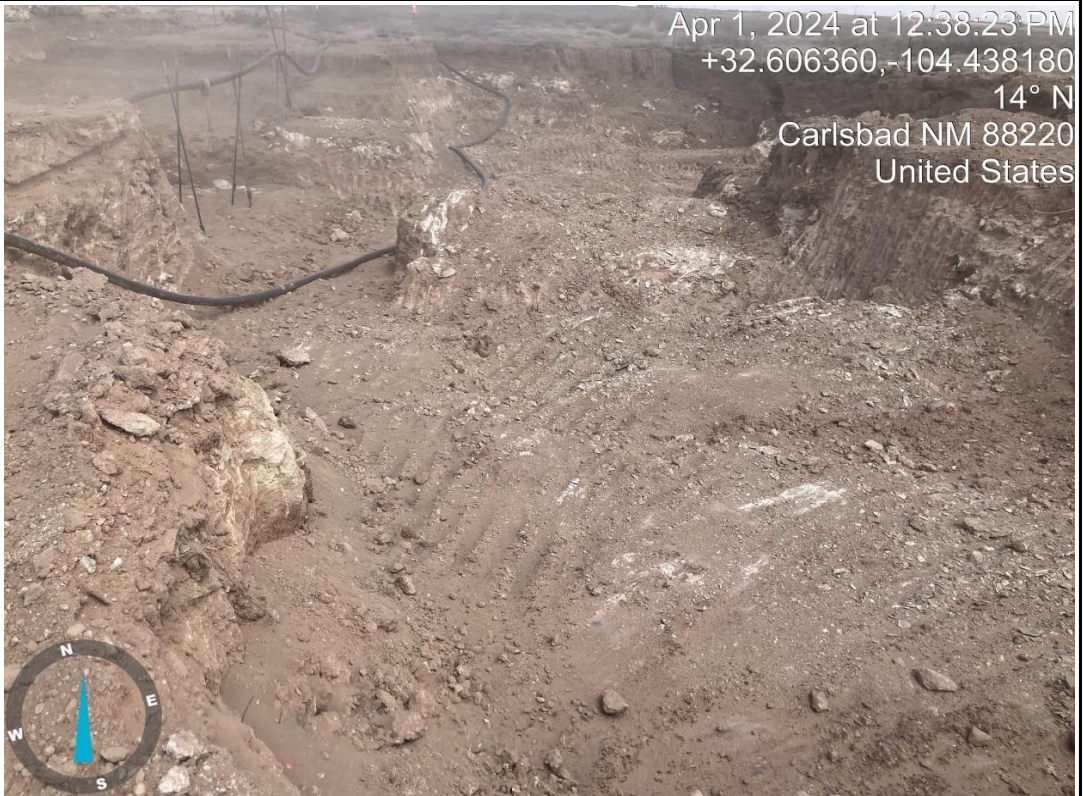
<b>Photo Number:</b> 8	<div>Apr 1, 2024 at 12:38:23 PM +32.606360,-104.438180 14° N Carlsbad NM 88220 United States</div>

<b>Photo Direction:</b> North	
<b>Photo Description:</b>  View of open excavation.

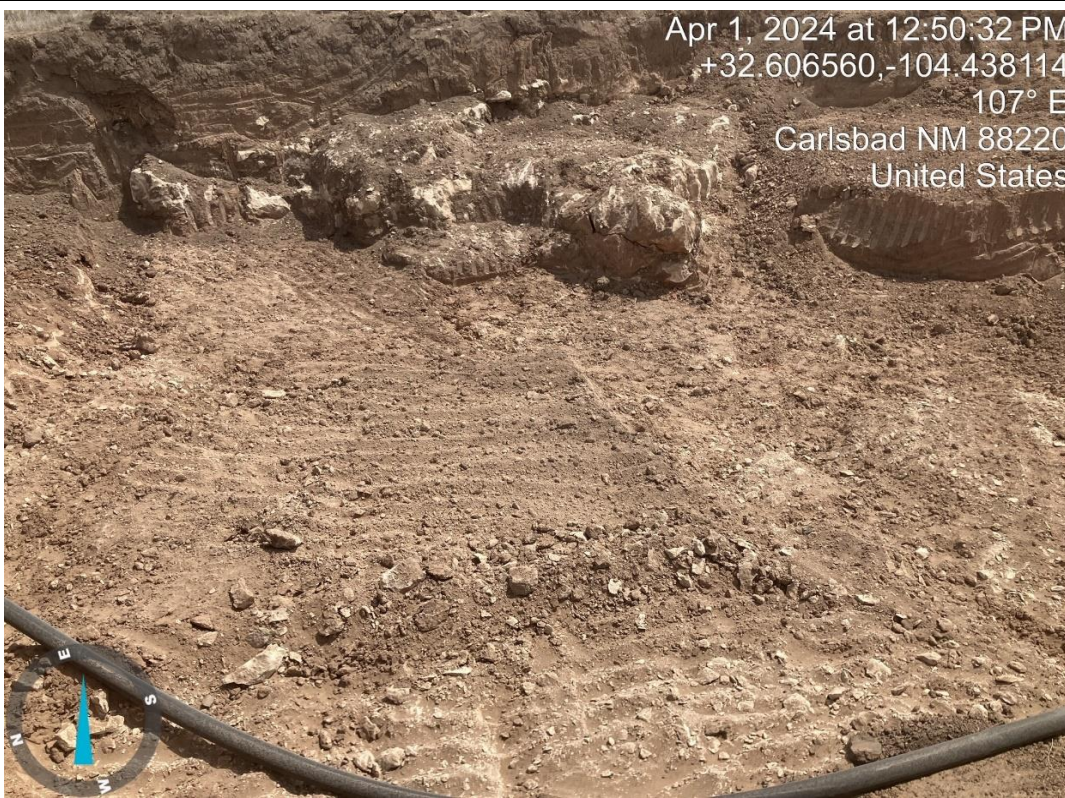
<b>Photo Number:</b> 9	<div>Apr 1, 2024 at 12:50:32 PM +32.606560,-104.438114 107° E Carlsbad NM 88220 United States</div>

<b>Photo Direction:</b> East	
<b>Photo Description:</b>  View of open excavation.

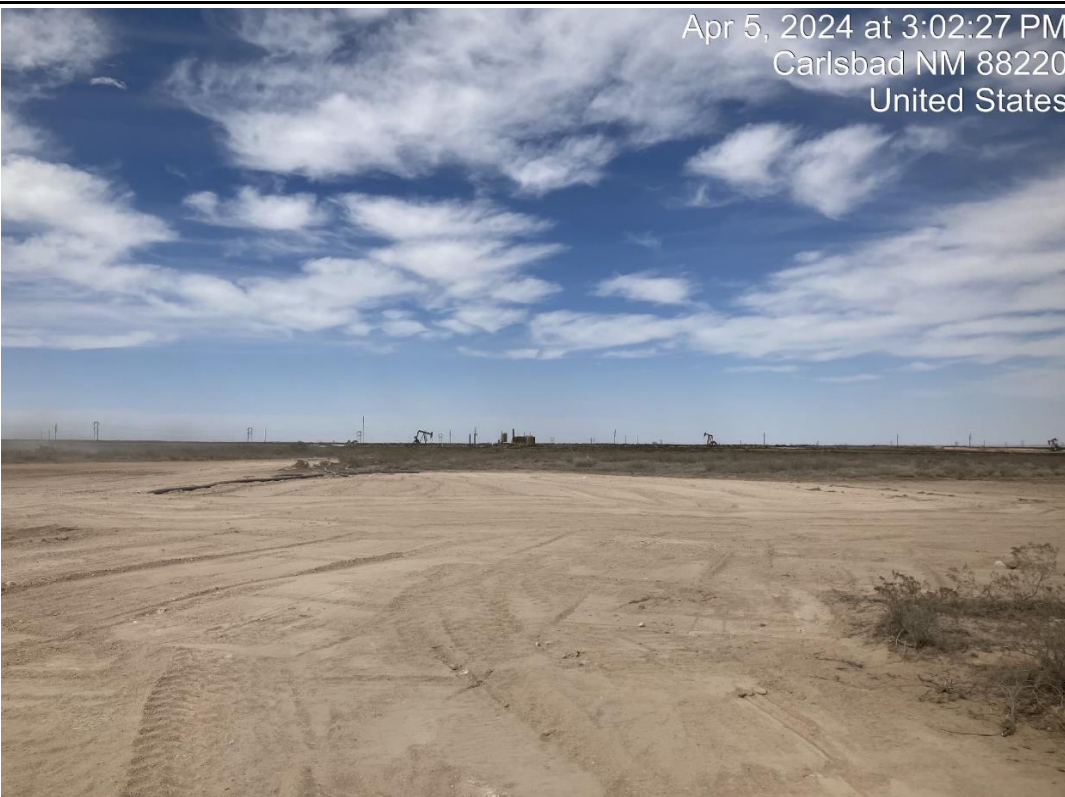
<b>Photo Number:</b> 10	<div>Apr 5, 2024 at 3:02:27 PM Carlsbad NM 88220 United States</div>

<b>Photo Direction:</b> North	
<b>Photo GPS:</b> 32.60630, -104.43805	
<b>Photo Description:</b>  View of remediated area after backfill and grading.

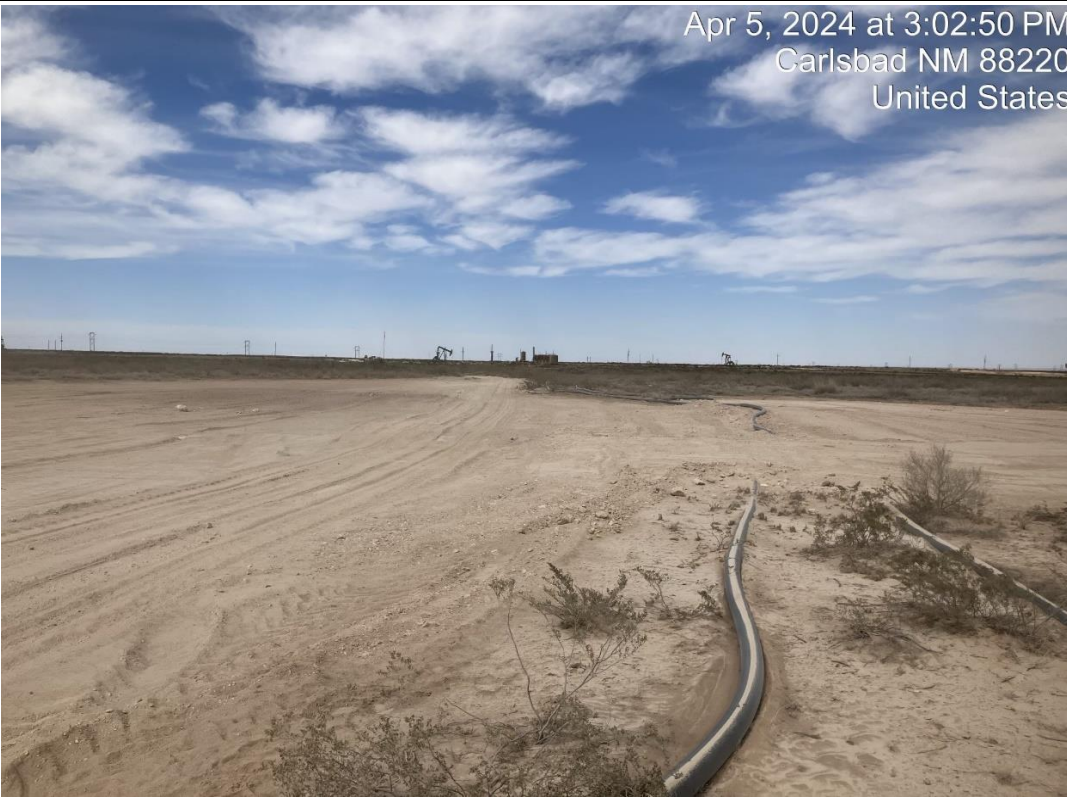
<b>Photo Number:</b> 11	<div>Apr 5, 2024 at 3:02:50 PM Carlsbad NM 88220 United States</div>

<b>Photo Direction:</b> North	
<b>Photo GPS:</b> 32.60639, -104.43813	
<b>Photo Description:</b>  View of remediated area after backfill and grading.

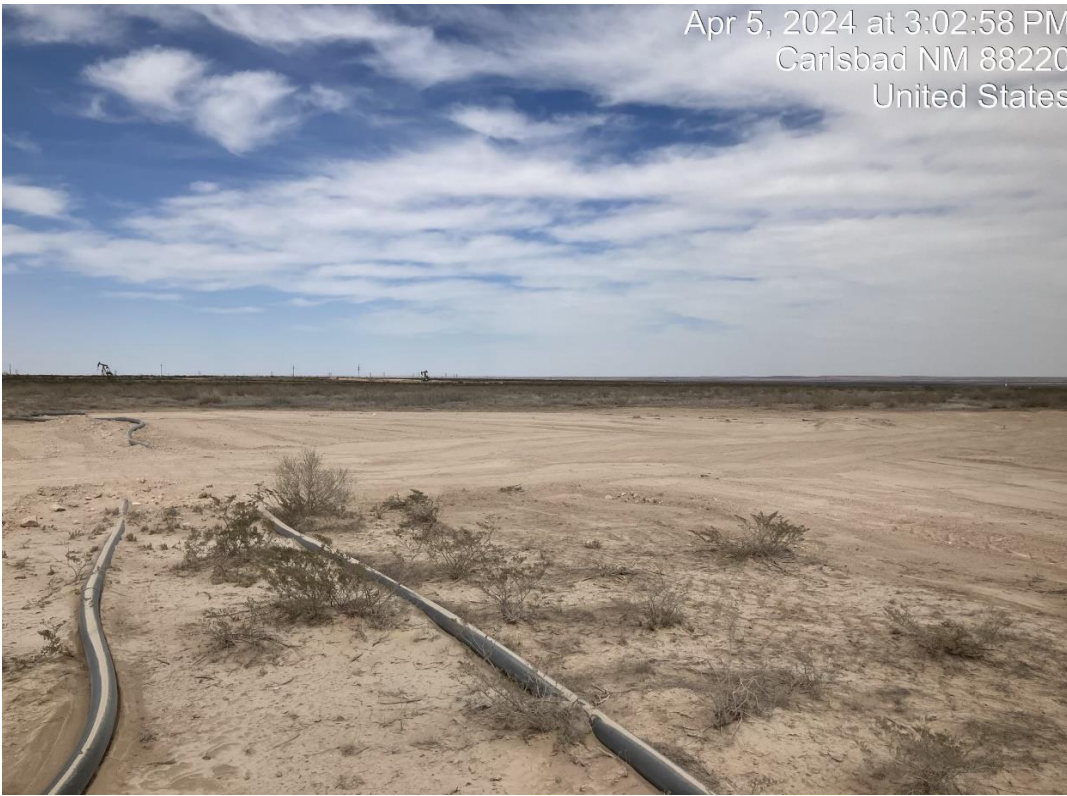
<b>Photo Number:</b> 12	<div>Apr 5, 2024 at 3:02:58 PM Carlsbad NM 88220 United States</div>

<b>Photo Direction:</b> South	
<b>Photo GPS:</b> 32.60667, -104.43804	
<b>Photo Description:</b>  View of remediated area after backfill and grading.
