## Remediation Summary & Soil Closure Request

### Mewbourne Oil Company Quick Draw 10 Battery

Eddy County, New Mexico  
Unit Letter "G", Section 10, Township 20 South, Range 25 East  
Latitude 32.58872 North, Longitude 104.469267 West  
NMOCD Reference No. nAPP2405854952

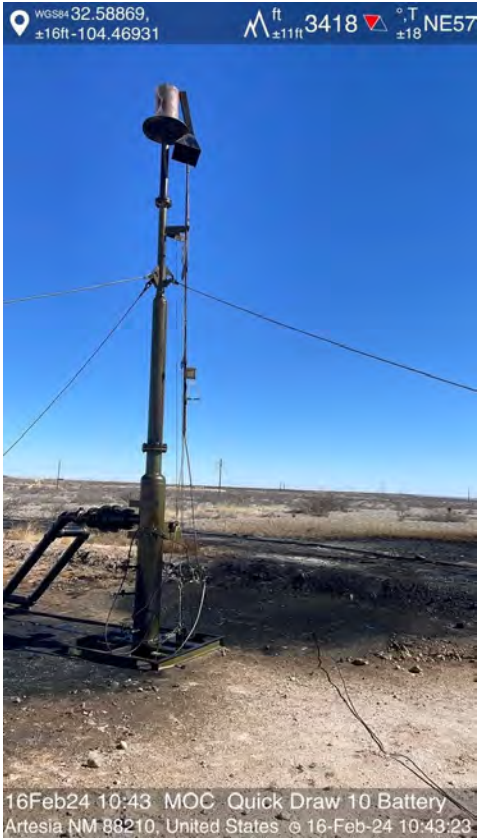
<div>Photo Number: 2</div>

<div>Photo Direction: East-Northeast</div>	
<div>Photo Description:  View of the affected area.</div>

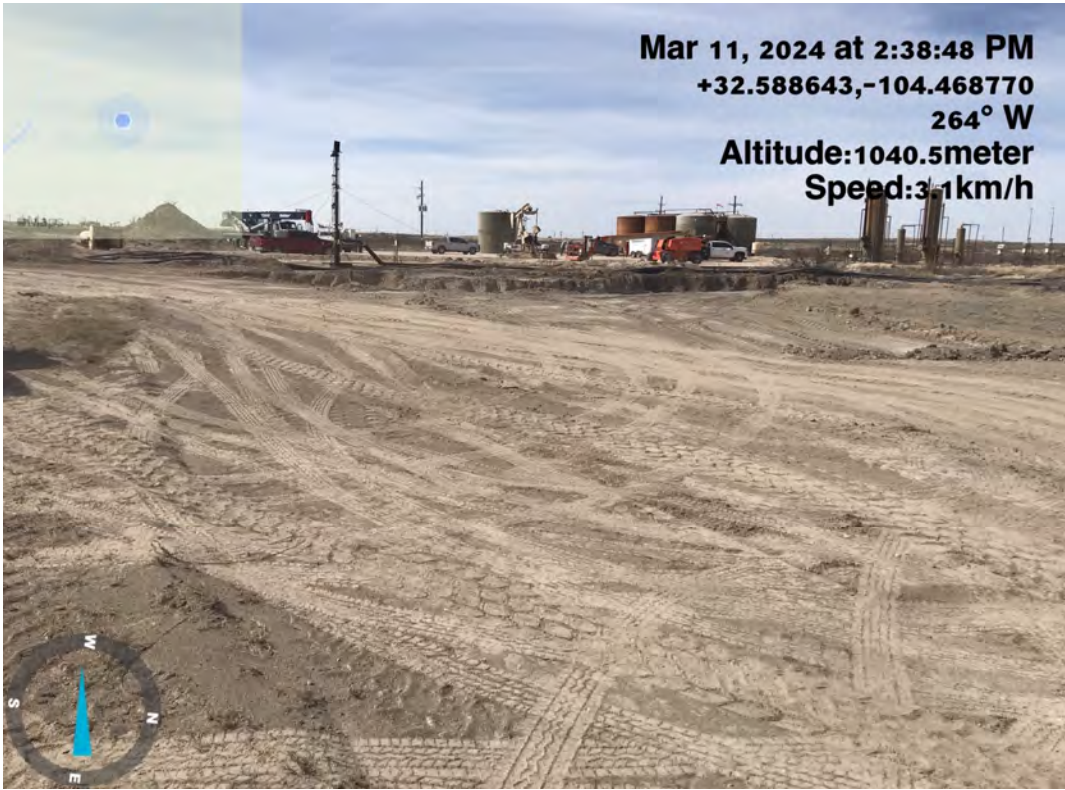
<b>Photo Number:</b> 7

<b>Photo Direction:</b> West	
<b>Photo Description:</b>  View of the excavated area.

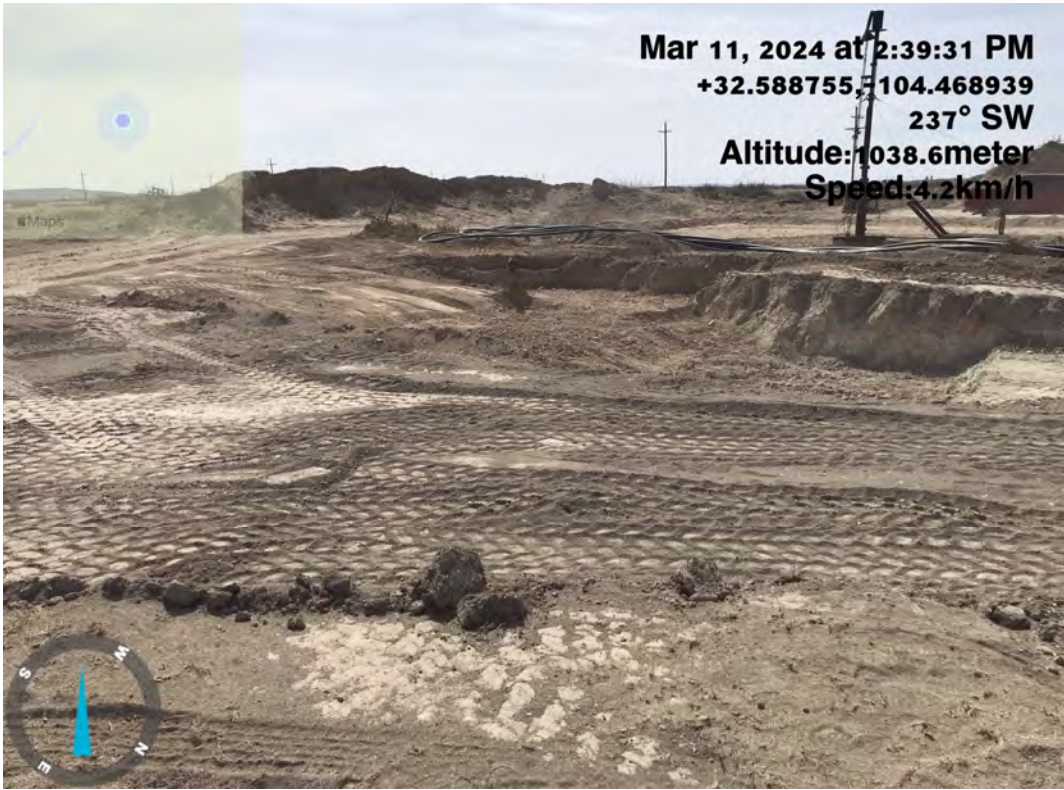
<b>Photo Number:</b> 9

<p><b>Mar 11, 2024 at 2:39:31 PM</b> <b>+32.588755,-104.468939</b> <b>237° SW</b> <b>Altitude: 1038.6 meter</b> <b>Speed: 4.2 km/h</b></p>
<b>Photo Direction:</b> West-Southwest	
<b>Photo Description:</b>  View of the excavated area.

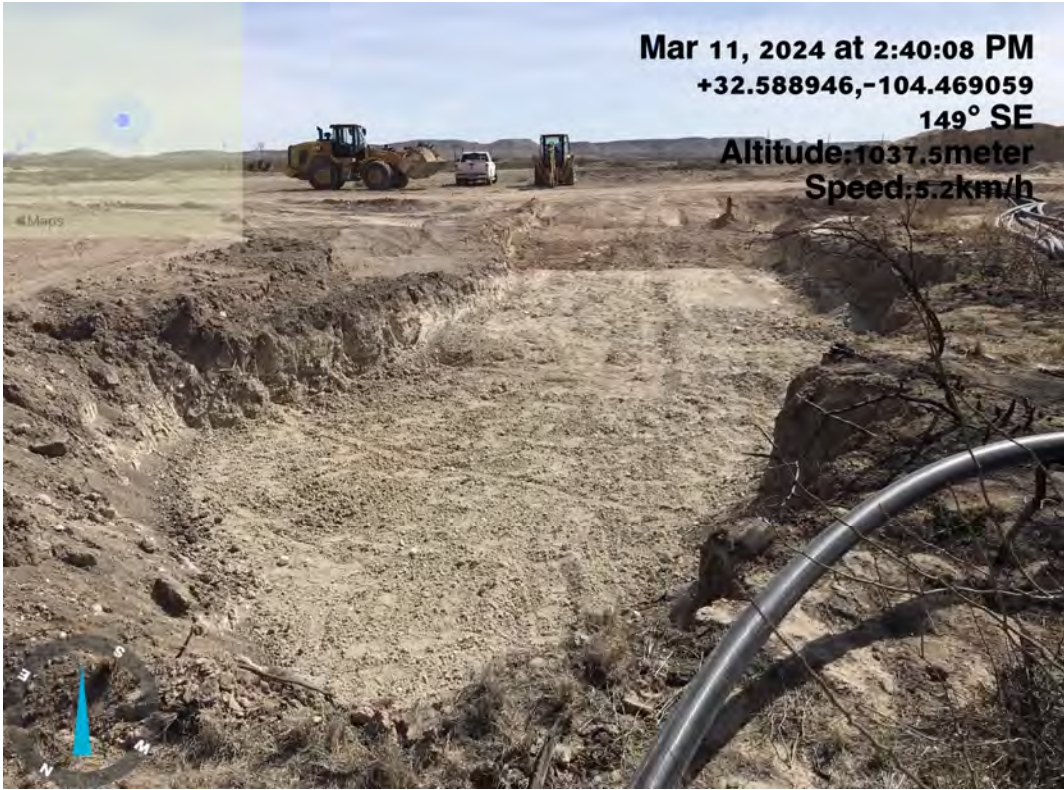
<b>Photo Number:</b> 10

<p><b>Mar 11, 2024 at 2:40:08 PM</b> <b>+32.588946,-104.469059</b> <b>149° SE</b> <b>Altitude: 1037.5 meter</b> <b>Speed: 5.2 km/h</b></p>
<b>Photo Direction:</b> South-Southeast	
<b>Photo Description:</b>  View of the excavated area.

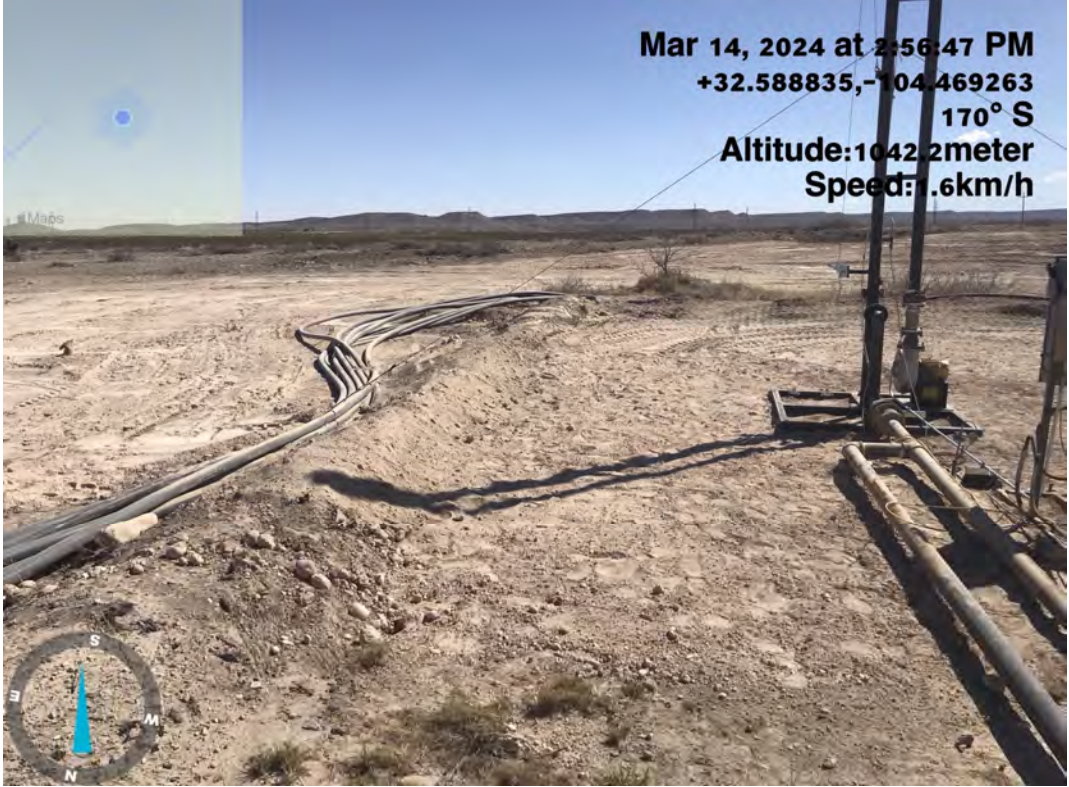
<b>Photo Number:</b> 15

<b>Photo Direction:</b> South	
<b>Photo Description:</b>  View of the remediated area after backfill and regrading.

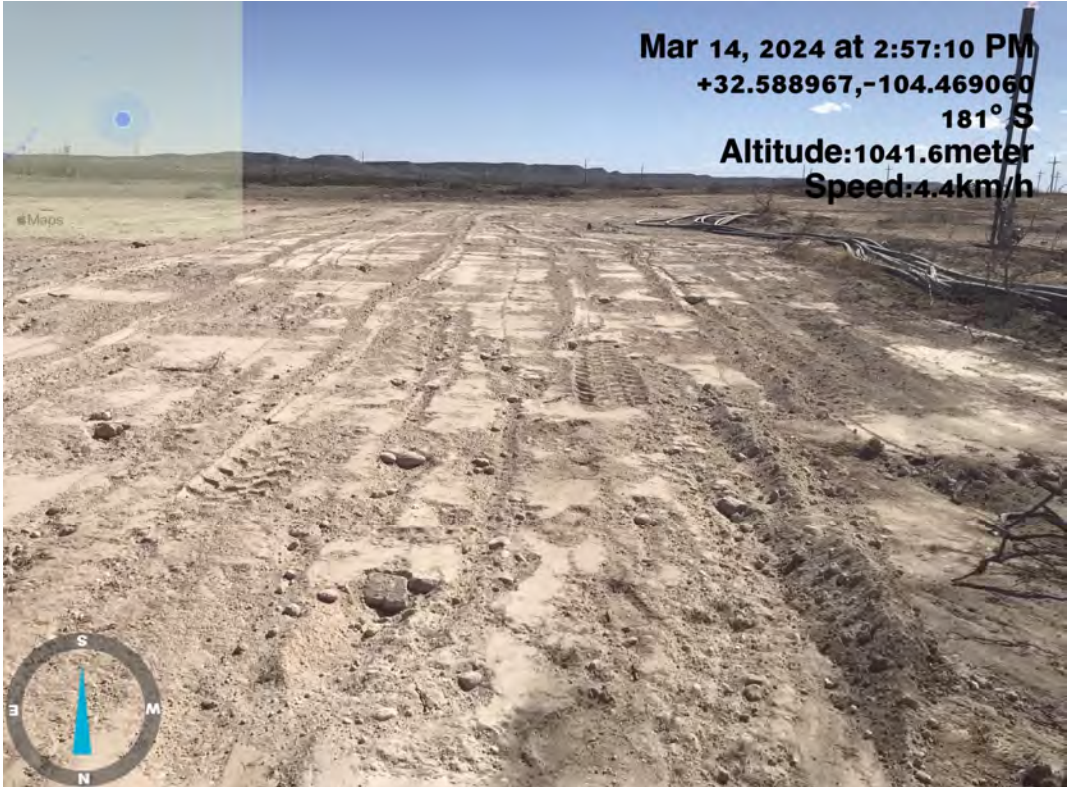
<b>Photo Number:</b> 16

<b>Photo Direction:</b> South	
<b>Photo Description:</b>  View of the remediated area after backfill and regrading.

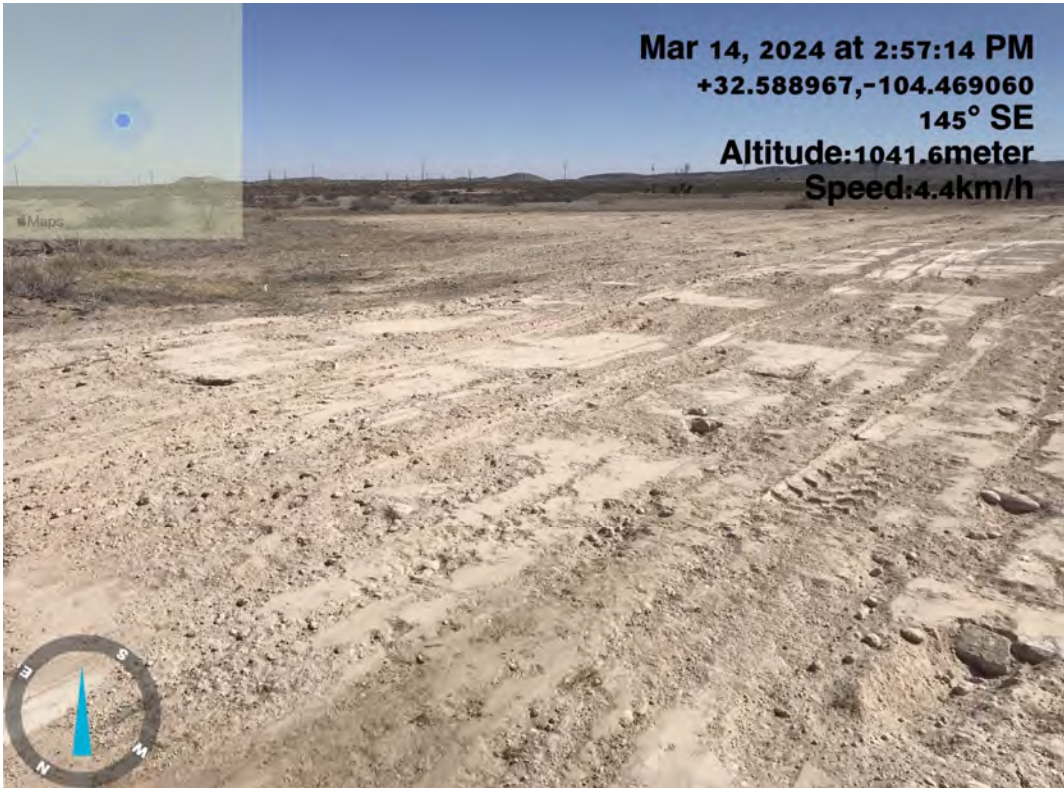
<b>Photo Number:</b> 17

<b>Photo Direction:</b> Southeast	
<b>Photo Description:</b>  View of the remediated area after backfill and regrading.

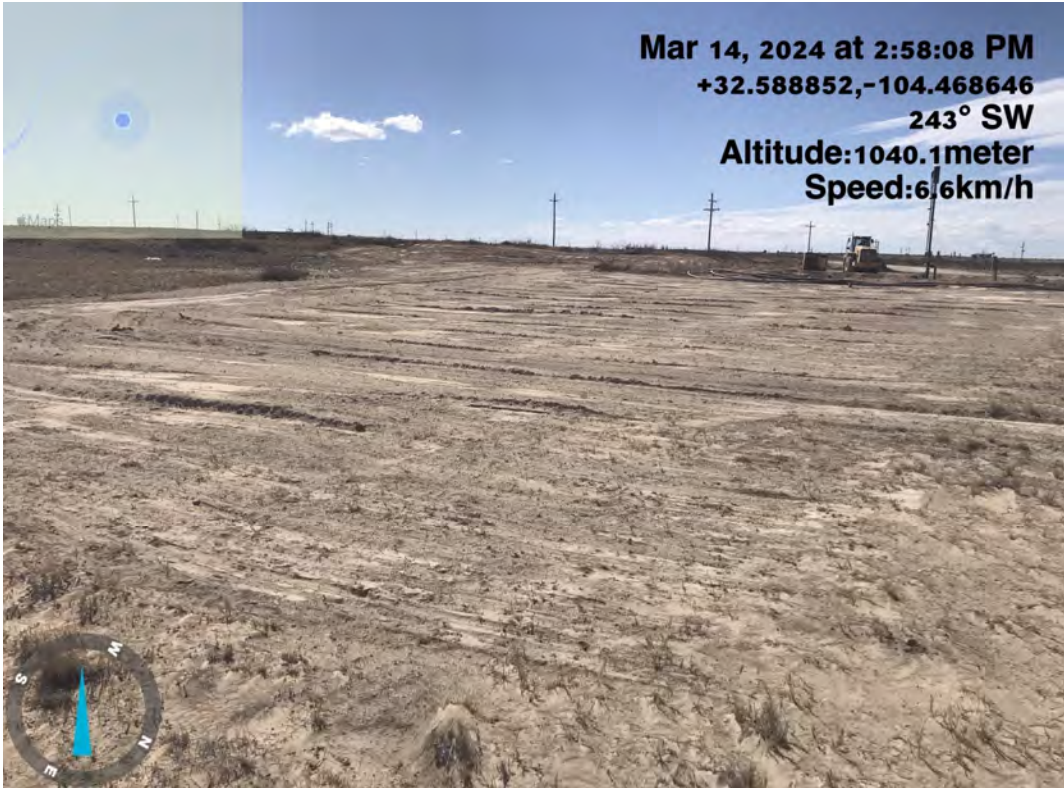
<b>Photo Number:</b> 18

<b>Photo Direction:</b> West-Southwest	
<b>Photo Description:</b>  View of the remediated area after backfill and regrading.
