**Re: Remediation/Reclamation Report and Closure Request  
Maverick Permian, LLC  
EVGSAU 3202-021 Flowline Release  
Unit Letter J, Section 32, Township 17 South, Range 35 East  
Lea County, New Mexico  
Incident ID# nPAC0605548324**

Remediation Report and Closure Request  
Maverick Permian, LLC  
EVGSAU 3202-021 Flowline Release  
Incident ID# nPAC0605548324

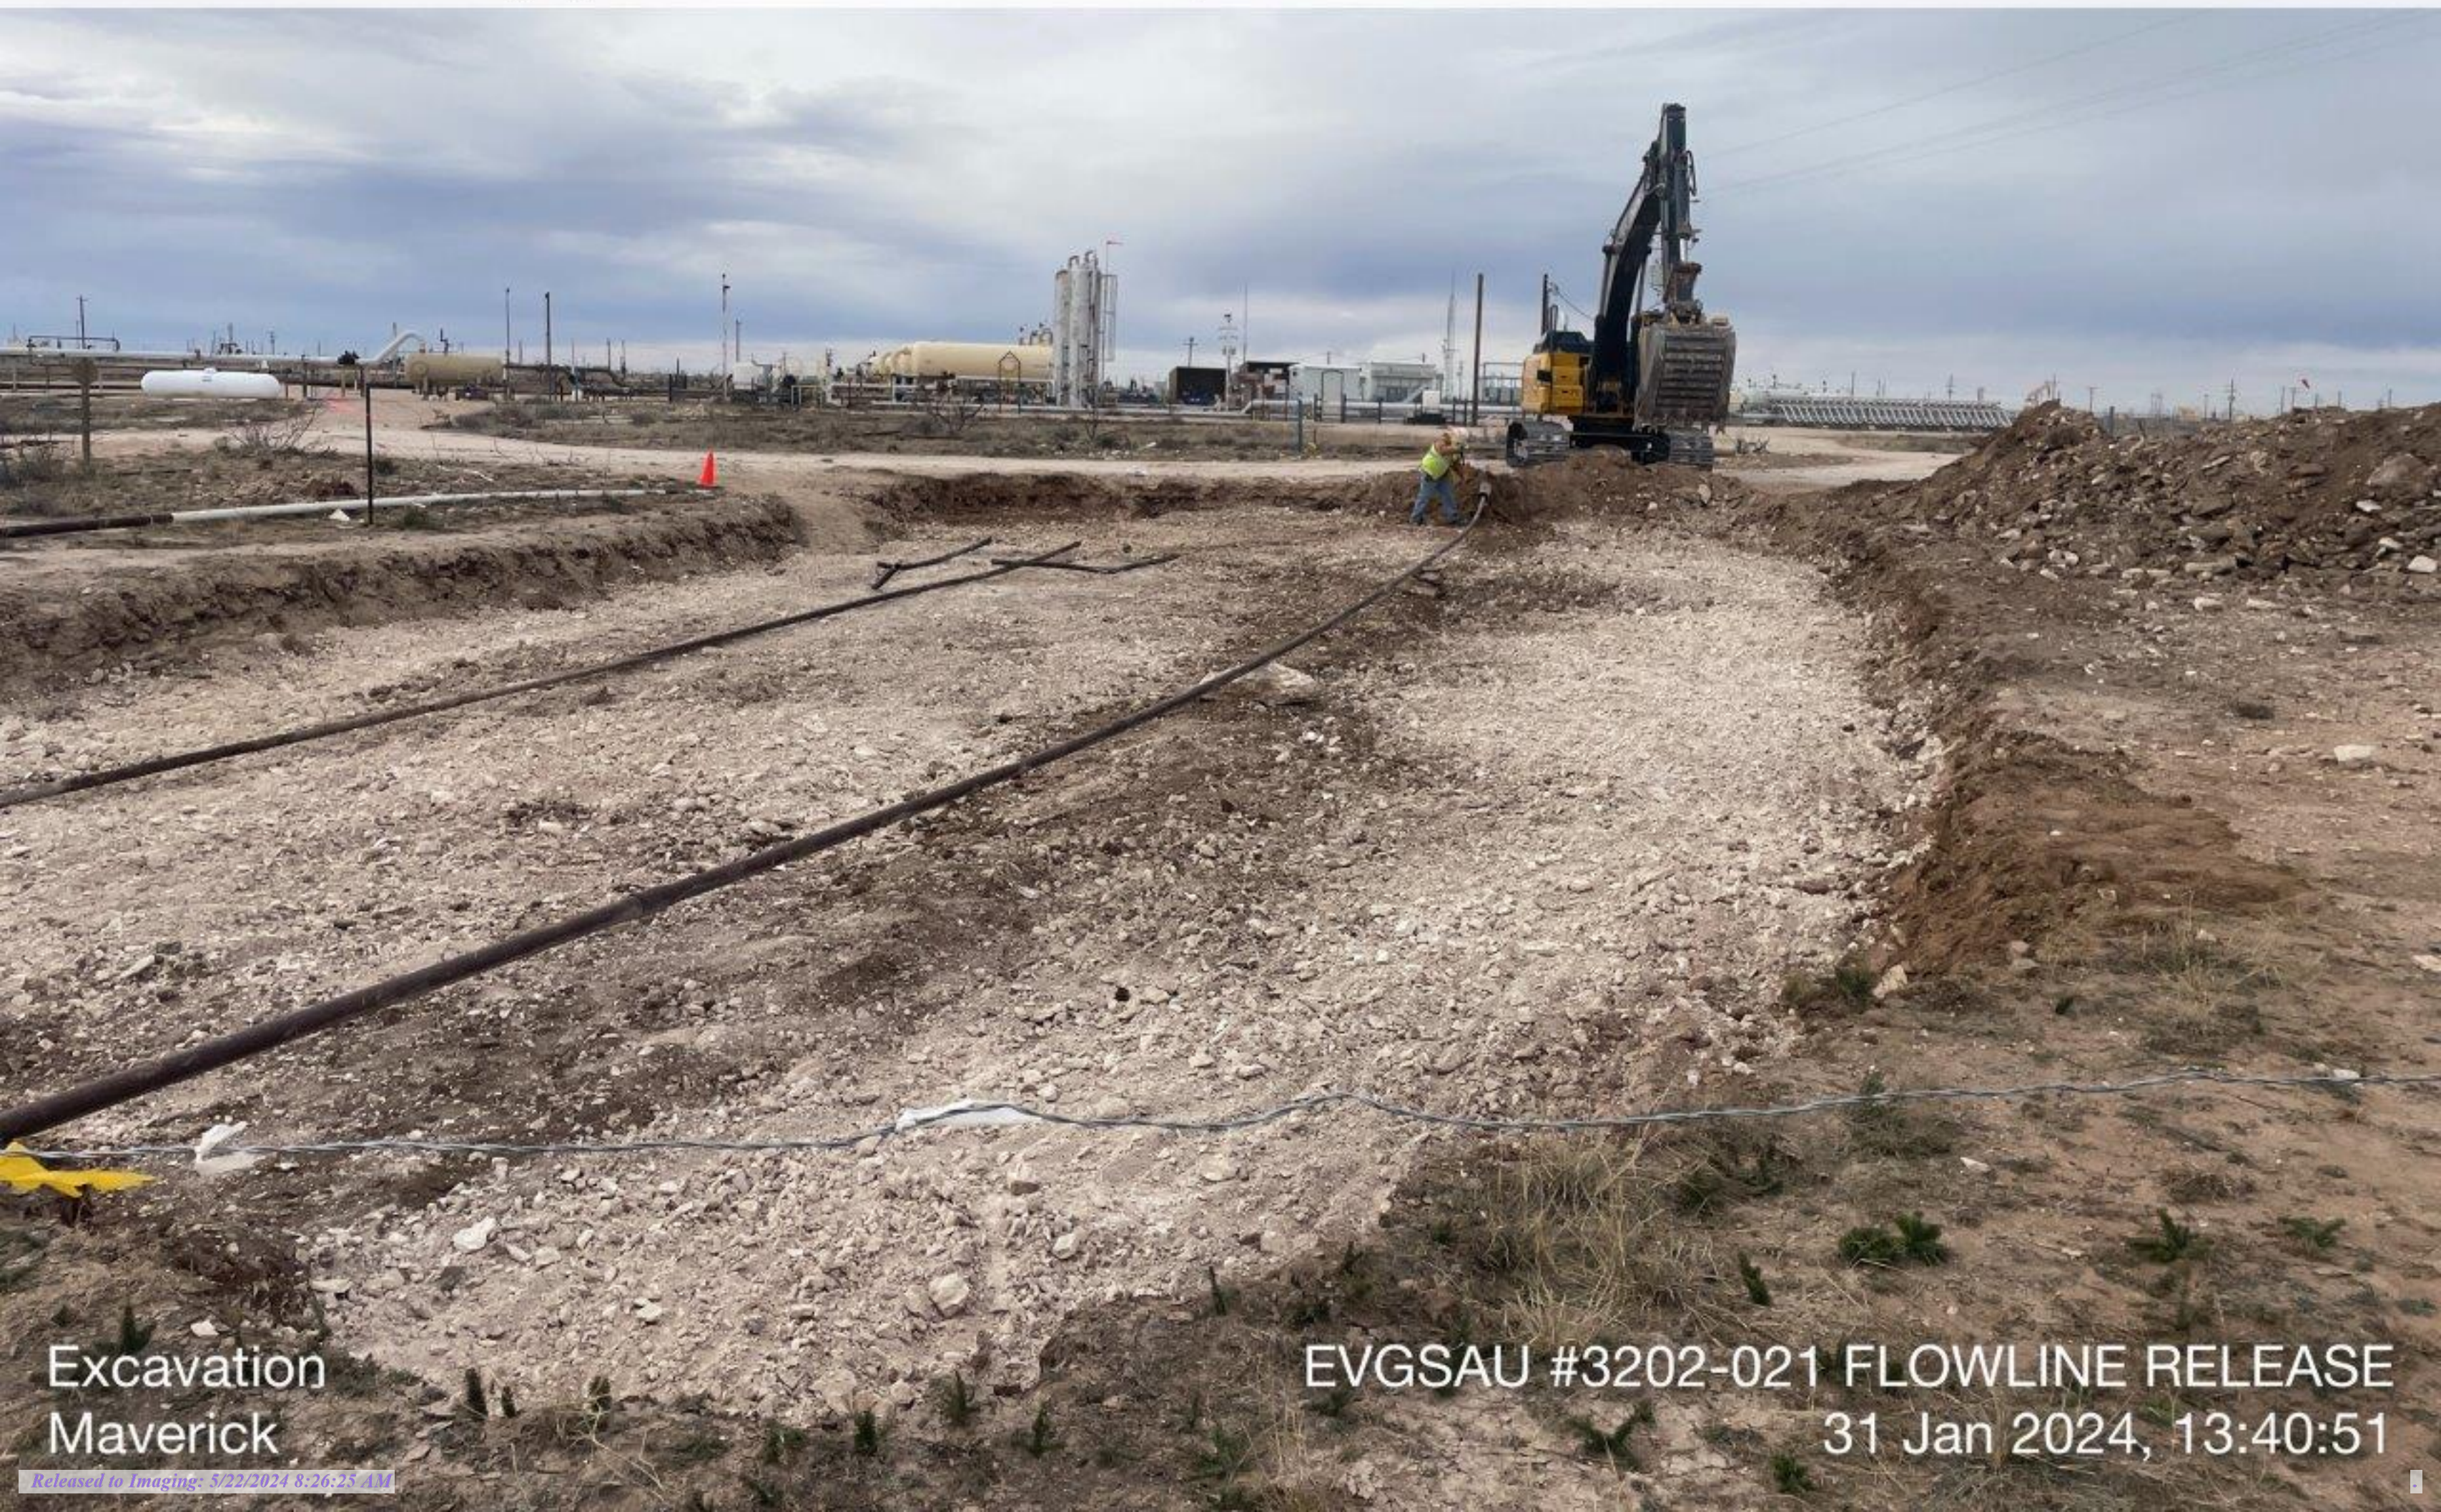
**NOTES:**

bgs: Below ground surface

To restore the impacted surface areas to the condition that existed prior to the release, the excavated areas have been backfilled with verified clean topsoil in pasture areas and clean caliche to restore the lease road on the western edge of the remediation excavation. The disturbed areas have been graded back to match the surrounding topography and the pre-existing conditions prior to contouring to provide erosion control, long-term stability, prevent ponding of water, and preserve surface water flow patterns.

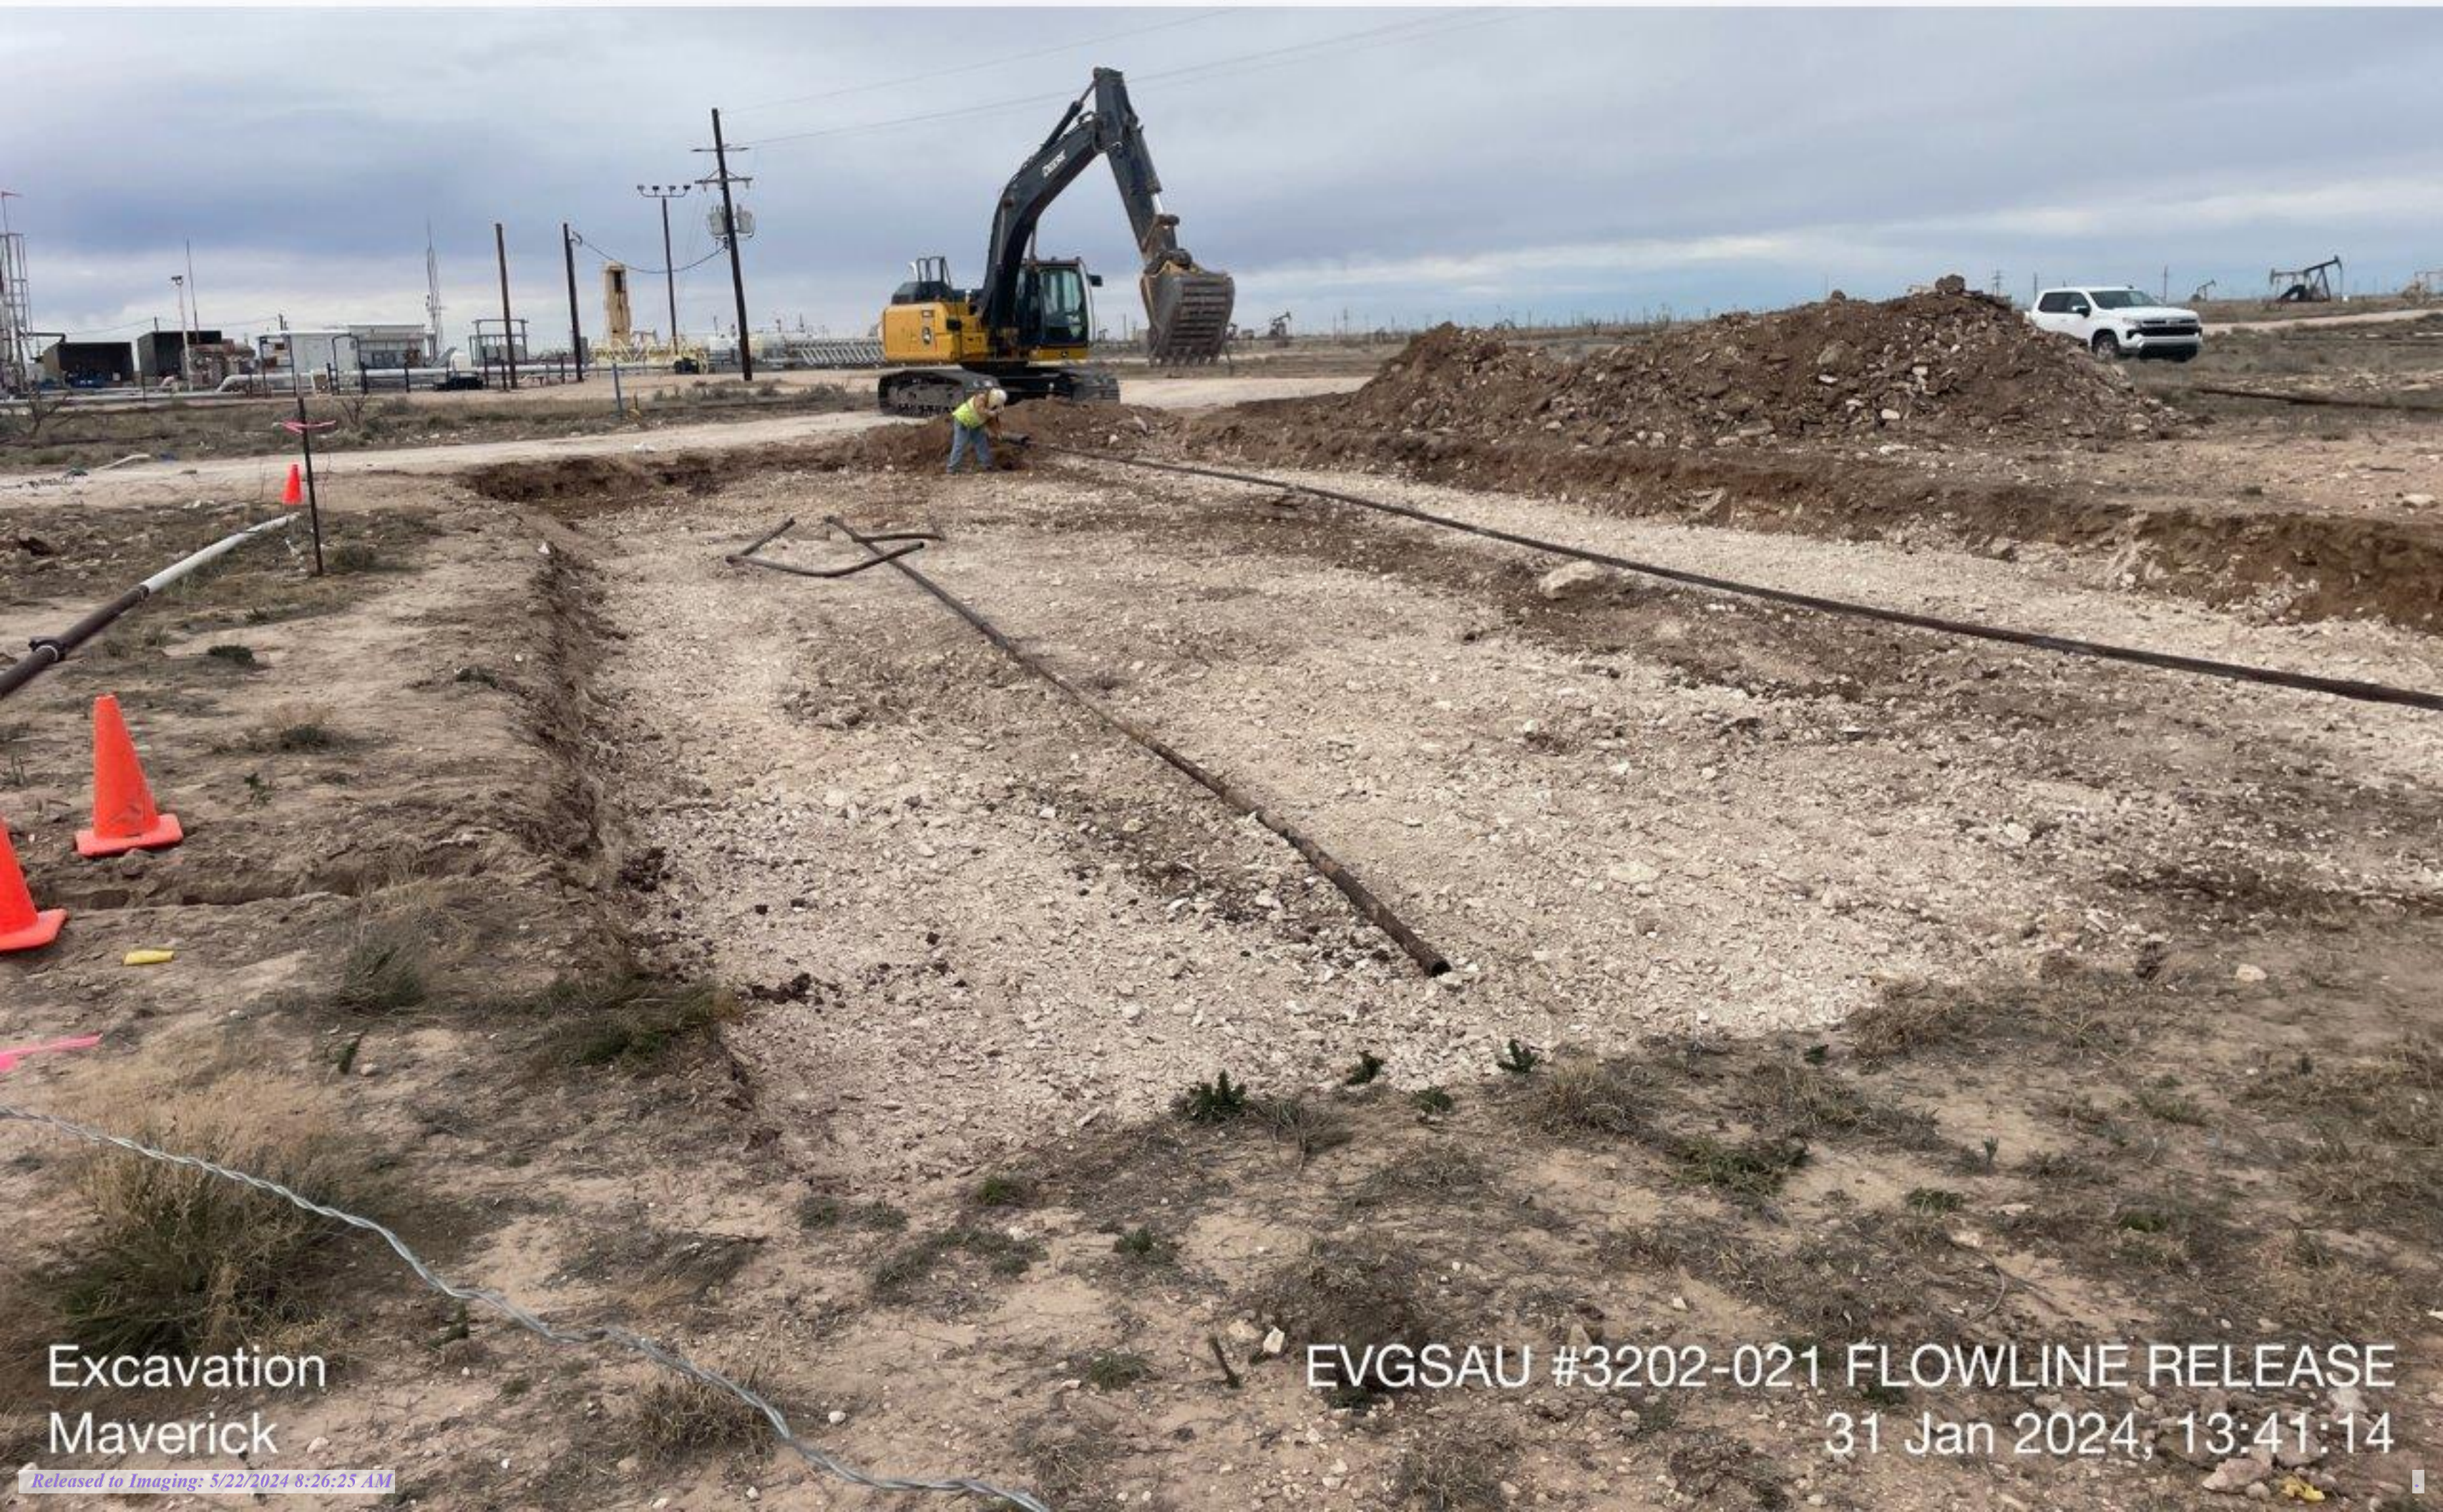
GRO: Gasoline Range Organics

DRO: Diesel Range Organics

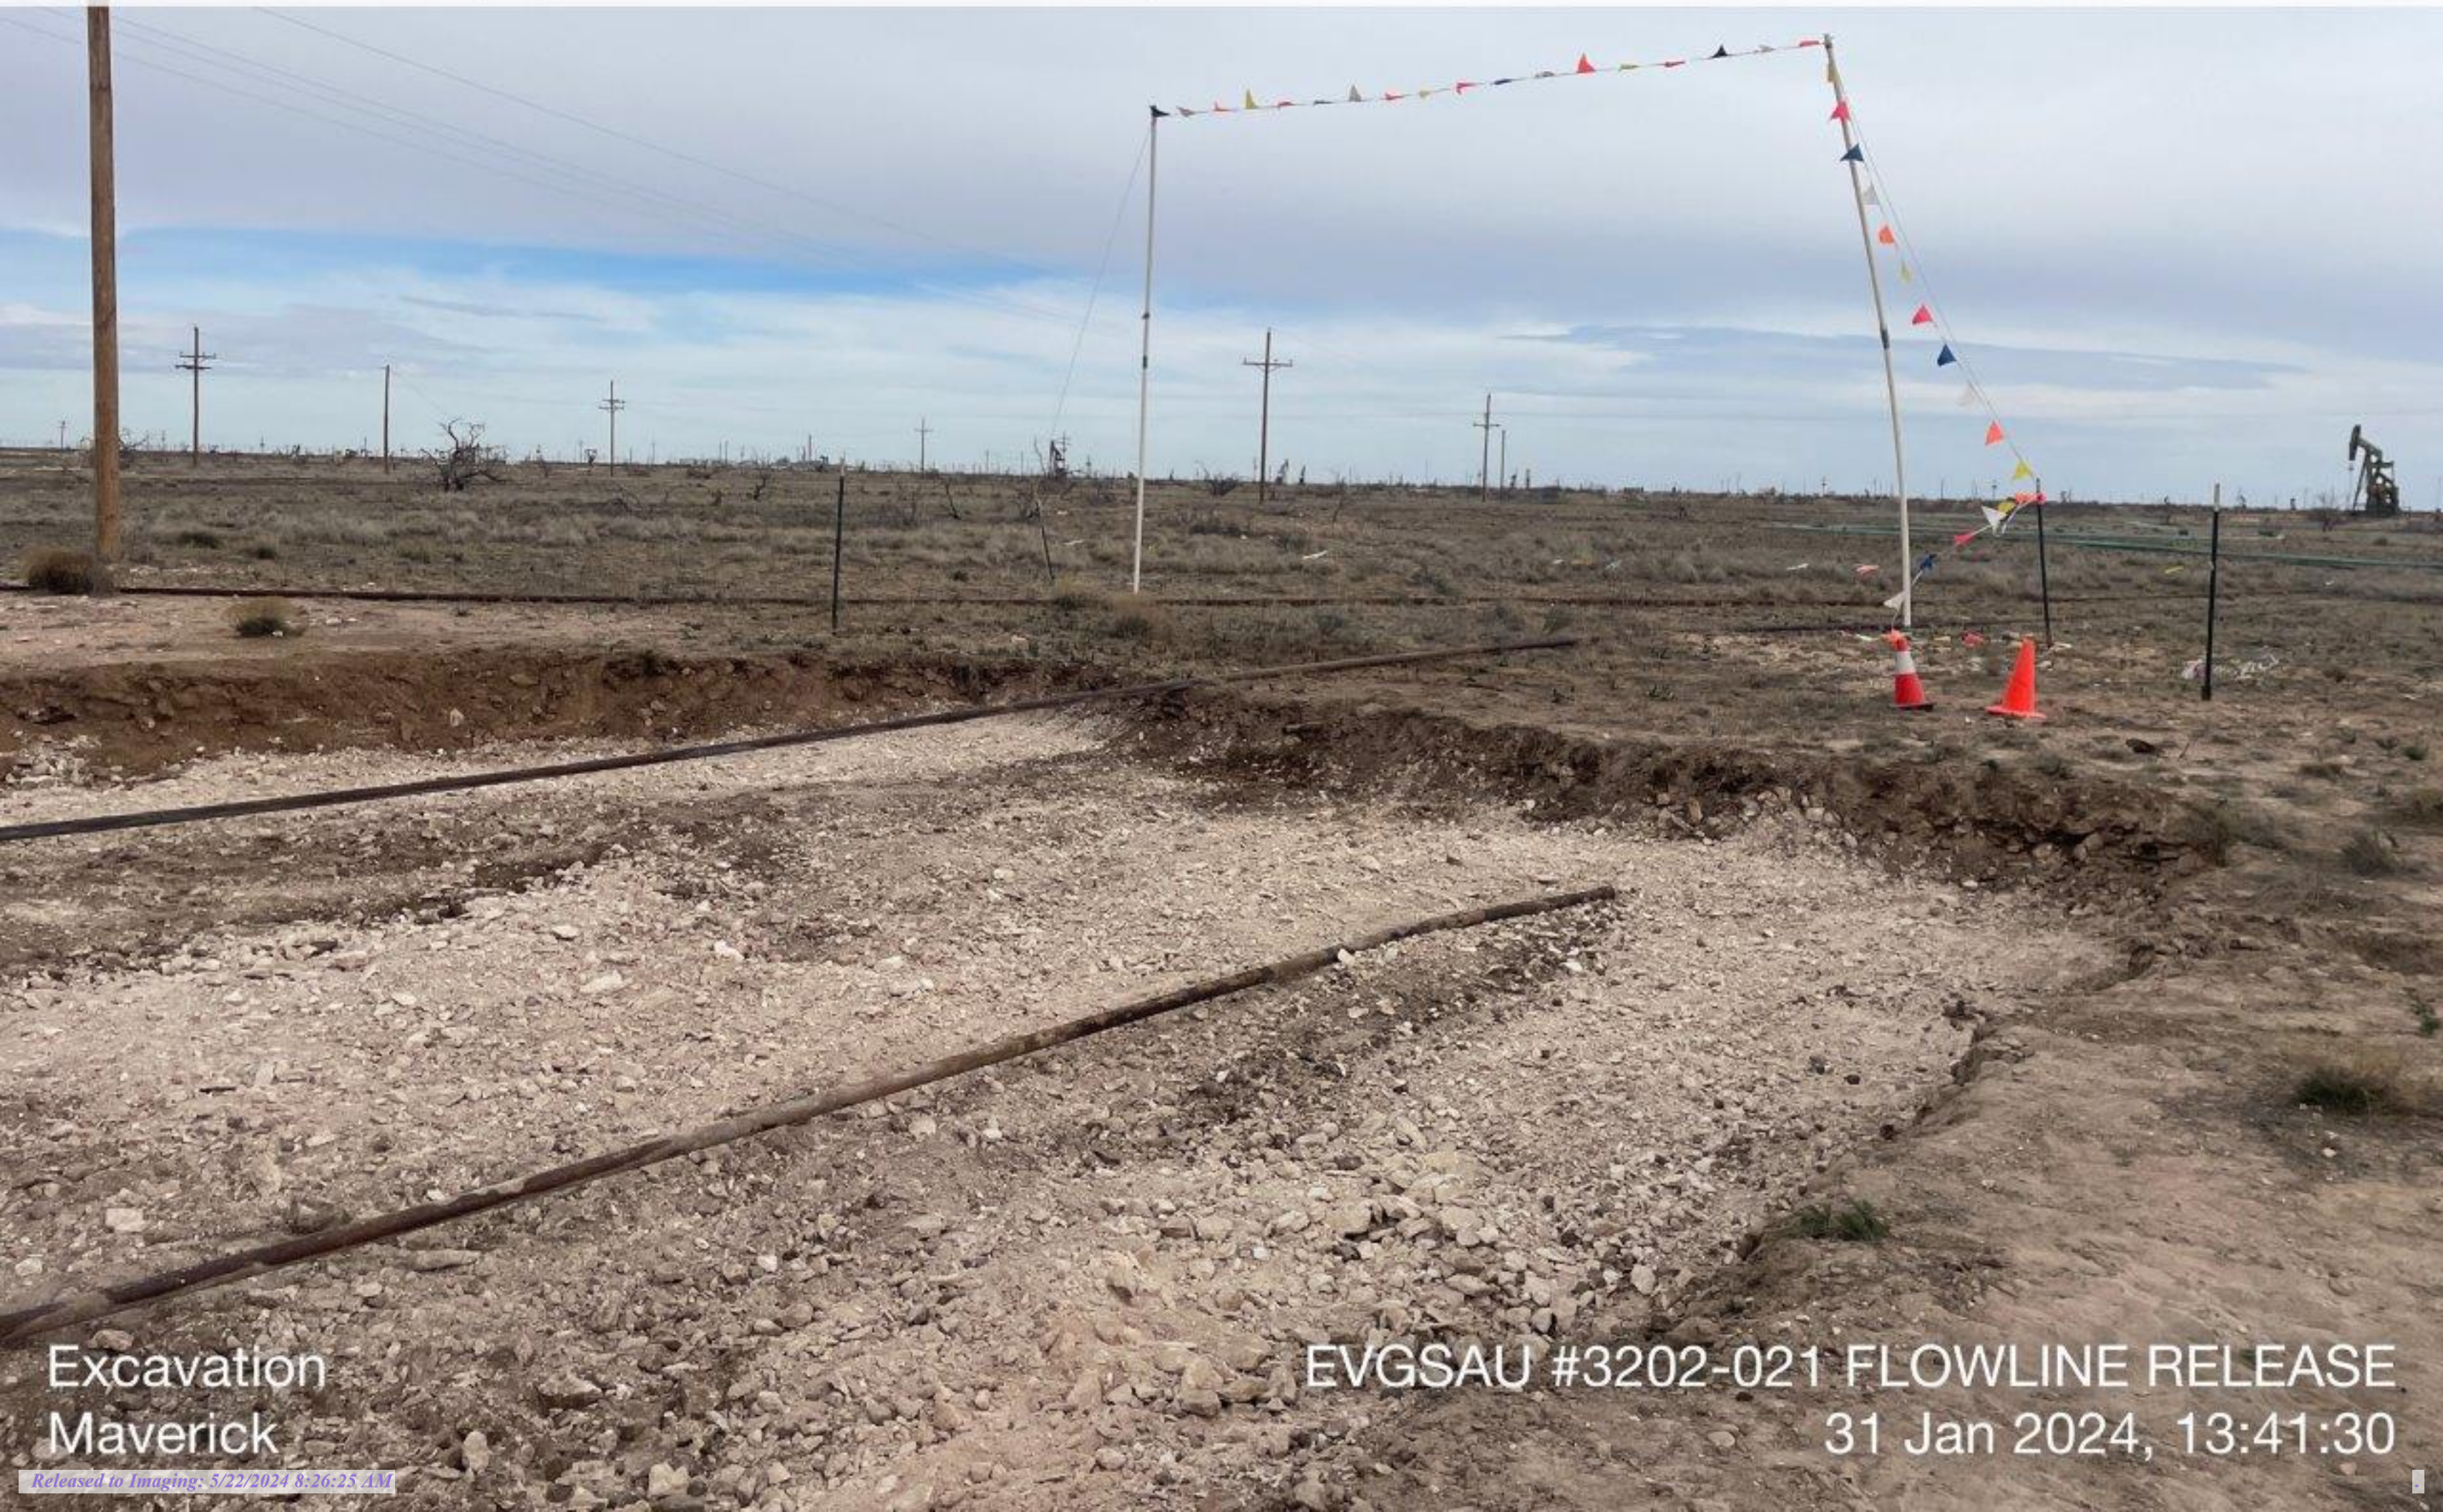
**NOTES:**

bgs: Below ground surface

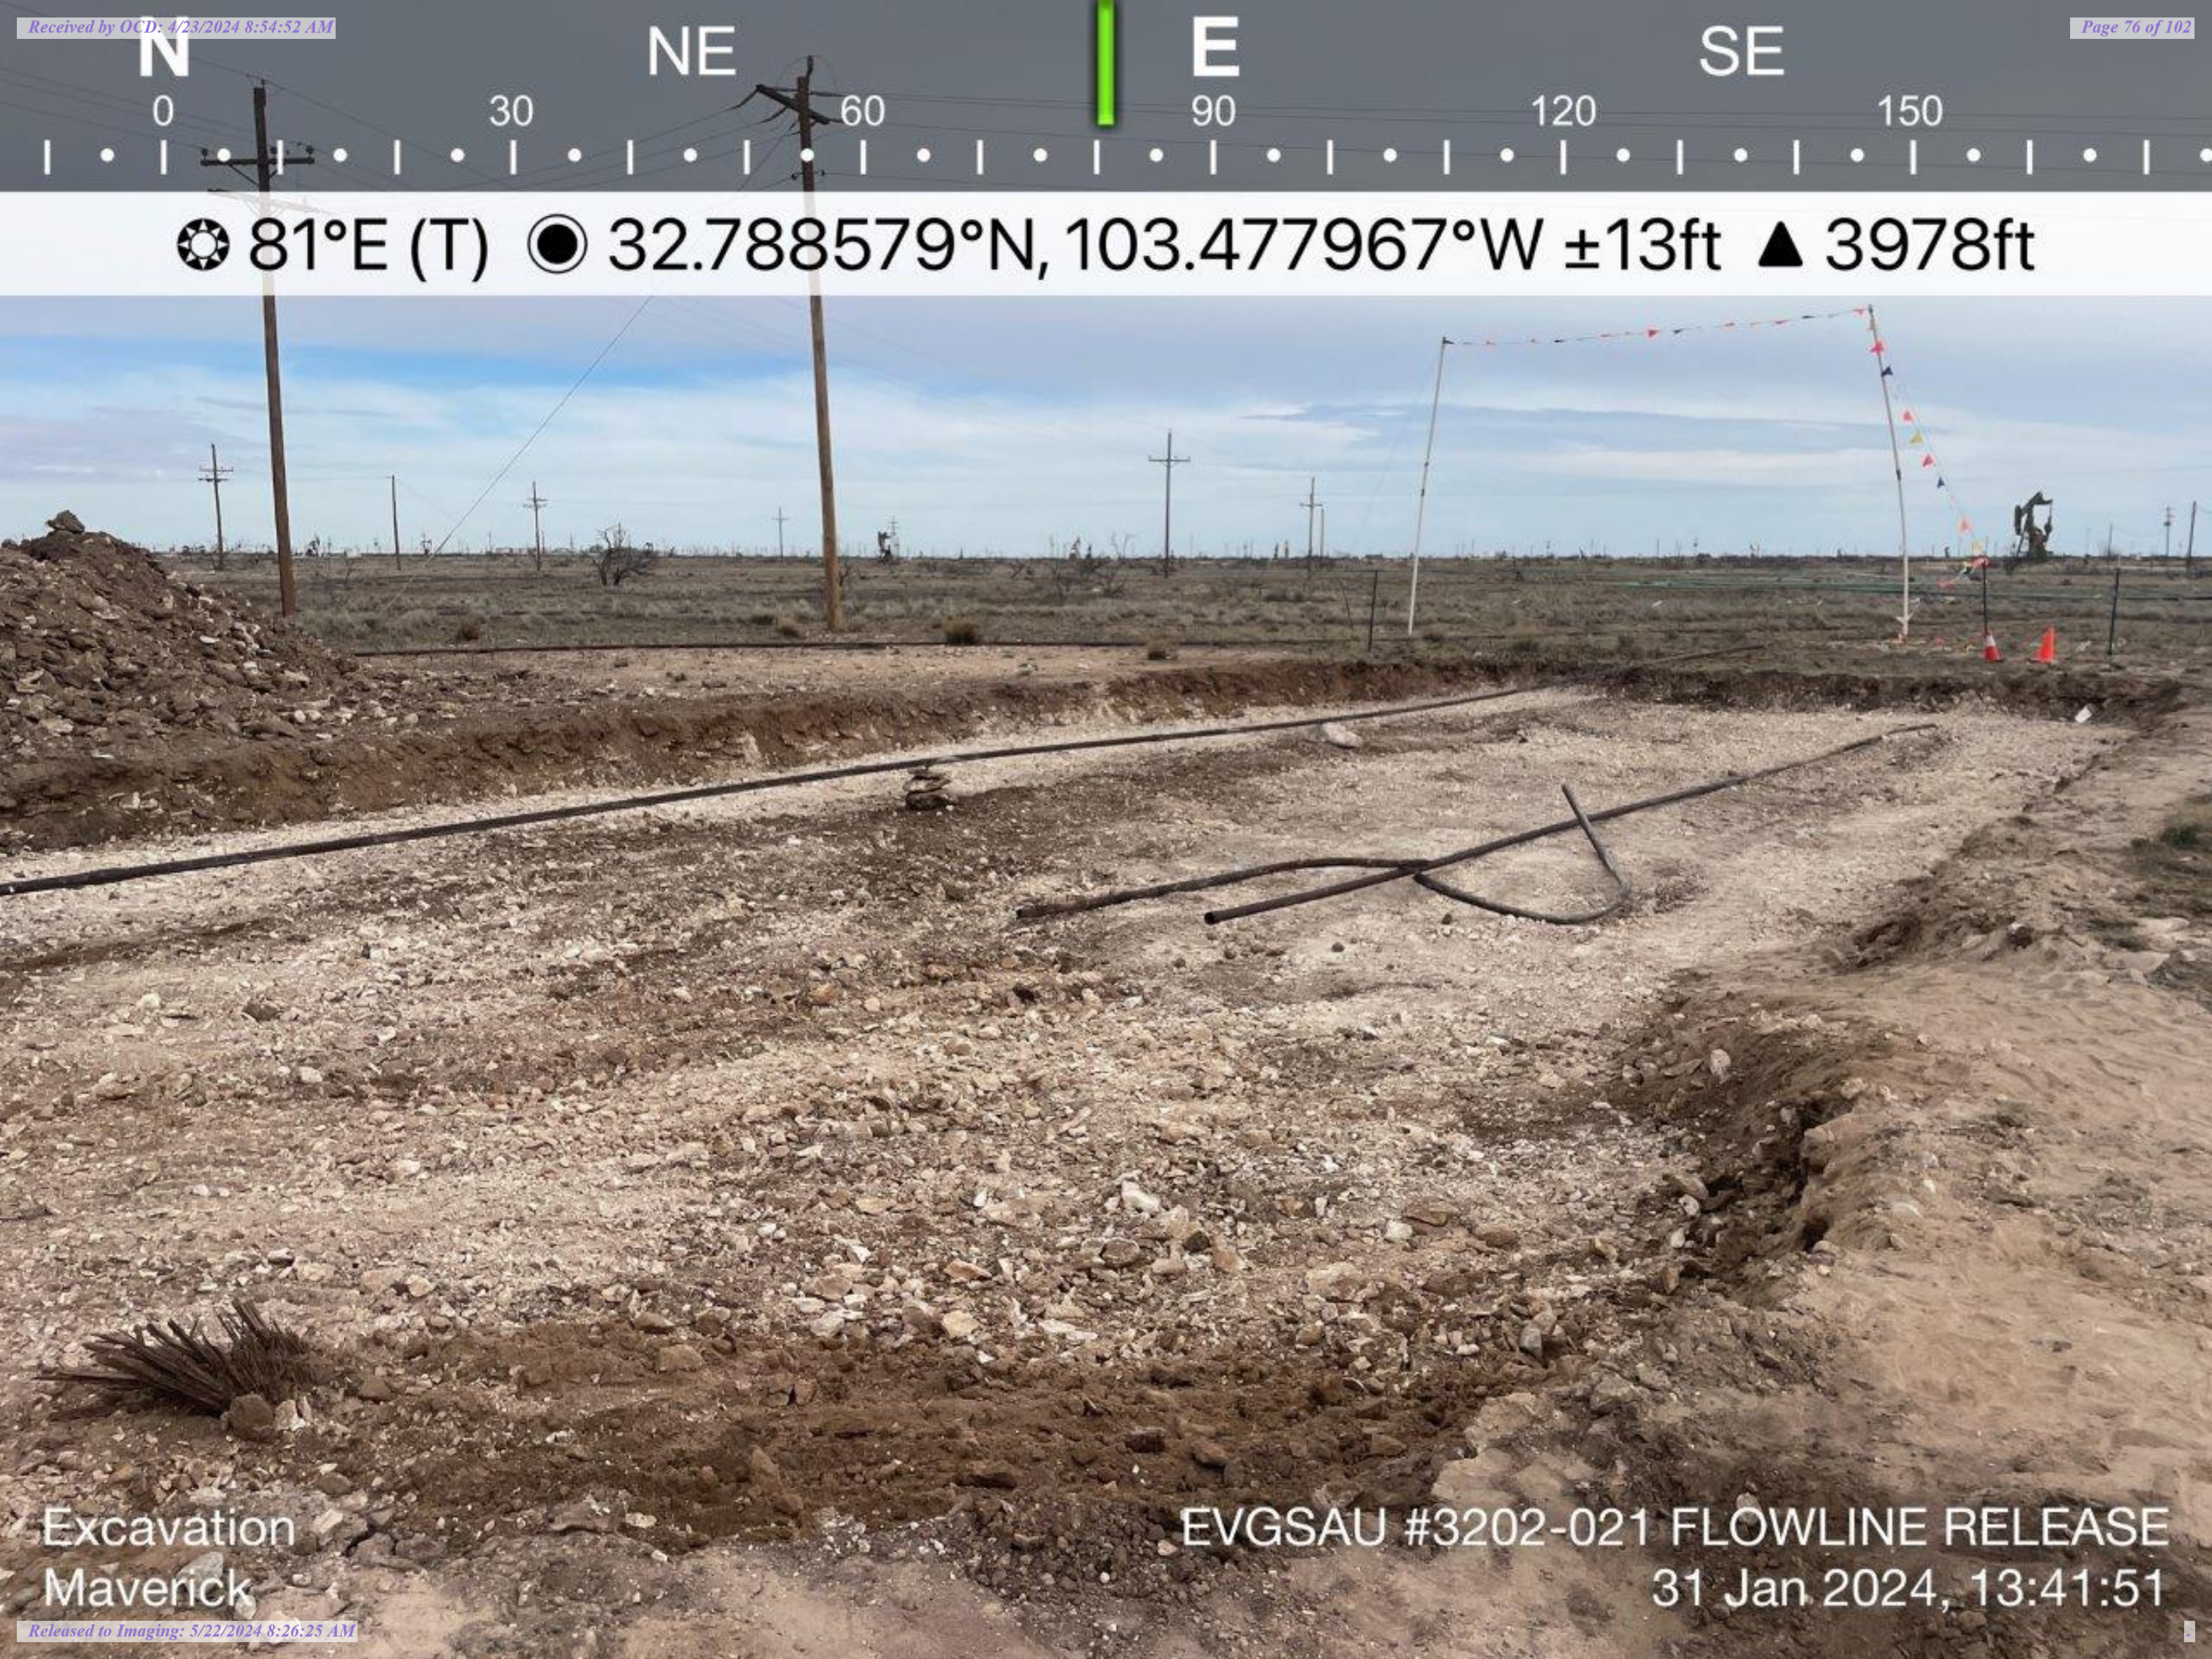
GRO: Gasoline Range Organics

DRO: Diesel Range Organics

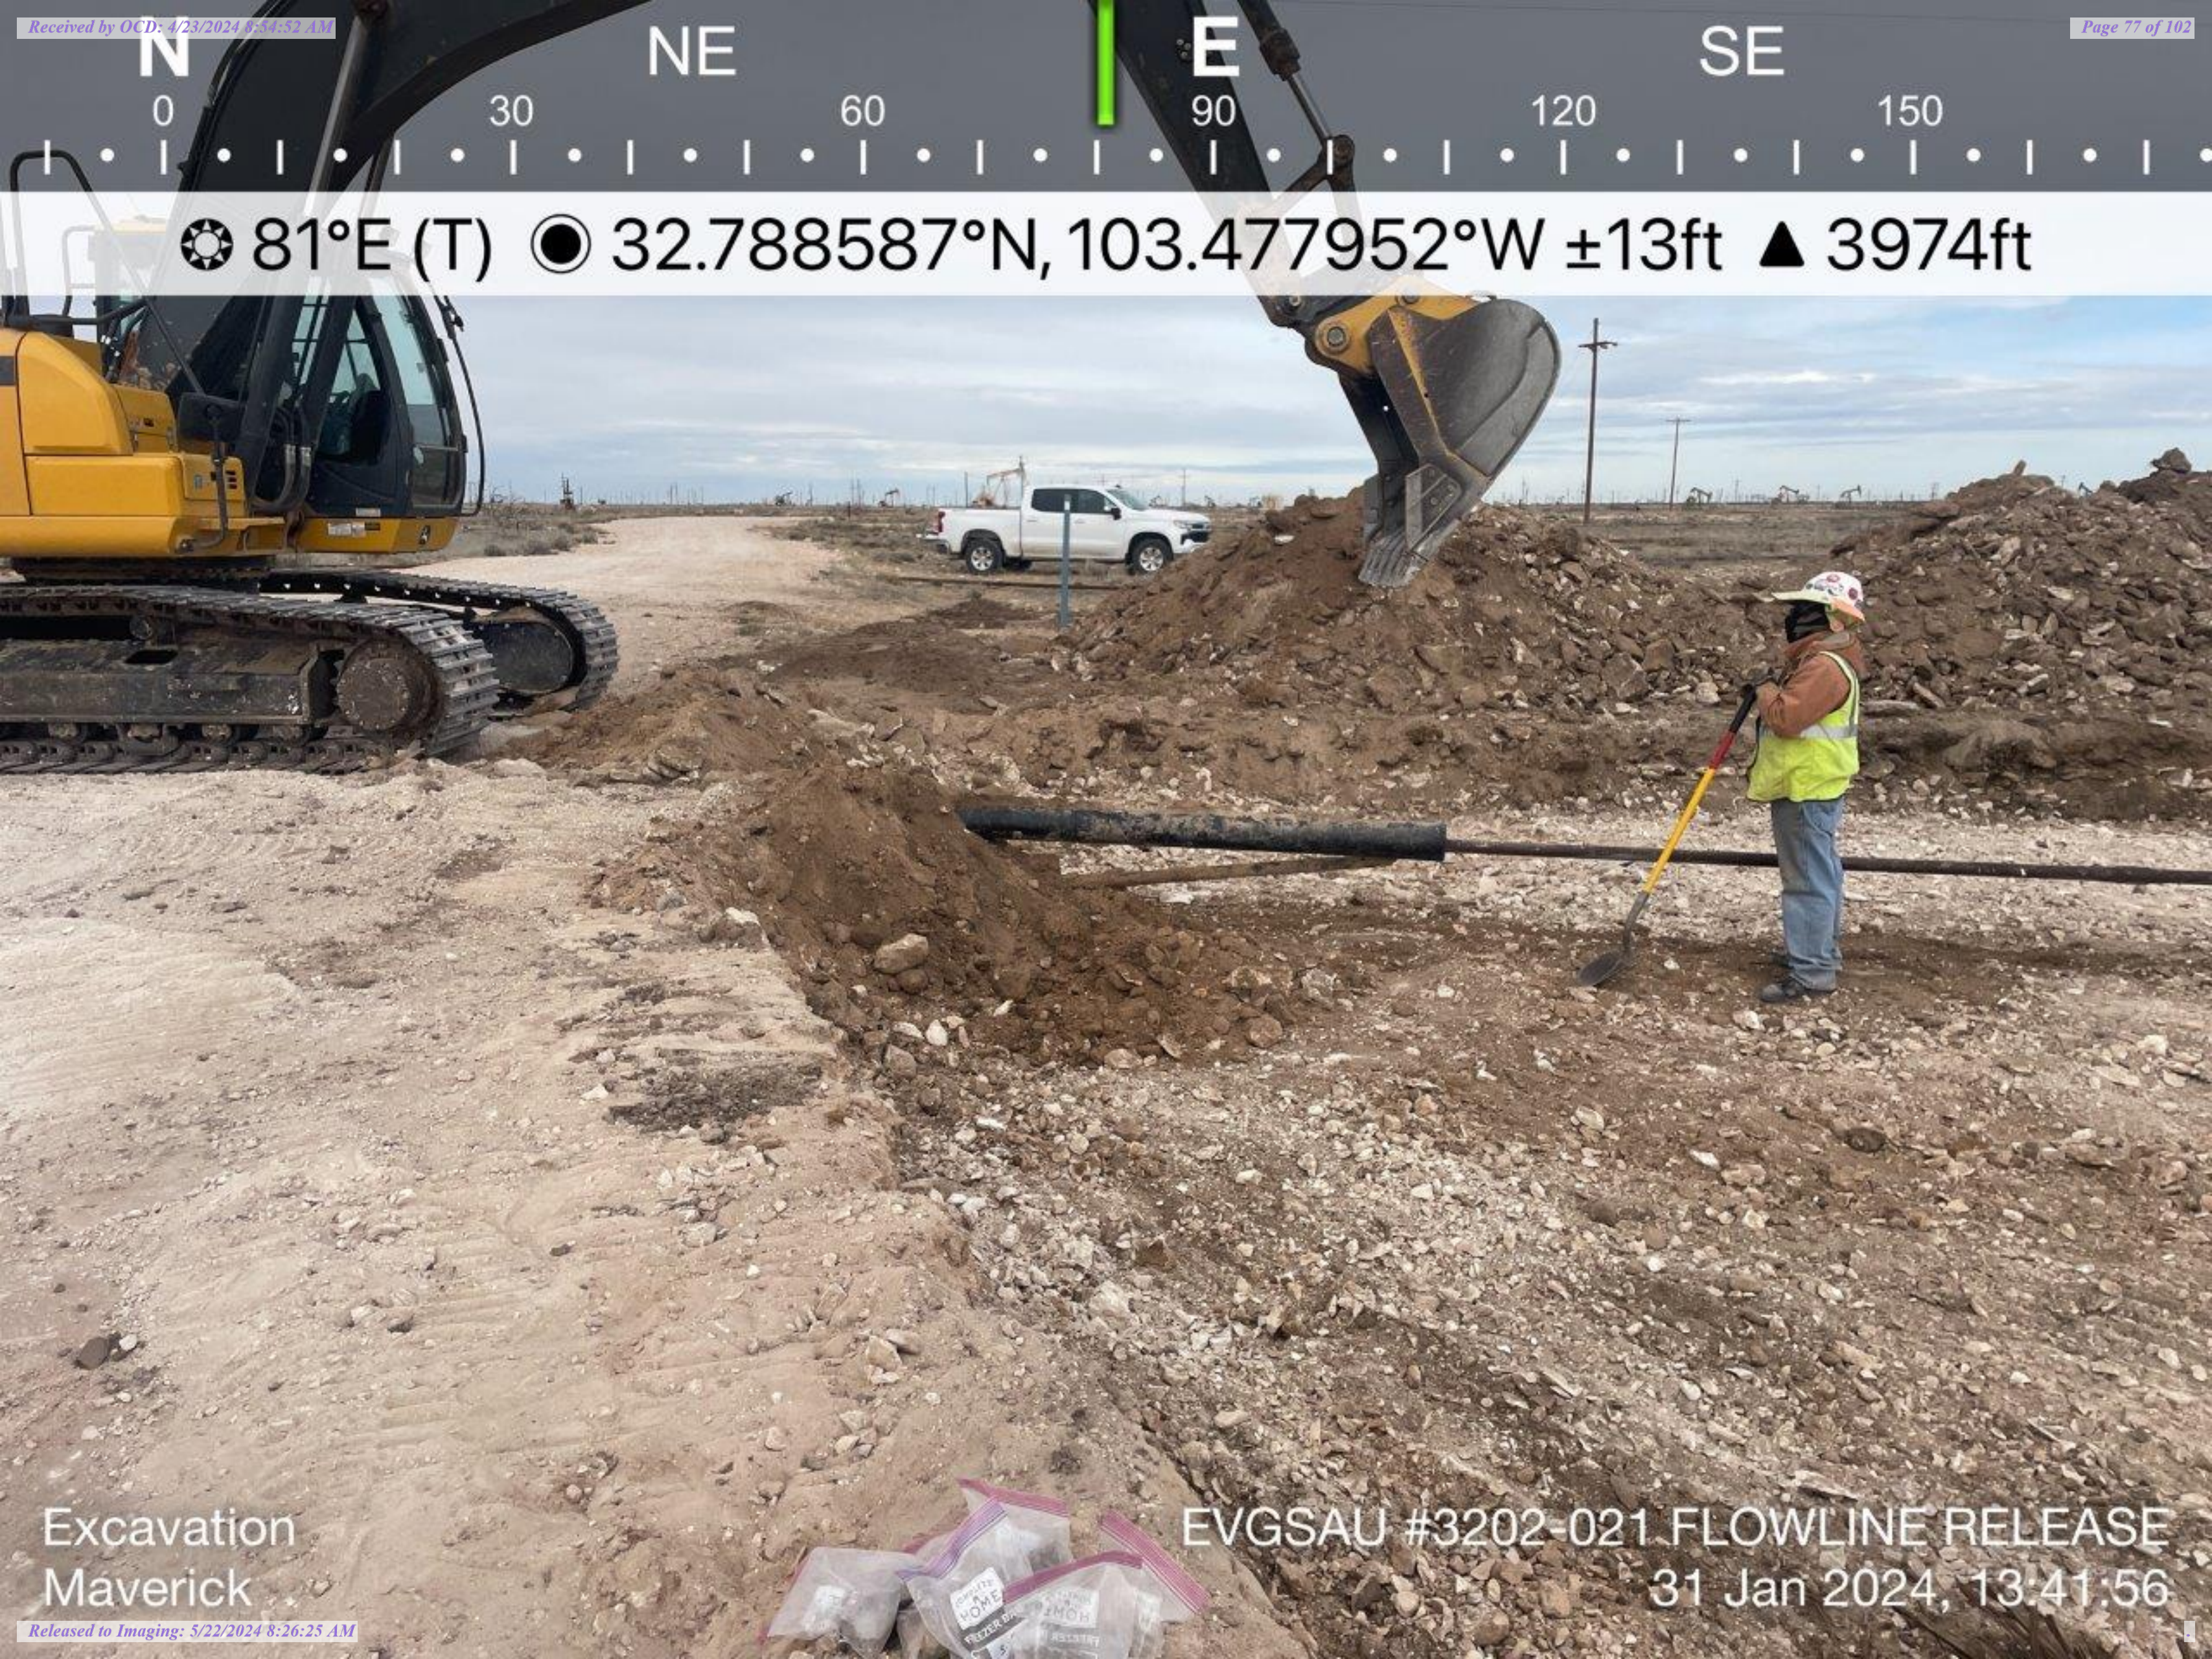
2: Method 8021B

3: Method 8015M

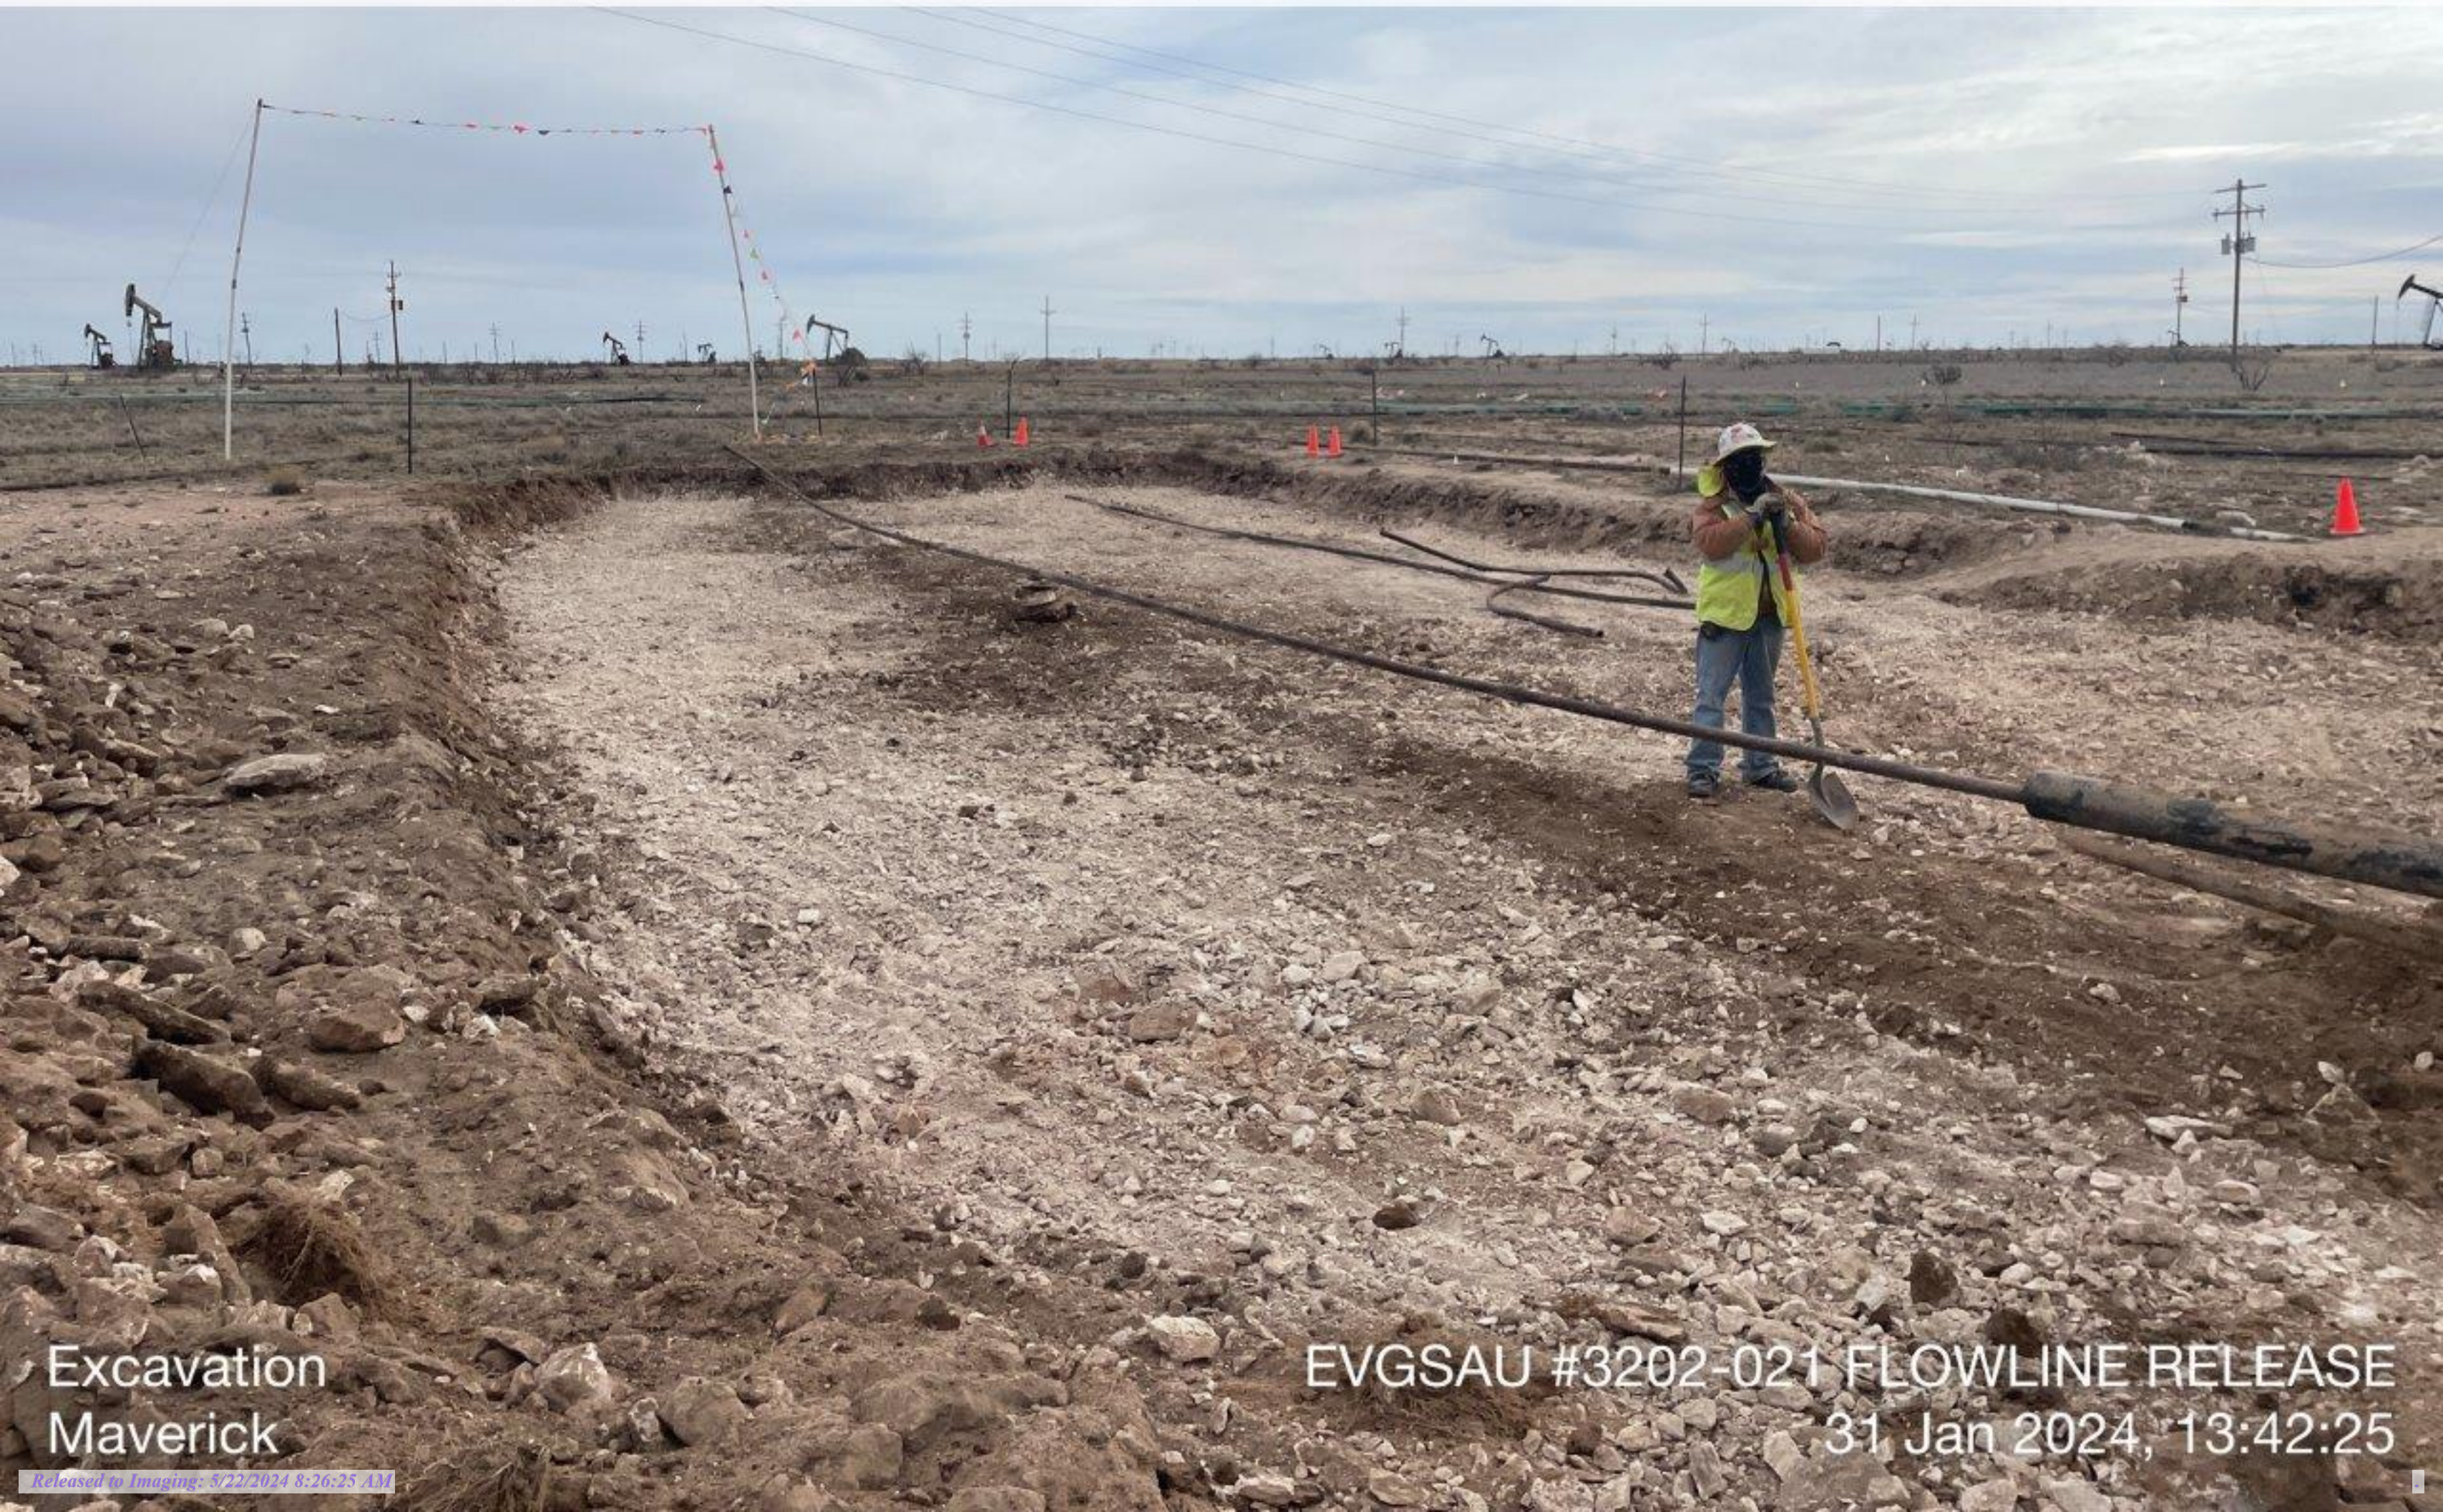
Sample ID	Sample Date	Sample Depth	Chloride <sup>1</sup>		BTEX <sup>2</sup>										TPH <sup>3</sup>							
					Benzene		Toluene		Ethylbenzene		Total Xylenes		Total BTEX		GRO		DRO		EXT DRO		Total TPH (GRO+DRO+EXT DRO)	
												C <sub>6</sub> - C <sub>10</sub>		> C <sub>10</sub> - C <sub>28</sub>		> C <sub>28</sub> - C <sub>36</sub>						
		feet bgs	mg/kg	Q	mg/kg	Q	mg/kg	Q	mg/kg	Q	mg/kg	Q	mg/kg	Q	mg/kg	Q	mg/kg	Q	mg/kg	Q	mg/kg	
Reclamation Requirements (19.15.29 NMAC)			600		10								50							100		
Backfill Validation	4/5/2024	0.0 - 2.0	16.0		<0.050		<0.050		<0.050		<0.150		<0.300		<10.0		<10.0		<10.0		-

NOTES:
