Red Willow Production Company: NC Ute 23D-2H (nAPP2401640502)
Site Assessment/Spill Characterization and Remediation Plan

1. Event and Background: On January 15, 2024 a leak of approximately 150 bbl of produced water with no visible evidence of hydrocarbons inside of secondary containment was discovered at Red Willow's "NC Ute 23D-2H" location (a Fruitland Coal well). The transfer pump froze allowing the production tanks to empty into the lined secondary containment tank battery mixing with the snow and stormwater already in the containment. A water truck was dispatched to recover what it could from the containment (produced water and snowmelt) and subsequently more snowmelt/released produced water continued to be recovered later as it thawed. Red Willow then had the gravel removed from the secondary containment to inspect the integrity of the liner; unfortunately, several small holes approximately ½" in diameter were observed. No signs of vegetation or soil impacts are visible near the backside of the tank battery where any produced water would have migrated off location via the stormwater diversion ditch.

NC Ute 23D #002H (nAPP2401640502)

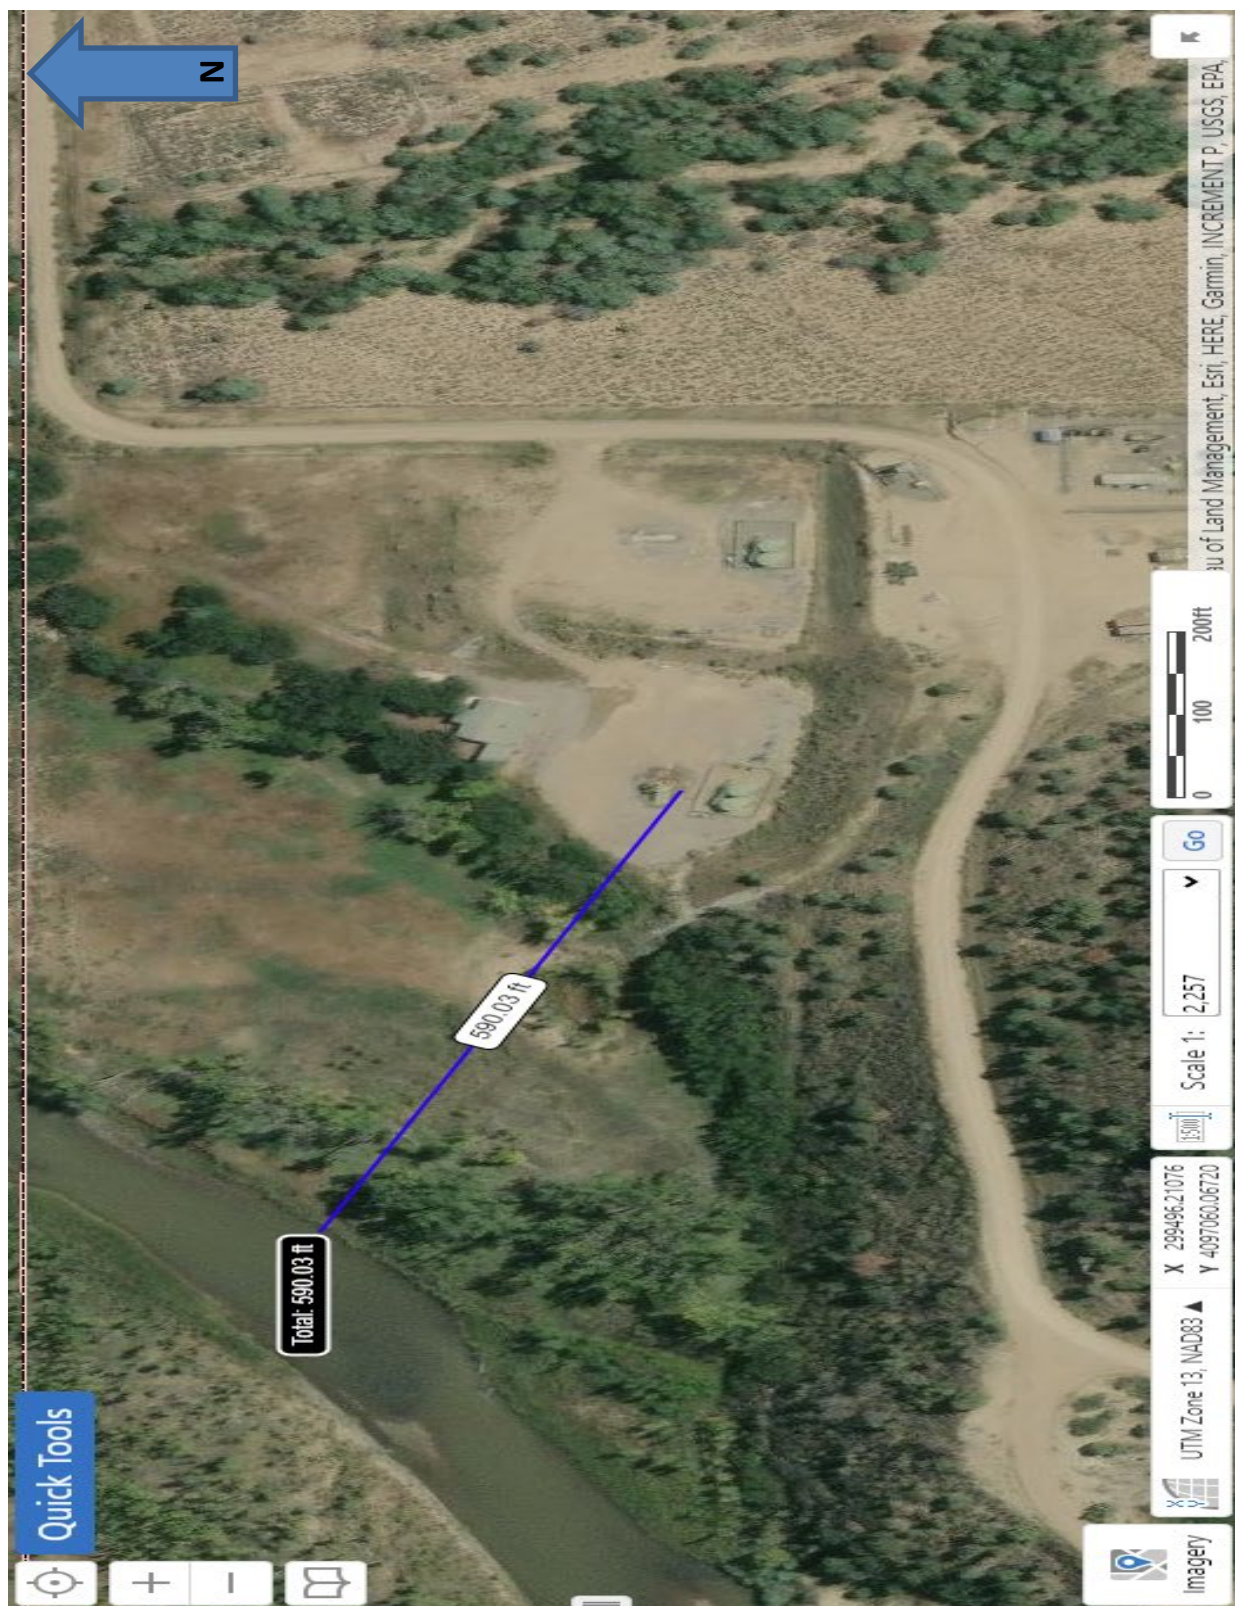
Map #2 - Distance to Live Water

- c. Distance to nearest surface water, irrigation canal or Waters of the U.S. (WOTUS):
 - The San Juan River is a jurisdictional drainage that is approximately 450' to the Northwest and downgradient of the release.

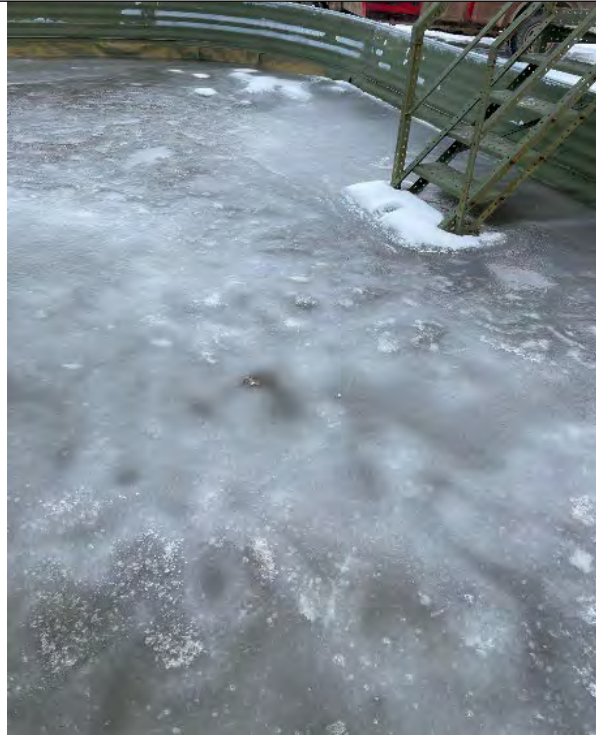
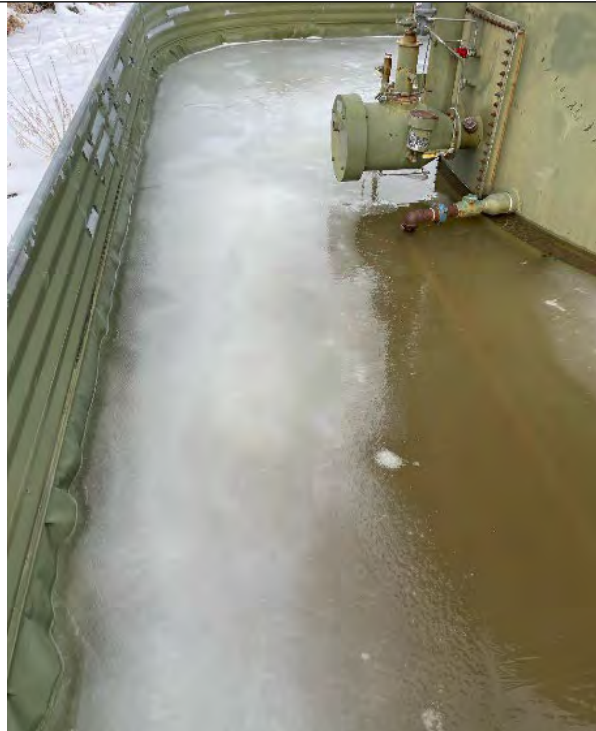
Frozen produced water gathered in lined steel ring tank battery.

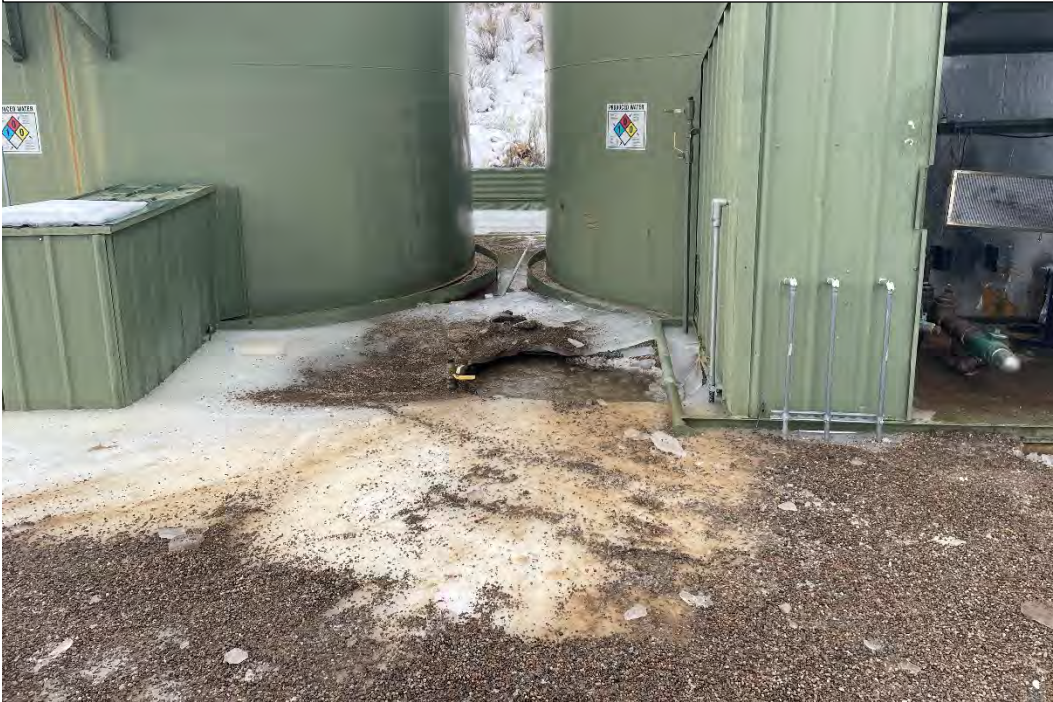
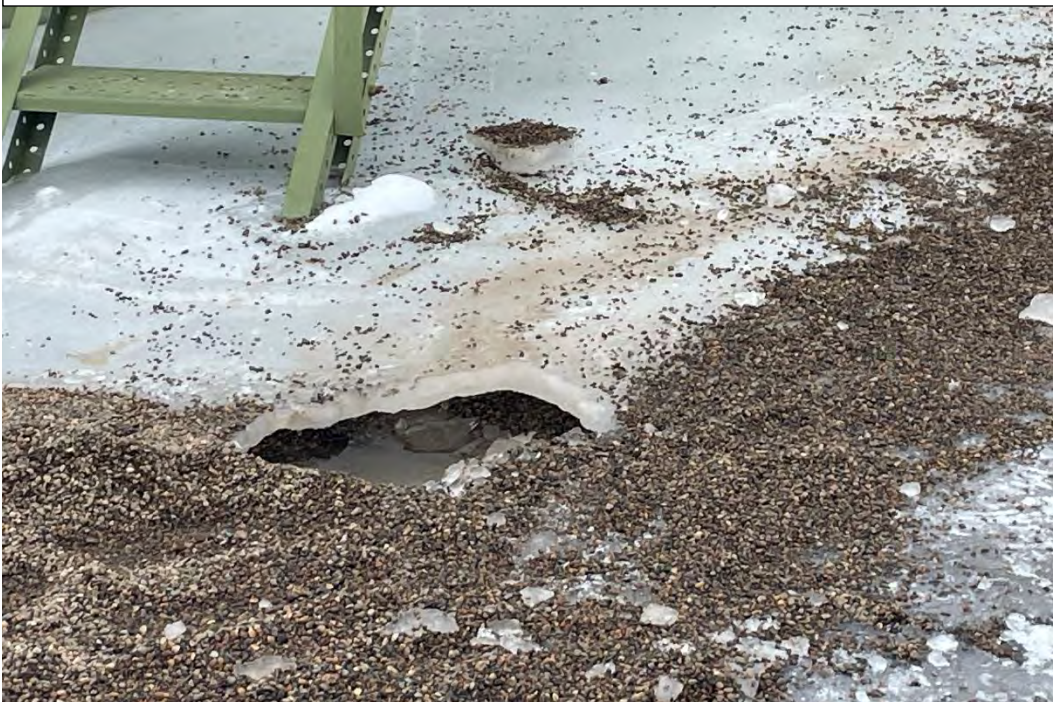
Released produced water was pulled by a vac truck; remaining ice will be pulled as it thaws.

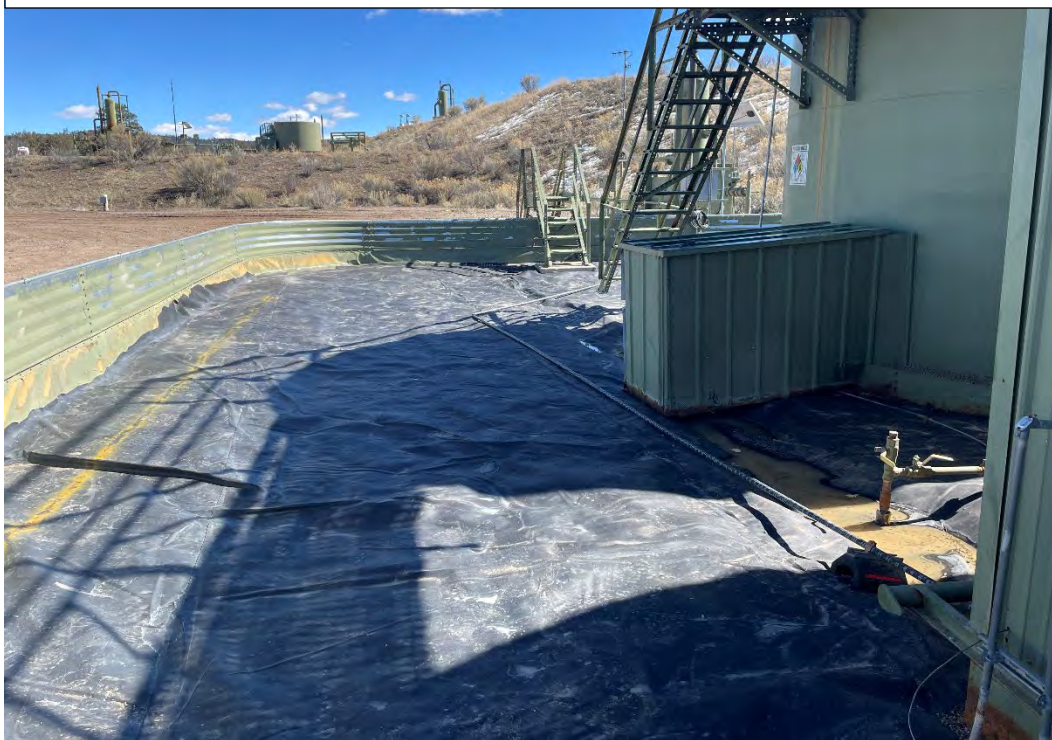
Looking North: Liquids and gravel were pulled from the secondary containment.

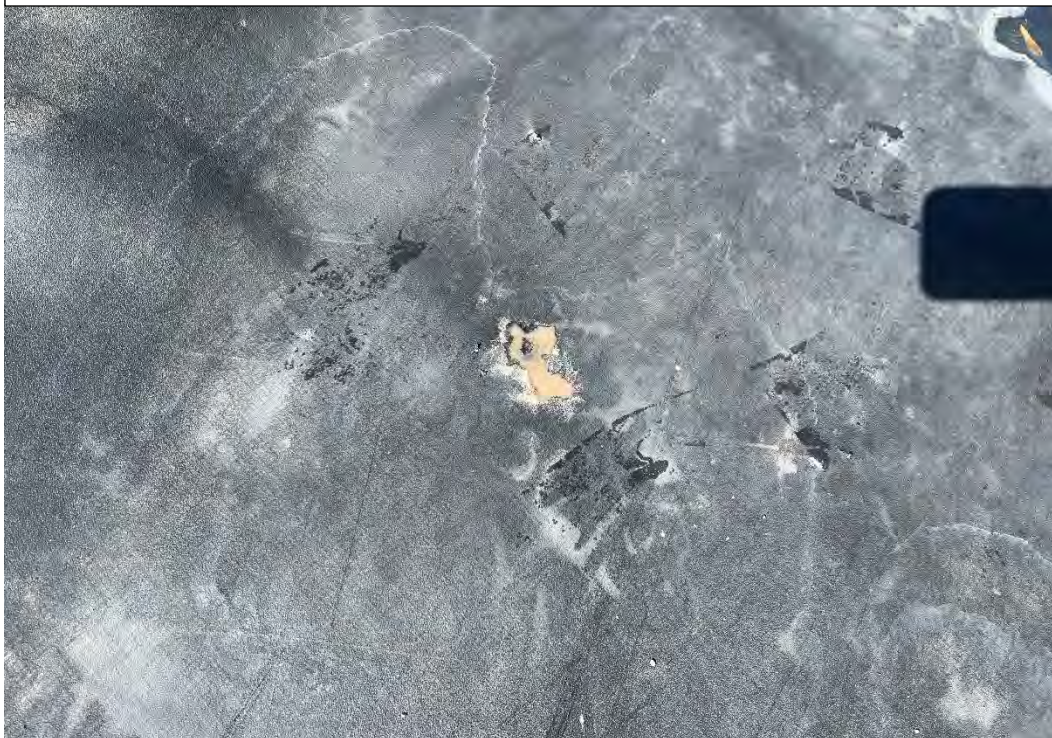
- b. Distance from producing agricultural land:
 - The majority of the spill stayed within the lined secondary containment and was recovered; while only an unknown, likely small volume may have permeated out of small holes in the liner. The nearest producing agricultural field is approximately 0.4 miles to the Northwest and is geographically isolated from the release by the San Juan River; the release is not immediately adjacent to any producing agricultural fields.

Small holes found in liner, approximately 0.5" diameter.

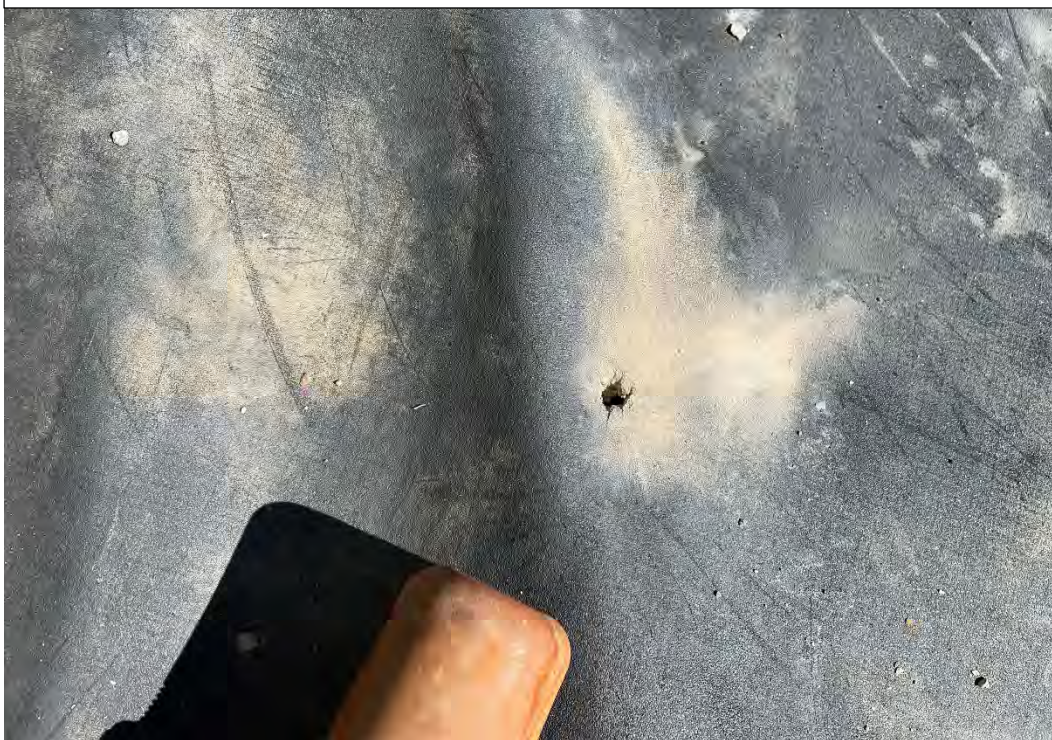
Small hole found in liner, approximately 0.5" diameter.

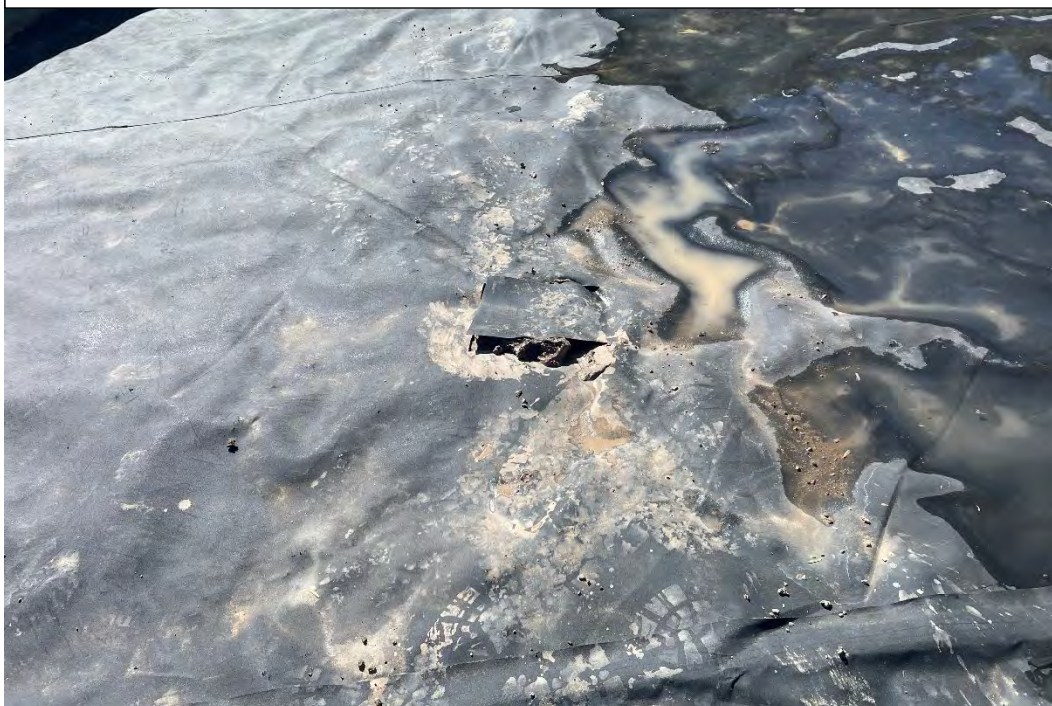
One of the holes cut into the line to collect samples from underneath the tank battery.

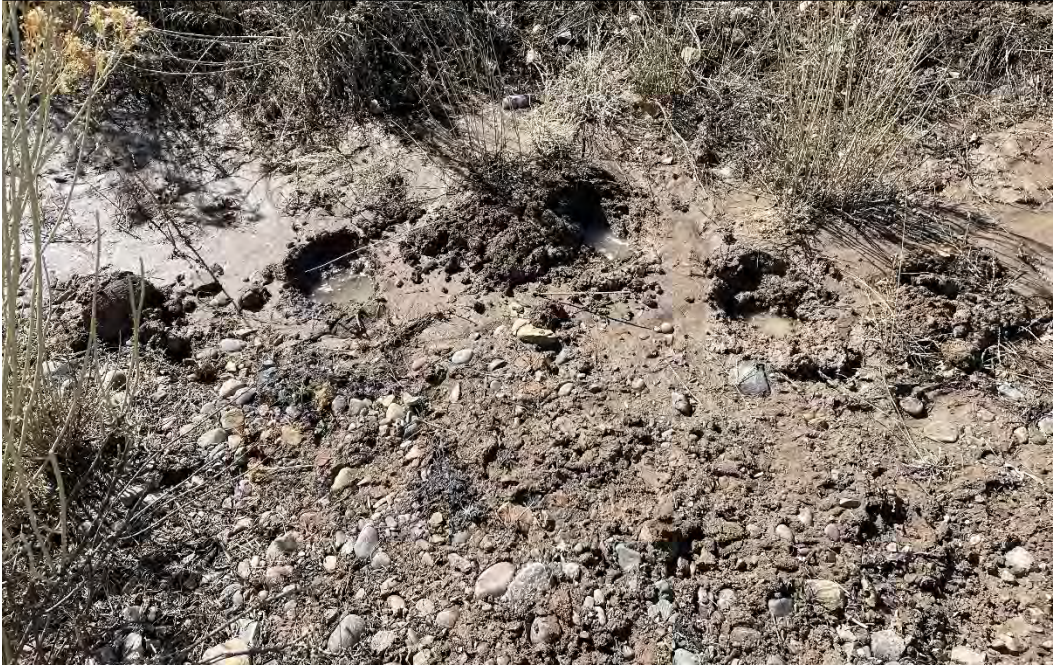
Sample "Diversion #2" collected from diversion ditch. Please note that the area is saturated from snowmelt coming from the North-facing slope above the diversion and is not produced water.

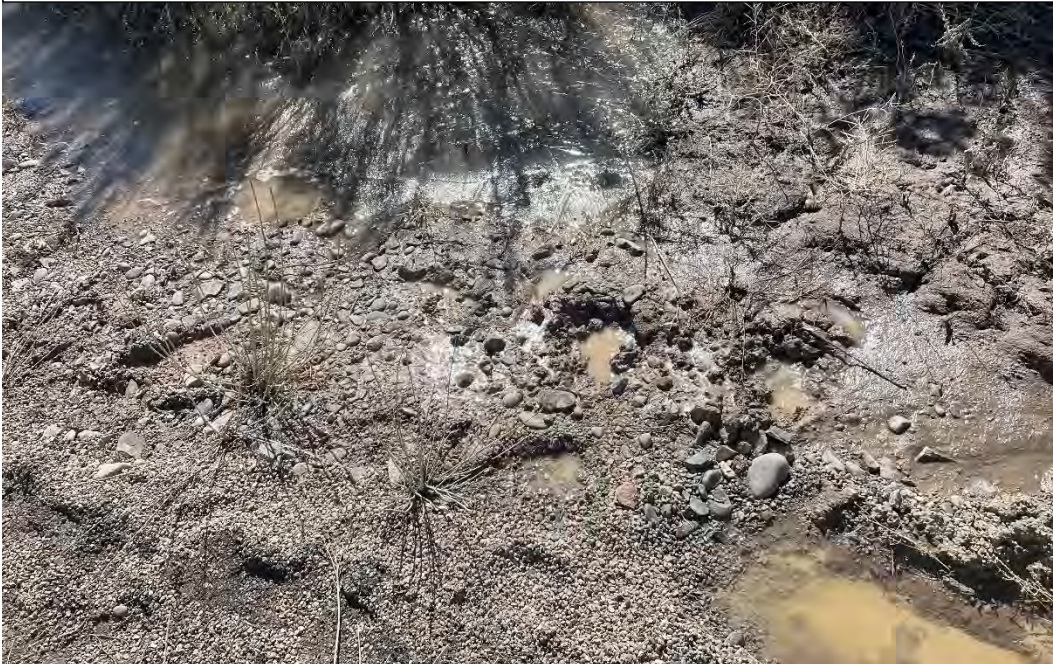
Sample "Diversion #1" collected from diversion ditch. Please note that the area is saturated from snowmelt coming from the North-facing slope above the diversion and is not produced water.
