**Re: Site Assessment, Remediation, and Closure Request**  
**Yale St #3 Battery**  
**API No. N/A**  
**GPS: Latitude 32.85720 Longitude -103.94510**  
**UL "N", Sec. 2, T17S, R30E**  
**Eddy County, NM**  
**NMOCD Ref. No. nAPP2301740961**

Paragon Environmental, LLC (Paragon) has been contracted by Spur Energy Partners (Spur) to perform a spill assessment and conduct remediation activities for the release site known as the Yale St. #3 Battery (Yale). Details of the release are summarized below:

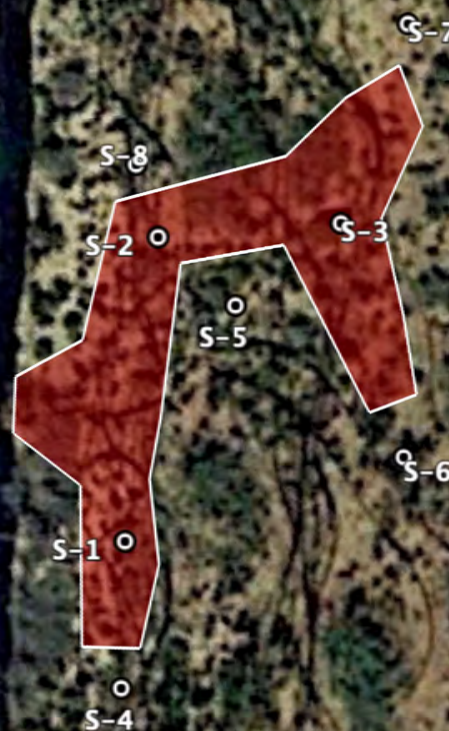
Yale ST 3 Battery 32.85720, -103.94510

- Samples
- Spill Area 2046 S/F

A Site Map is provided in Figure #1. Laboratory results can be found in Appendix D.

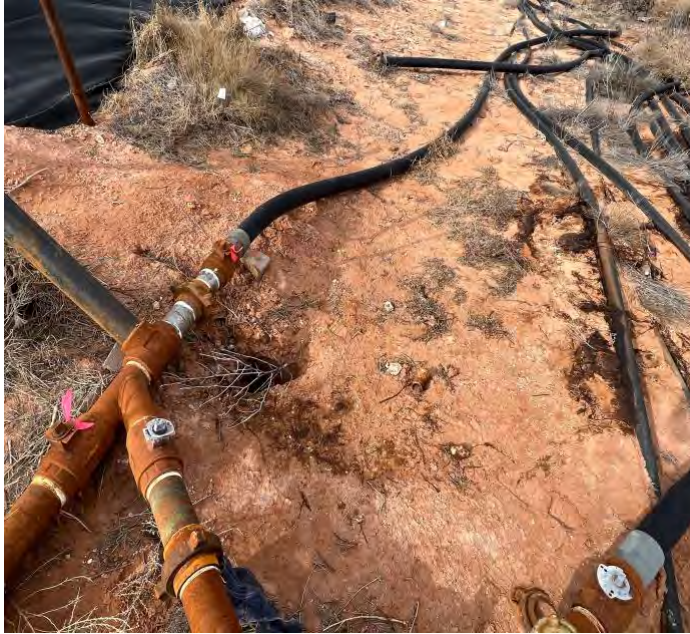
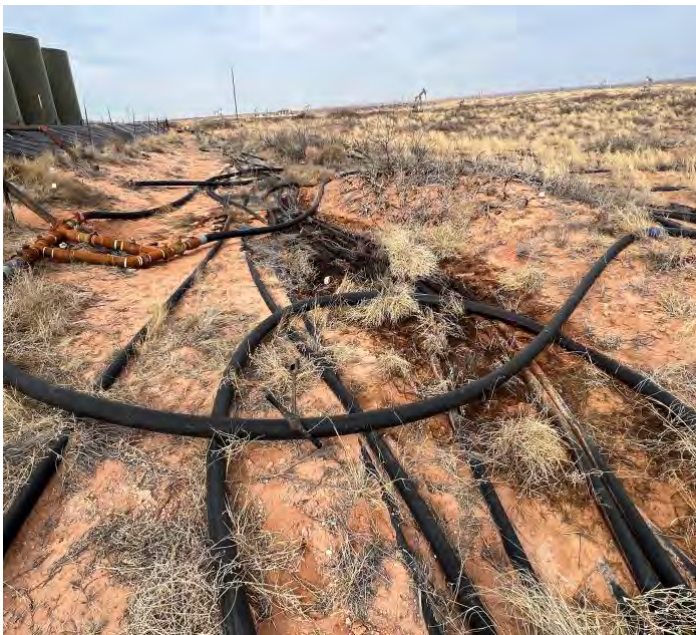
### Before Remediation

Release Details			
<b>Type of Release:</b>	Produced Water	<b>Volume of Release:</b>	14 bbls
		<b>Volume Recovered:</b>	12 bbls
<b>Source of Release:</b>	Transfer Line	<b>Date of Release:</b>	1/12/23
<b>Was Immediate Notice Given?</b>	No	<b>If, Yes, to Whom?</b>	N/A
<b>Was a Watercourse Reached?</b>	No	<b>If Yes, Volume Impacting Watercourse:</b>	N/A
<b>Surface Owner:</b>	Federal	<b>Mineral Owner:</b>	Federal
Defective nipple on the transfer line developed a hole due to corrosion and released produced water into the pasture.
