Vertex Project #: 20E-00141-031

Spill Closure Report: Apache 25 Federal #006
Unit P, Section 25, Township 22 South, Range 30 East
County: Eddy
API: 30-015-29894
Tracking Numbers: NHMP1419941498

Prepared For: Devon Energy Production Company
6488 Seven Rivers Highway
Artesia, New Mexico 88210

2020 Spill Assessment and Closure
June 2020

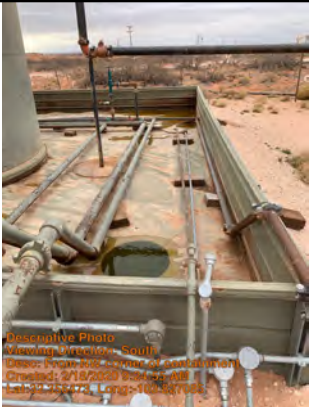
<p>From NW corner of containment</p>
<p>Viewing Direction: West</p>

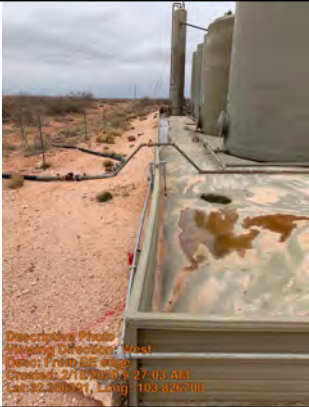
<p>From SE edge</p>	<p>Viewing Direction: North</p>

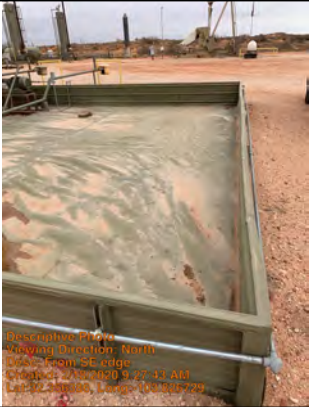
<p>From SE edge</p>

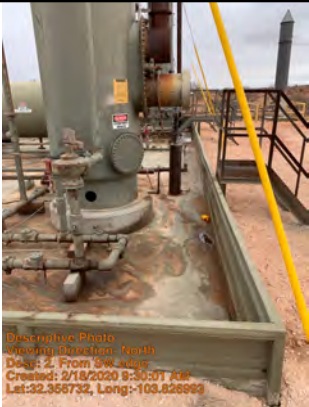
<p>Viewing Direction: North</p>

<p> <small> Descriptive Photo Viewing Direction: North Desc: 2. From SE edge Created: 2/18/2020 8:30:01 AM Lat:32.356732, Long:-103.826983 </small> </p>	<p>Viewing Direction: West</p>

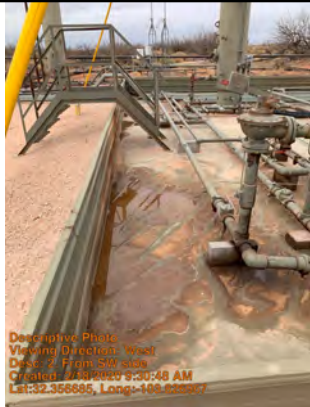
<p> <small> Descriptive Photo Viewing Direction: West Desc: 2. From SE side Created: 2/18/2020 8:30:48 AM Lat:32.356685, Long:-103.82697 </small> </p>
2. From SE edge	2. From SE side
<p>Viewing Direction: North</p>

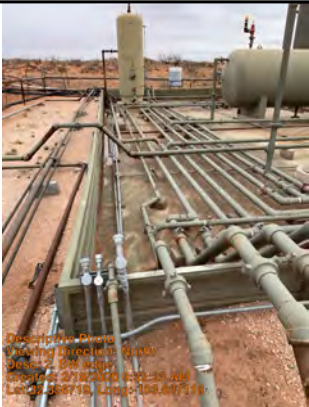
<p> <small> Descriptive Photo Viewing Direction: North Desc: 2. SW edge Created: 2/18/2020 8:32:19 AM Lat:32.356719, Long:-103.827111 </small> </p>	<p>Viewing Direction: East</p>

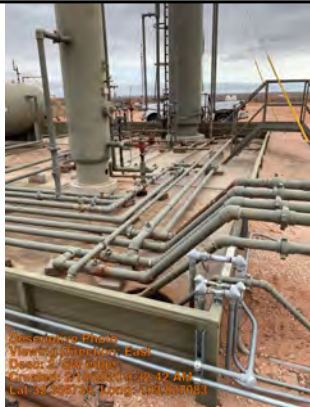
<p> <small> Descriptive Photo Viewing Direction: East Desc: 2. SW edge Created: 2/18/2020 8:32:47 AM Lat:32.356734, Long:-103.827083 </small> </p>
2. SW edge	2. SW edge

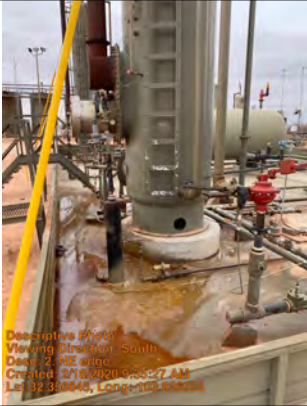
<p>Descriptive Photo Viewing Direction: South Deck 2, NE edge Created: 2/18/2020 9:35:27 AM Lat:32.355846, Long: -103.826584</p> <p>2. NE edge</p>	<p>Viewing Direction: West</p>

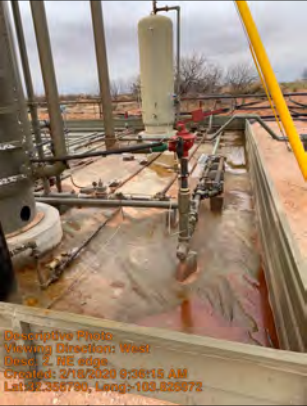
<p>Descriptive Photo Viewing Direction: West Deck 2, NE edge Created: 2/18/2020 9:35:18 AM Lat:32.355790, Long: -103.826672</p> <p>2. NE edge</p>
