Remediation Summary and Soil Closure Request

Spur Energy Partners, LLC Arkansas 23 Fee #003 Pad

Eddy County, New Mexico
Unit Letter E, Section 23, Township 19 South, Range 25 East
Latitude 32.64745 North, Longitude 104.46073 West
NMOCD Reference No. nAPP2300636521

Etech Environmental & Safety Solutions, Inc.
2617 W. Marland
Hobbs, New Mexico 88240

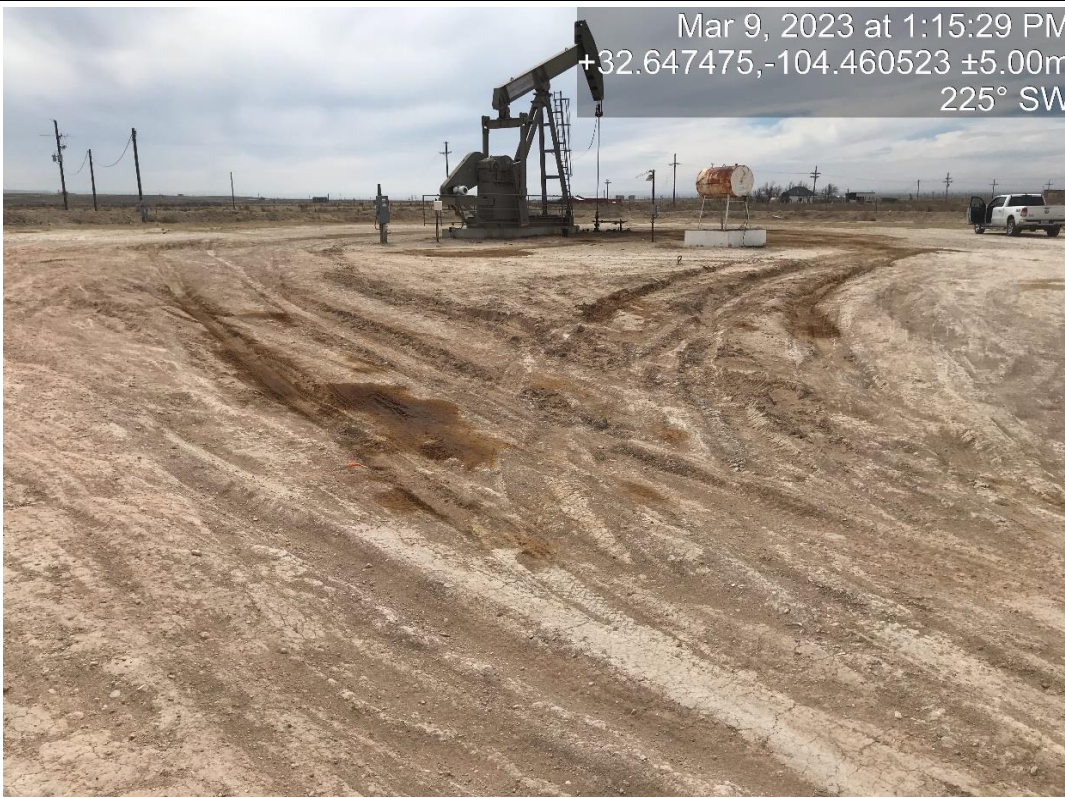
Photo Number: 1	<div>Mar 9, 2023 at 1:15:29 PM +32.647475,-104.460523 ±5.00m 225° SW</div>

Photo Direction: Southwest	
Photo Description: View of impacted area.

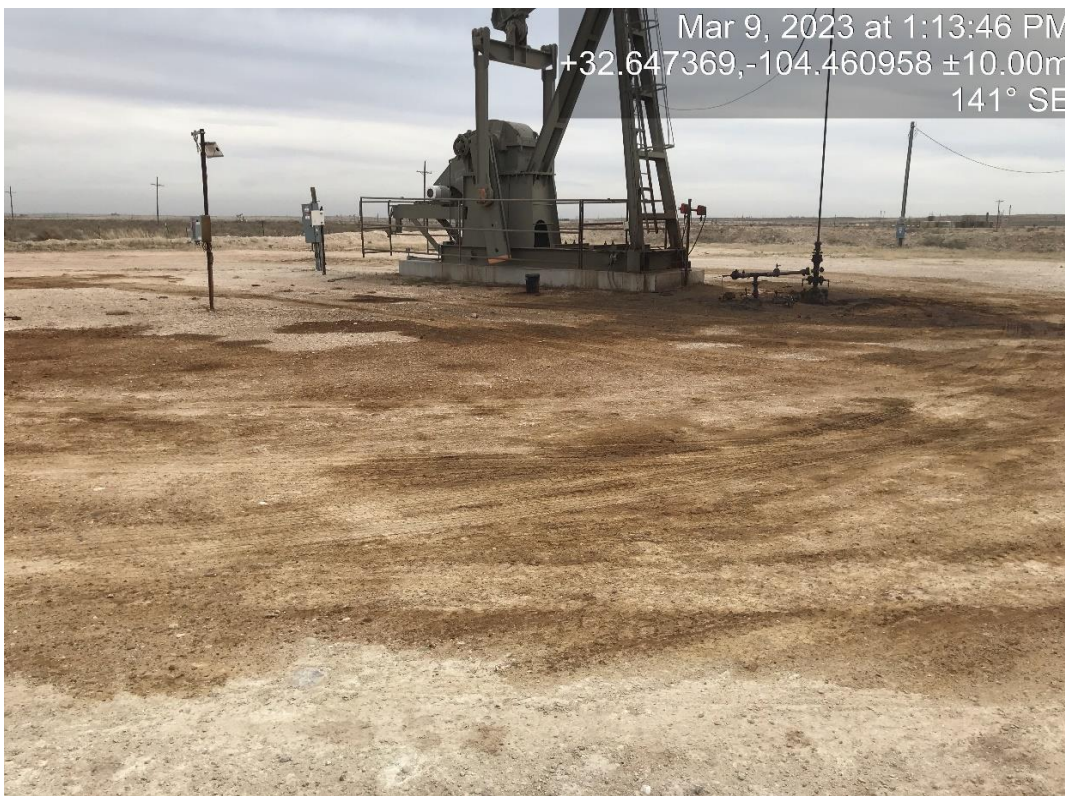
Photo Number: 4

<div>Mar 9, 2023 at 1:13:46 PM +32.647369,-104.460958 ±10.00m 141° SE</div>
Photo Direction: Southeast	
Photo Description: View of impacted area.

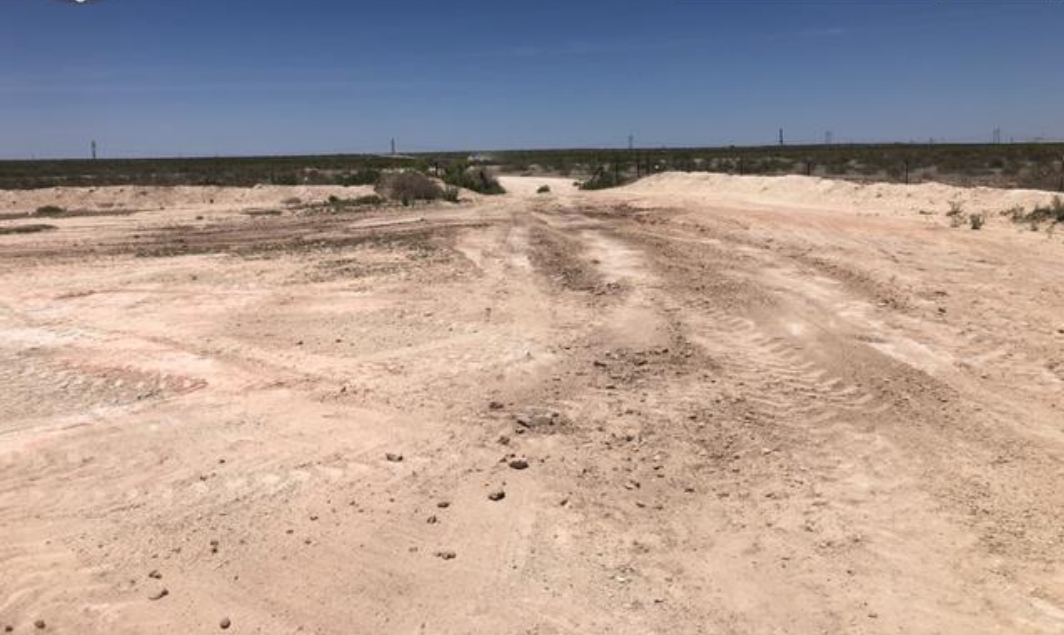
Photo Number: 5

<p>Jun 8, 2023 at 2:01:38 PM +32.647076,-104.460889 25° NE Eddy County</p>
Photo Direction: Northeast	
Photo Description: View of excavated area.

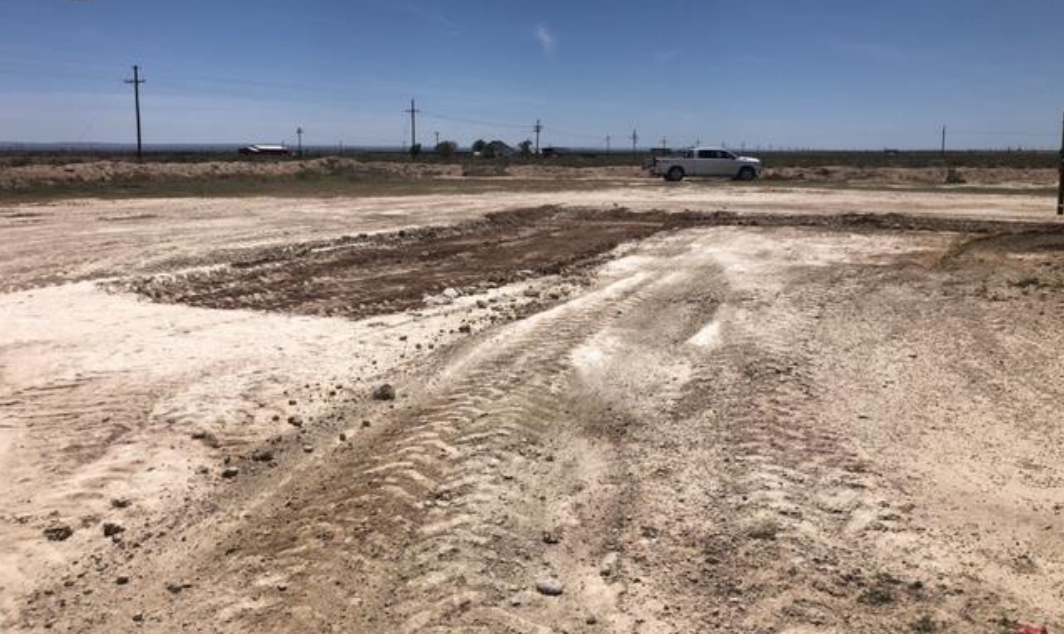
Photo Number: 7

<p>Jun 8, 2023 at 2:01:45 PM +32.647089,-104.460857 220° SW Eddy County</p>
Photo Direction: Southwest	
Photo Description: View of excavated area.

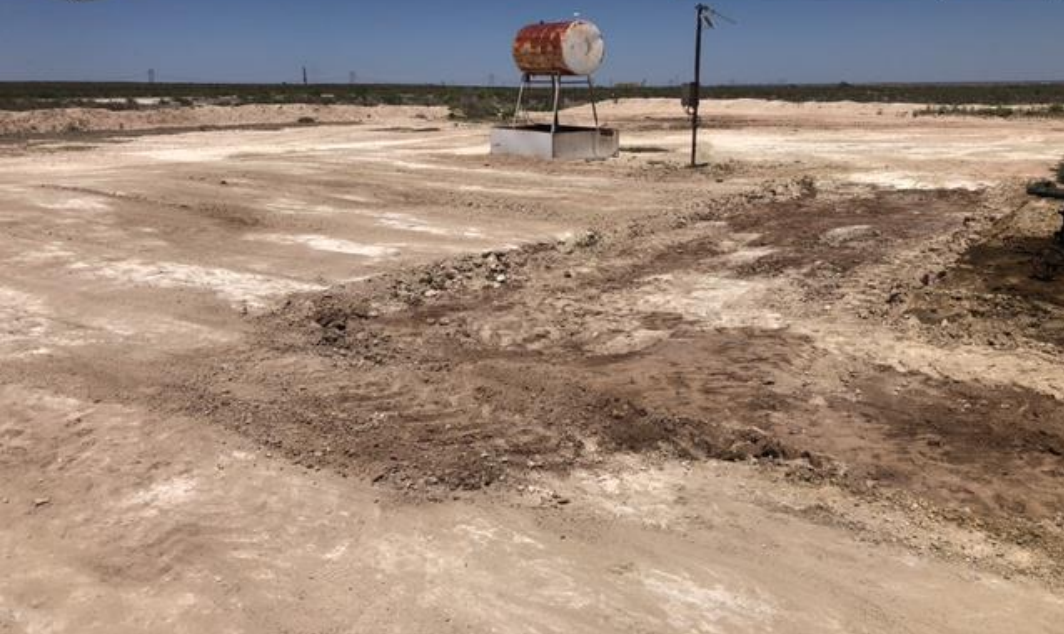
Photo Number: 8

<p>Jun 8, 2023 at 2:02:29 PM +32.647219,-104.461018 54° NE Eddy County</p>
Photo Direction: Northeast	
Photo Description: View of excavated area.

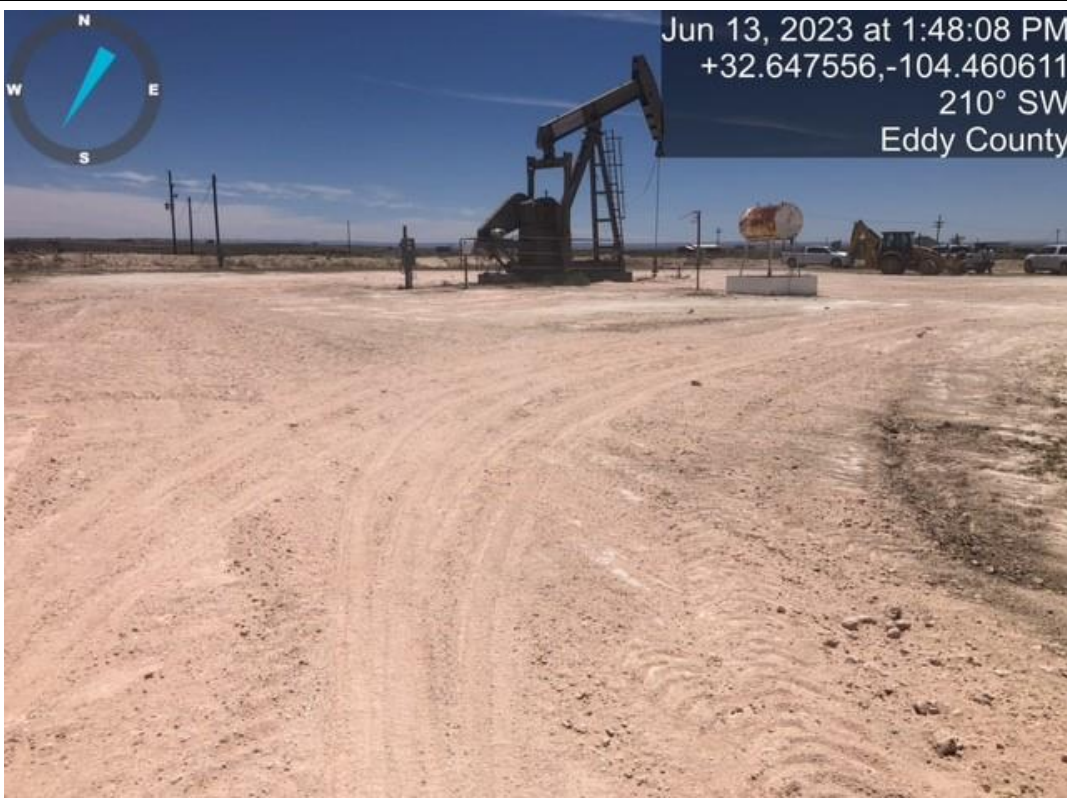
Photo Number: 9

Photo Direction: Southwest	
Photo Description: View of remediated area after backfill and grading.

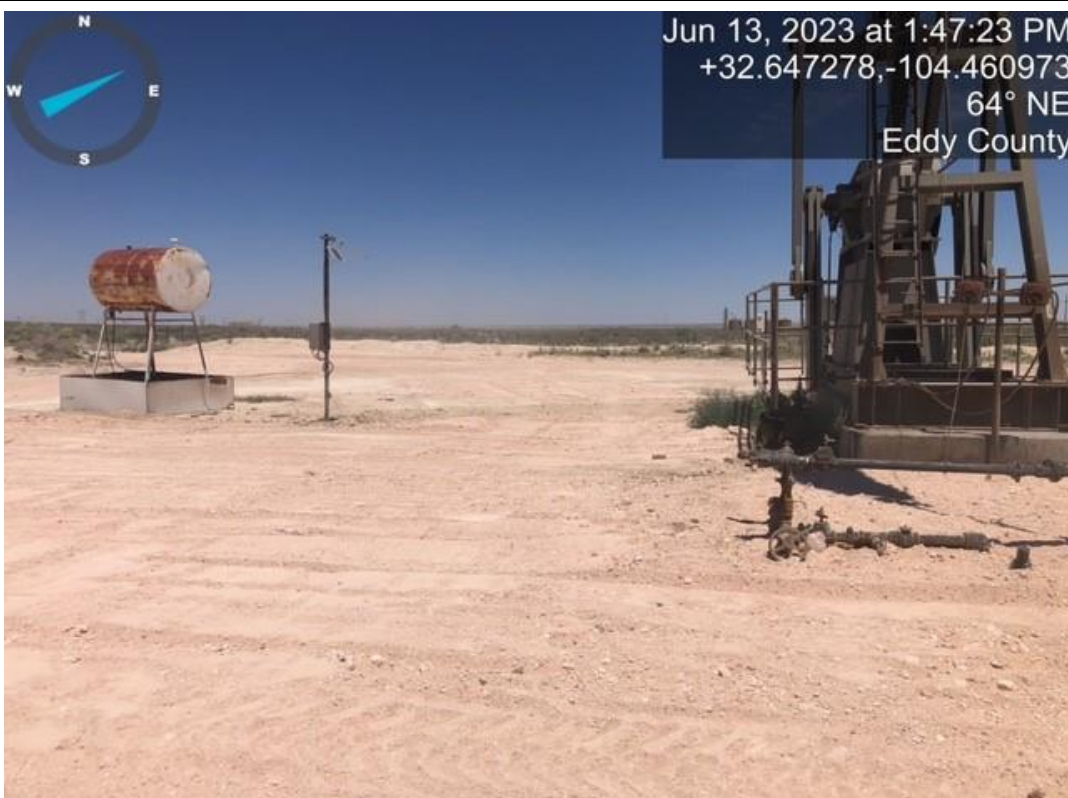
Photo Number: 11

<p>Jun 13, 2023 at 1:47:23 PM +32.647278,-104.460973 64° NE Eddy County</p>
Photo Direction: Northeast	
Photo Description: View of remediated area after backfill and grading.
