**Devon Energy Production Company, LP.
6488 Seven Rivers HWY
Artesia, NM 88210
575-748-0167**

May 15, 2024

**Re: Site Characterization and Remediation Plan Report
Regulus 26 Fed 5H Wellpad
API No. 30-015-42489
GPS: Latitude 32.637432 Longitude -103.833465
UL -- A, Sec. 26, T19S, R31E Eddy County, NM
NMOCD Incident IDs. nRM2026532878 & nAPP2118853816**

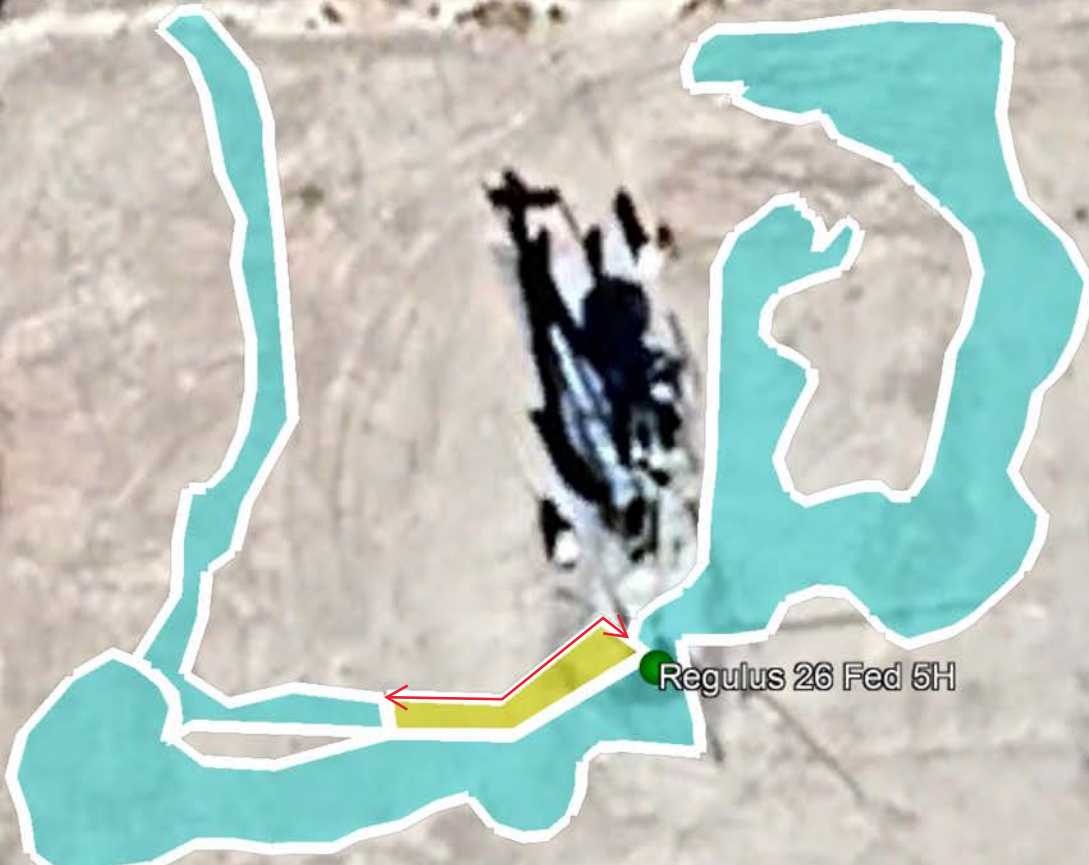
3' Excavation - 204 sqft 23 cu yds

- Submit a one-call through the NM811 system.
- The estimated total combined volume of soil to be remediated is approximately 208 cubic yards. Approximately 1' of soil will be excavated from a 4,988 square foot area. Approximately 3' of soil will be excavated from a 204 square foot area. A Combined Excavation Map can be found in Figure 5.
