**Re: Remediation Report and Closure Request
Maverick Permian, LLC
Vacuum Abo Battery #4 Trunkline
Unit Letter D, Section 35, Township 17 South, Range 35 East
Lea County, New Mexico
Incident IDs# nJXK1616547061 and nRM2003534693**

Remediation Report and Closure Request
Maverick Permian, LLC
Vacuum Abo Battery #4 Trunkline Releases
Incident IDs: nJXK1616547061 & nRM2003534693

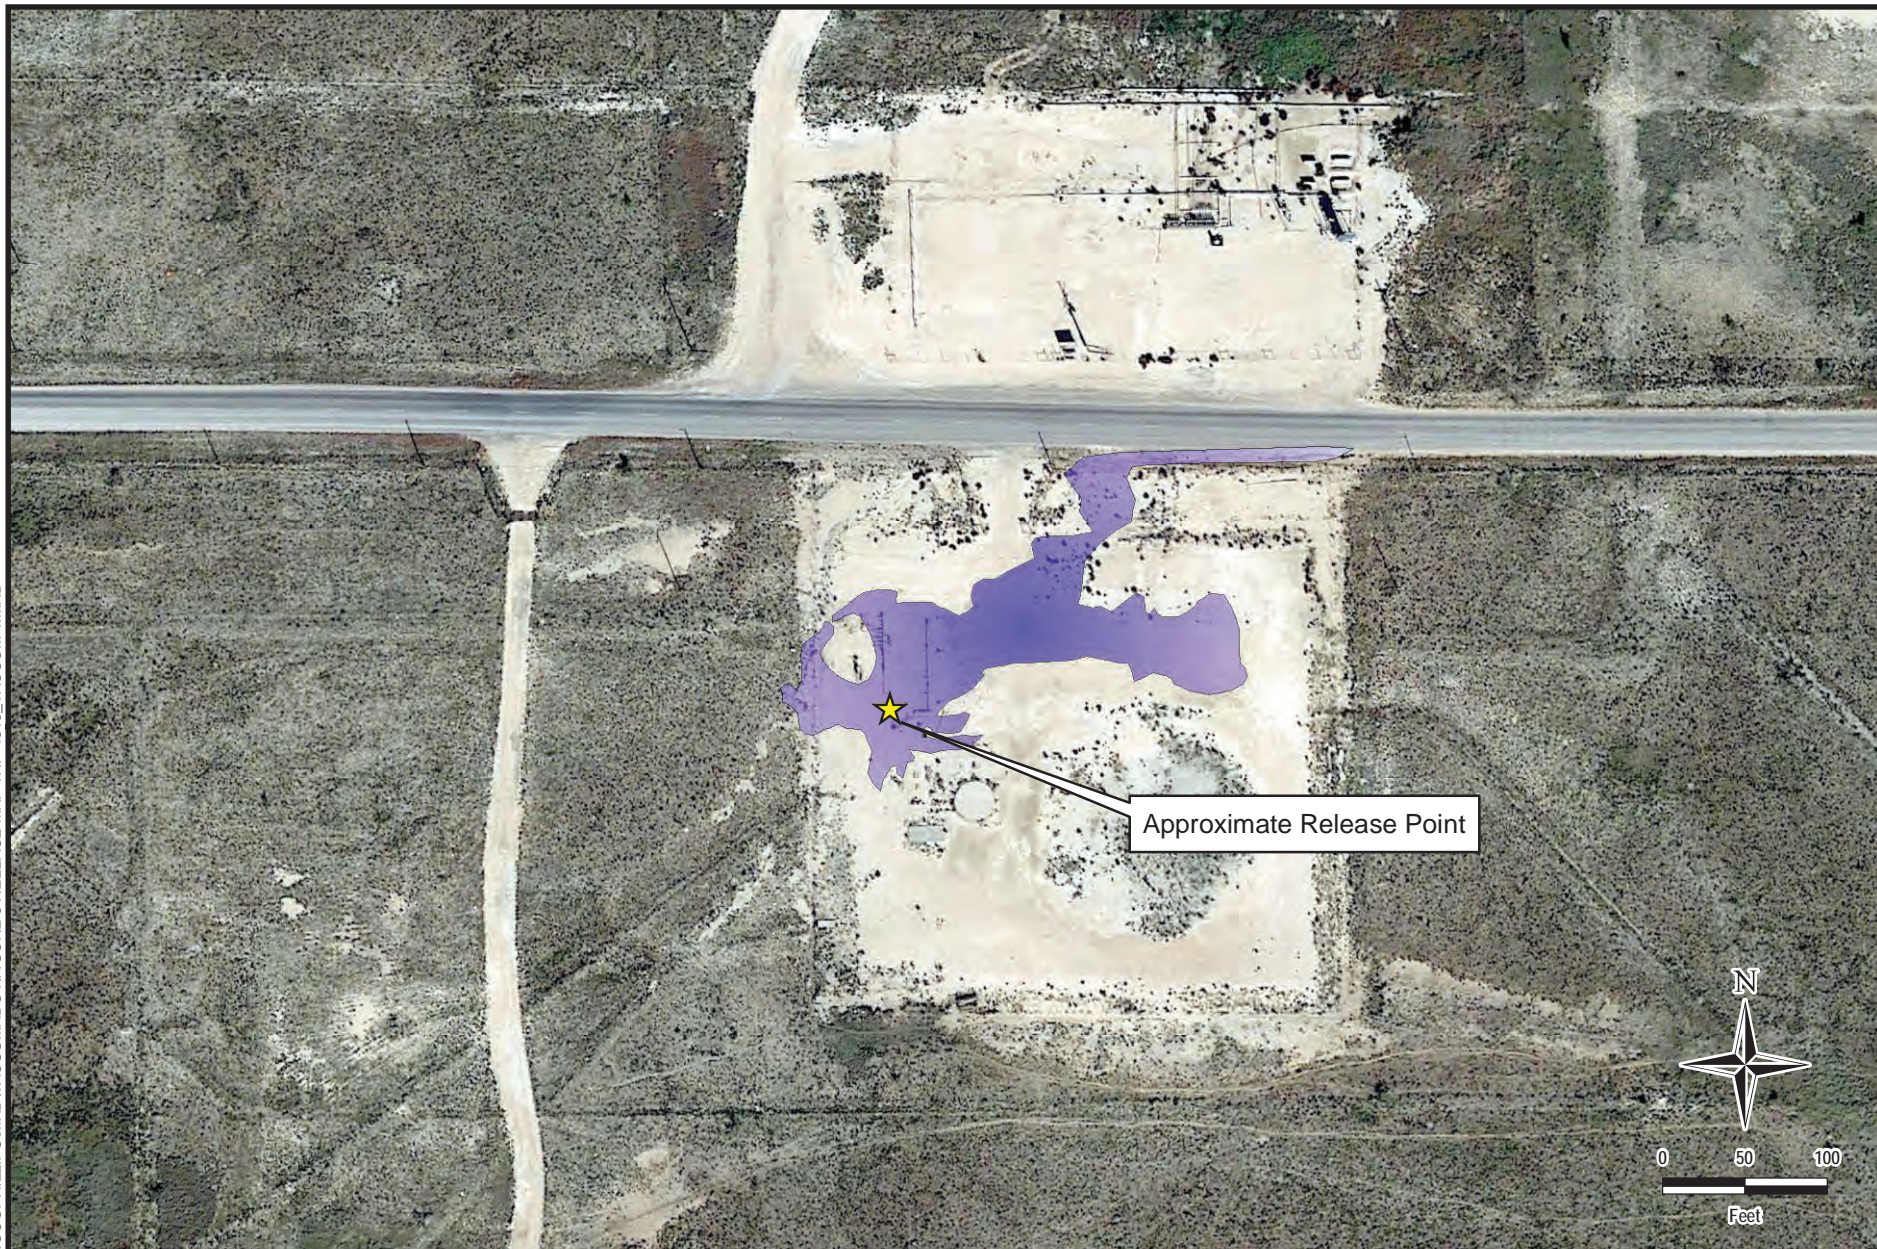
3A

According to the State of New Mexico C-141 Initial Report, the release was discovered on June 11, 2016, occurring as the result of a buried trunkline on the south side of County Road (CR) 50. The release consisted of 38 barrels (bbls) of produced water, of which 25 bbls were recovered with a vacuum truck. Immediate action was to shut in all manual header valves. The NMOCDD received notification of the release on June 13, 2016, and the release was subsequently assigned Incident ID nJXK1616547061. The approximate release extent is presented in **Figure 3A**.

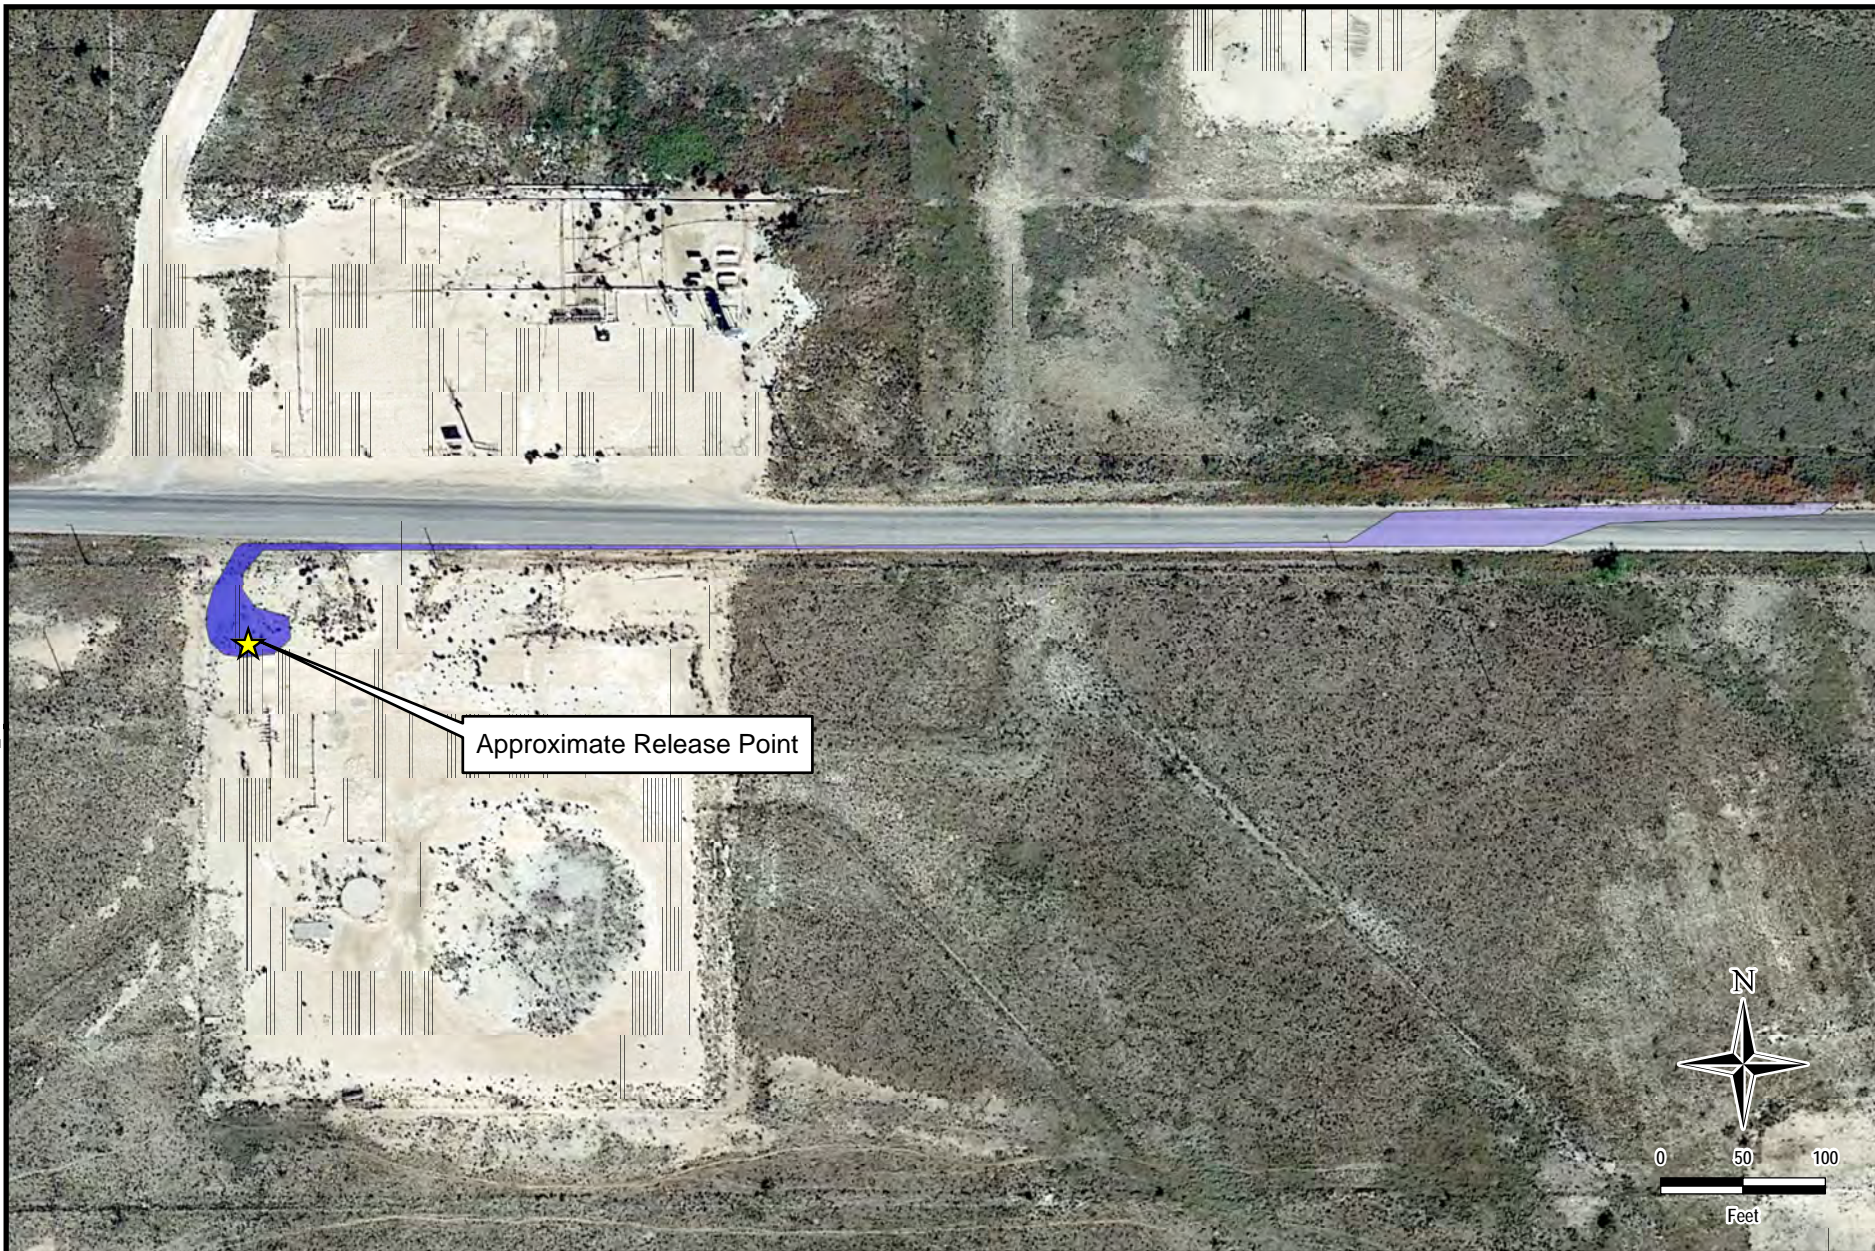
3B

According to the State of New Mexico C-141 Initial Report, on December 30, 2019, a release occurred from a trunkline at the Vacuum Abo Battery #4. The release consisted of approximately 0.713 barrels (bbls) of oil and 27.791 bbls of produced water, of which 1 bbl of produced water was recovered. The release traveled up from the subsurface trunk line, off of the Vacuum Abo Battery #4 pad north into the ditch on the southern side of CR 50, then to the east along the ditch until it reached a point where it pooled and crossed the highway. The approximate release extent is presented in **Figure 3B**.
