Re: Site Assessment, Remediation, and Closure Request
Noose Fed Com #10H
API No. 30-015-42500
GPS: Latitude 32.6101608 Longitude -104.4551849
UL "O", Sec. 35, T19S, R25E
Eddy County, NM
NMOCD Ref. No. nAPP2111859050

Paragon Environmental, LLC (Paragon) has been contracted by Spur Energy Partners (Spur) to perform a spill assessment and conduct remediation activities for the release site known as the Noose Fed Com #10H (Noose). Details of the release are summarized below:

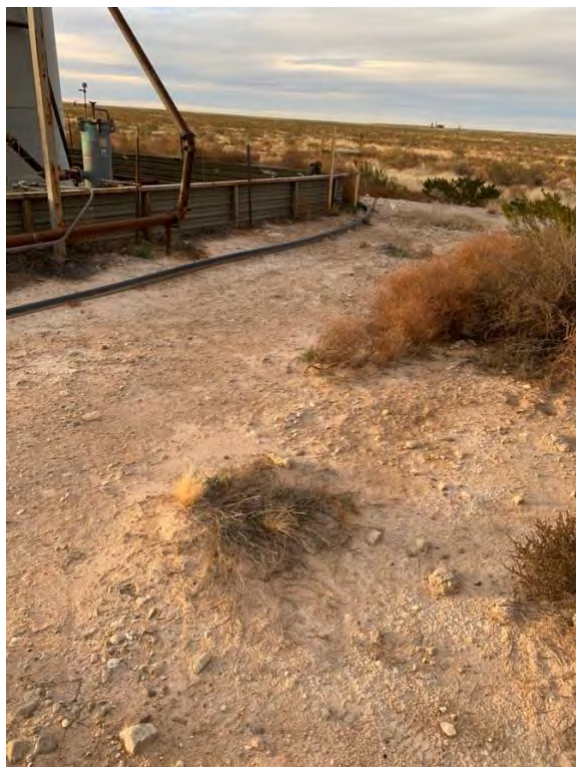
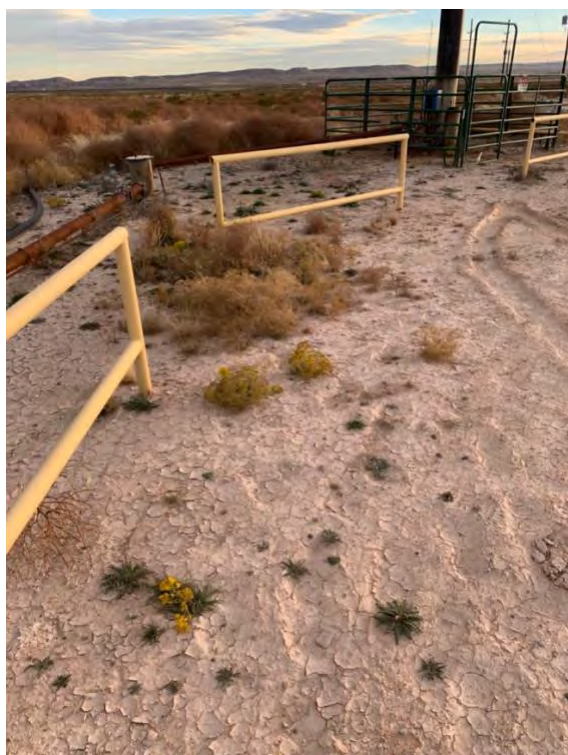
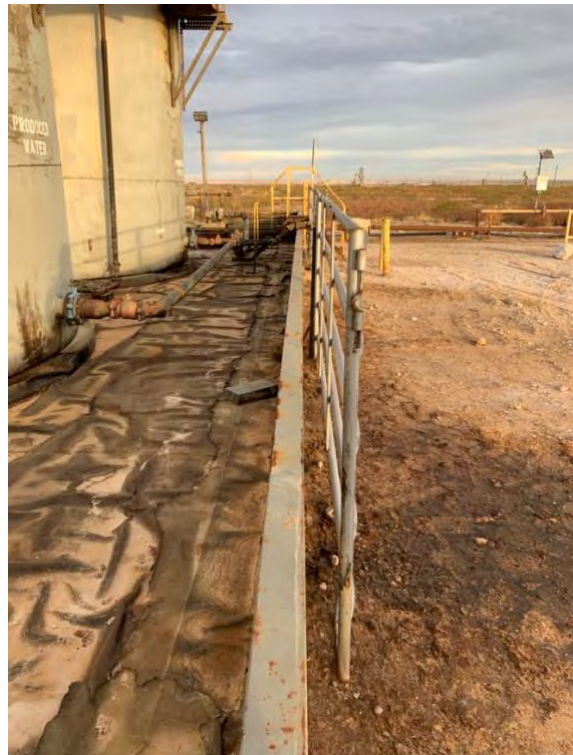
Before Remediation

Release Details			
Type of Release:	Crude Oil & Produced Water	Volume of Release:	42.6 bbls
		Volume Recovered:	40 bbls
Source of Release:	Transfer Pump	Date of Release:	4/25/21
Was Immediate Notice Given?	Yes	If, Yes, to Whom?	NMOCD
Was a Watercourse Reached?	No	If Yes, Volume Impacting Watercourse:	N/A
Surface Owner:	Federal	Mineral Owner:	Federal
<p>The PLC had a communication error causing false tank readings and no alarm was sent out. This caused the transfer pump not to come on, and the water tank ran over. A Vacuum truck was immediately dispatched to recover all standing fluids. Alarm issue was repaired.</p>

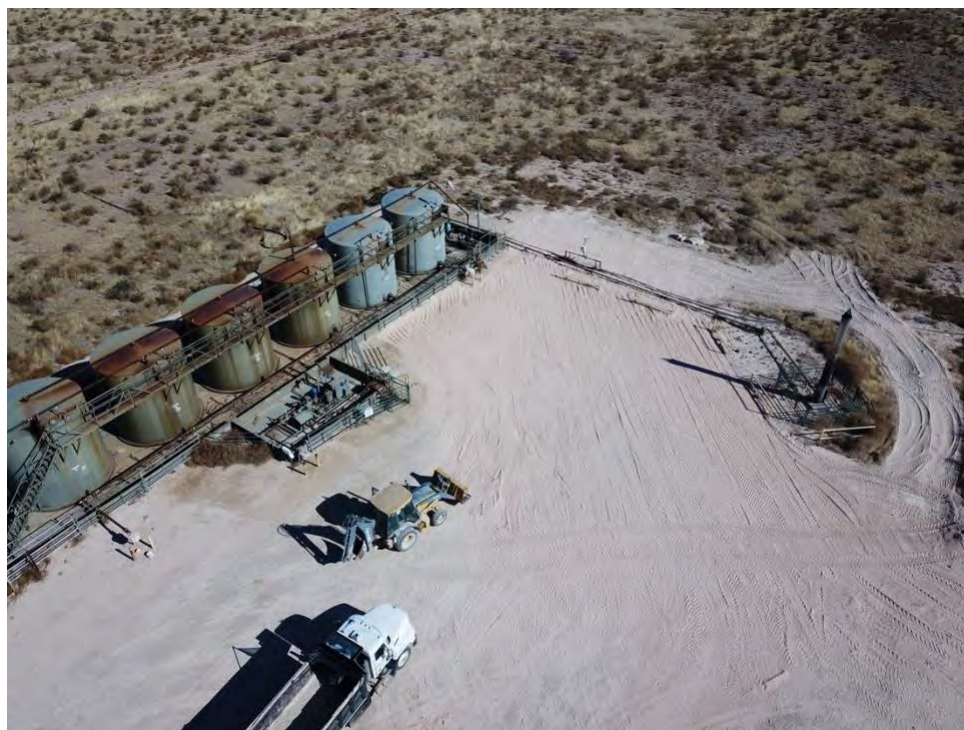
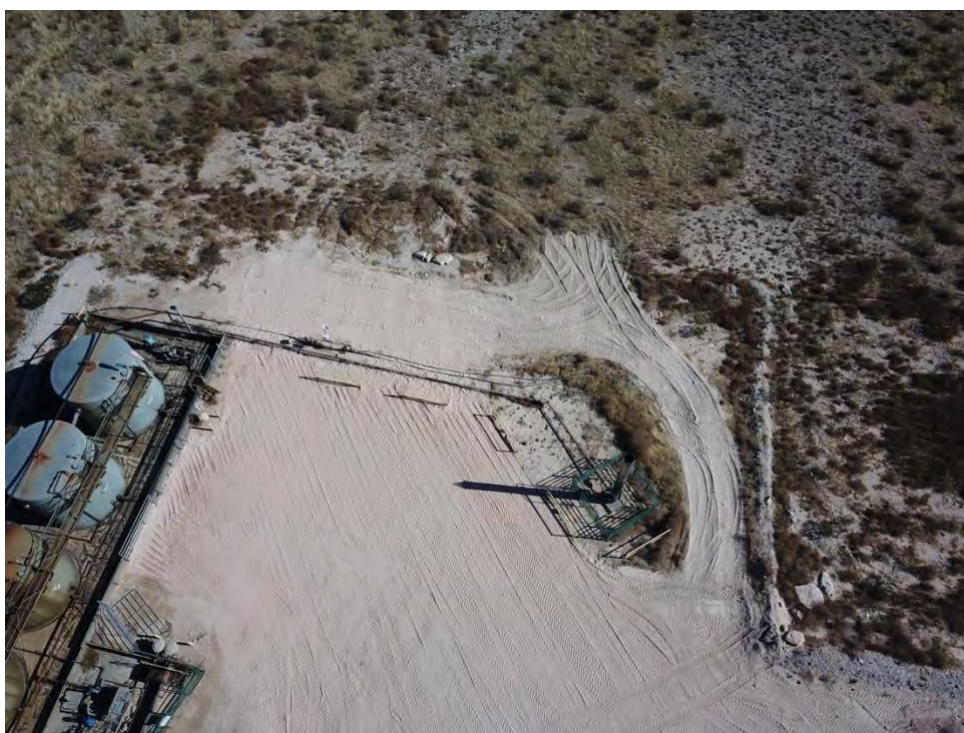
Completed

Summarize any additional remediation activities not included by answers (above)	ALL CONTAMINATED SOIL REMOVED TO THE MOST STRINGENT STANDARD AND LINER INSPECTION FOUND LINER TO BE ABLE TO CONTAIN FLUIDS

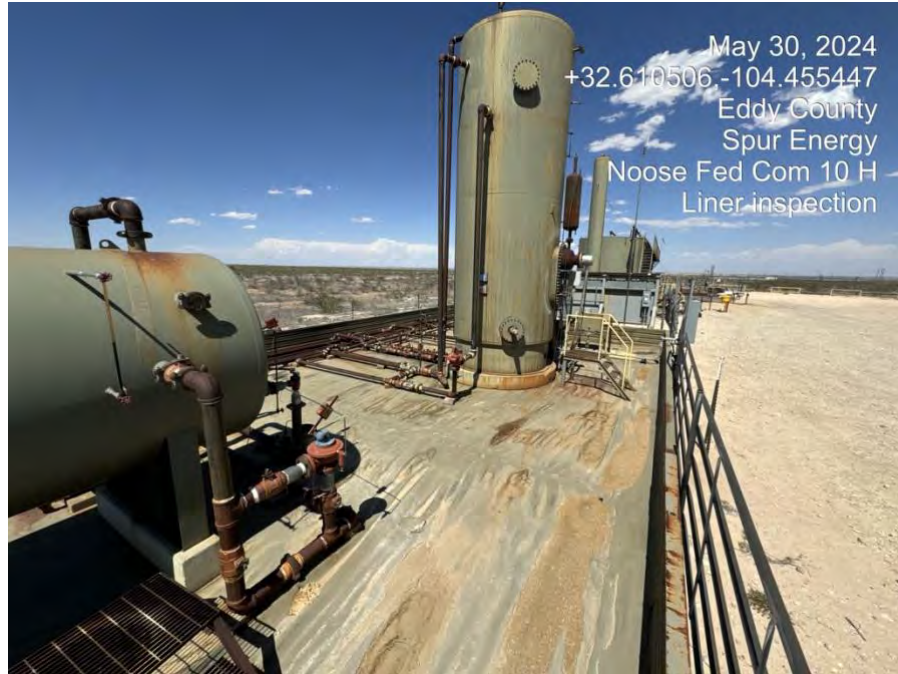
Liner Inspection

The NMOCD advised Spur the initial closure report had been rejected. On May 28, 2024, Paragon submitted a notification that we would be conducting a liner inspection at this facility on May 30, 2024. The notification and results of the inspection can be found in Appendix C.

Visualization	Yes	No	Comments
Is there a tear in the liner?		x	
Are there holes in the liner?		x	
Is the liner retaining any fluids?		x	
Does the liner have integrity to contain a leak?	x
