**Re: Closure Report**  
**Longview Federal 1 #44H**  
**Unit P, S01, T23S, R28E**  
**Site Coordinates: 32.32916667, -104.03416667**  
**Eddy County, New Mexico**  
**Incident ID: nAPP2324024755**

On behalf of Devon Energy Production Company (Devon), New Tech Global Environmental, LLC (NTGE) has prepared this closure report to document site assessment, remedial action, and sampling activities at the Longview Federal 1 #44H (Site) for submittal to the New Mexico Oil Conservation Division (NMOCD) District 2 Office in Artesia, New Mexico. The Site is located in Unit P, Section 01, Township 23 South of Range 28 East in Eddy County, New Mexico. The site location with respect to the nearest town is shown in Figure 1 and the topography of the area is shown in Figure 2.

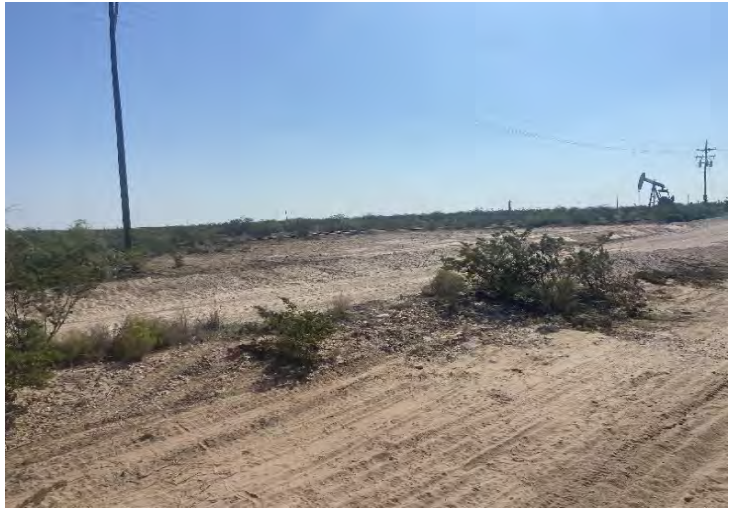
**Description:**  
Area of concern.

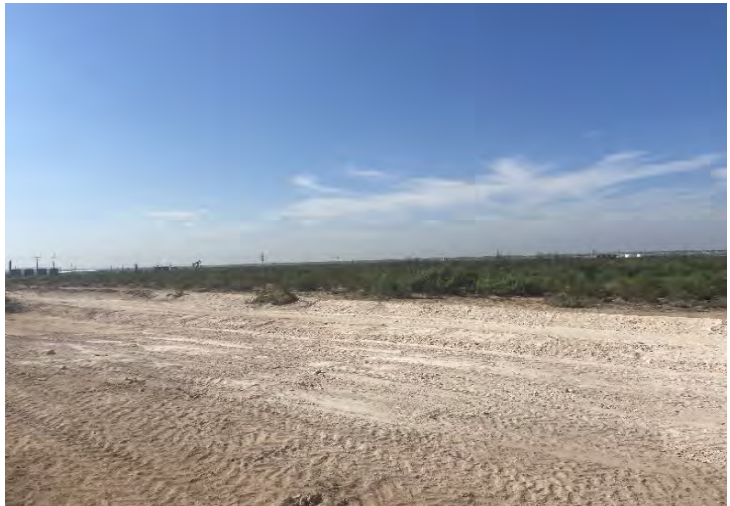
#### Photograph No. 2

**Description:**  
Area of concern.

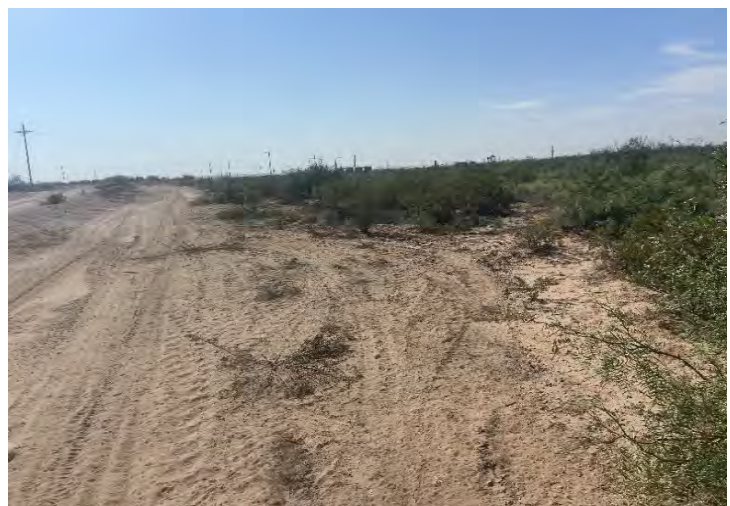
#### Photograph No. 3

**Description:**  
Area of concern.

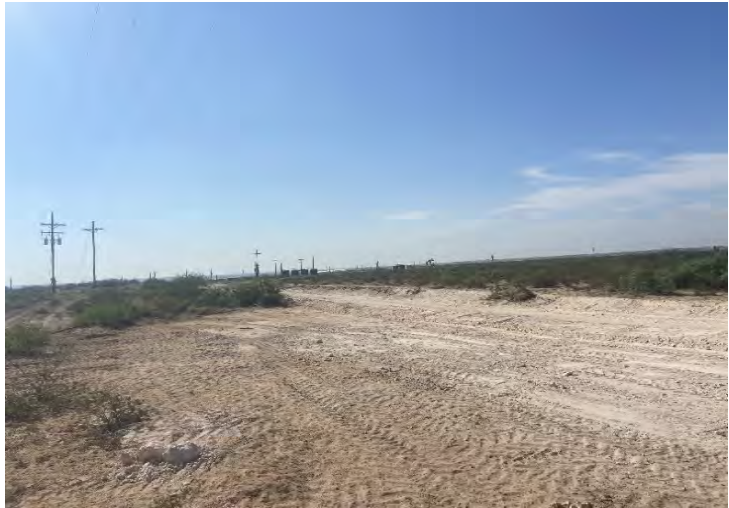
**Description:**  
Area of concern.

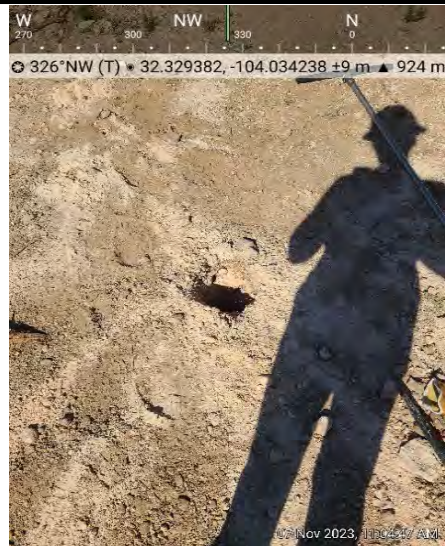
**Photograph No. 5**

**Description:**  
Area of concern.

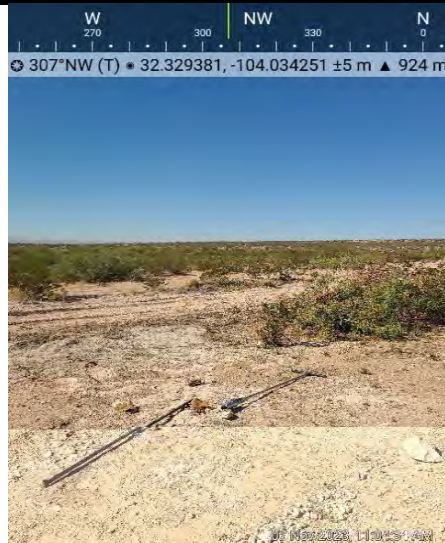
**Photograph No. 6**

**Description:**  
Area of concern.

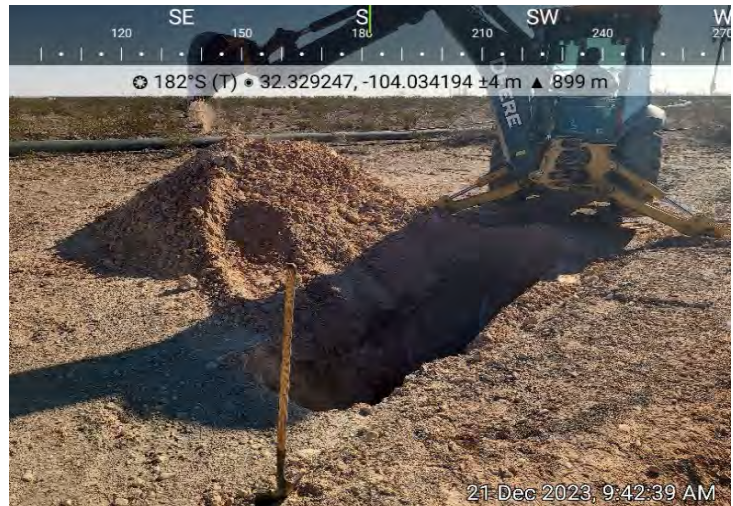
**Photograph No. 8**

**Description:**  
Area of concern.

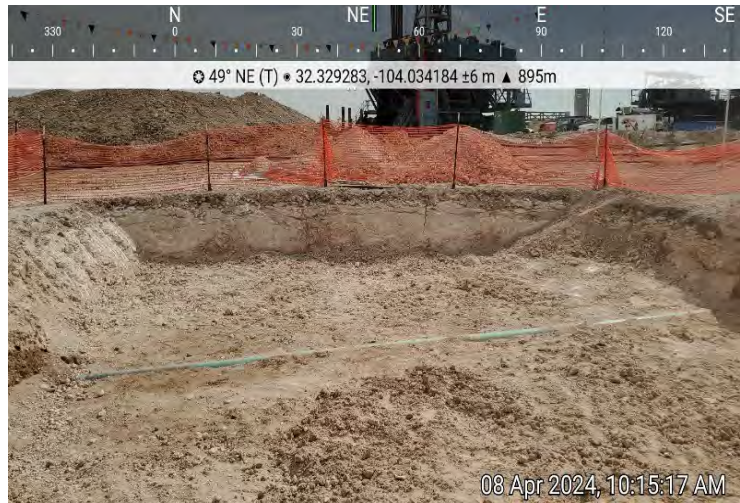
**Description:**  
Area of concern.

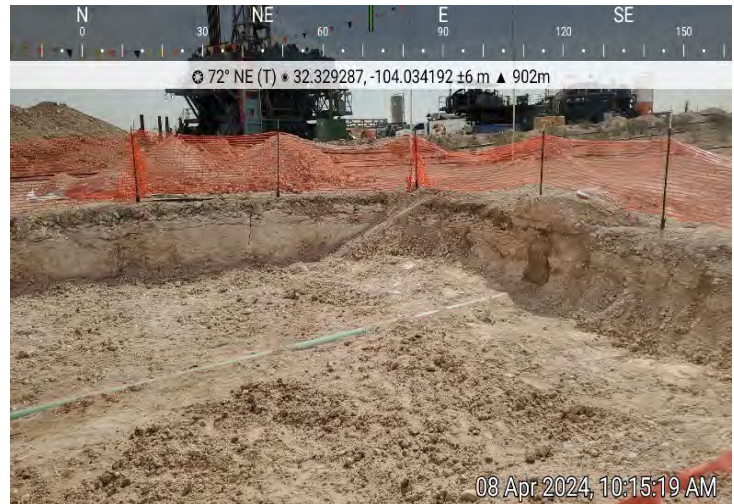
**Photograph No. 11**

**Description:**  
Area of concern.

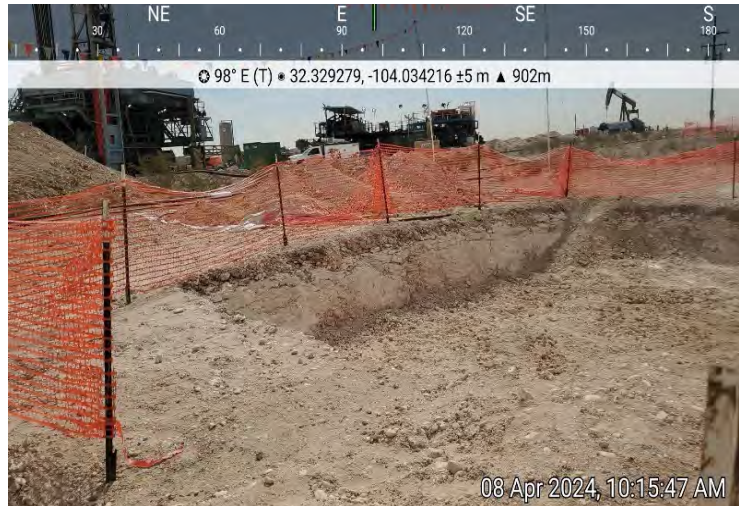
**Description:**  
Area of concern.

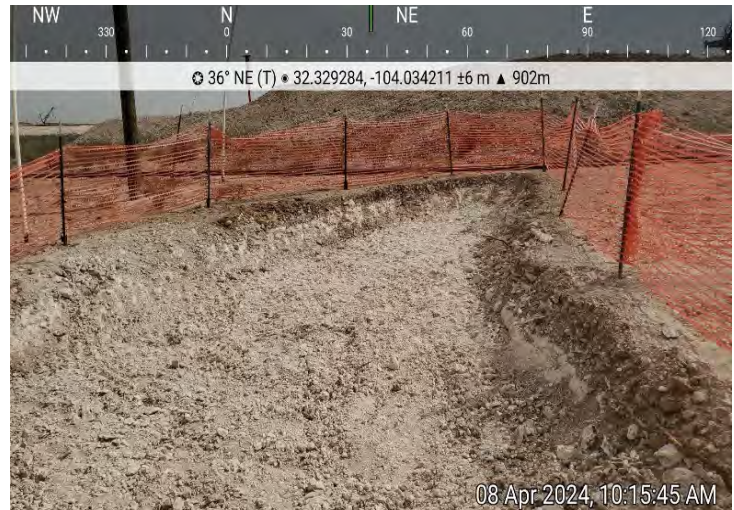
**Photograph No. 14**

**Description:**  
Area of concern.

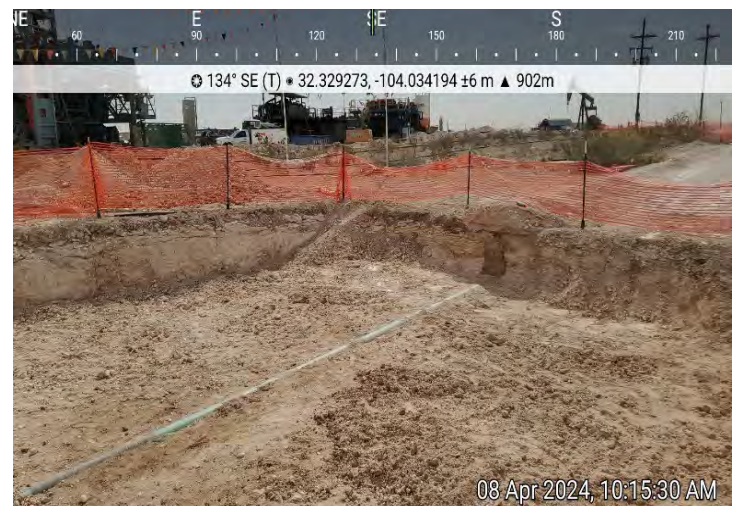
**Photograph No. 15**

**Description:**  
Area of concern.
