Remediation Summary & Soil Closure Request

XTO Energy, Inc. Poker Lake Unit 274

Eddy County, New Mexico
Unit Letter "O", Section 12, Township 24 South, Range 29 East
Latitude 32.225808 North, Longitude 103.936977 West
NMOCD Reference No. nAPP2406461829

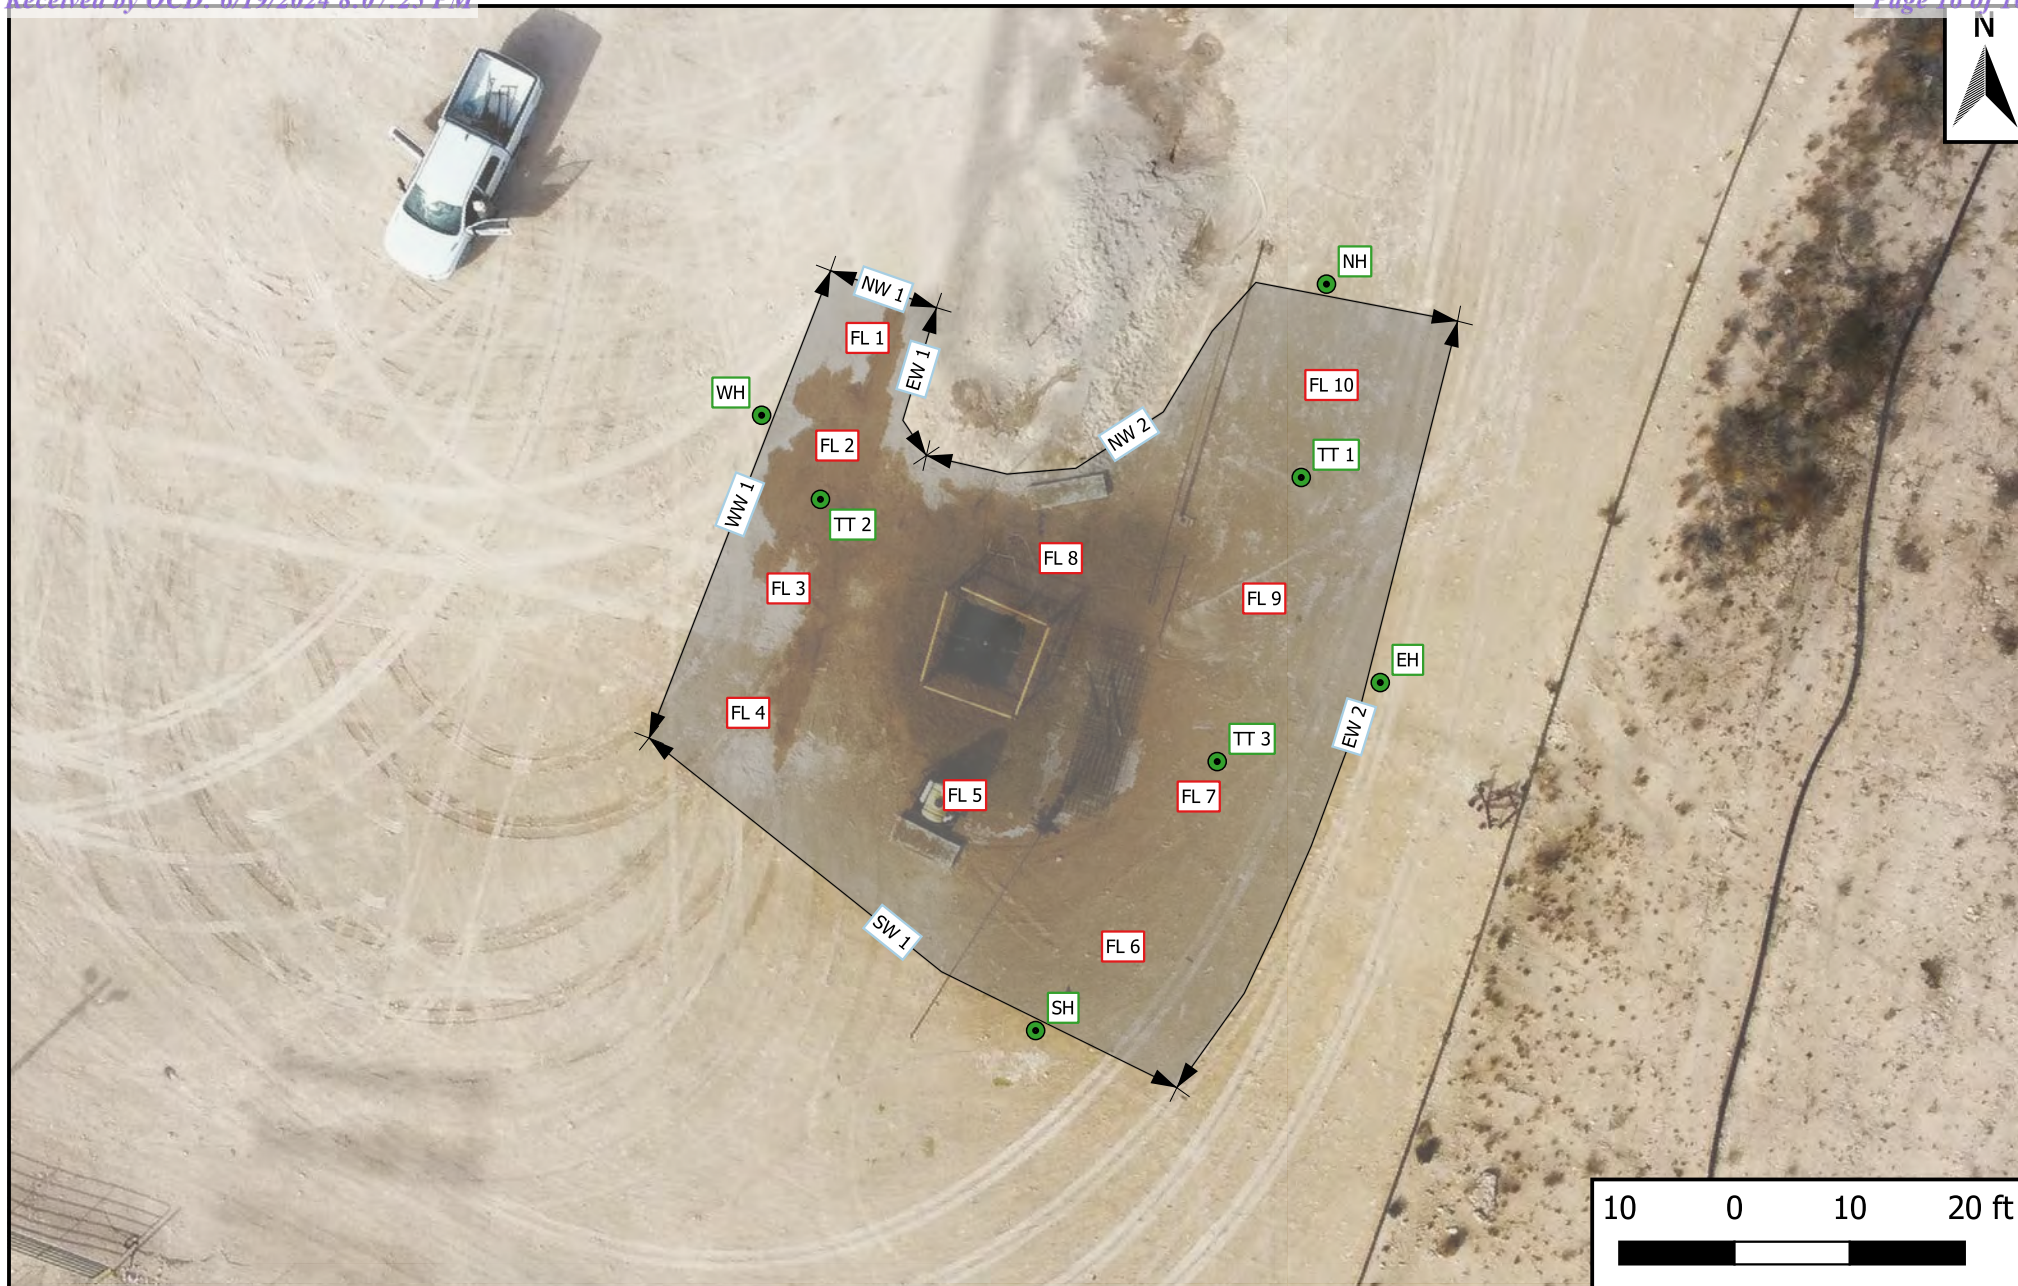
Figure 3

Sample Location Map

- Excavation Extent
- Composite Floor Sample
- Composite Wall Sample
- Delineation Sample Point

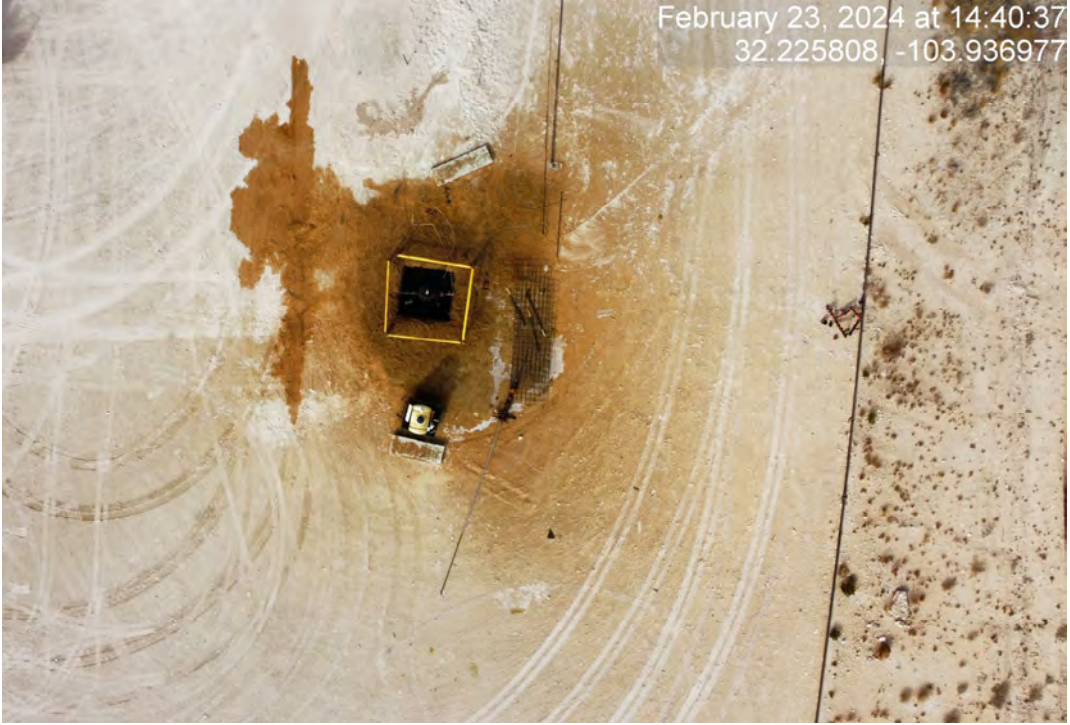
Photo Number: 1

Photo Direction: Overhead/Bird's Eye	
Photo Description: View of the affected area.

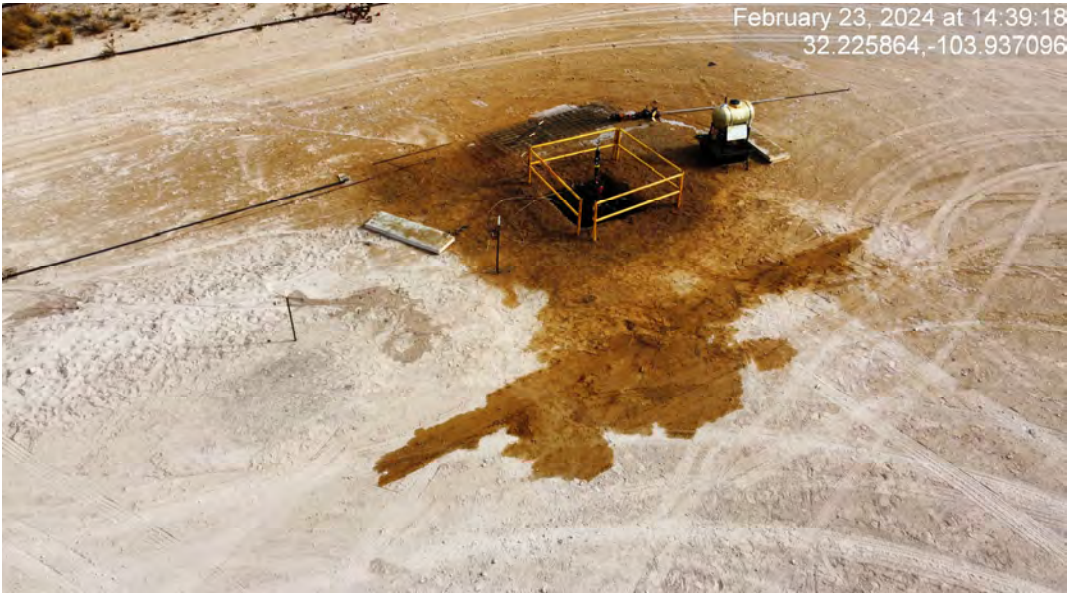
Photo Number: 2

Photo Direction: Southeast	
Photo Description: View of the affected area.

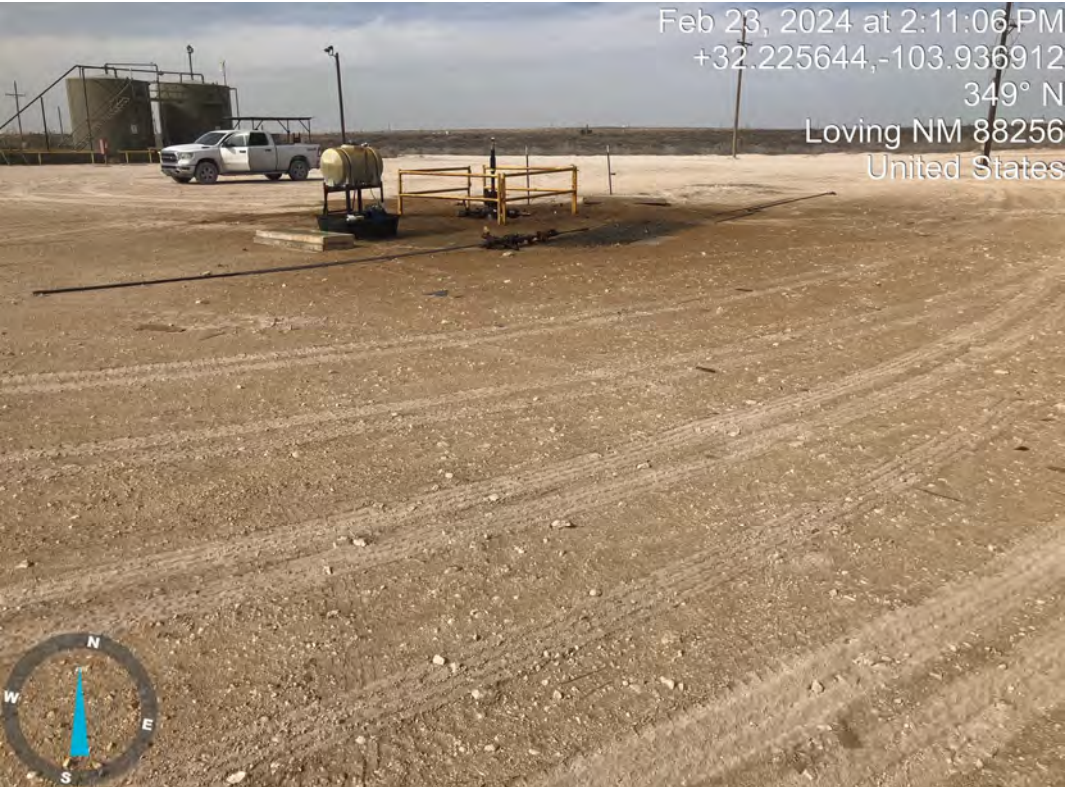
Photo Number: 4	<div>Feb 23, 2024 at 2:11:06 PM +32.225644,-103.936912 349° N Loving NM 88256 United States</div>

<div>View of the affected area.</div>
Photo Direction: North	
Photo Description:

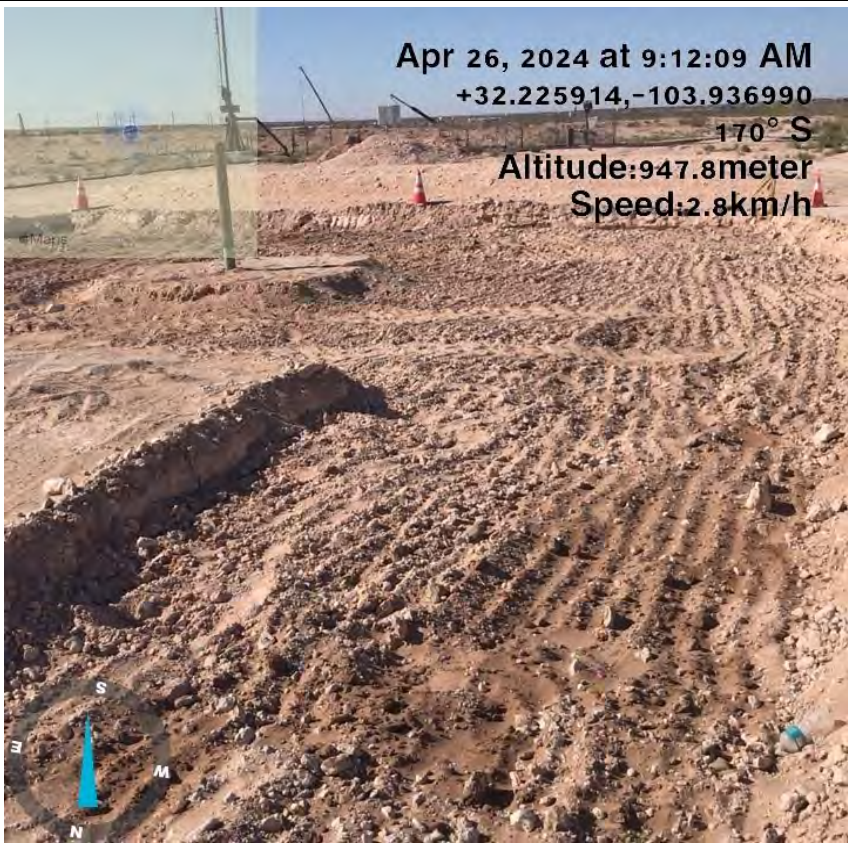
Photo Number: 5

<p>Apr 26, 2024 at 9:12:09 AM +32.225914,-103.936990 170° S Altitude: 947.8 meter Speed: 2.8 km/h</p>
Photo Direction: South	
Photo Description: View of the excavated area.

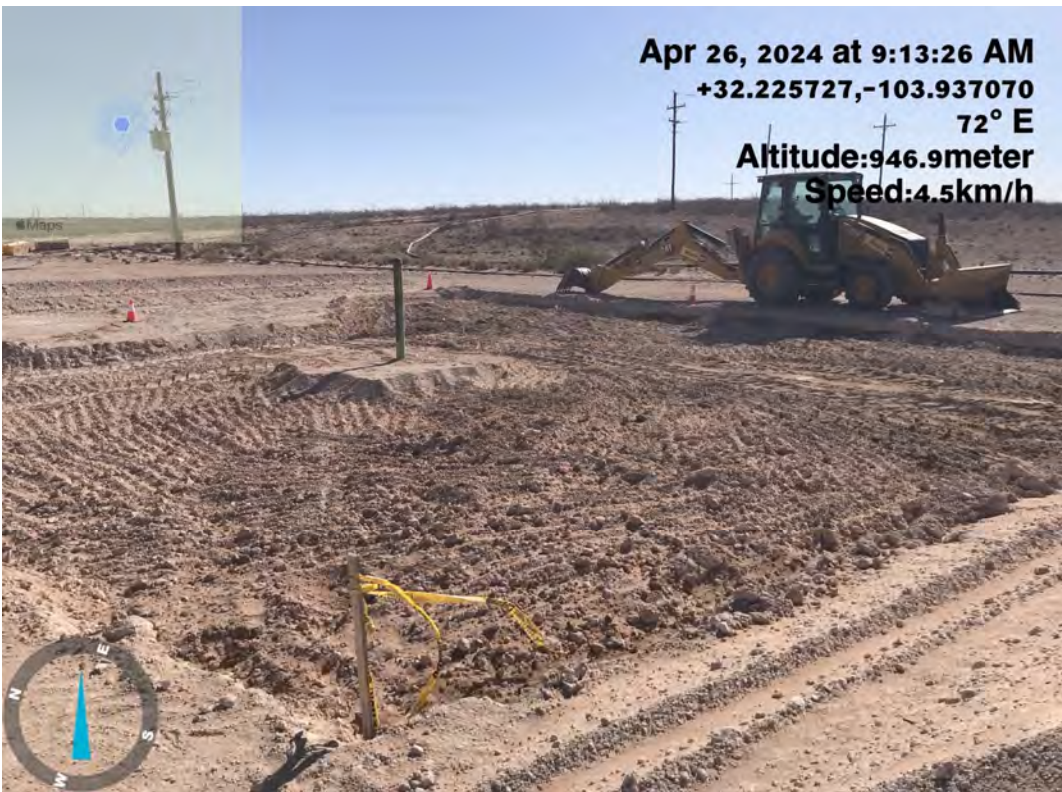
Photo Number: 6

<p>Apr 26, 2024 at 9:13:26 AM +32.225727,-103.937070 72° E Altitude: 946.9 meter Speed: 4.5 km/h</p>
Photo Direction: East-Northeast	
Photo Description: View of the excavated area.

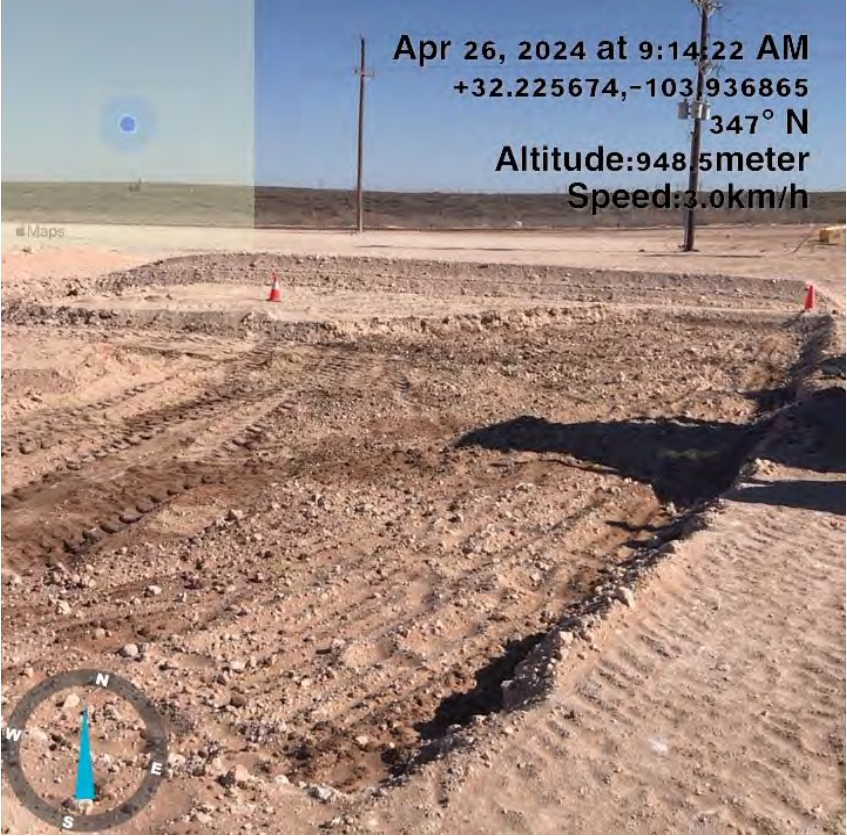
<div>Photo Number: 7</div>	<div>

<p>Apr 26, 2024 at 9:14:22 AM +32.225674,-103.936865 347° N Altitude:948.5meter Speed:3.0km/h</p><p>View of the excavated area.</p></div>
<div>Photo Direction: North-Northwest</div>	
<div>Photo Description:</div>

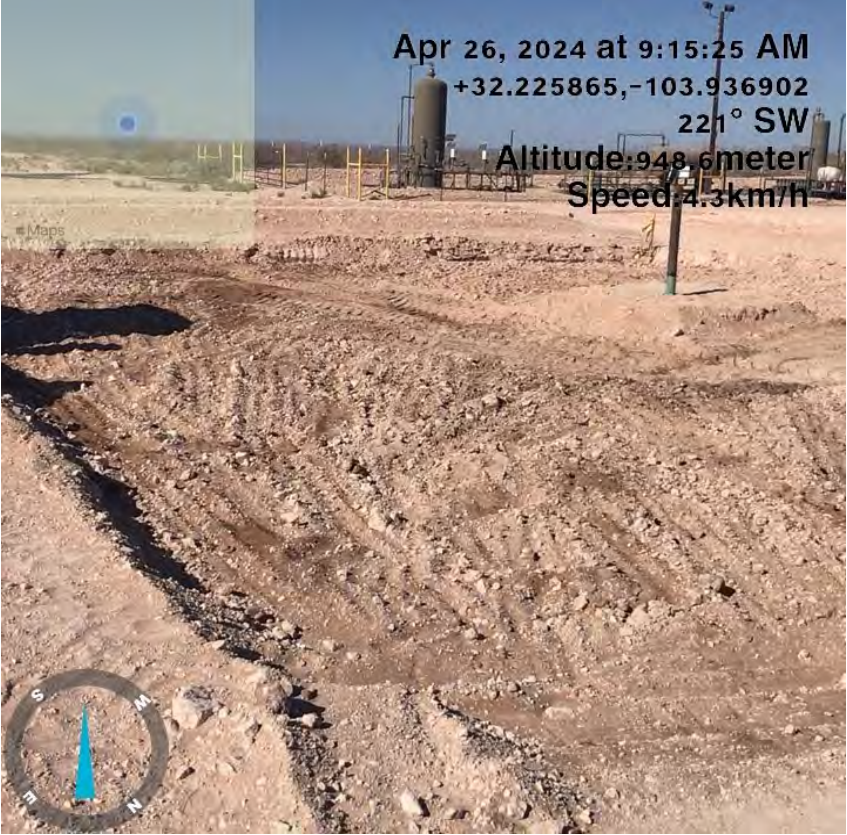
<div>Photo Number: 8</div>	<div>

<p>Apr 26, 2024 at 9:15:25 AM +32.225865,-103.936902 221° SW Altitude:948.6meter Speed:4.3km/h</p><p>View of the excavated area.</p></div>
<div>Photo Direction: Southwest</div>	
<div>Photo Description:</div>

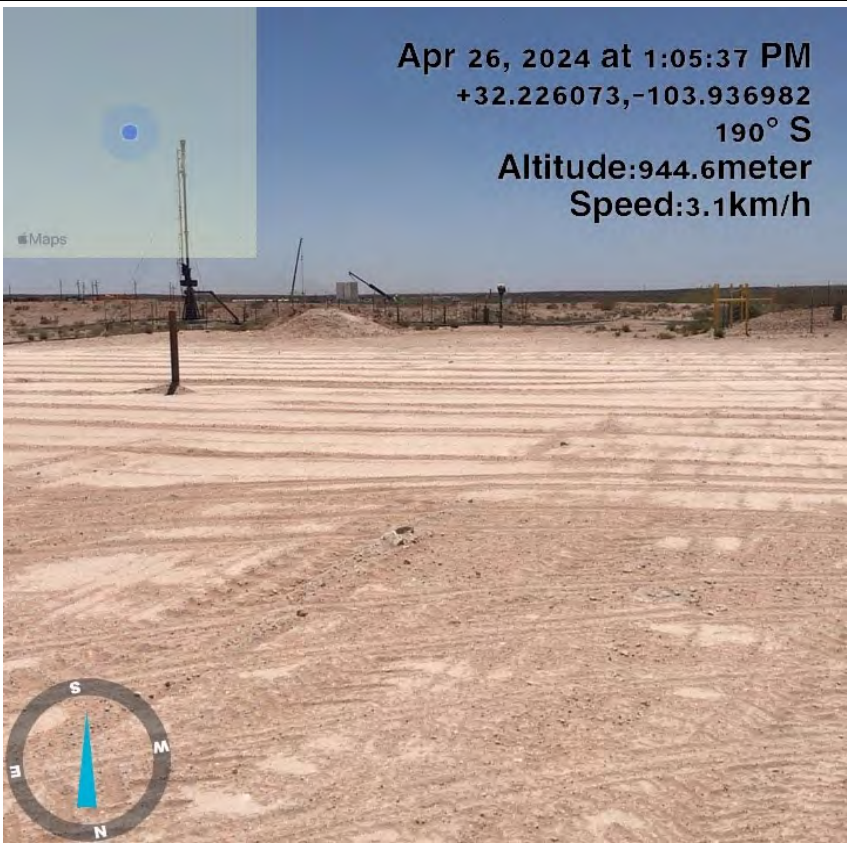
Photo Number: 9

<p>Apr 26, 2024 at 1:05:37 PM +32.226073,-103.936982 190° S Altitude:944.6meter Speed:3.1km/h</p>
Photo Direction: South	
Photo Description: View of the remediated area following backfilling and regrading.

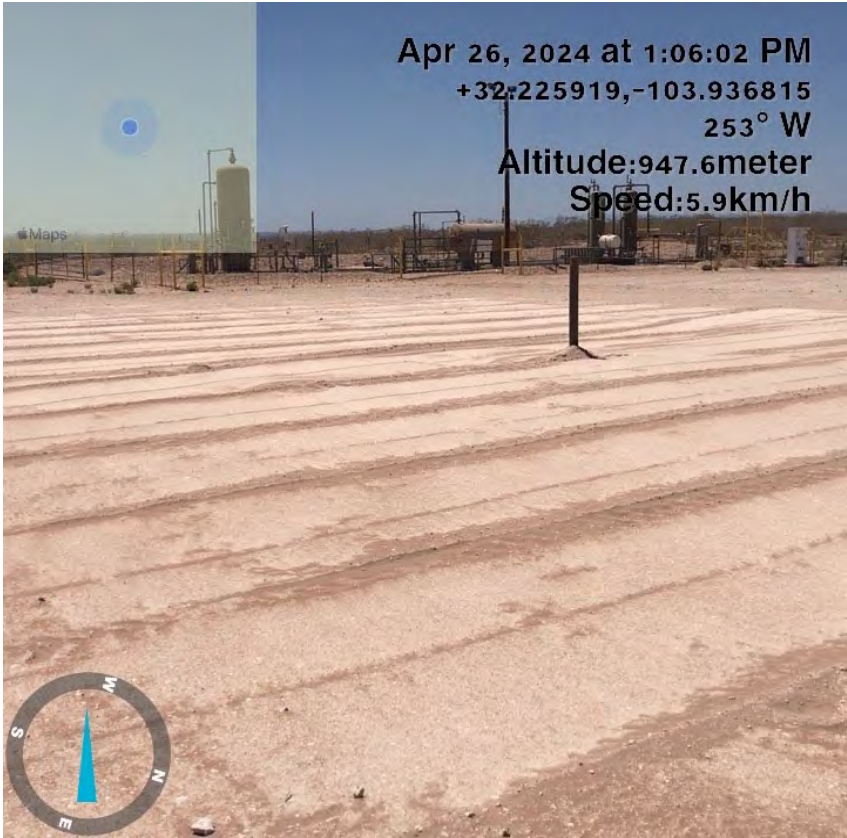
Photo Number: 10

<p>Apr 26, 2024 at 1:06:02 PM +32.225919,-103.936815 253° W Altitude:947.6meter Speed:5.9km/h</p>
Photo Direction: West-Southwest	
Photo Description: View of the remediated area following backfilling and regrading.
