Closure Report
Sebastian Federal Com 001H (04.29.24)
Lea County, New Mexico
Incident ID: NAPP2412045238
Unit D Sec 18 T24S R34E
32.2239°, -103.5158°

Crude Oil Release
Point of Release: Flare Fire
Release Date: 04.29.2024
Volume Released: 0.0237 barrels of Crude Oil
Volume Recovered: 0 barrels of Crude Oil

Re: Closure Report
Sebastian Federal Com 001H (04.29.24)
Concho Operating, LLC
Incident # NAPP2412045238
Site Location: Unit D, S18, T24S, R34E
(Lat 32.2239°, Long -103.5158°)
Lea County, New Mexico

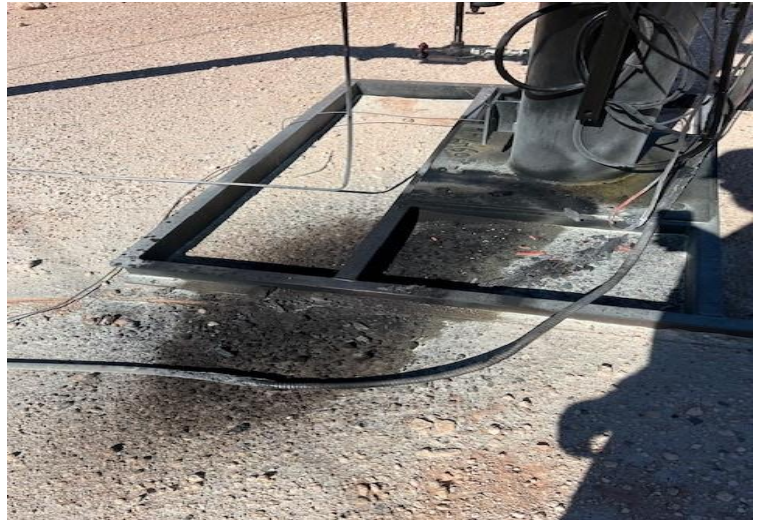
Photograph No. 1

View Southwest, area affected by flare fire.

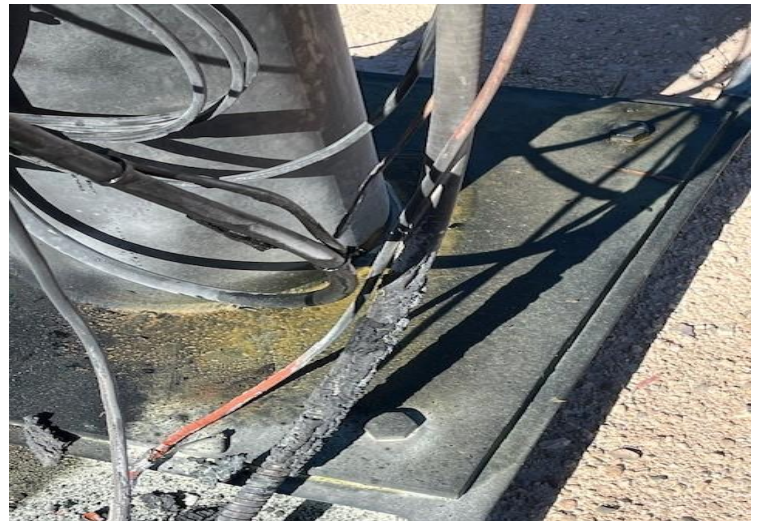
Photograph No. 2

View Southwest, area affected by flare fire.

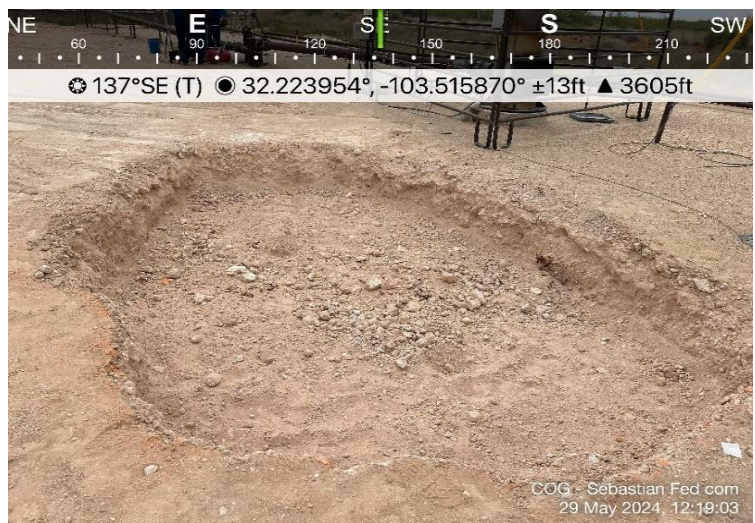
Photograph No. 3

View Southeast, area of CS-1 and CS-2.

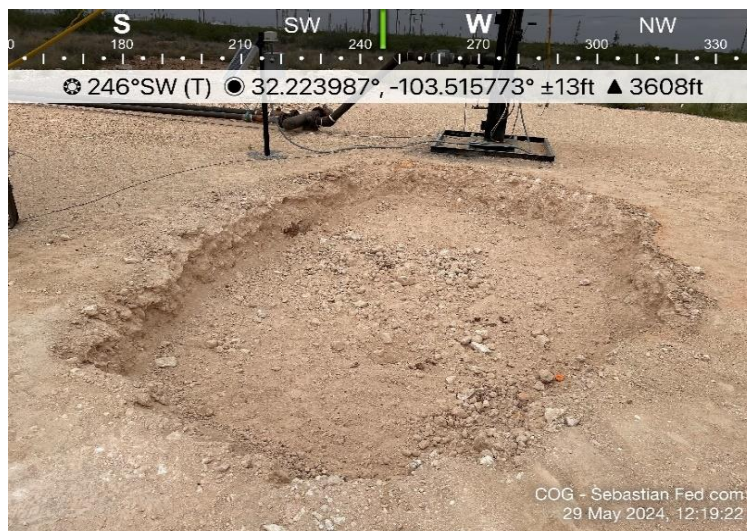
Photograph No. 4

View Southwest, area of CS-1 and CS-2.

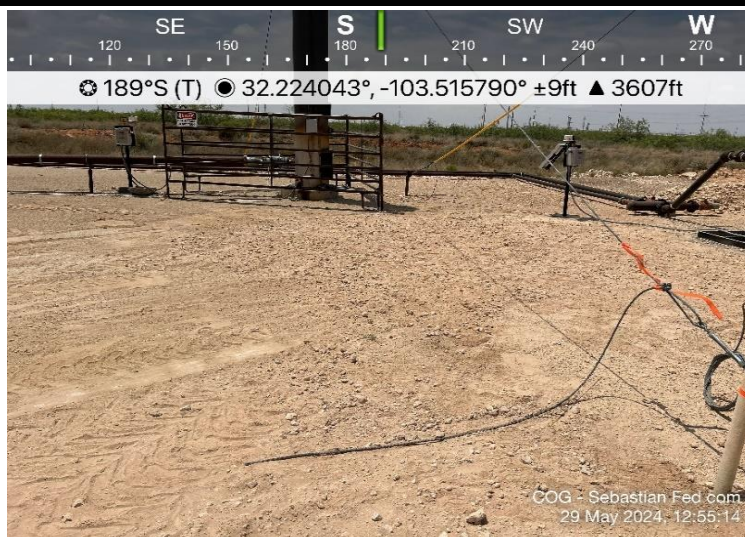
Photograph No. 5

View South, backfilled area.

Once the remediation activities were completed, the excavated areas were backfilled with clean material to surface grade. The material utilized for backfill was sourced from the Quail Ranch Delaware Basin Road Pit, located at GPS 32.231062, -103.512762. The pit sample was analyzed for TPH analysis by EPA method 8015 modified, BTEX by EPA Method 8021B, and chloride by EPA method 4500. Copies of laboratory analysis and chain-of-custody documentation are included in Appendix E.

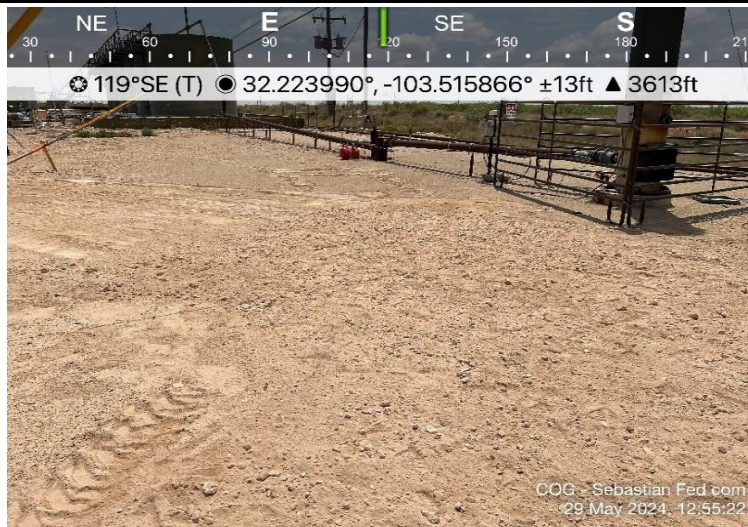
Photograph No. 6

View Southeast, backfilled area.

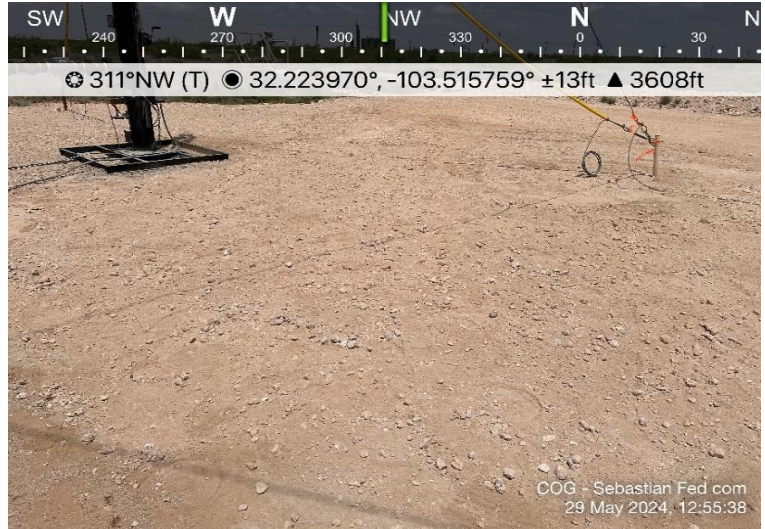
Photograph No. 7

View Northwest, backfilled area.
