June 18, 2024

**Re: Closure Report
ConocoPhillips (Heritage COG Operating, LLC)
SRO State Com #018H Flowline Release
Unit Letter A, Section 17, Township 26 South, Range 28 East
Eddy County, New Mexico
Incident ID nAB1719137895
2RP-4288**

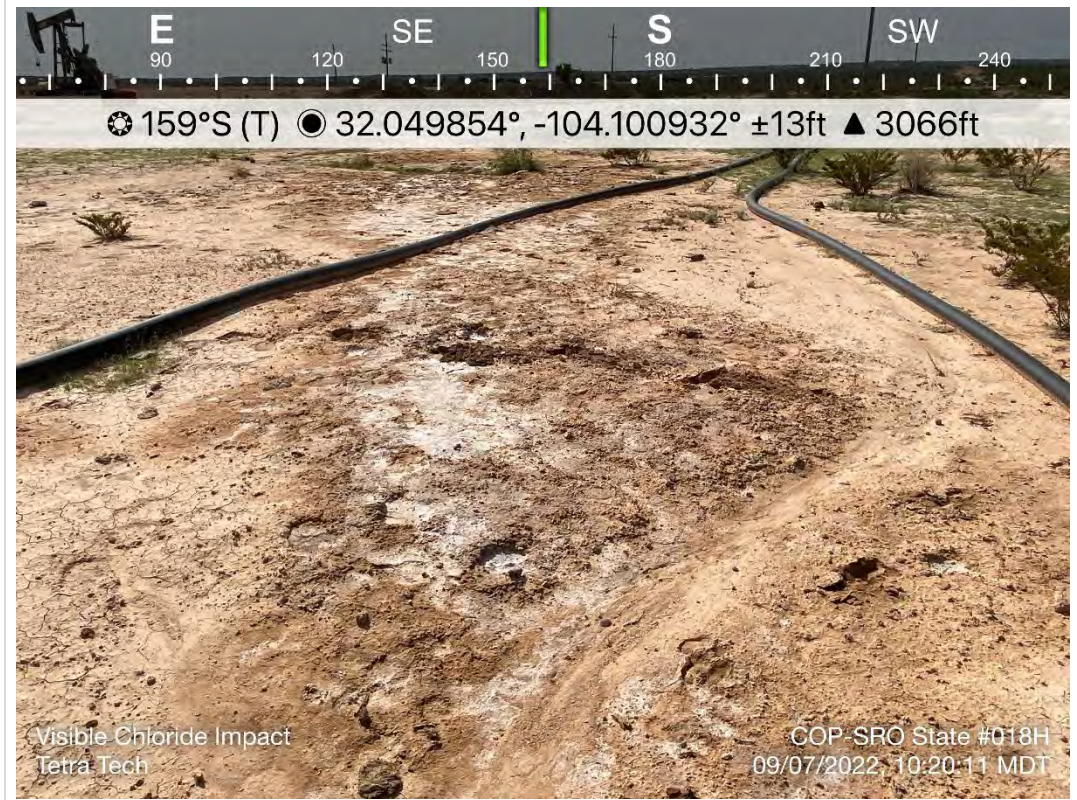
TETRA TECH, INC. PROJECT NO. 212C-MD-02826	DESCRIPTION	View south-southeast of surface flowlines. View of approximate release extent with visible chloride staining.	4
	SITE NAME	SRO State Com #018H Release	9/7/2022

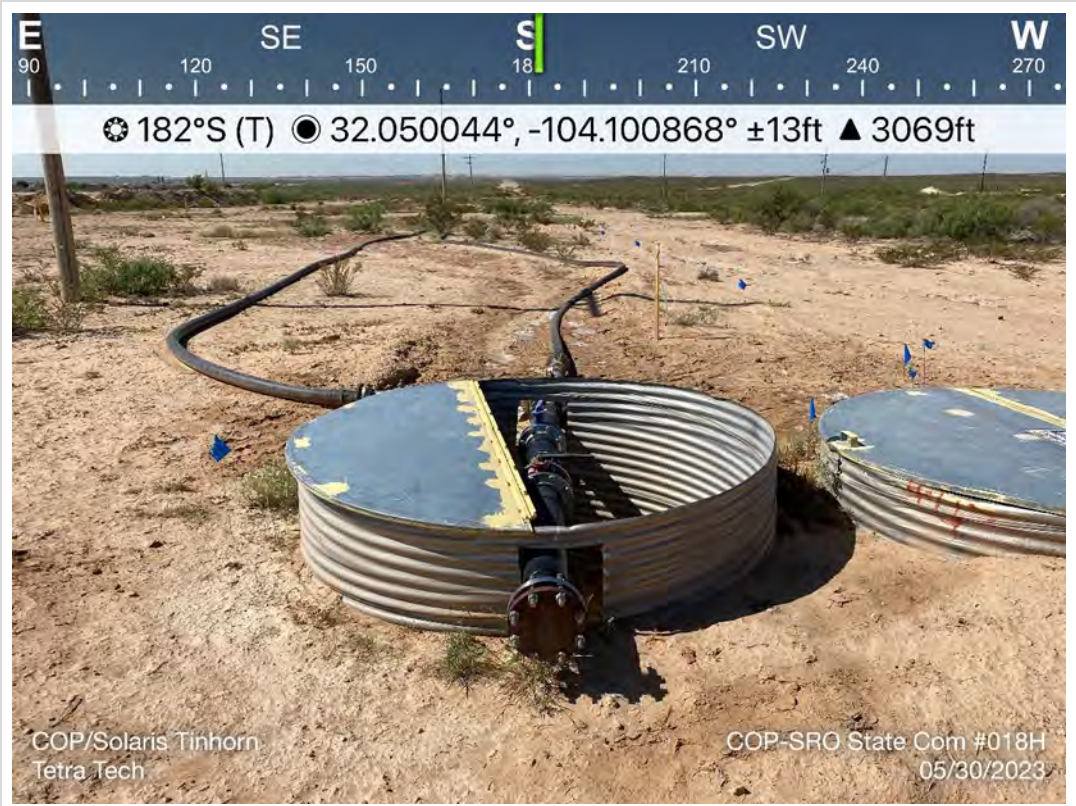
TETRA TECH, INC. PROJECT NO. 212C-MD-02826	DESCRIPTION	View south of valve can and surface flowlines. View of approximate release extent with visible chloride staining.	5
	SITE NAME	SRO State Com #018H Release	5/30/2023

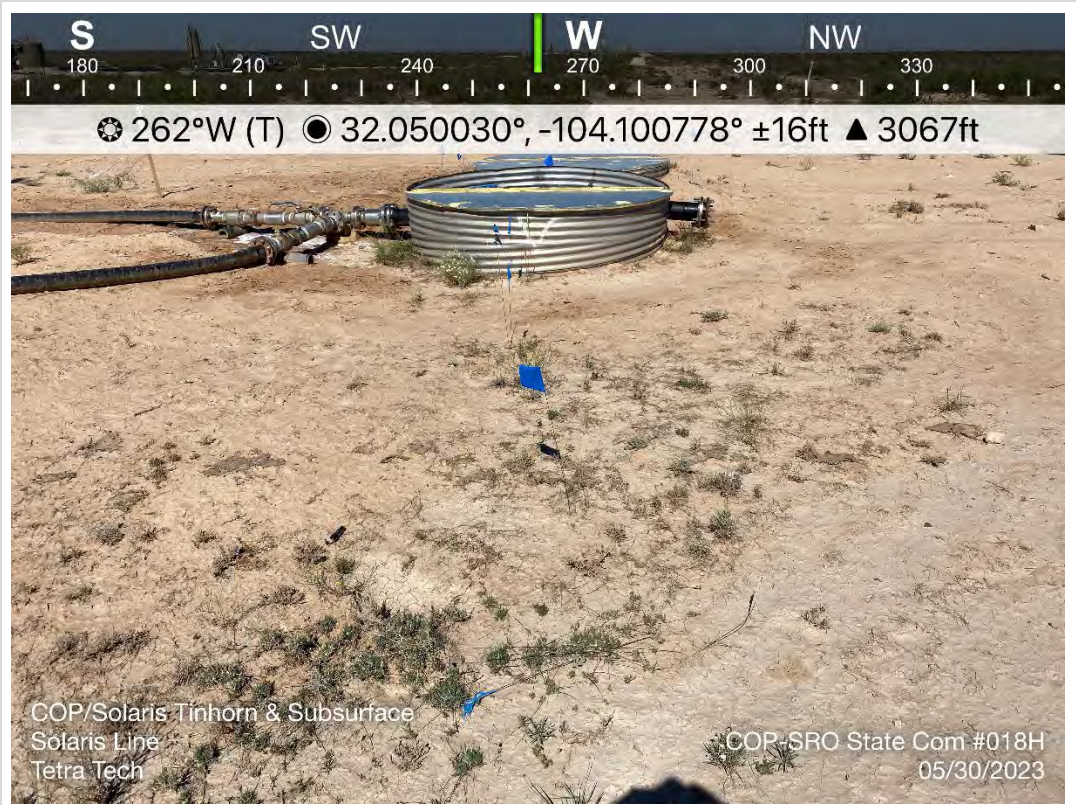
TETRA TECH, INC. PROJECT NO. 212C-MD-02826	DESCRIPTION	View west of Solaris tinhorn and subsurface water line. View of approximate release extent with visible chloride staining.	6
	SITE NAME	SRO State Com #018H Release	5/30/2023

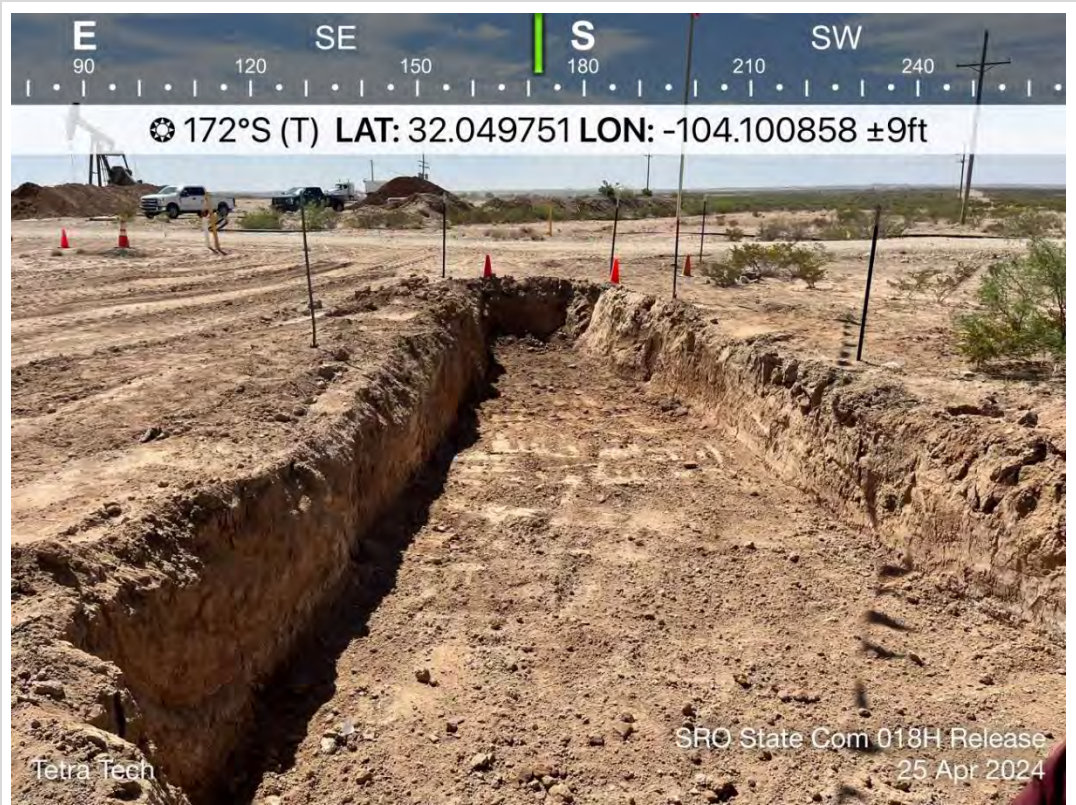
TETRA TECH, INC. PROJECT NO. 212C-MD-02826	DESCRIPTION	View south of open excavation of approximately 4 ft bgs.	8
	SITE NAME	SRO State Com #018H Release	4/25/2024

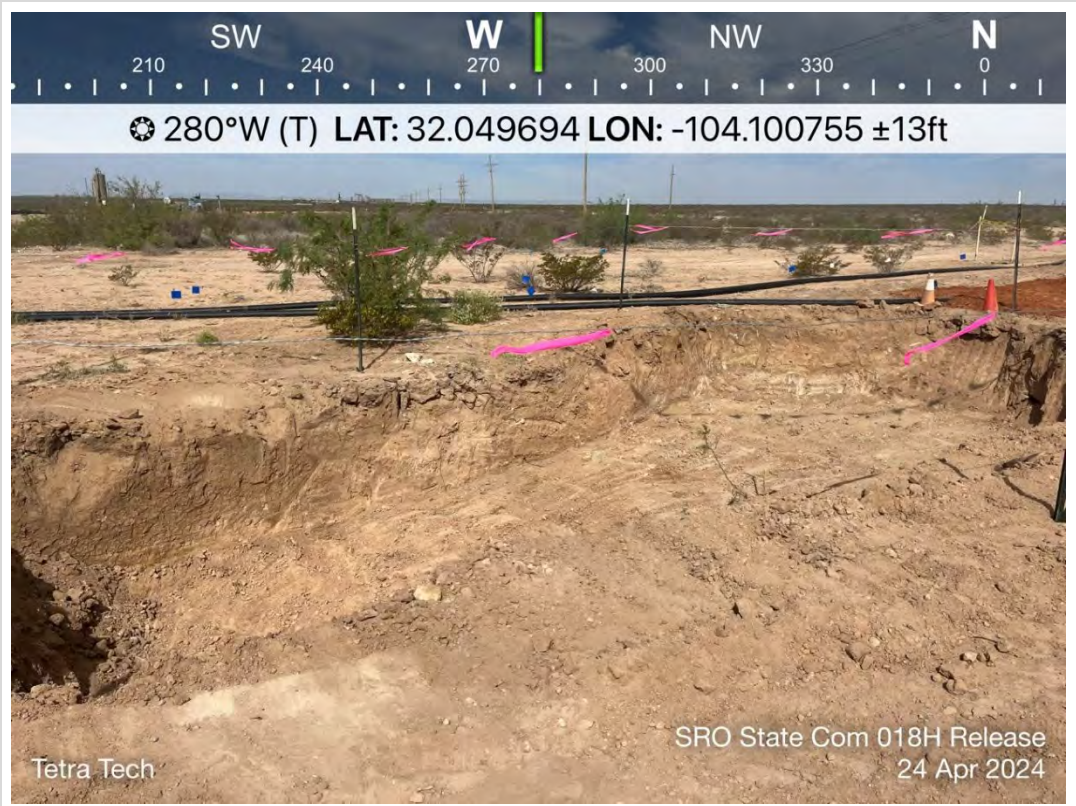
TETRA TECH, INC. PROJECT NO. 212C-MD-02826	DESCRIPTION	View of south-southeast of open excavation of approximately 4 ft bgs.	9
	SITE NAME	SRO State Com #018H Release	4/24/2024

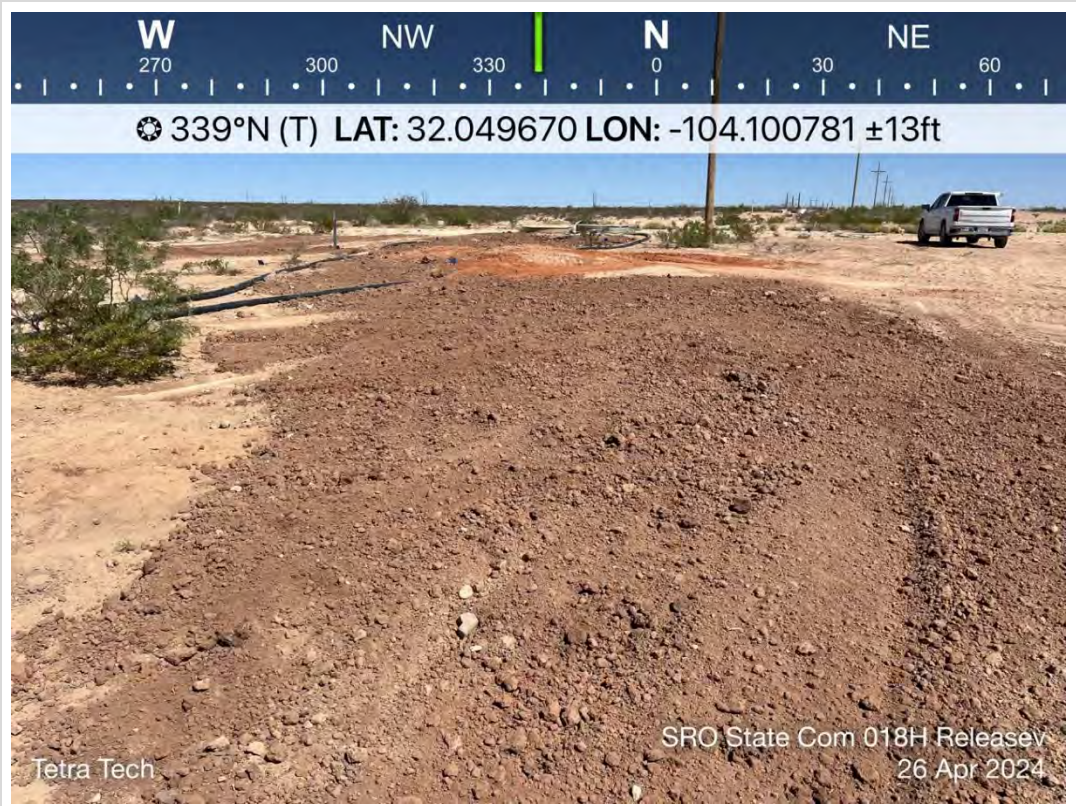
TETRA TECH, INC. PROJECT NO. 212C-MD-02826	DESCRIPTION	View north-northwest of backfilled and seeded excavation.	11
	SITE NAME	SRO State Com #018H Release	4/26/2024

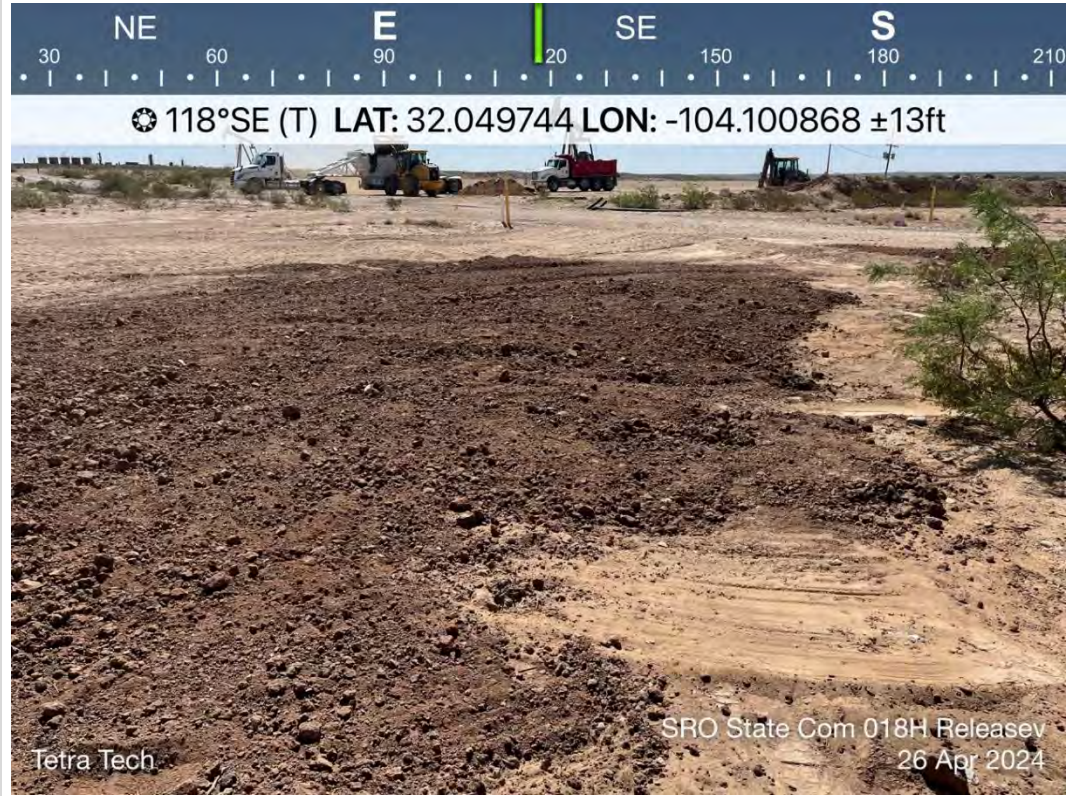
TETRA TECH, INC. PROJECT NO. 212C-MD-02826	DESCRIPTION	View east-southeast of backfilled and seeded excavation.	12
	SITE NAME	SRO State Com #018H Release	4/26/2024

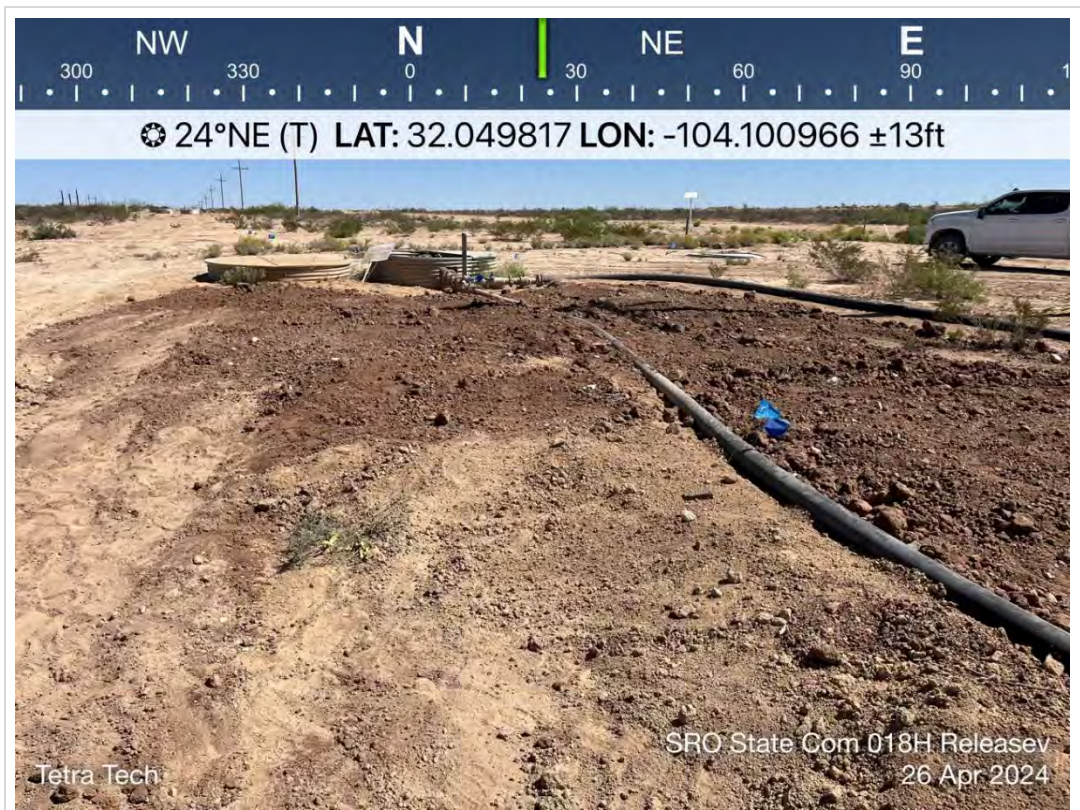
TETRA TECH, INC. PROJECT NO. 212C-MD-02826	DESCRIPTION	View north-northeast of backfilled and seeded excavation.	13
	SITE NAME	SRO State Com #018H Release	4/26/2024
