## **Remediation, Reclamation, and Closure Report**

Cottonwood Draw 22 Federal Com #005H  
API# 30-015-37431  
Eddy County, New Mexico  
Incident ID: NKMW1106054103

Cimarex Energy Co. of Colorado  
600 Marienfeld St.  
Midland, TX 79701

H&R Enterprises, LLC  
5120 W. Kansas St.  
Hobbs, New Mexico 88242

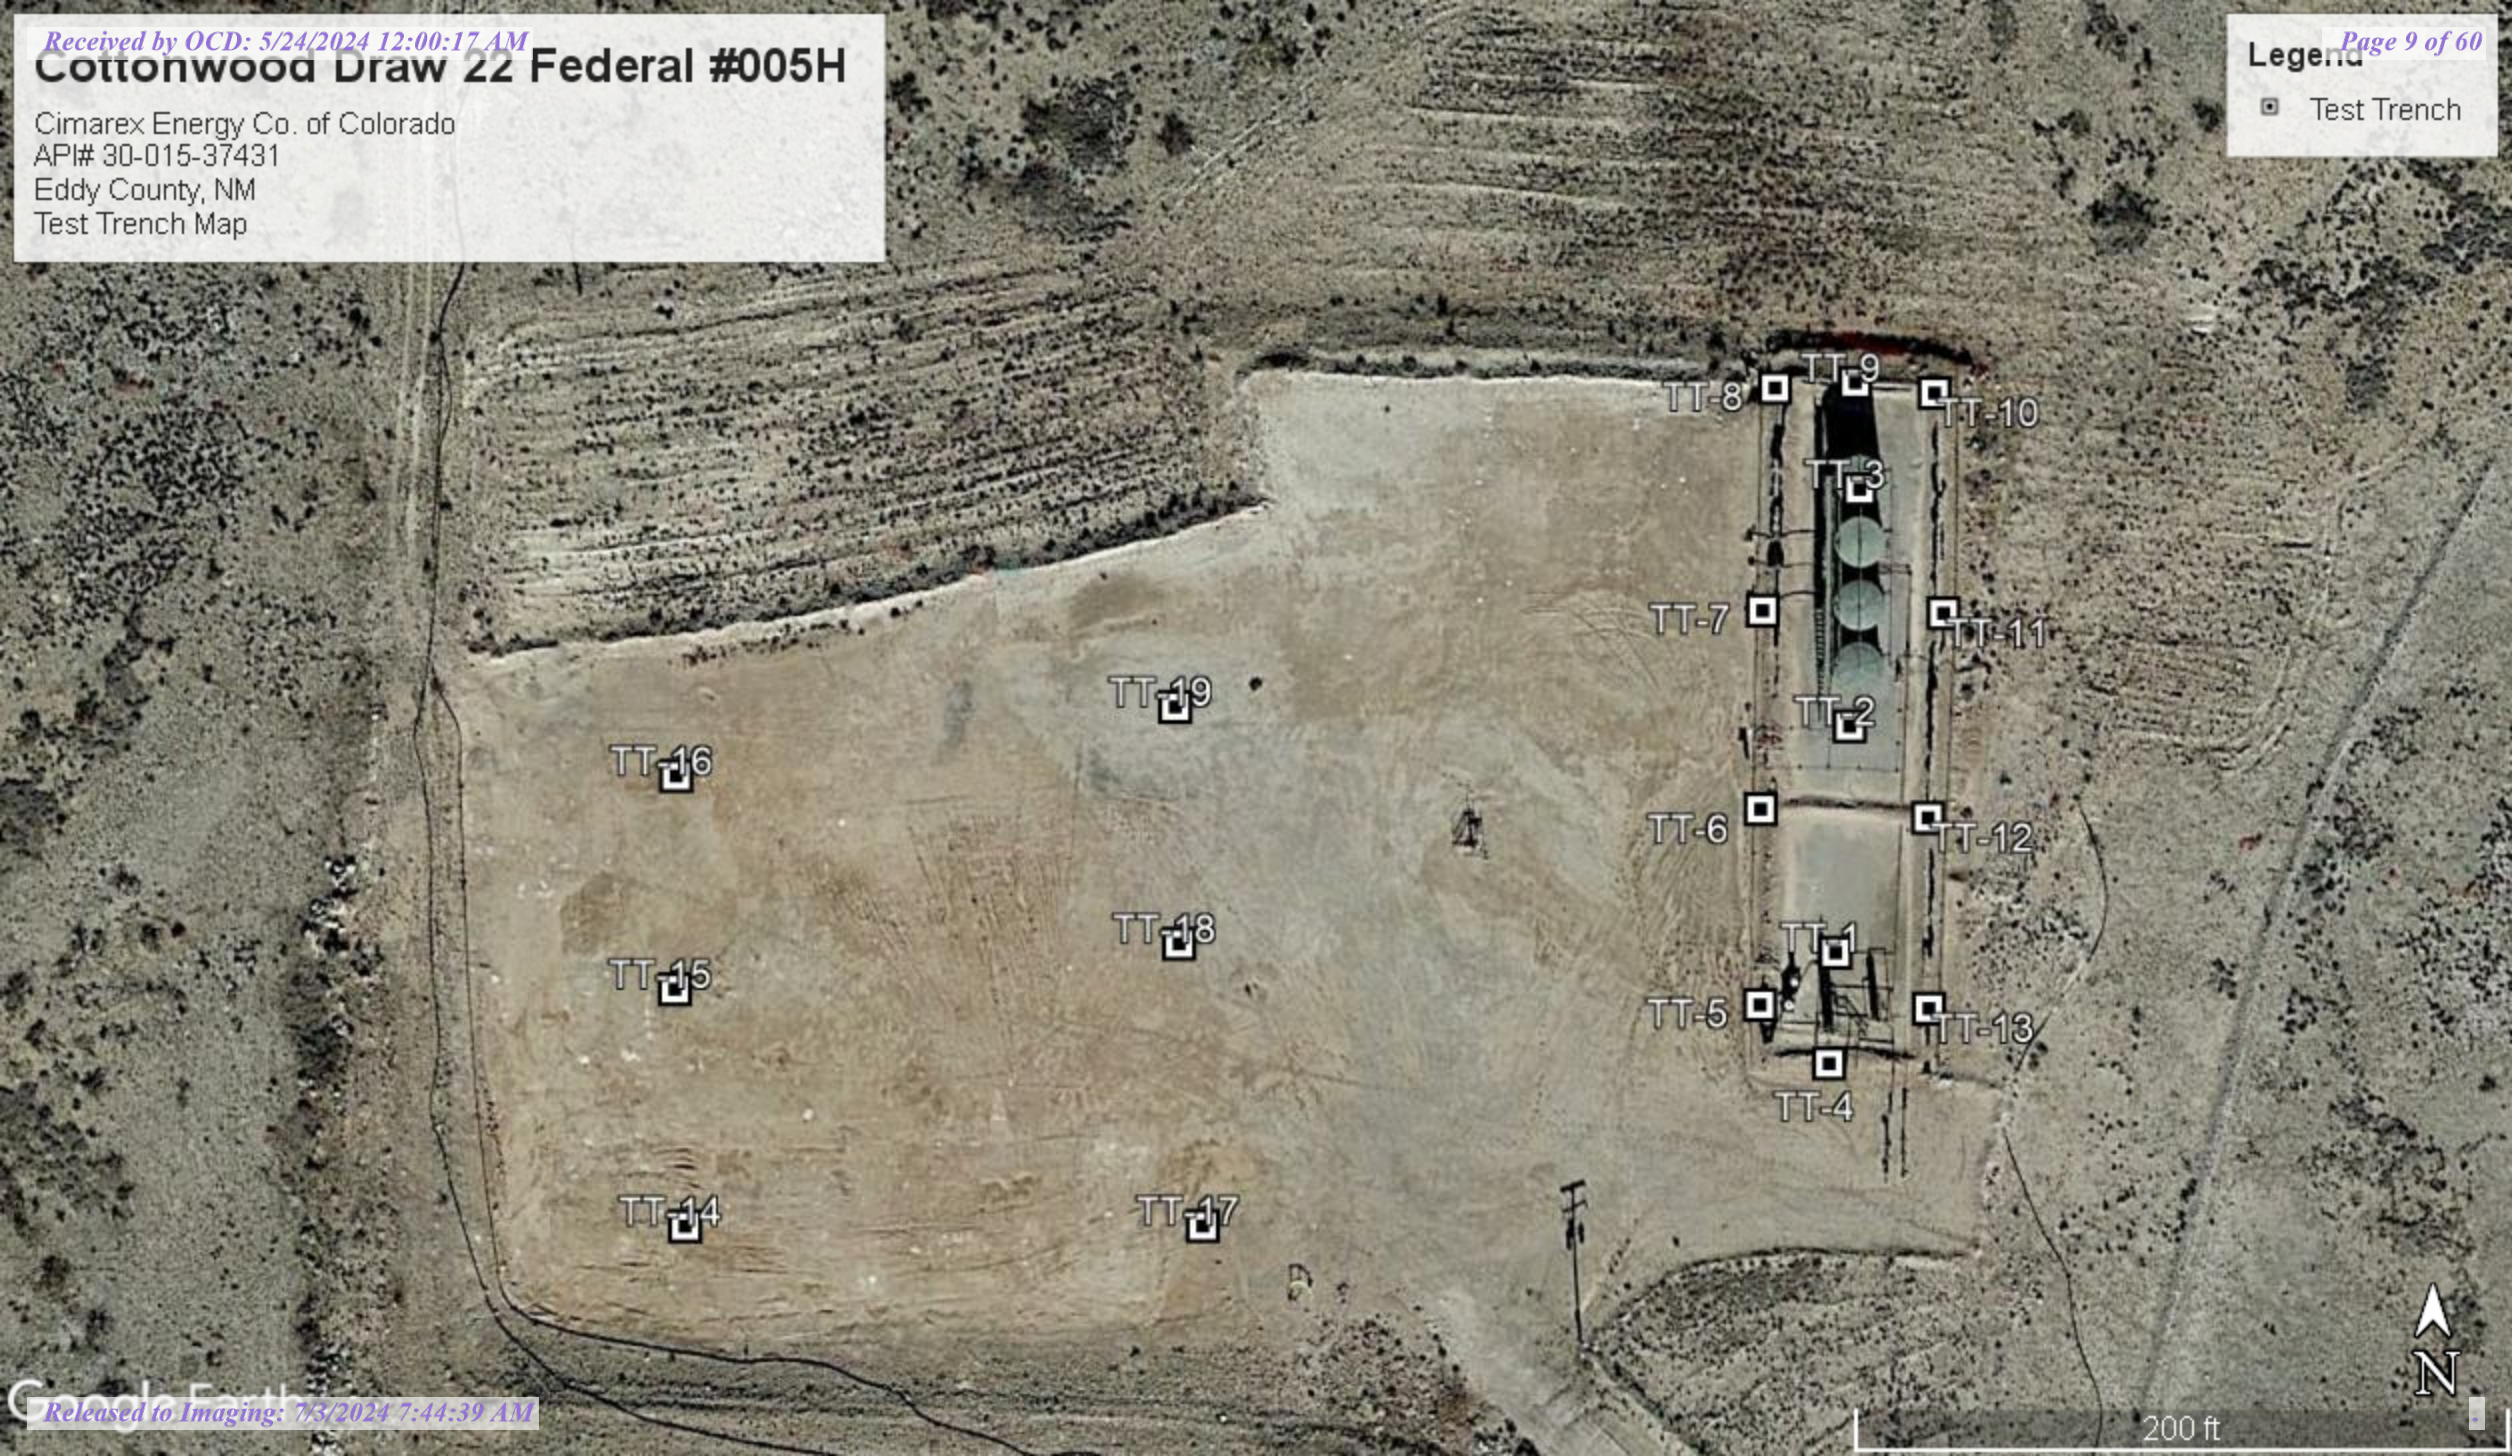
# Cottonwood Draw 22 Federal Com #005H

On February 20, 2022, H&R mobilized personnel to begin site assessment, sampling, and reclamation activities of the location. Grab samples were obtained by way of test trenching in the tank battery as well as throughout the location to identify possible areas of contamination. Field chloride titrations were performed, and the results are presented in the following data table (Table 1). Laboratory analysis was also performed by Cardinal Laboratories on samples collected from test trenches 1 through 3 due to encountering possible petroleum hydrocarbon contamination. Those results are presented in the following data table (Table 1a). Initial site assessment sampling and excavation locations are illustrated on Test Trench Map, [Appendix I](#). After remediation and reclamation was complete, 4 composite confirmation samples were collected from the Northeast, Northwest, Southeast, and Southwest quadrants of the location and sent to Cardinal Laboratories to confirm NMOCD closure criteria had been met. Before and after photographs of the location are attached in [Appendix II](#). Complete laboratory reports can be found in [Appendix III](#).

▣ Test Trench

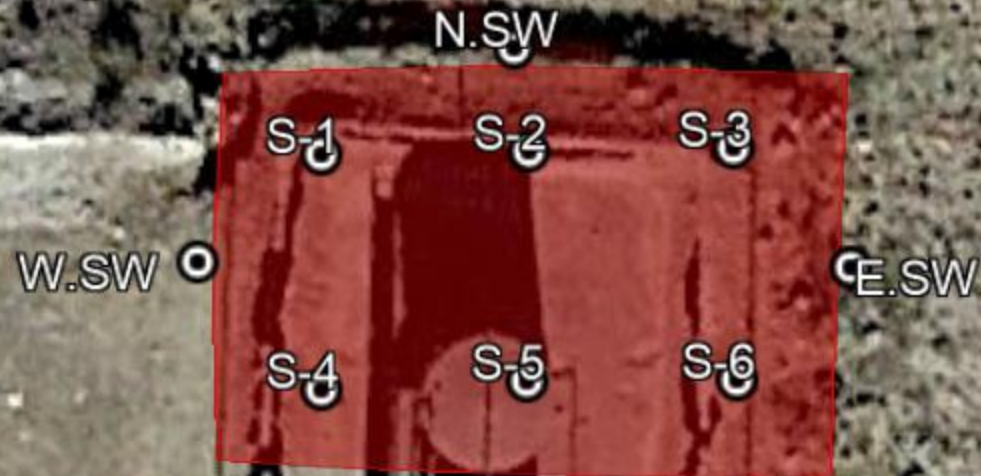
Cimarex Energy Co. of Colorado  
API# 30-015-37431  
Eddy County, NM  
Confirmation Sample Map

Based on the results of our site assessment and upon client authorization, further excavation activities of the impacted area commenced. Confirmation samples were collected to confirm that NMOCD closure criteria had been met, the results of which can be found in the following data table. Confirmation sample locations and excavation dimensions can be found on Confirmation Sample Map in [Appendix I](#). Complete laboratory reports are attached in [Appendix III](#).

Confirmation Sample Point

- The impacted area in the vicinity of TT-3 was excavated to a total depth of 5 feet BGS.
- Composite confirmation samples were obtained from the sidewalls and bottoms of the excavated area to verify that all contaminants above closure criteria had been removed. The results from those samples as well as the final quadrant samples are shown on Table 2 and the corresponding lab reports may be found in [Appendix III](#).
- All the excavated material (540 yards) was hauled to Lea Land, a NMOCD approved solid waste disposal facility.
- The excavated area was backfilled with surrounding soil at depth and brought to grade, ripped, and contoured to match the surrounding location.
- The location will be seeded with the appropriate BLM seed mixture in accordance with the monsoon season to ensure proper seed germination and growth.
