Subject: 2023 Second Quarter – Solar SVE System Update
Trunk L Tank Battery
Harvest Four Corners, LLC
Incident Number NVF1900731813
Remediation Permit Number 3RP-13665
Rio Arriba County, New Mexico

Ensolum, LLC (Ensolum), on behalf of Harvest Four Corners, LLC (Harvest), presents the following *2023 Second Quarter – Solar SVE System Update* report summarizing the soil vapor extraction (SVE) system performance at the Trunk L Tank Battery (Site), located in Unit A of Section 28, Township 28 North, Range 05 West, in Rio Arriba County, New Mexico (Figure 1).

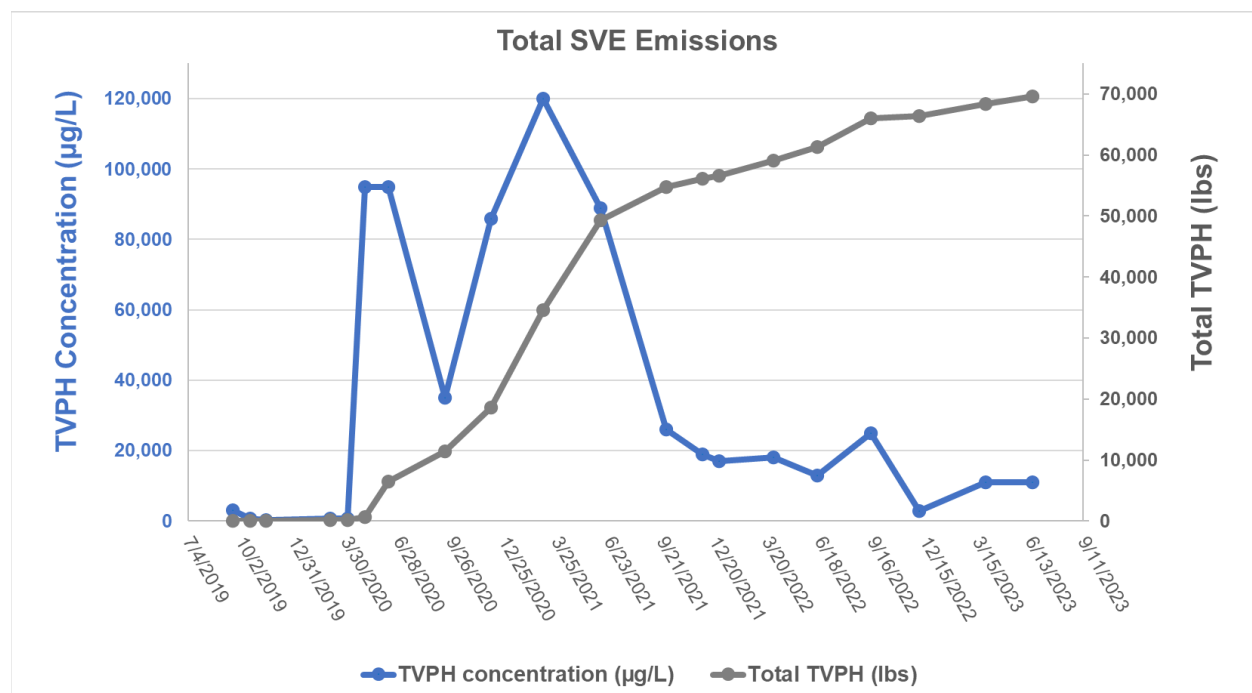
Estimated air emissions were calculated using air sample data collected to-date (Table 2). The impacted mass source removal via the solar SVE system to-date is estimated to be 69,586 pounds (lbs) of TVPH. An increase in TVPH mass removal was observed in May 2020 as a result of system optimization, through focusing system operation on the four SVE wells that were recovering vapor with the highest photoionization detector (PID) measurements (SVE03, SVE04, SVE05, and SVE06). After the reconfiguration in May 2020, there was a peak TVPH inlet concentration in March 2021 of 120,000 micrograms per liter (µg/L). Since March 2021, mass removal has continued to generally decline, as seen in the graph below.

The June 2023 TVPH emissions rate decreased slightly, to approximately 1.11 pounds per hour (lbs/hr) or approximately 13.9 pounds per day, based on the average nominal daylight hours available, indicating that the SVE system is still effectively remediating the Site. The mass removal rate will continue to be monitored to evaluate system effectiveness.
