Remediation/Reclamation Plan

New Mexico CR State #002
Chaves County, New Mexico
API ID # 30-005-20413
nAPP2208959497

May 21, 2024

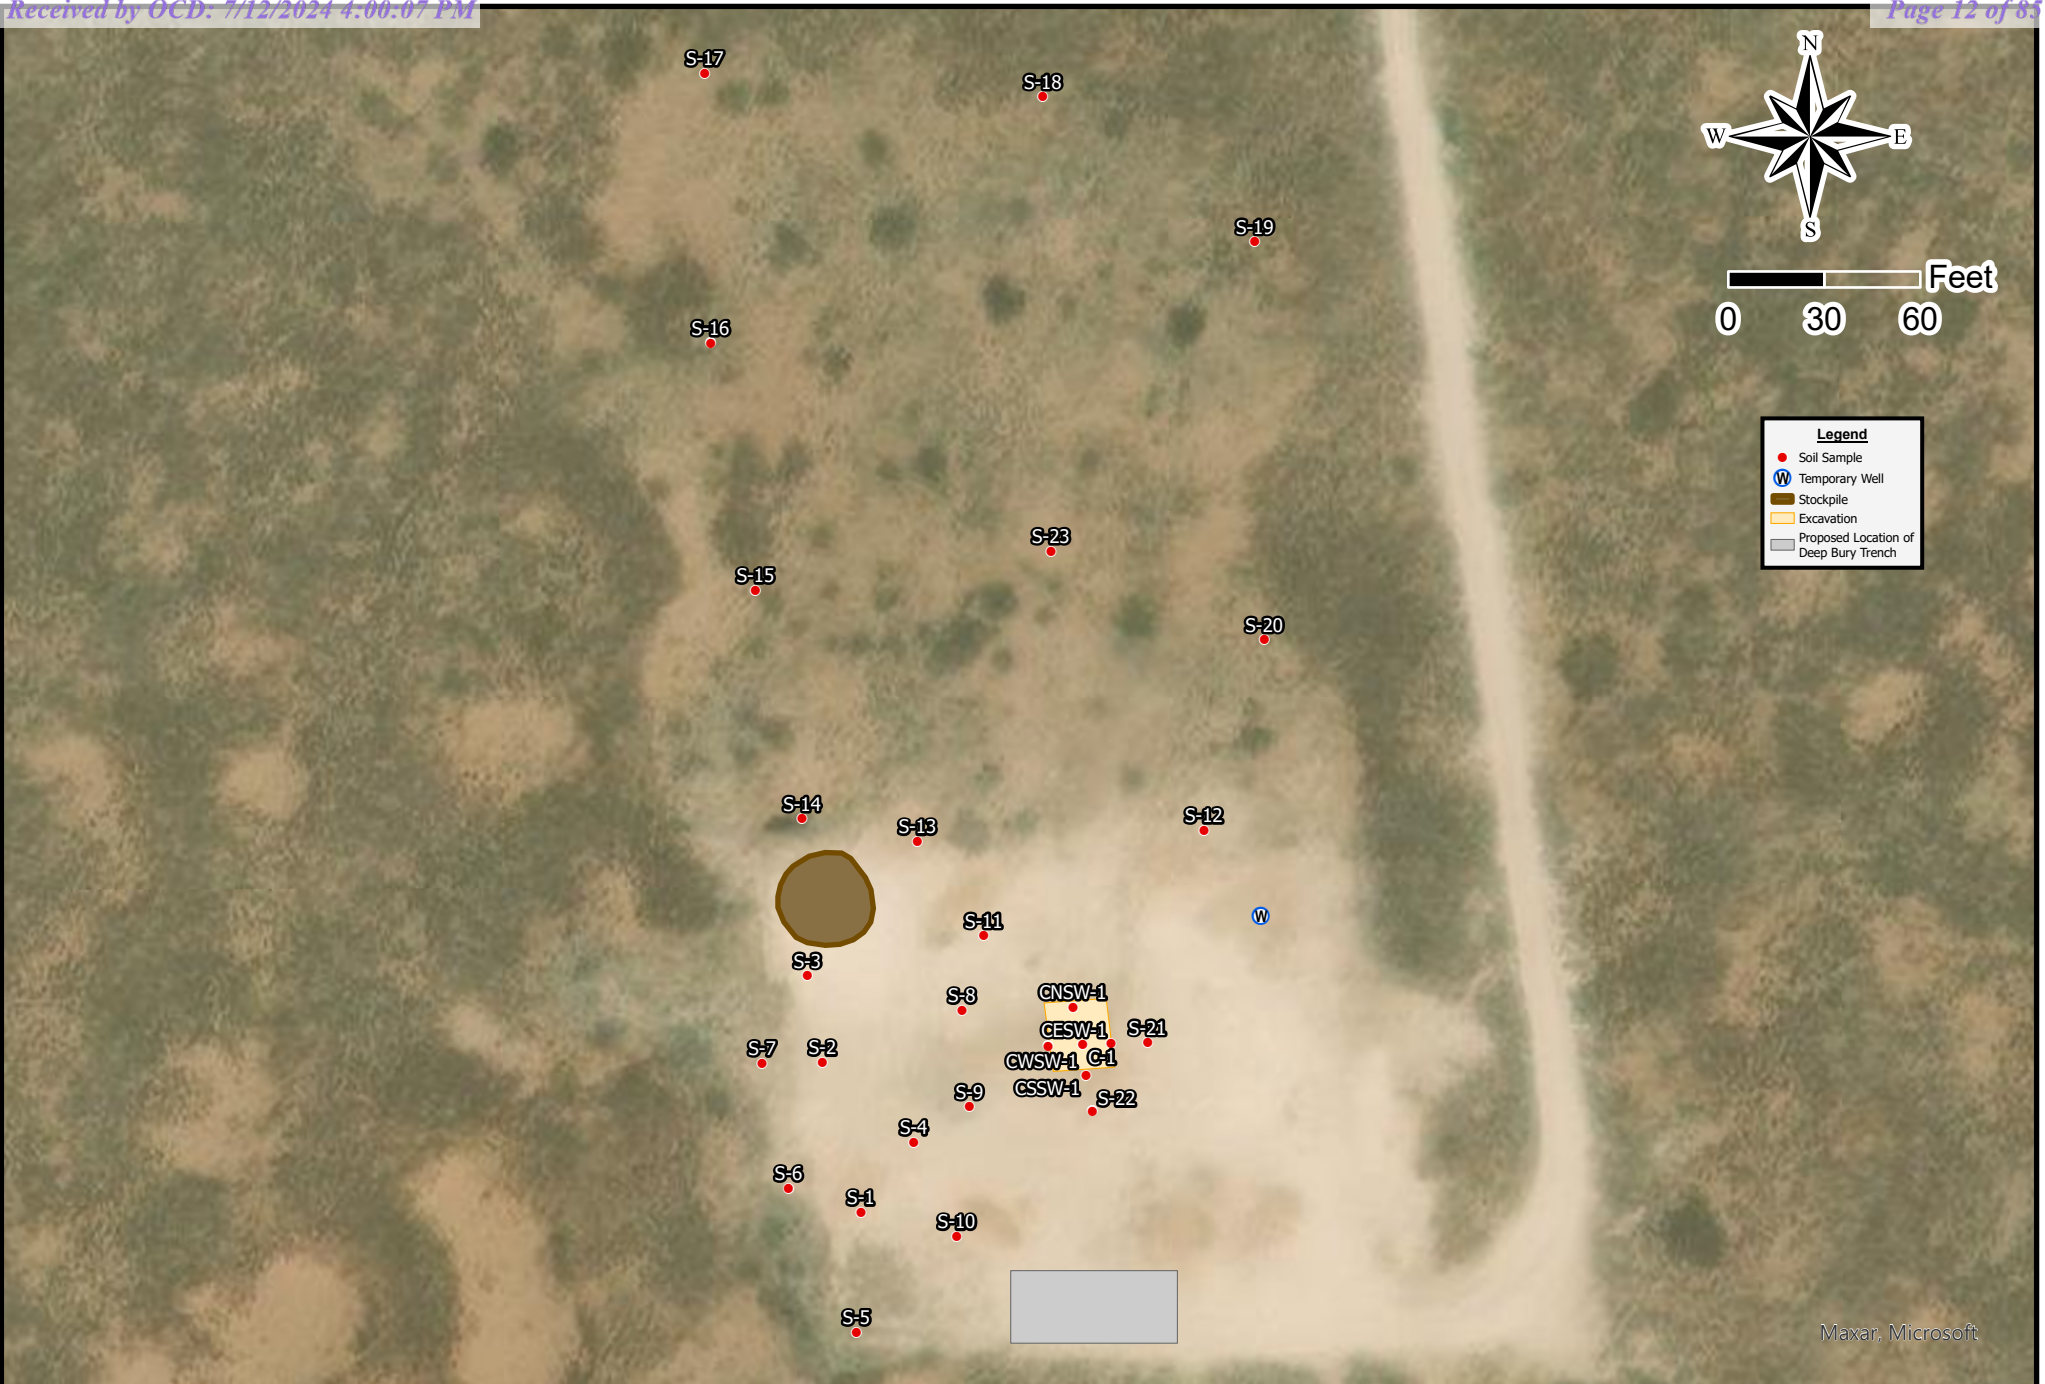
Ford Resources
CR State #2
Chaves County, New Mexico
Figure 1 - Site Assessment Map

Drafted: 12/4/2023
1 in = 60 ft
Drafted By: IJR

The New Mexico CR State #002 is located approximately 36 miles northeast of Roswell, New Mexico. The legal location for this site is Unit Letter M, Section 32, Township 09 South and Range 30 East in Chaves County, New Mexico. The latitude and longitude for the release are 33.4840508 and -103.9101639. Site maps are presented in [Appendix I](#).
