Re: Closure Report Request Addendum

RDX 17 Federal Com #020H

Incident Numbers NAB1422341439 & NAB1706053151

**Eddy County, New Mexico**

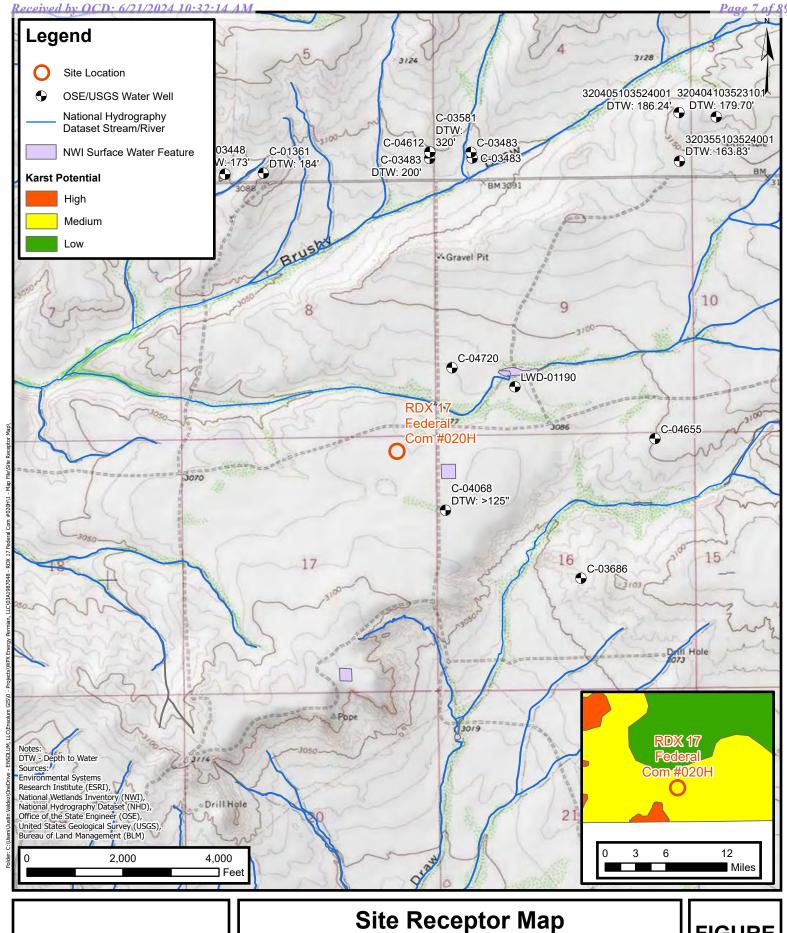
# **Site Receptor Map**

The Site was characterized to assess the applicability of Table I, Closure Criteria for Soils Impacted by a Release, of Title 19, Chapter 15, Part 29 (19.15.29) of the New Mexico Administrative Code (NMAC). Results from the characterization desktop review are presented on page 3 of Form C-141 (see Appendix A), Site Assessment/Characterization. Potential Site receptors are identified in Figure 1.

The closest continuously flowing or significant watercourse to the Site is a dry wash, located approximately 797 feet north of the Site. The Site is greater than 200 feet from a lakebed, sinkhole, or playa lake and greater than 300 feet from an occupied residence, school, hospital, institution, church, or wetland. The Site is greater than 1,000 feet to a freshwater well or spring and is not within a 100-year floodplain or overlying a subsurface mine. The Site is not underlain by unstable geology (medium potential karst designation area). Site receptors are identified on Figure 1.

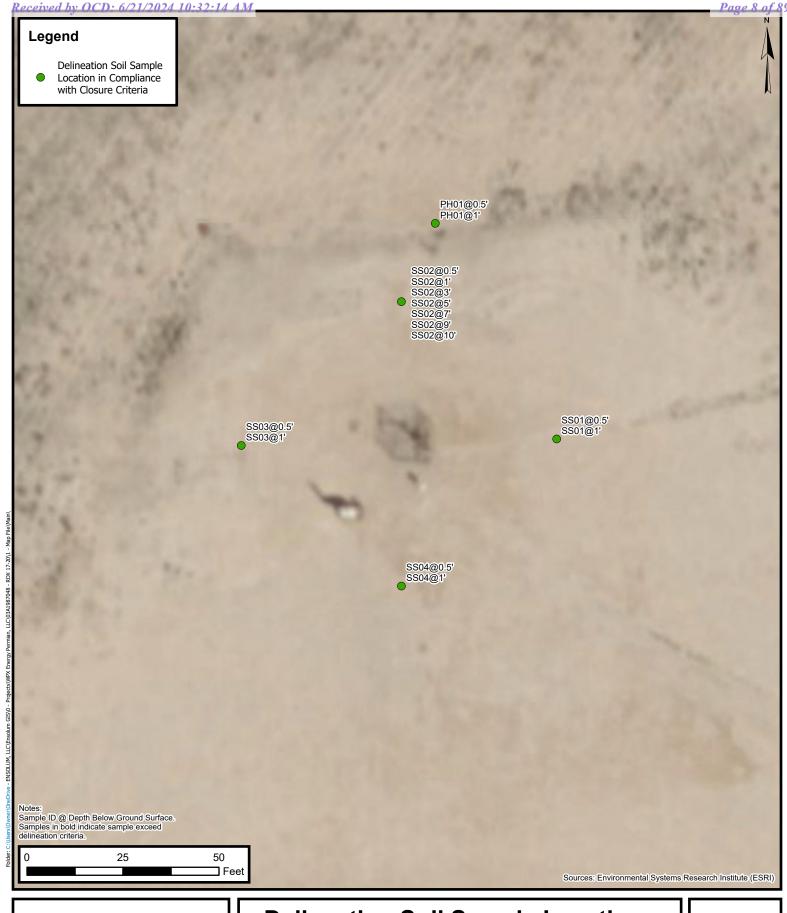
# Delineation Soil Sample Locations WPX Energy Permian, LLC

Laboratory analytical results for preliminary soil sample SS02 collected on September 24, 2018, indicated concentrations of chloride exceeded the strictest Site Closure Criteria at a depth of 1-foot bgs indicating further vertical delineation would be required. Laboratory analytical results from pothole (PH01) indicated COC concentations, associated with Incident Number NAB1422341439, were all in compliance with the strictest Closure Criteria per NMOCD Table I at ground surface and 1-foot bgs. Laboratory analytical results for soil samples collected from potholes associated with Incident Number NAB1706053151 (PH01 through PH11) indicated all COCs were in compliance with the Site Closure Criteria and successfully defined the lateral and vertical extents of the release.

Beginning on March 12, 2024, through March 13, 2024, Ensolum personnel returned to the Site to complete additional delineation sampling activities in sample location SS02, which is associated with Incident Number NAB1422341439. Sample location SS02 was advanced via backhoe to a terminal depth of 10 feet bgs in order to assess the vertical extent of the spill area in accordance with the strictest Closure Criteria per NMOCD Table I. Discrete delineation soil samples were collected from the pothole (SS02) at depths ranging from 3 feet to 10 feet bgs.

Laboratory analytical results for vertical delineation soil samples collected from sample location SS02 were in compliance with the strictest Closure Criteria at 10 feet bgs and were all in compliance with the Site Closure Criteria from ground surface to 10 feet bgs. Laboratory analytical results for excavation floor samples FS01@4' and FS02@4' were both in compliance with the strictest Closure Criteria per NMOCD Table I. Laboratory analytical results are summarized in Tables 1 and 2 and laboratory analytical reports are included in Appendix E.

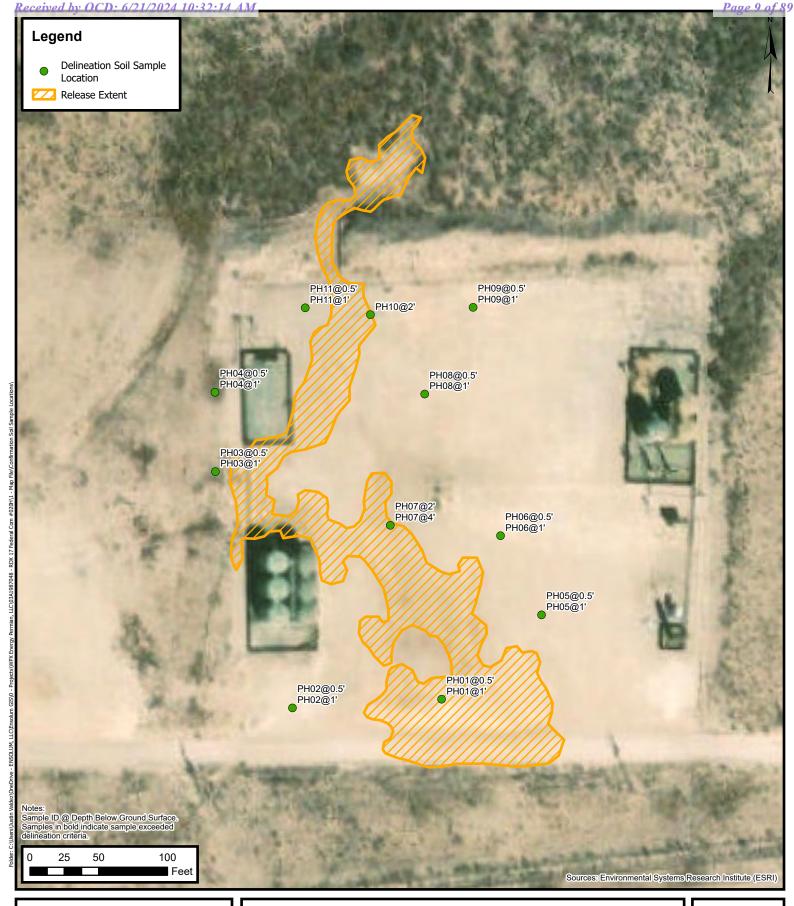
# **Delineation Soil Sample Locations**

analysis. Eleven potholes (PH01 through PH11) were advanced via backhoe in the release area associated with Incident Number NAB1706053151 to a terminal depth of 1-foot bgs in potholes (PH01 through PH09 and PH11); Pothole PH10 was collected at a terminal depth of 2 feet bgs. The preliminary soil samples were field screened for volatile aromatic hydrocarbons and chloride utilizing a calibrated photoionization detector (PID) and Hach® chloride QuanTab® test strips, respectively. Field screening results and observations from the borehole were logged on a lithologic/soil sampling log, which is included in Appendix C. The release extent and preliminary soil sample location were mapped utilizing a handheld Global Positioning System (GPS) unit and are depicted on Figure 2. Photographic documentation is included in Appendix D.

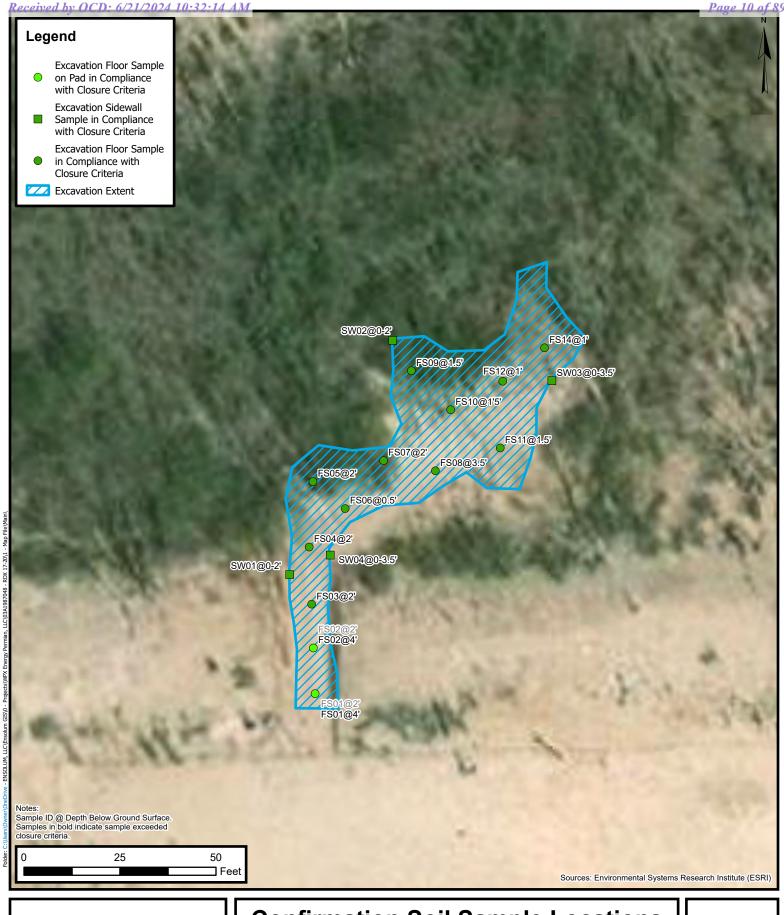
# **Confirmation Soil Sample Locations**

In addition to the delineation sampling activities, Ensolum personnel were onsite to oversee the excavation of confirmation sample areas FS01 and FS02, associated with Incident Number NAB1706053151. It was determined that sample areas FS01 and FS02 were located off-pad and as such, a reclamation requirement of 600 mg/kg chloride and 100 mg/kg TPH was applied to the top 4 feet of the confirmation sample areas. Confirmation sample areas FS01 and FS02 were advanced via backhoe to a depth of 4 feet bgs. Approximately 30 cubic yards of soil from removed from the excavation area and transported to R360 in Hobbs, New Mexico for disposal. The excavation area will be backfilled and recontoured to match preexisting conditions and reseeded with the appropriate BLM seed mixture.

Ensolum personnel collected two, 5-point composite soil samples representing up to 200 square feet from the floor of the excavation (FS01@4' and FS02@4'). The 5-point composite samples were collected by placing five equivalent aliquots of soil into a 1-gallon, resealable plastic bag and homogenizing the samples by thoroughly mixing. The excavation extent and excavation soil sample locations are presented on Figure 4.

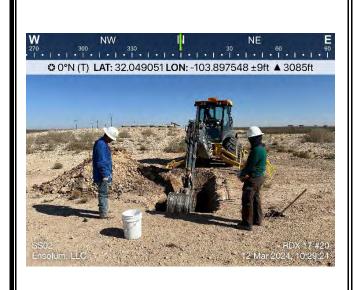
Photograph 1 Date:3/12/24

Description: Delineation sampling

View: North
