Re: Site Characterization and Remediation Work Plan
Devon Energy Production Company
North Thistle 2-35 Federal #001H
Unit B, Section 02, Township 23S, Range 33E
Site Coordinates: 32.3395618, -103.5413391
Lea County, New Mexico
Incident ID: nAPP2409932604

SITE LOCATION MAP
SITE CHARACTERIZATION AND REMEDIATION WORKPLAN
DEVON ENERGY PRODUCTION COMPANY
NORTH THISTLE 2-35 FED #001H
LEA COUNTY, NEW MEXICO

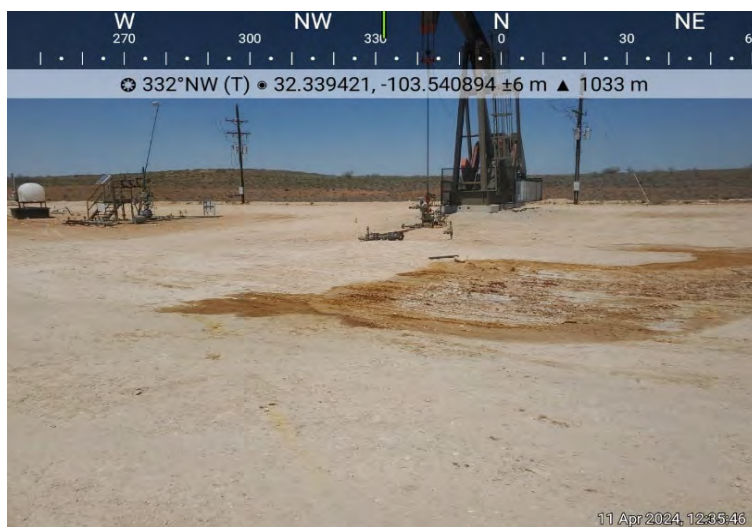
Description:
Area of Concern

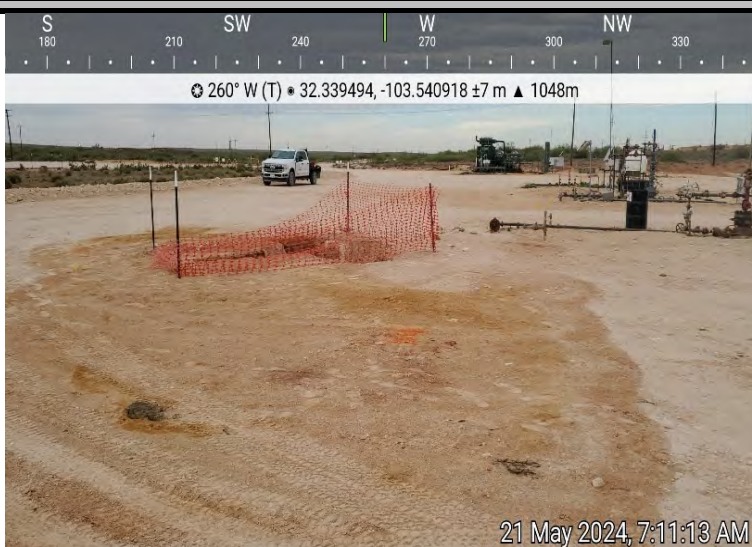
**Photograph No. 5**

Description:
Area of Concern
