## Remediation Summary and Closure Request

**Lucas Fee #1**

**Chaves County, New Mexico**

**NMOCD Incident # nAPP2411639976**

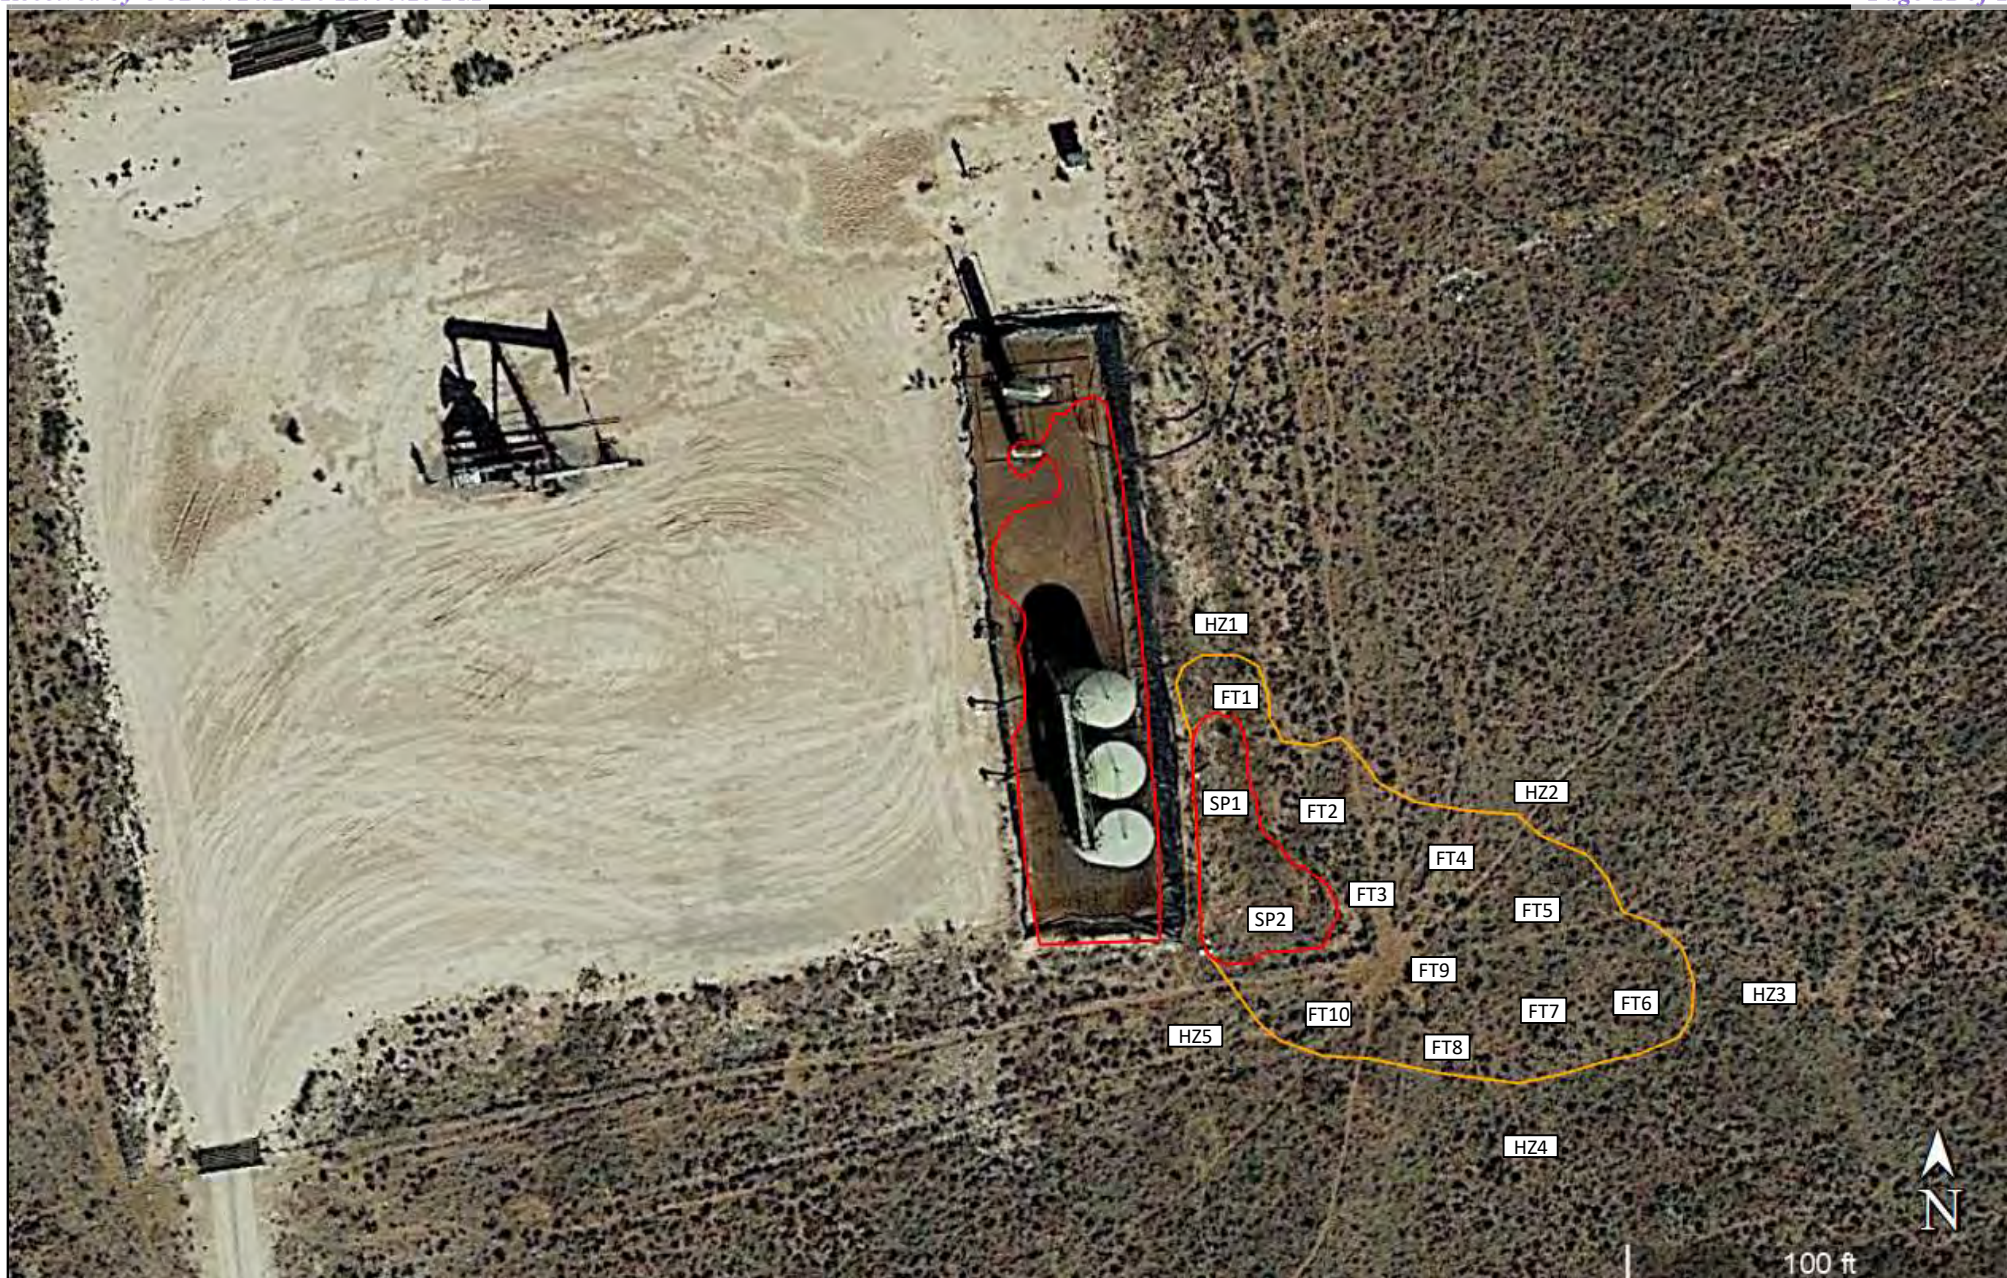
**Figure 4**

Proposed Delineation Sample Map  
 Energex, LLC  
 Lucas Fee #1  
 GPS: 33.605541, -103.519656  
 Chaves County

Based on field observations and field test data noted above and provided in Attachment V, fourteen representative soil samples were selected for laboratory analysis. Delineation soil samples SP1 and SP2, HZ1 through HZ5, were submitted to the laboratory for analysis of BTEX, TPH, and chloride. Laboratory analytical results indicated contaminant concentrations were below the NMOCD Closure Criteria in each submitted sample, with the exception of SP1 and SP2, each at Surface, which exhibited TPH concentrations in excess of NMOCD Closure Criteria.

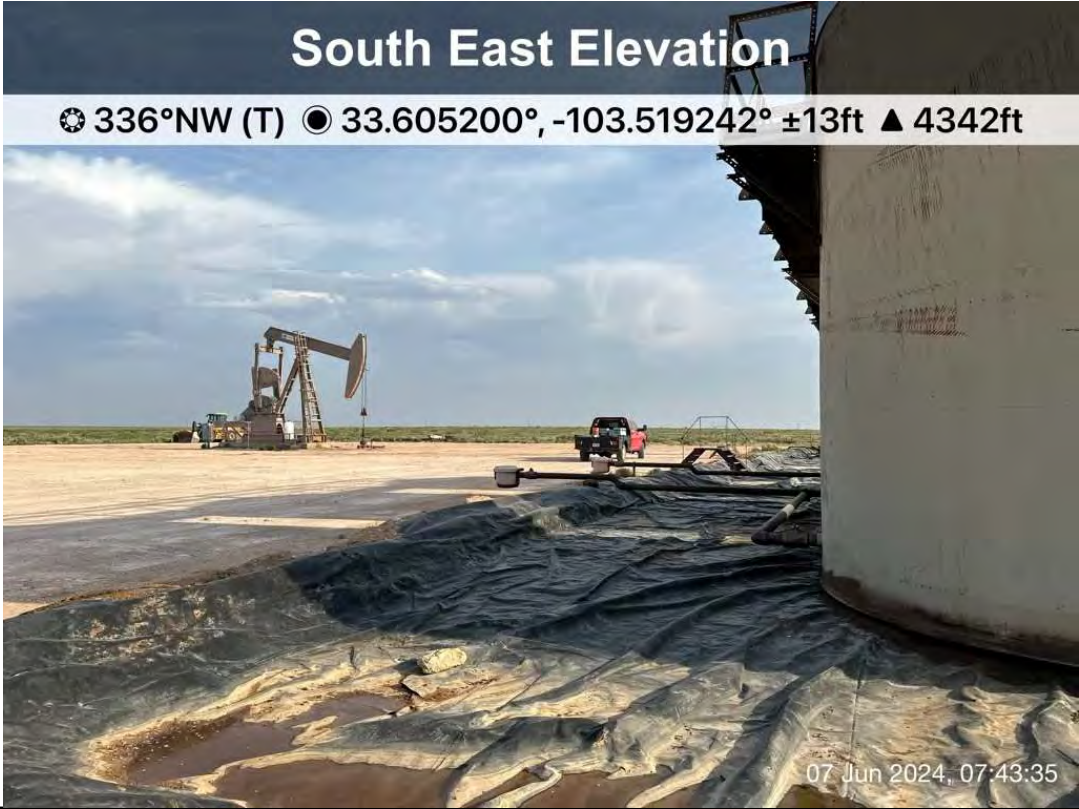
Photo: 13	Description: Liner Inspection - note water from overnight storm
<div><div>South East Elevation</div><div>☼ 336°NW (T) ● 33.605200°, -103.519242° ±13ft ▲ 4342ft</div>

Photo: 14	Description: Liner Inspection - note water from overnight storm
<div><div>South Elevation</div><div>☼ 16°N (T) ● 33.605199°, -103.519243° ±13ft ▲ 4342ft</div> </div>

The liner was power washed on May 31, 2024. On June 3, 2024, Hungry Horse, LLC notified NMOCD that a liner inspection would be conducted on June 7, 2024. On June 7, 2024, Hungry Horse personnel arrived on location to inspect the liner. It was noted that it had rained the night before, leaving some standing water within the lined containment area. The liner and containment were thoroughly inspected from edge to edge, as well as around the tanks and process equipment installed on the liner itself. The liner was found to be in place, intact, with no visible breaks, or tears. There was no evidence of the release leaking through the lined containment area. Photographs are provided as Attachment III and a completed Liner Inspection Form as Attachment V.
