# Remediation Summary and Soil Closure Request

## Permian Resources Raider Fed Com 101H

Lea County, New Mexico  
Unit Letter A, Section 21, Township 24 South, Range 34 East  
Latitude 32.20917 North, Longitude 103.46866 West  
NMOCD Reference No. nAPP2329024748

**Etech Environmental & Safety Solutions, Inc.**  
2617 W. Marland  
Hobbs, New Mexico 88240

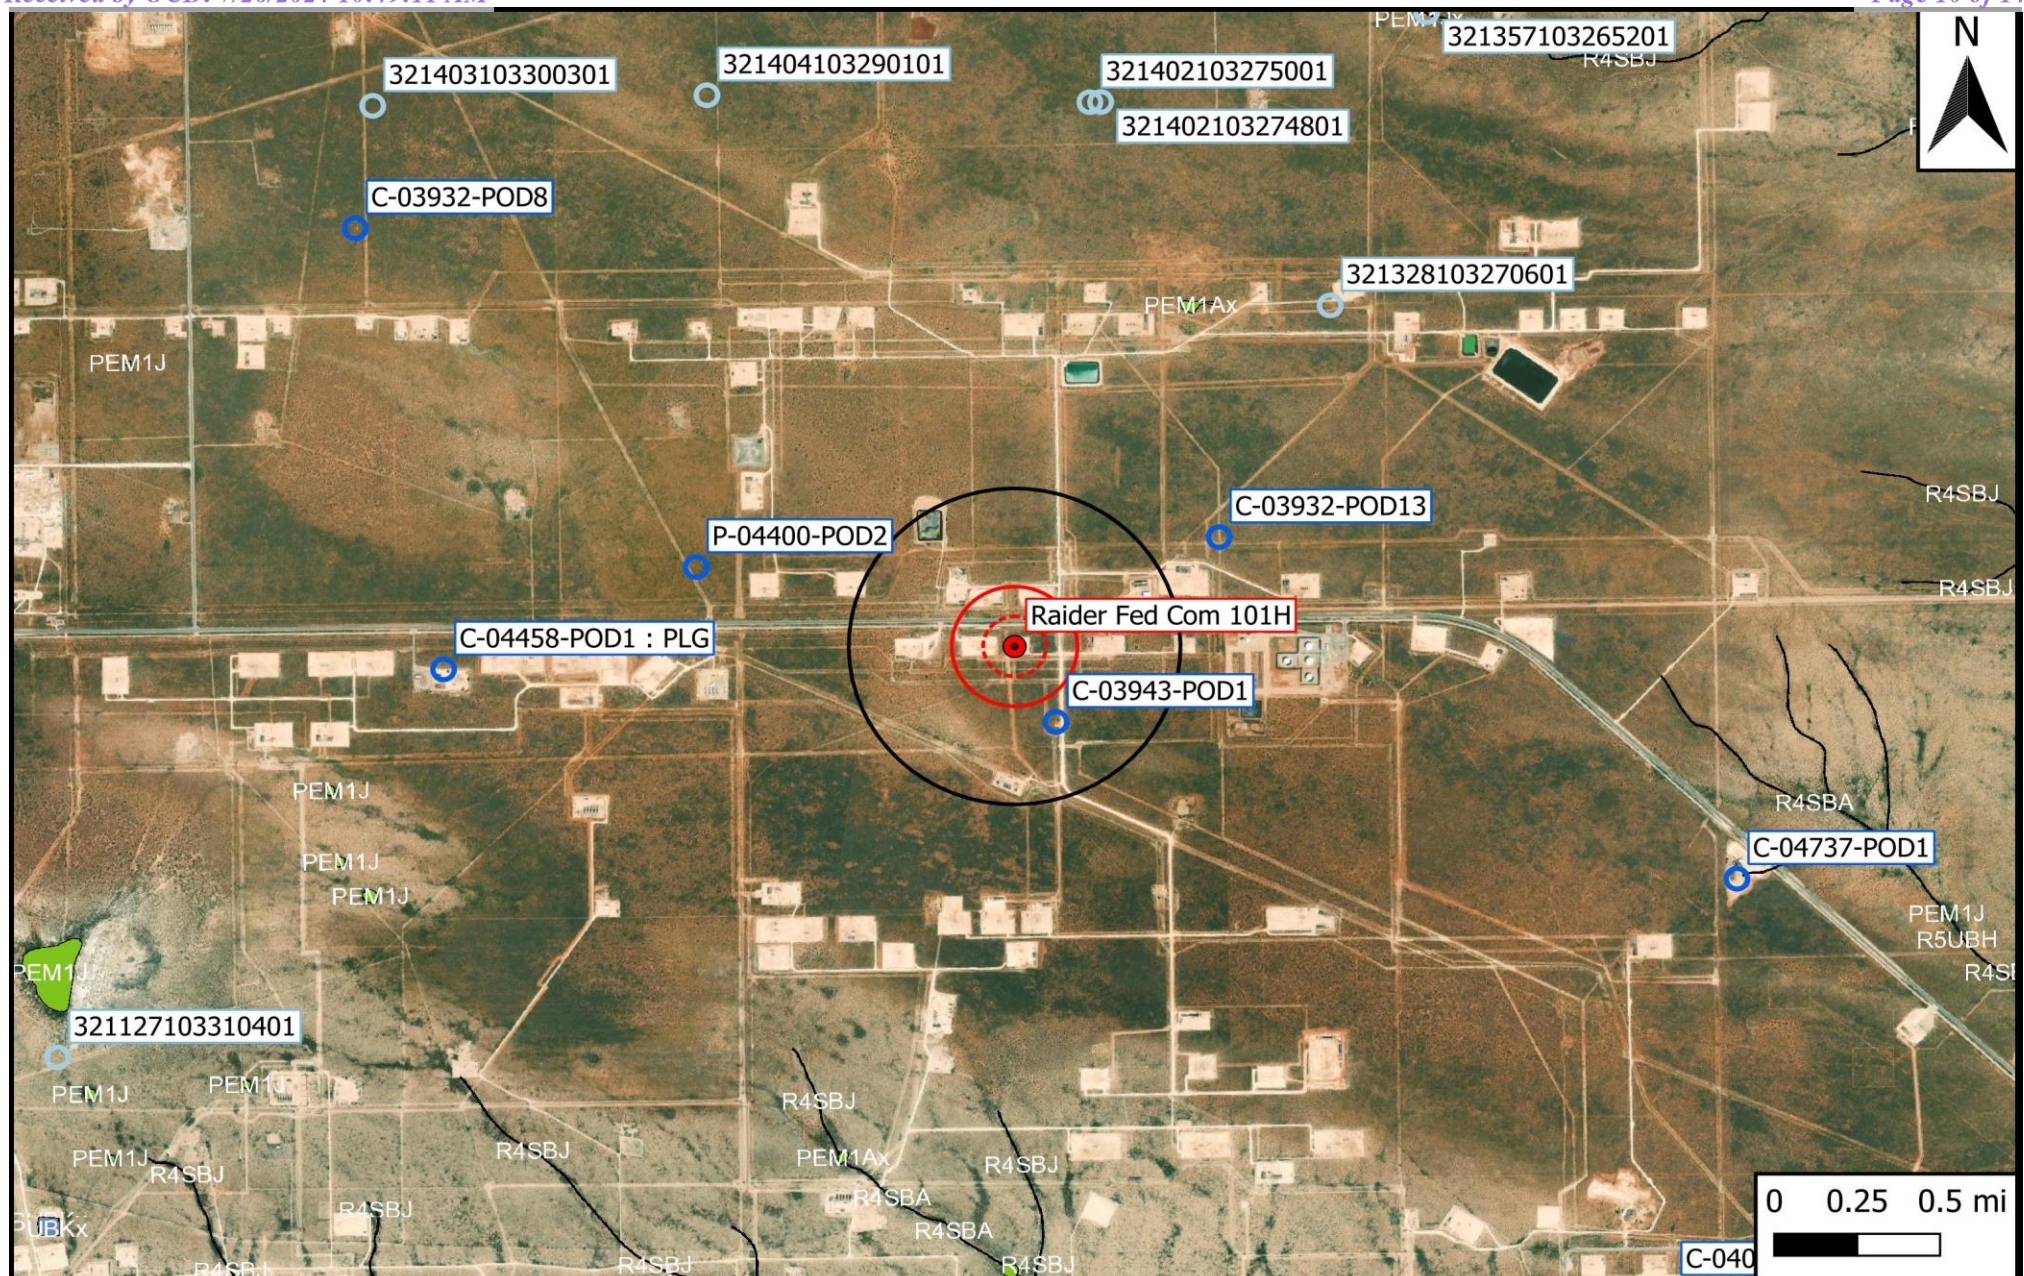
## **Figure 2**

### **Aerial Proximity Map**

**Figure 2**  
Aerial Proximity Map  
Permian Resources  
Raider Fed Com 101H  
GPS: 32.20917, -103.46866  
Lea County
