Closure Report
Ohkay BHH State #001 (03.15.24)
Eddy County, New Mexico
Incident ID: nAPP2407637319
Unit D Sec 6 T25S R30E
32.165948°, -103.928501°

Crude Oil Release
Point of Release: Equipment Failure Resulting in Flare Fire
Release Date: 03.15.2024
Volume Released: 1 barrels of Crude Oil
Volume Recovered: 0 barrels of Crude Oil

**Re: Closure Report
Ohkay BHH State #001 (03.15.24)
Concho Operating, LLC
Incident ID: nAPP2407637319
Site Location: Unit D, S6, T25S, R30E
(Lat 32.165948°, Long -103.928501°)
Eddy County, New Mexico**

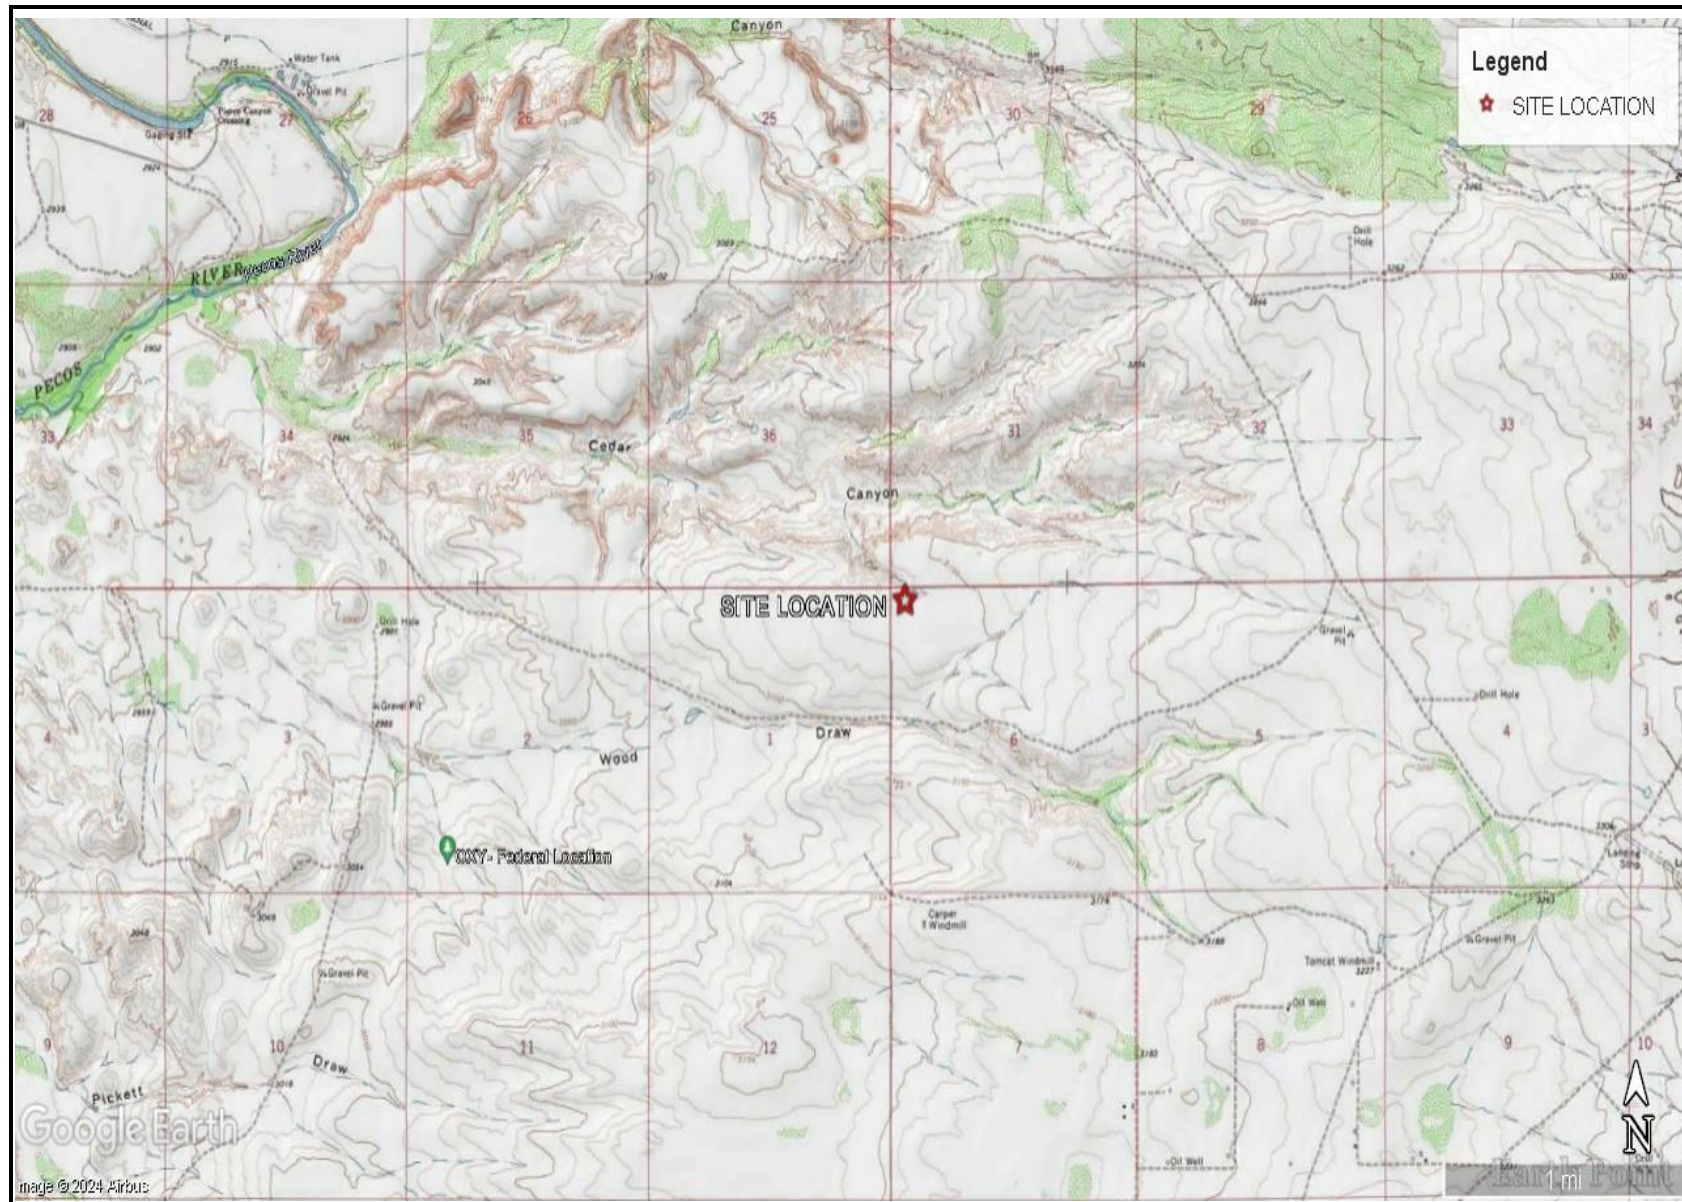
FIGURE 2

TOPOGRAPHIC MAP
 COG OPERATING, LLC
 OHKAY BHH STATE #001 (03.15.24)
 EDDY COUNTY, NEW MEXICO
 32.165948°, -103.928501°

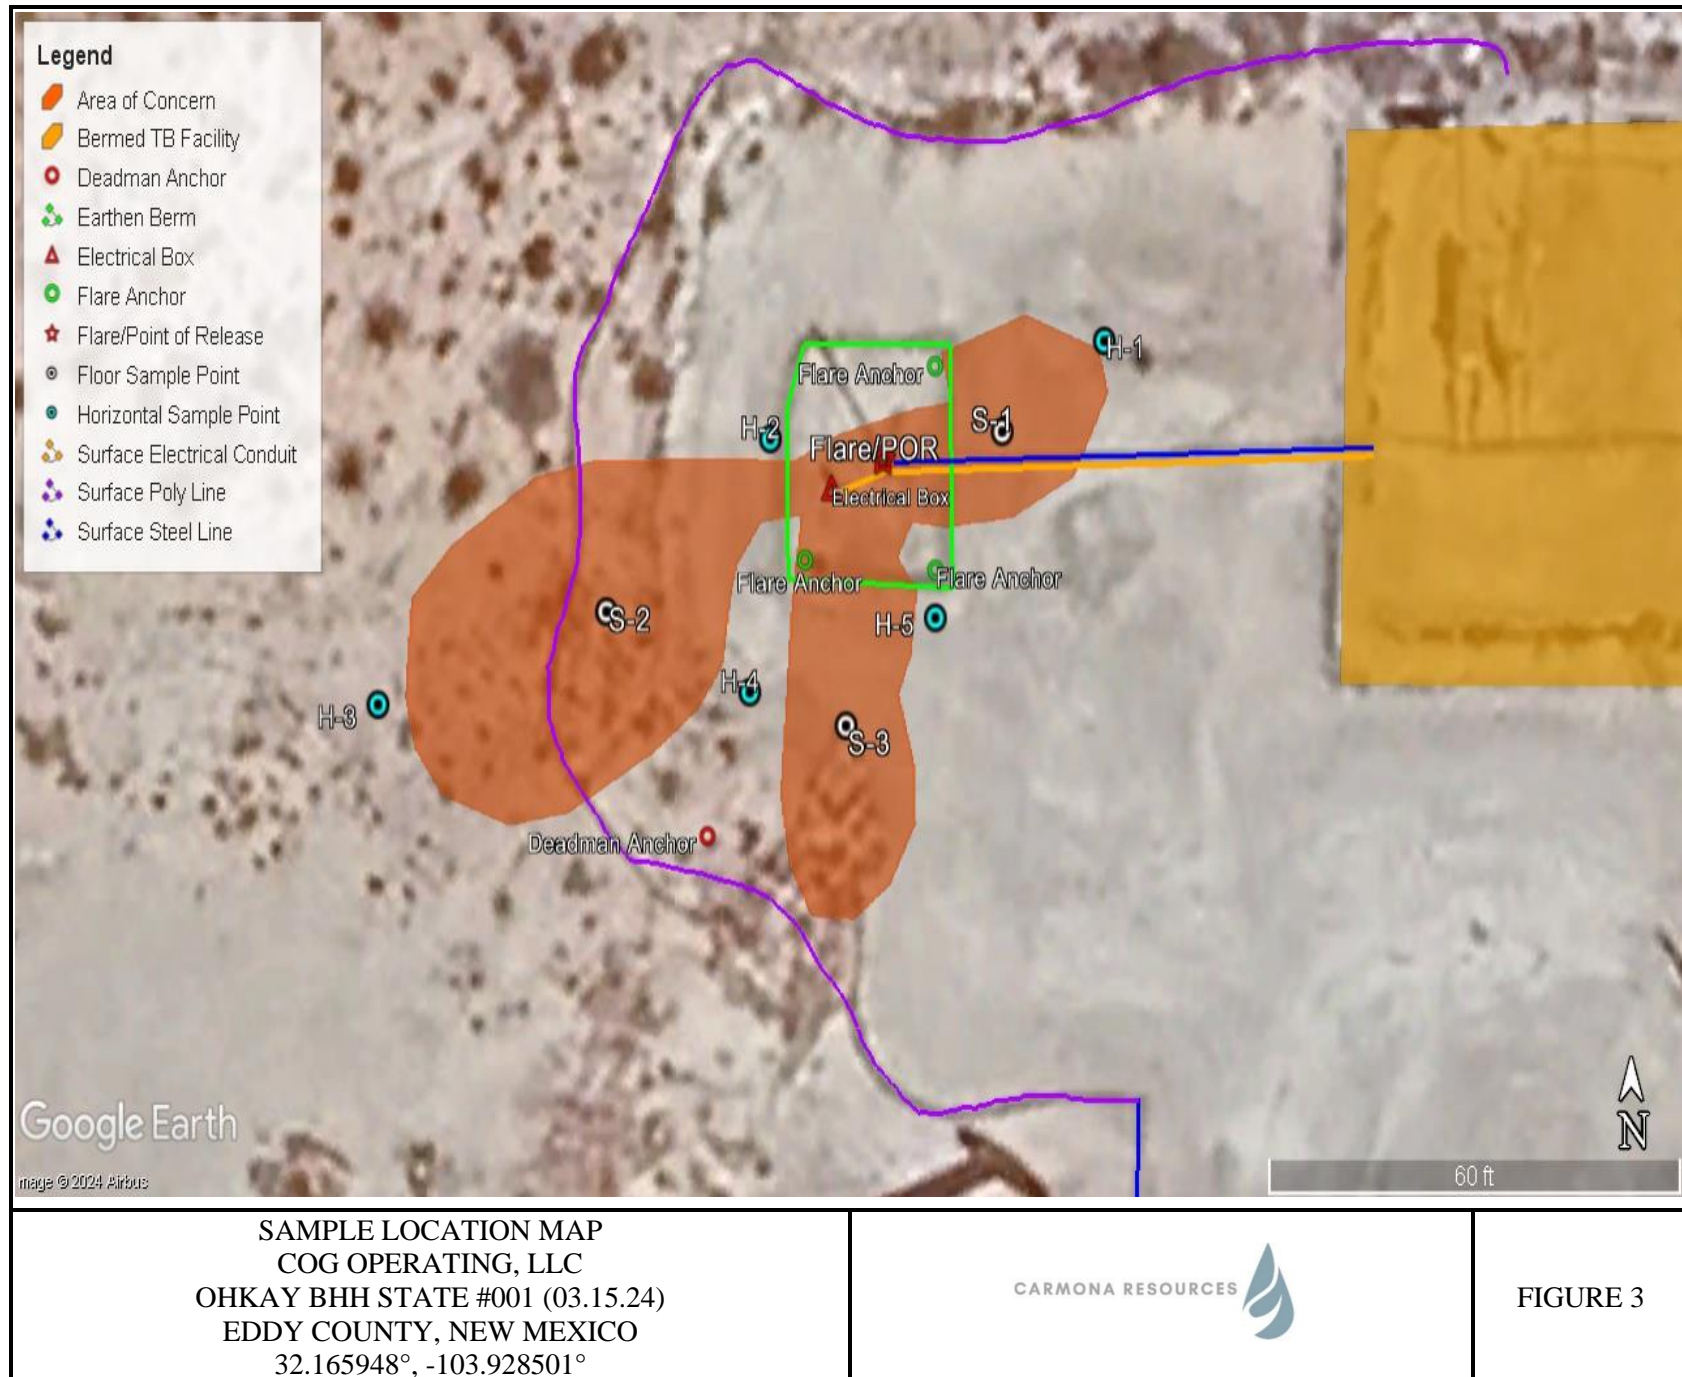
Based on the initial C-141 obtained from the New Mexico Oil Conservation Division (NMOCD), the release was discovered on March 15, 2024, due to equipment failure, resulting in a flare fire. It resulted in approximately one (1) barrels of crude oil being released and zero (0) barrels of crude oil being recovered. The impacted area occurred on the pad, shown in Figure 3. The initial C-141 form is attached in Appendix C.

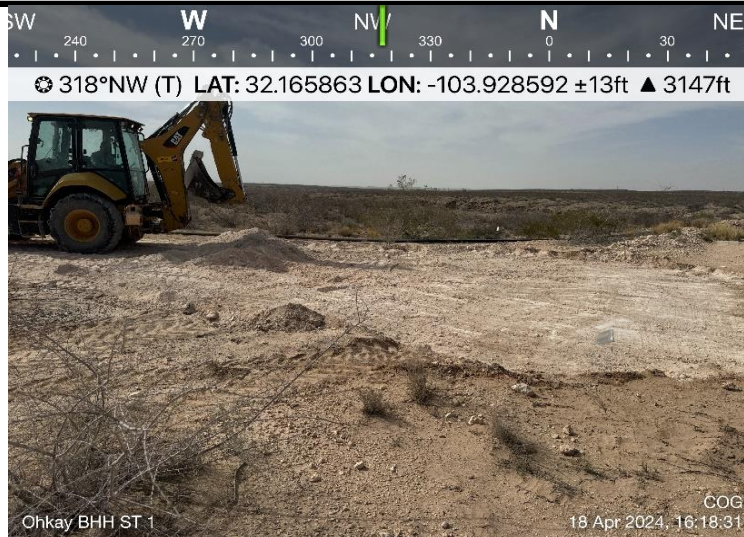
View Northwest, area of CS-1 through CS-7.

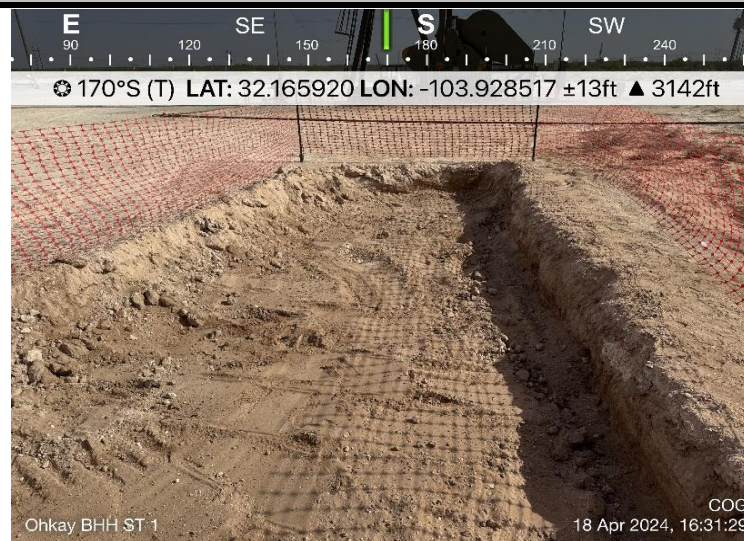
Photograph No. 2

View South, area of CS-8 through CS-10.

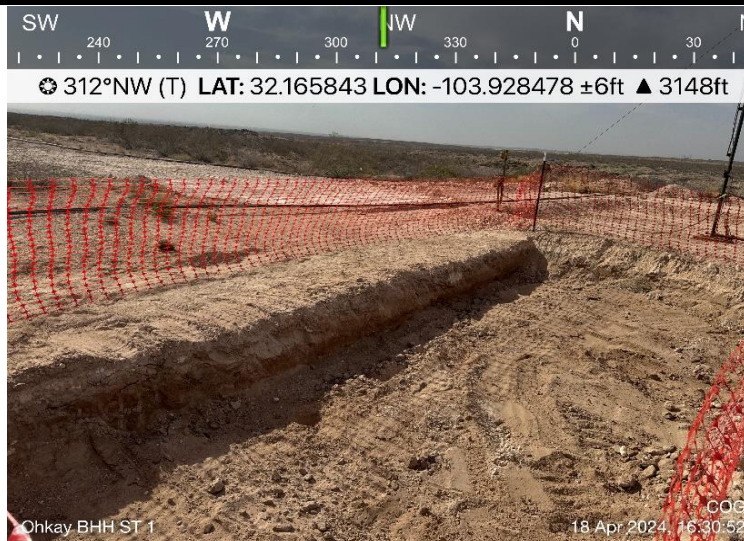
Photograph No. 3

View Northwest, area of CS-11 and CS-12
