Subject: 2024 Second Quarter – Solar SVE System Update
Trunk L Tank Battery
Harvest Four Corners, LLC
Incident Number NVF1900731813
Remediation Permit Number 3RP-13665
Rio Arriba County, New Mexico

Ensolum, LLC (Ensolum), on behalf of Harvest Four Corners, LLC (Harvest), presents the following *2024 Second Quarter – Solar SVE System Update* report summarizing the soil vapor extraction (SVE) system performance at the Trunk L Tank Battery (Site), located in Unit A of Section 28, Township 28 North, Range 05 West, in Rio Arriba County, New Mexico (Figure 1).

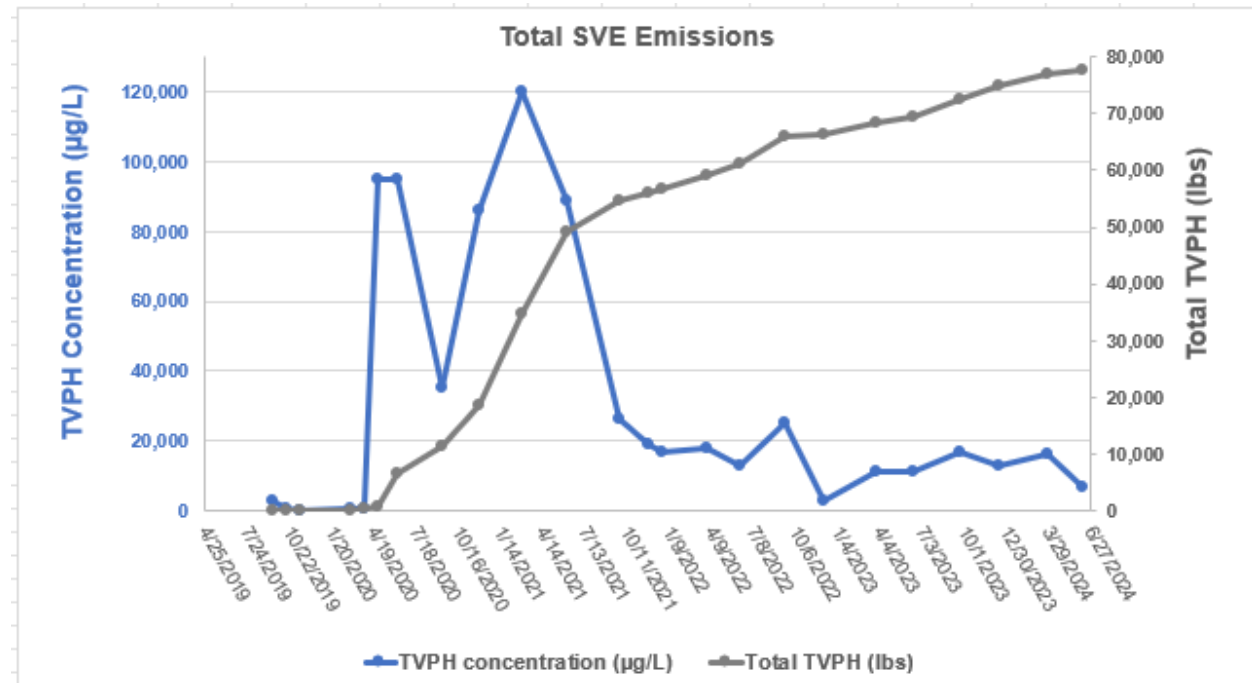
Estimated air emissions were calculated using air sample data collected to date (Table 2). The impacted mass source removal via the solar SVE system to-date is estimated to be 77,777 pounds (lbs) (or 38.89 tons) of TVPH. An increase in TVPH mass removal was observed in May 2020 as a result of system optimization, through focusing system operation on the four SVE wells that were recovering vapor with the highest photoionization detector (PID) measurements (SVE03, SVE04, SVE05, and SVE06). After the reconfiguration in May 2020, there was a peak TVPH inlet concentration in March 2021 of 120,000 micrograms per liter (µg/L). Concentrations have since decreased and have generally ranged between 10,000 to 20,000 µg/L since 2022. Total mass removal has continued at a steady rate, as seen in the graph below, due to system repairs and optimization.

The June 2024 TVPH emissions rate decreased slightly from the first quarter 2024 rate, with a rate of approximately 0.7826 pounds per hour (lbs/hr) or approximately 10.9 pounds per day, based on the average nominal daylight hours available, indicating the SVE system is still effectively remediating the Site. The mass removal rate will continue to be monitored to evaluate system effectiveness.

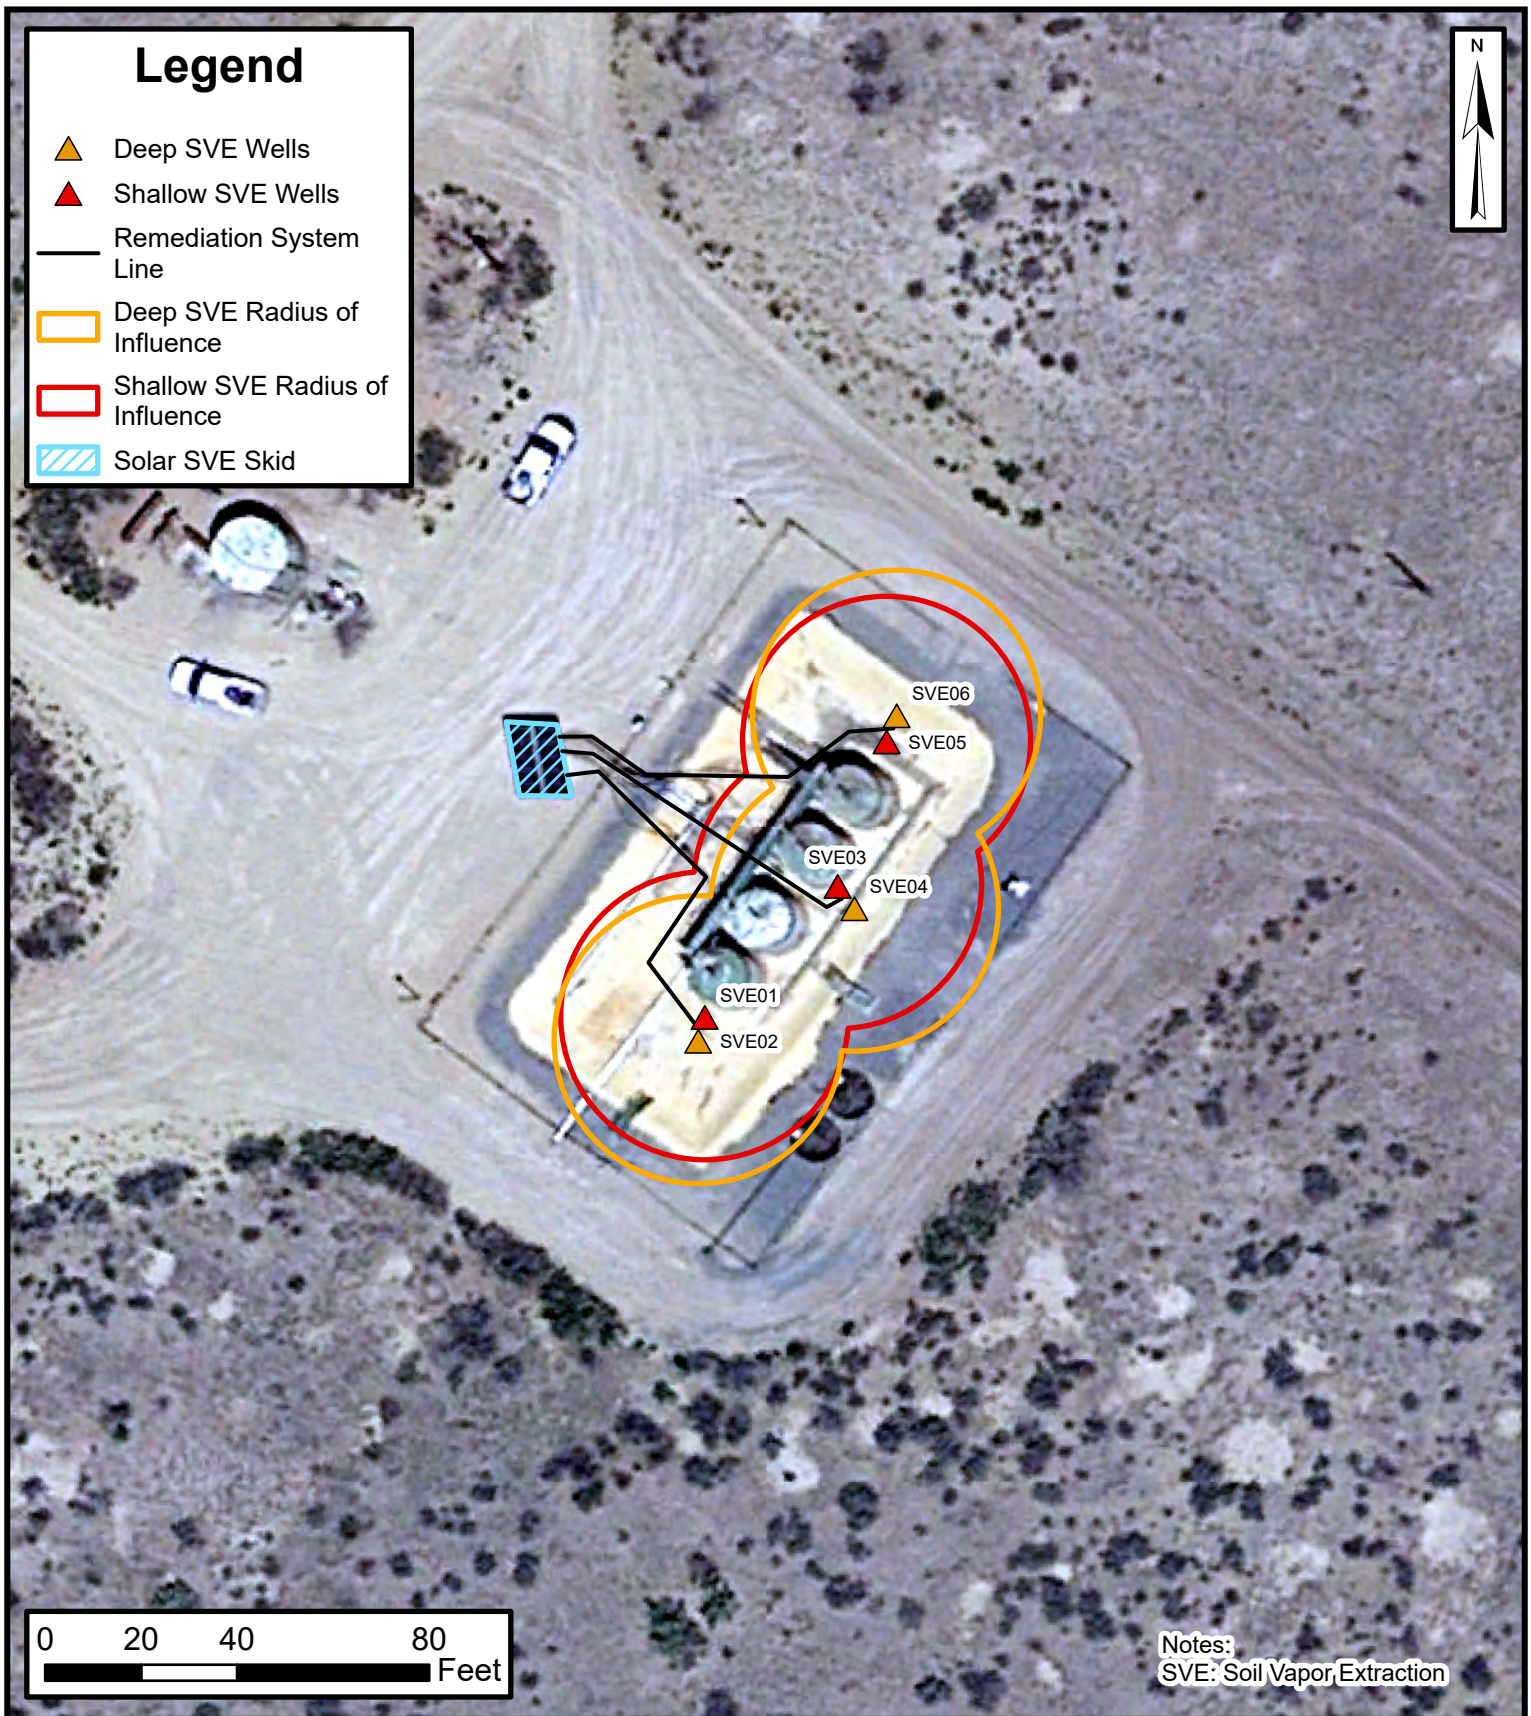
SVE System Layout

The solar SVE system consists of three shallow wells (SVE01, SVE03, and SVE05) with depths ranging from 15 feet to 20 feet below ground surface (bgs) with 10-foot screened intervals, and three deep wells (SVE02, SVE04, and SVE06) with depths ranging from 35 feet to 40 feet bgs with 10-foot screened intervals. The solar SVE system is comprised of a 2.75 horsepower, three-phase blower capable of extracting 105 cubic feet per minute (cfm) at 50 inches of water column (IWC) vacuum, with a maximum vacuum capability of 84 IWC. Each SVE well has a dedicated leg with an adjustable valve and vacuum gauge to control the individual flow rates and vacuum prior to manifolding together before the water knockout tank and blower. Harvest utilized a solar-powered SVE system due to the remote location and the lack of electrical grid power at the Site. The direct-drive blower motor is connected to the solar panels via a motor controller that automatically starts the system as sunlight is available and throttles the blower up as sun power increases throughout the day to maximize efficiency. Seasonally, there are approximately 10 hours in the winter and 12 hours in the summer of available solar power in Farmington, New

Mexico. The complete solar SVE system is constructed as one unit designed for utilization at off-grid locations and operates autonomously. The layout of the solar SVE system is depicted on Figure 2.

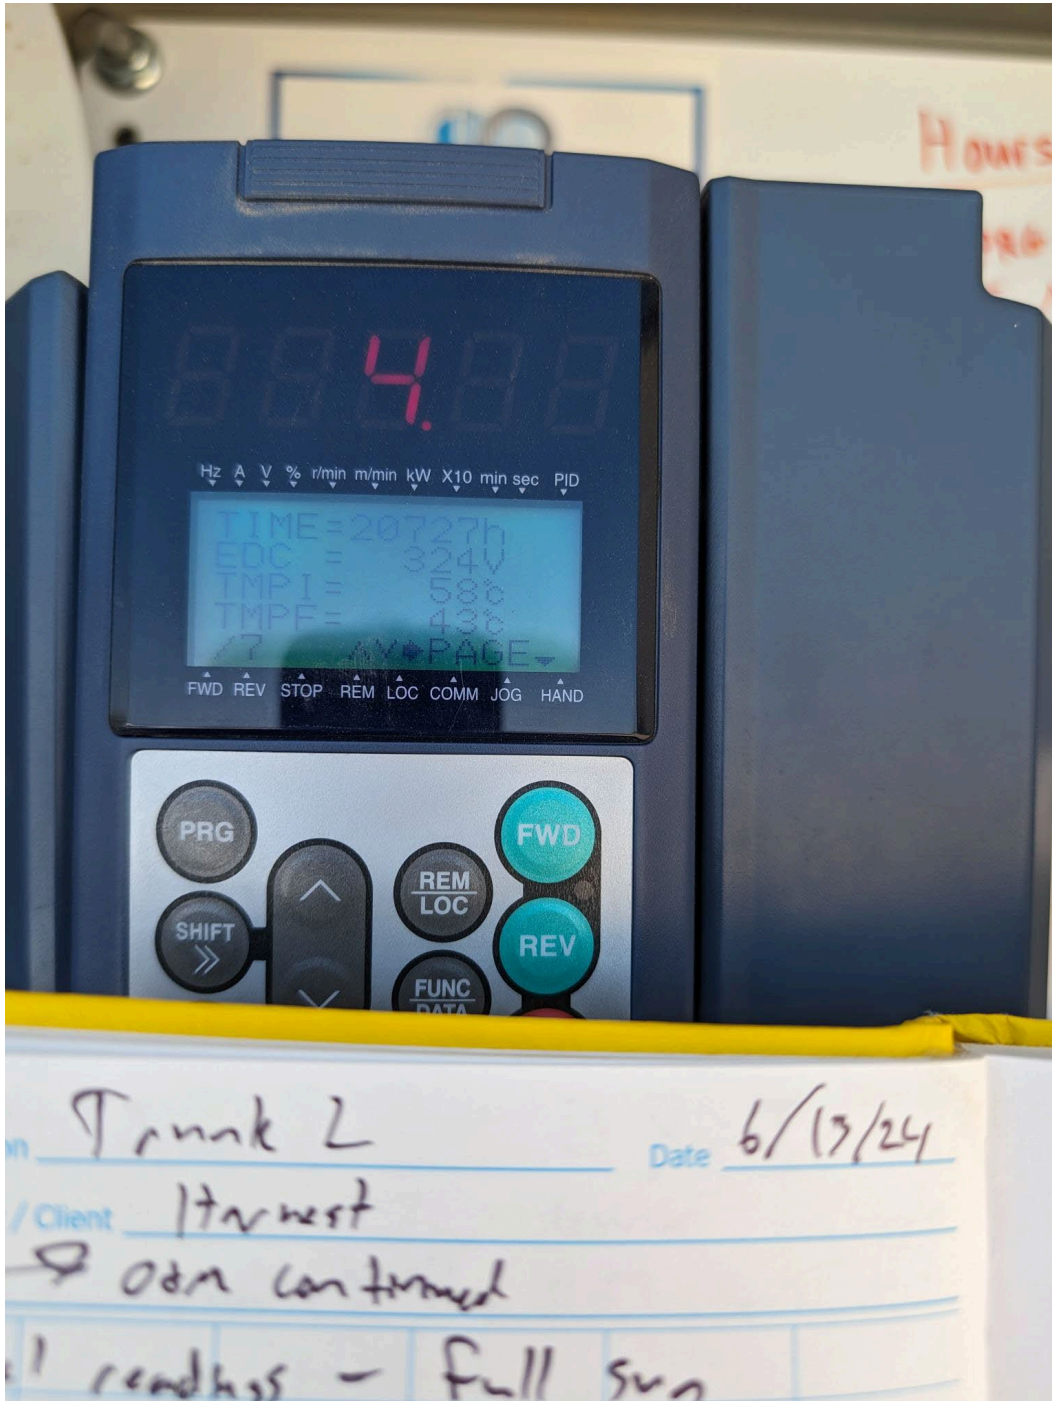
Photo #1
SVE Hours Reading 6/13/2024

Between startup of the solar SVE system on September 18, 2019, and the last quarterly Site visit on June 13, 2024, there have been 1,730 days of operation, with an estimated 20,213 total hours of nominal daylight available for solar SVE system operations. A photographic log of the hours meter reading is included as Appendix A. Since installation, the system has had an actual runtime of 20,727 hours, for an overall uptime of 102.5 percent (%) of the available runtime hours. Below is a table showing SVE system runtime in comparison with nominal available daylight hours per month, according to the National Renewable Energy Laboratory (NREL).
