CLOSURE REQUEST REPORT

**East Lusk 15 Federal Com 2H
Lea County, New Mexico
Incident Number nAPP2406276831**

**Prepared for:
Coterra Energy (Cimarex Energy Co. Of Colorado)**

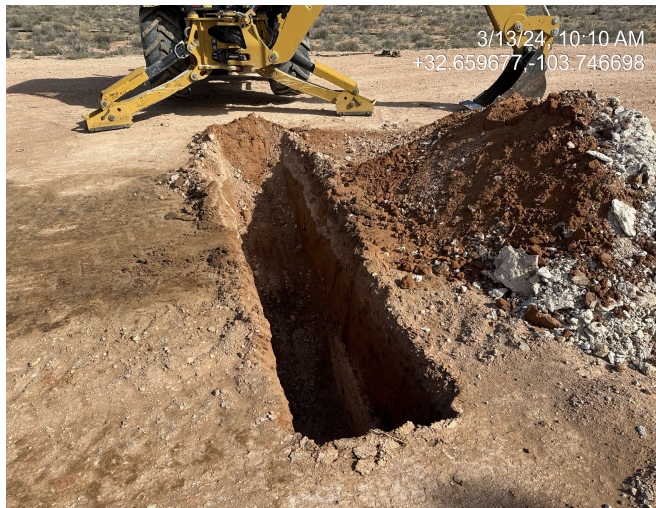
Photograph 1

Description: Northern view of delineation activities.

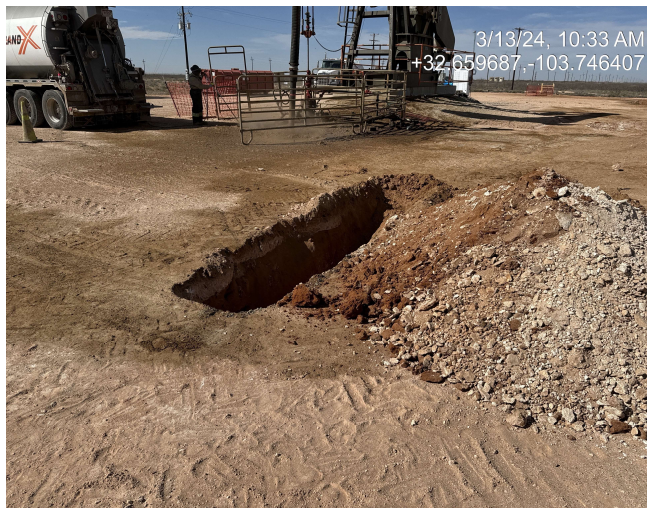
Photograph 2

Description: Southwestern view of delineation activities.

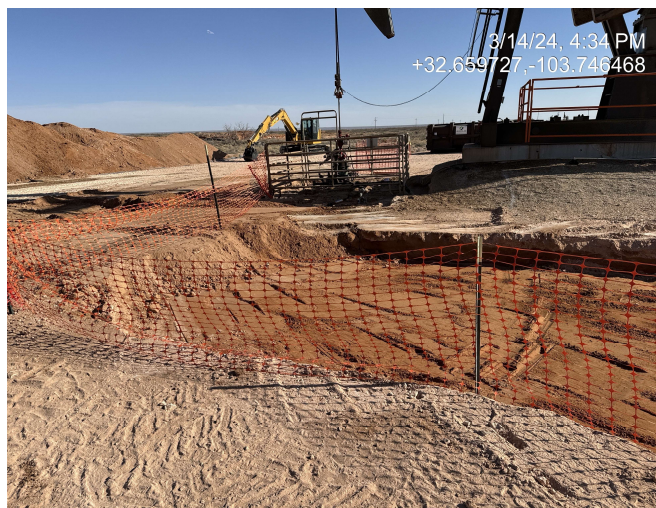
Photograph 3

Description: Southeastern view of excavation activities.

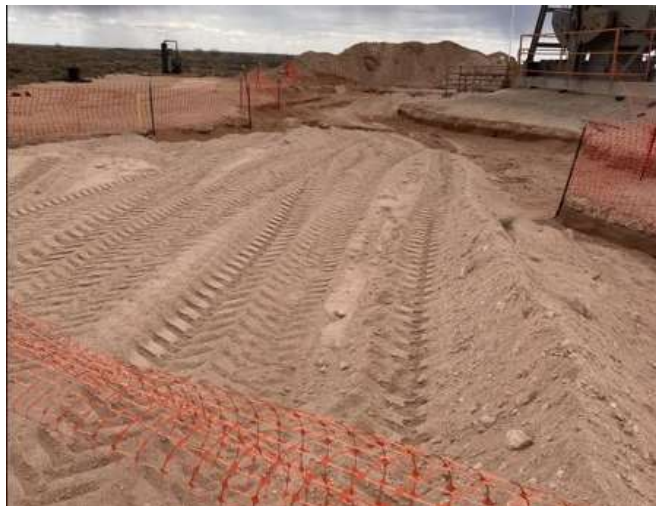
Photograph 5

Description: Southeastern view of restoration activities.

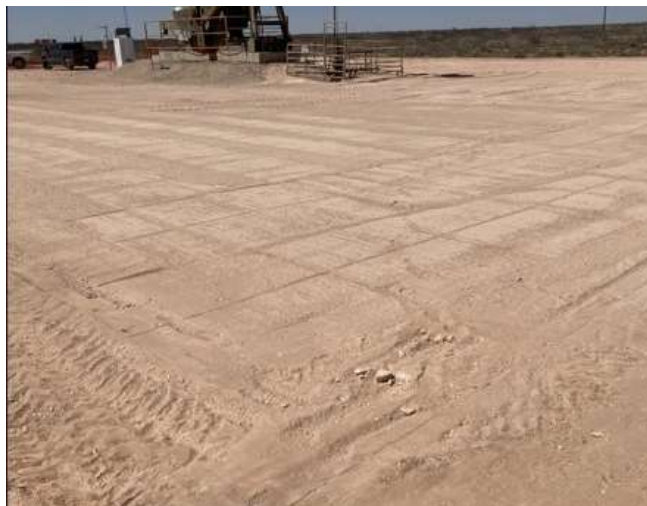
Photograph 6

Description: Northwestern view of restoration activities.

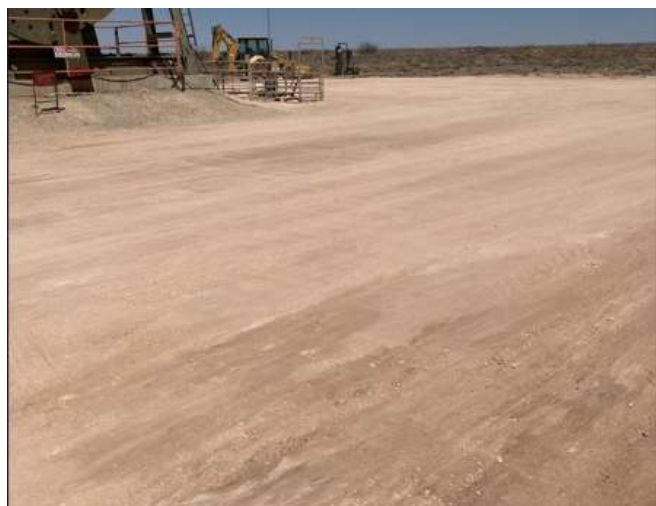
Photograph 7

Description: Northeastern view of restoration activities.
