Release Assessment and Closure

Outland State #003

API: 30-025-35243

Devon Energy Production Company, LP

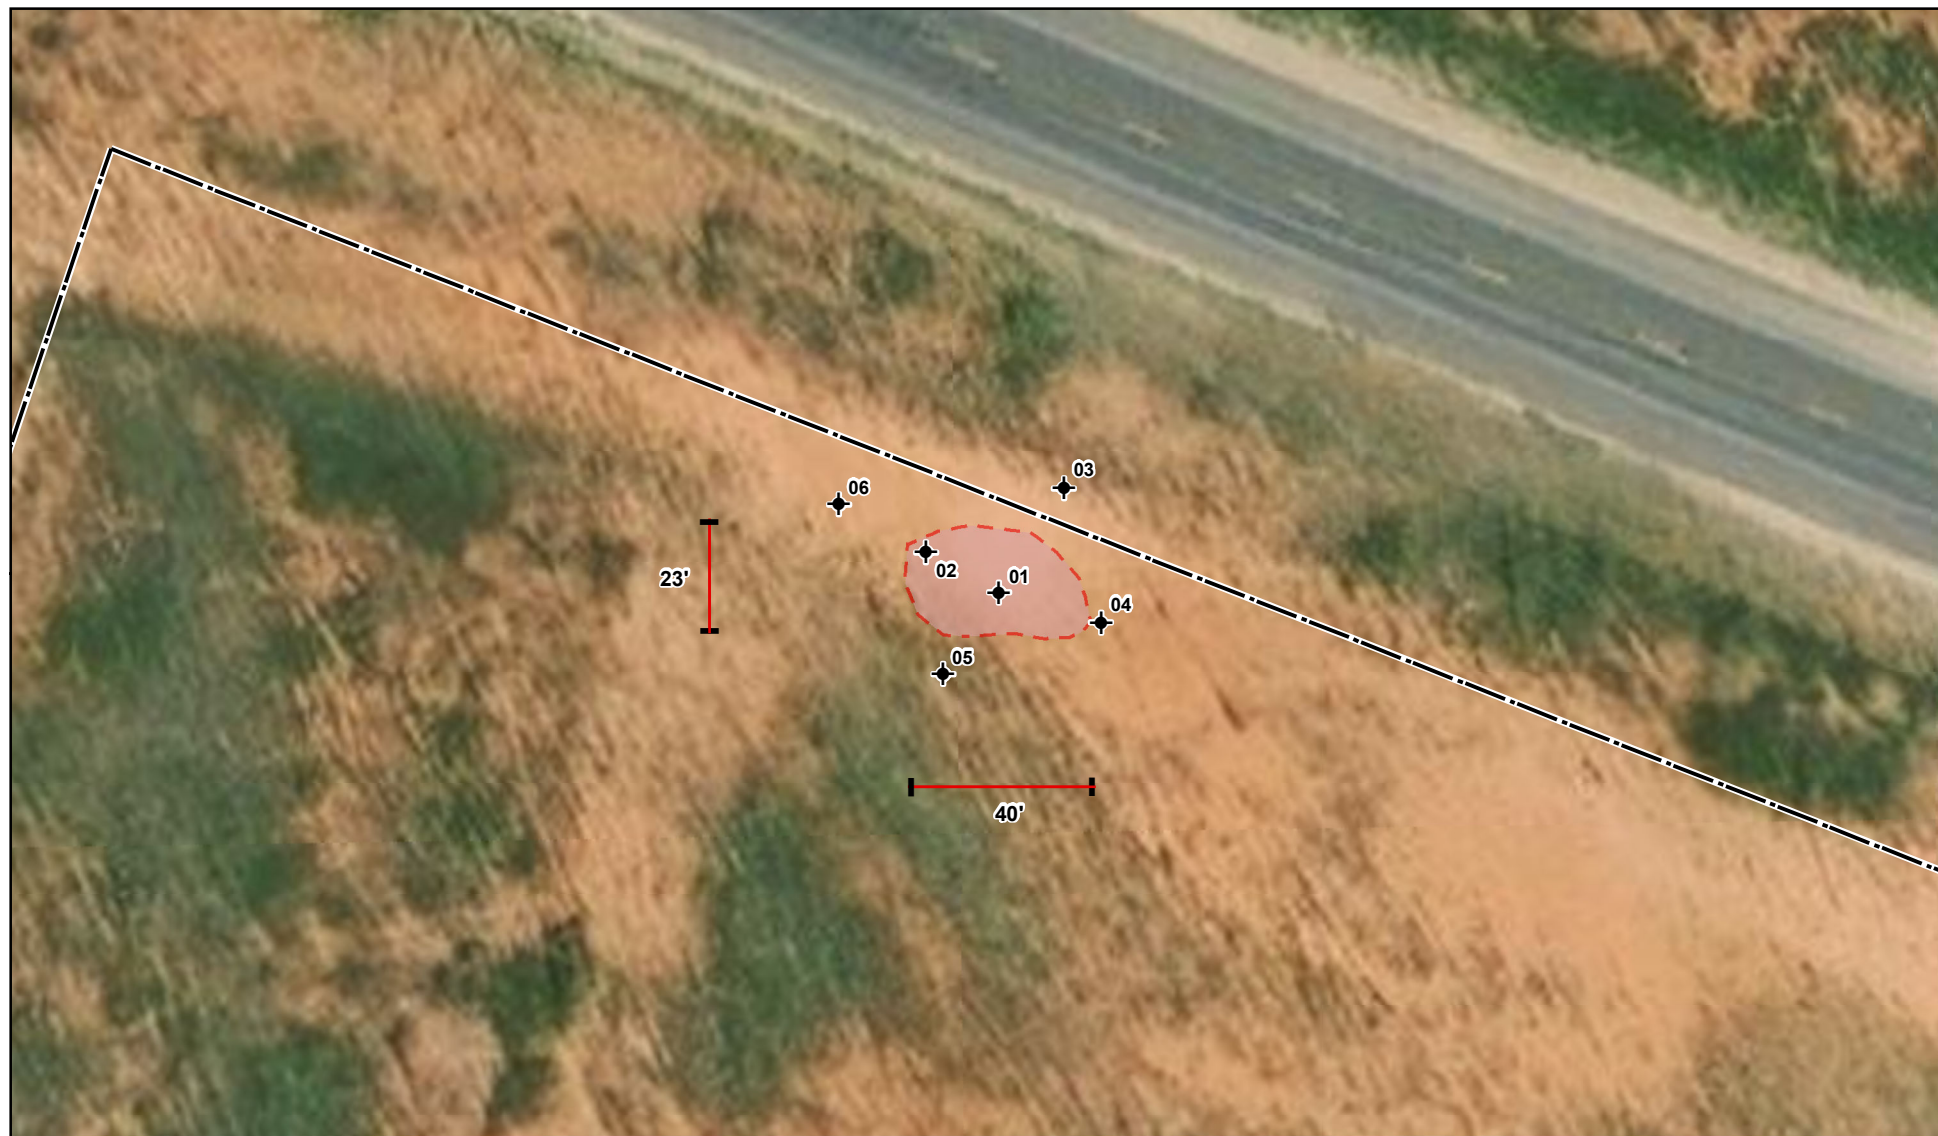
◆ Borehole (Prefixed by "BH23-") [---] Approximate Lease Boundary [---] Approximate Release Area (~ 785 sq. ft.)

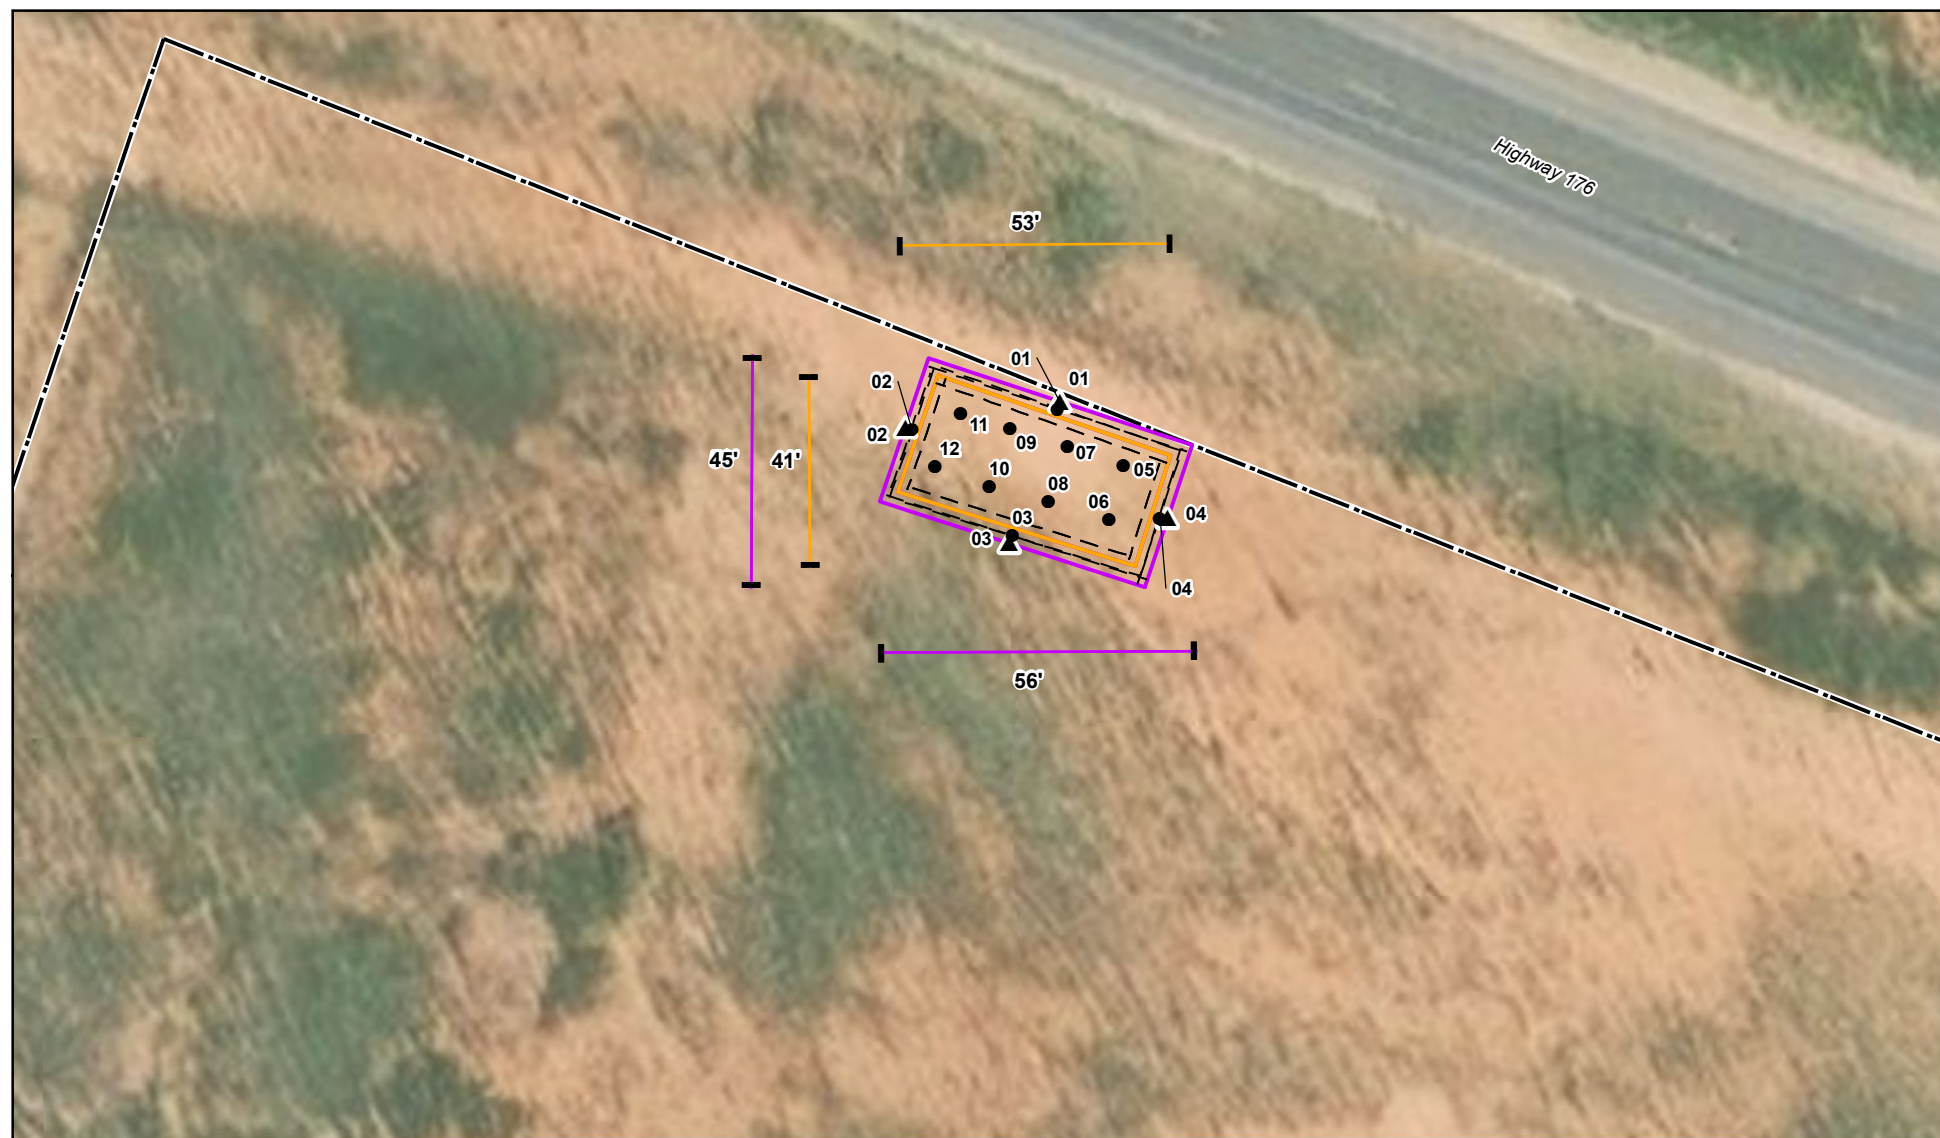
● Base Sample (Excavated) (Prefixed by "BE24-")

▲ Wall Sample (Excavated) (Prefixed by "WS24-")

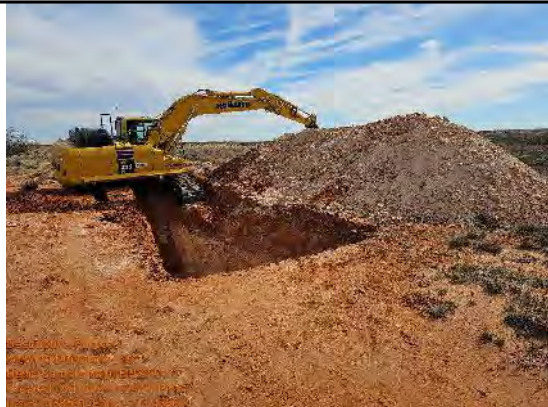
Sample point BH23-01.

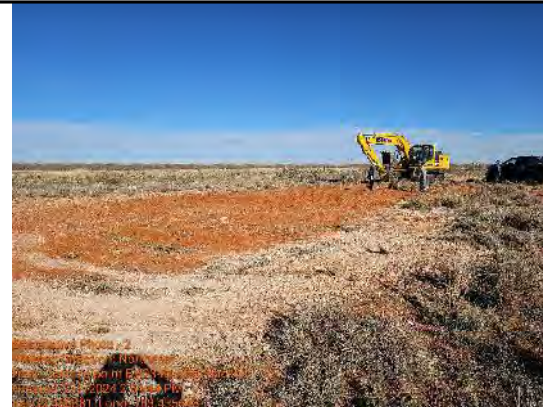
Sample point BH23-01 after backfill.

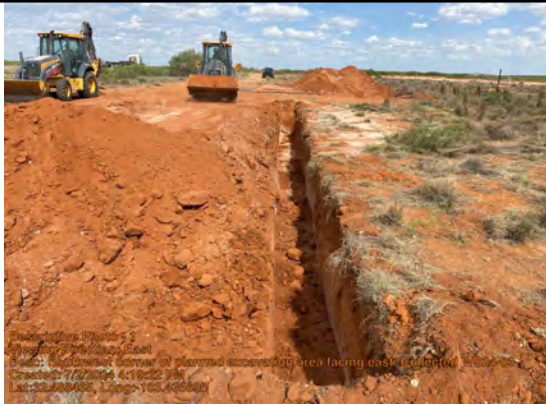
Southwest corner of planned excavation area facing east. Collected WS24-03 and BS24-03 from south portion of excavation.

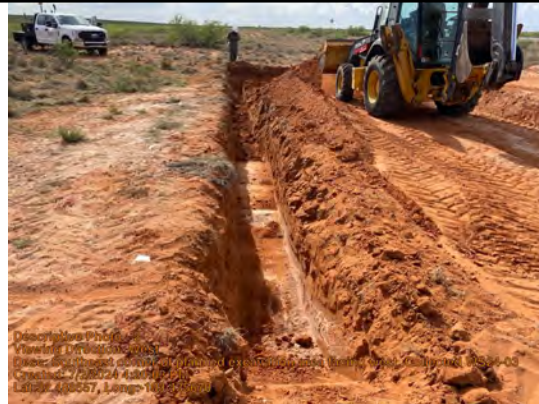
Southeast corner of planned excavation area facing west. Collected WS24-03 and BS24-03 from south portion of excavation.

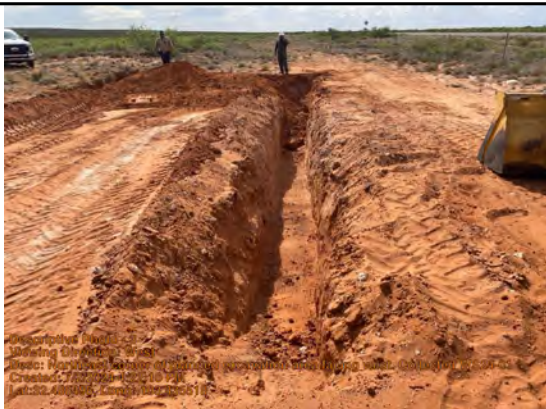
Northeast corner of planned excavation area facing west. Collected WS24-01 and BS24-01 from north portion of excavation.

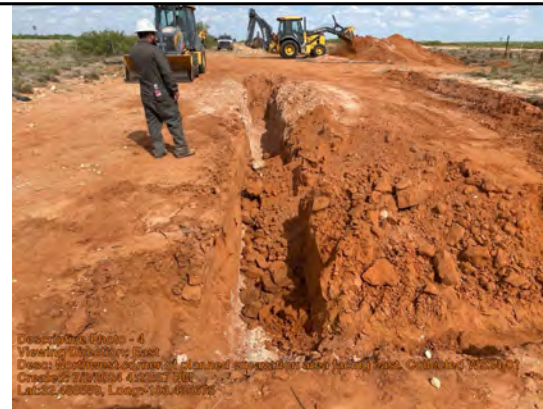
Northwest corner of planned excavation area facing east. Collected WS24-01 and BS24-01 from north portion of excavation.

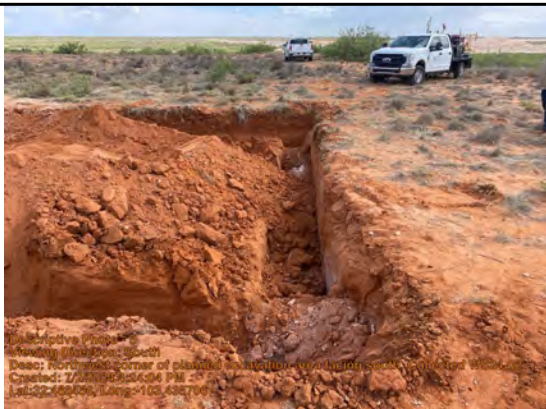
Northwest corner of planned excavation area facing south. Collected WS24-02 and BS24-02 from west portion of excavation.

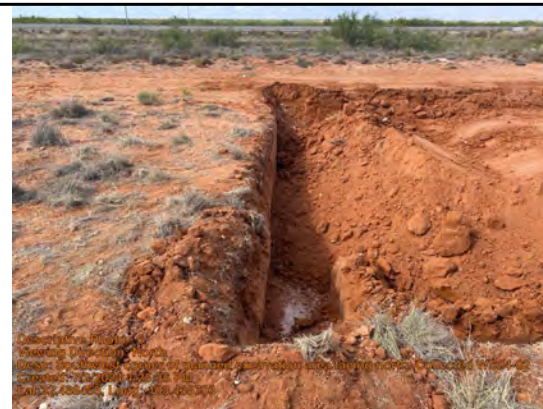
Southwest corner of planned excavation area facing north. Collected WS24-02 and BS24-02 from west portion of excavation.

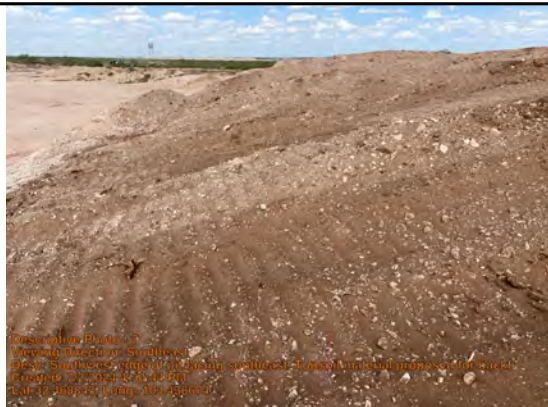
Southwest edge of pit facing southeast. Topsoil material proposed for backfill.

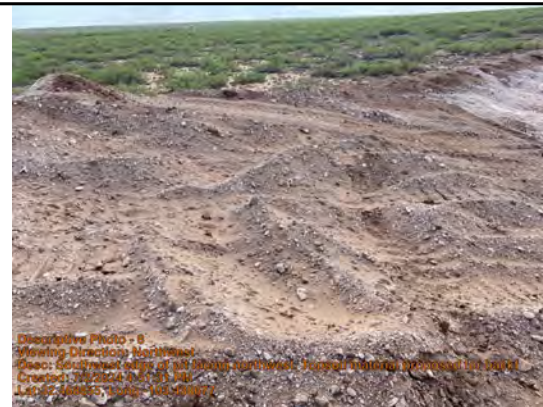
Southwest edge of pit facing northwest. Topsoil material proposed for backfill.

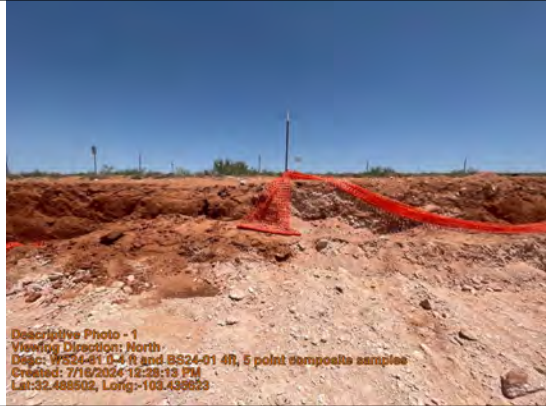
WS24-01 0-4 ft and BS24-01 4ft, 5 point composite samples

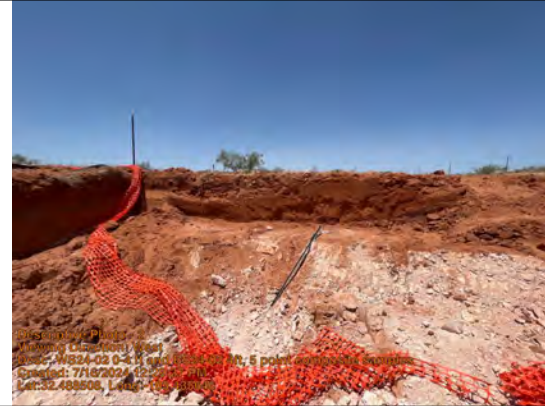
WS24-02 0-4 ft and BS24-02 4ft, 5 point composite samples

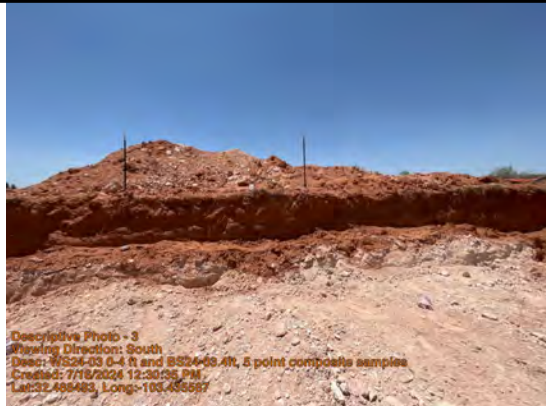
WS24-03 0-4 ft and BS24-03 4ft, 5 point composite samples

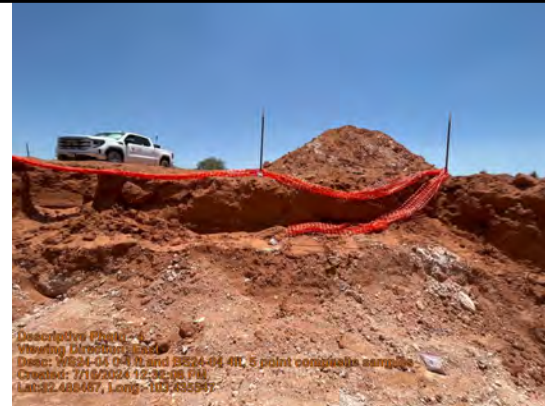
WS24-04 0-4 ft and BS24-04 4ft, 5 point composite samples

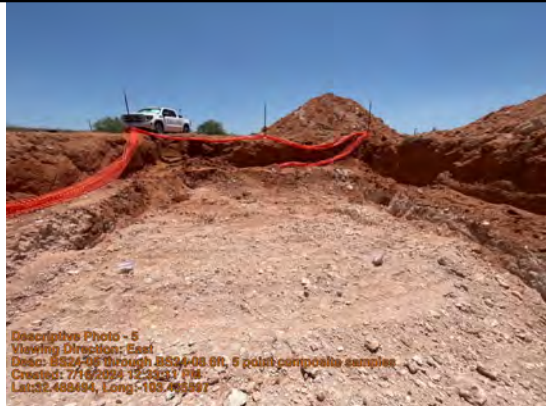
BS24-05 through BS24-08 6ft, 5 point composite samples

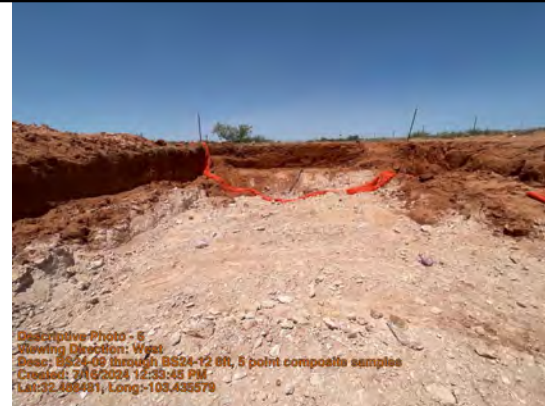
BS24-09 through BS24-12 6ft, 5 point composite samples

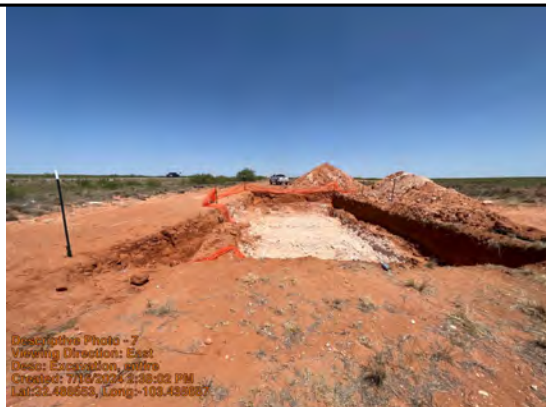
Excavation, entire
