BROADSDE 12 FACILITY 2

nAPP2312824558

**Re: Site Assessment and Closure Report**  
**Broadside 12 CTB 2**  
**API No. N/A**  
**GPS: Latitude 32.22580359 Longitude -103.5185014**  
**UL –P Section 12, T24S, R33E**  
**Lea County, NM**  
**NMOCD Ref. No. NAPP2312824558**

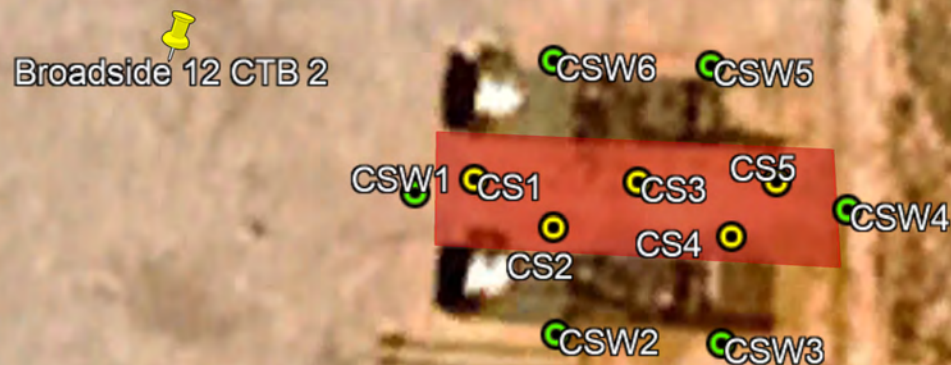
Devon Energy  
API: N/A  
Lea County, NM  
Confirmation Map

On May 30, 2024, after sending a 48-hour notification, application ID:348565 (Appendix C), Pima returned to the site to collect confirmation samples of the area. The results of this sampling event can be found in the following table. A Confirmation Sample Map can be found in Figure 5.

The sample results were below NMOCD Closure Criteria 19.15.29 NMAC. Based on these findings, no further remediation activities are required at this time.

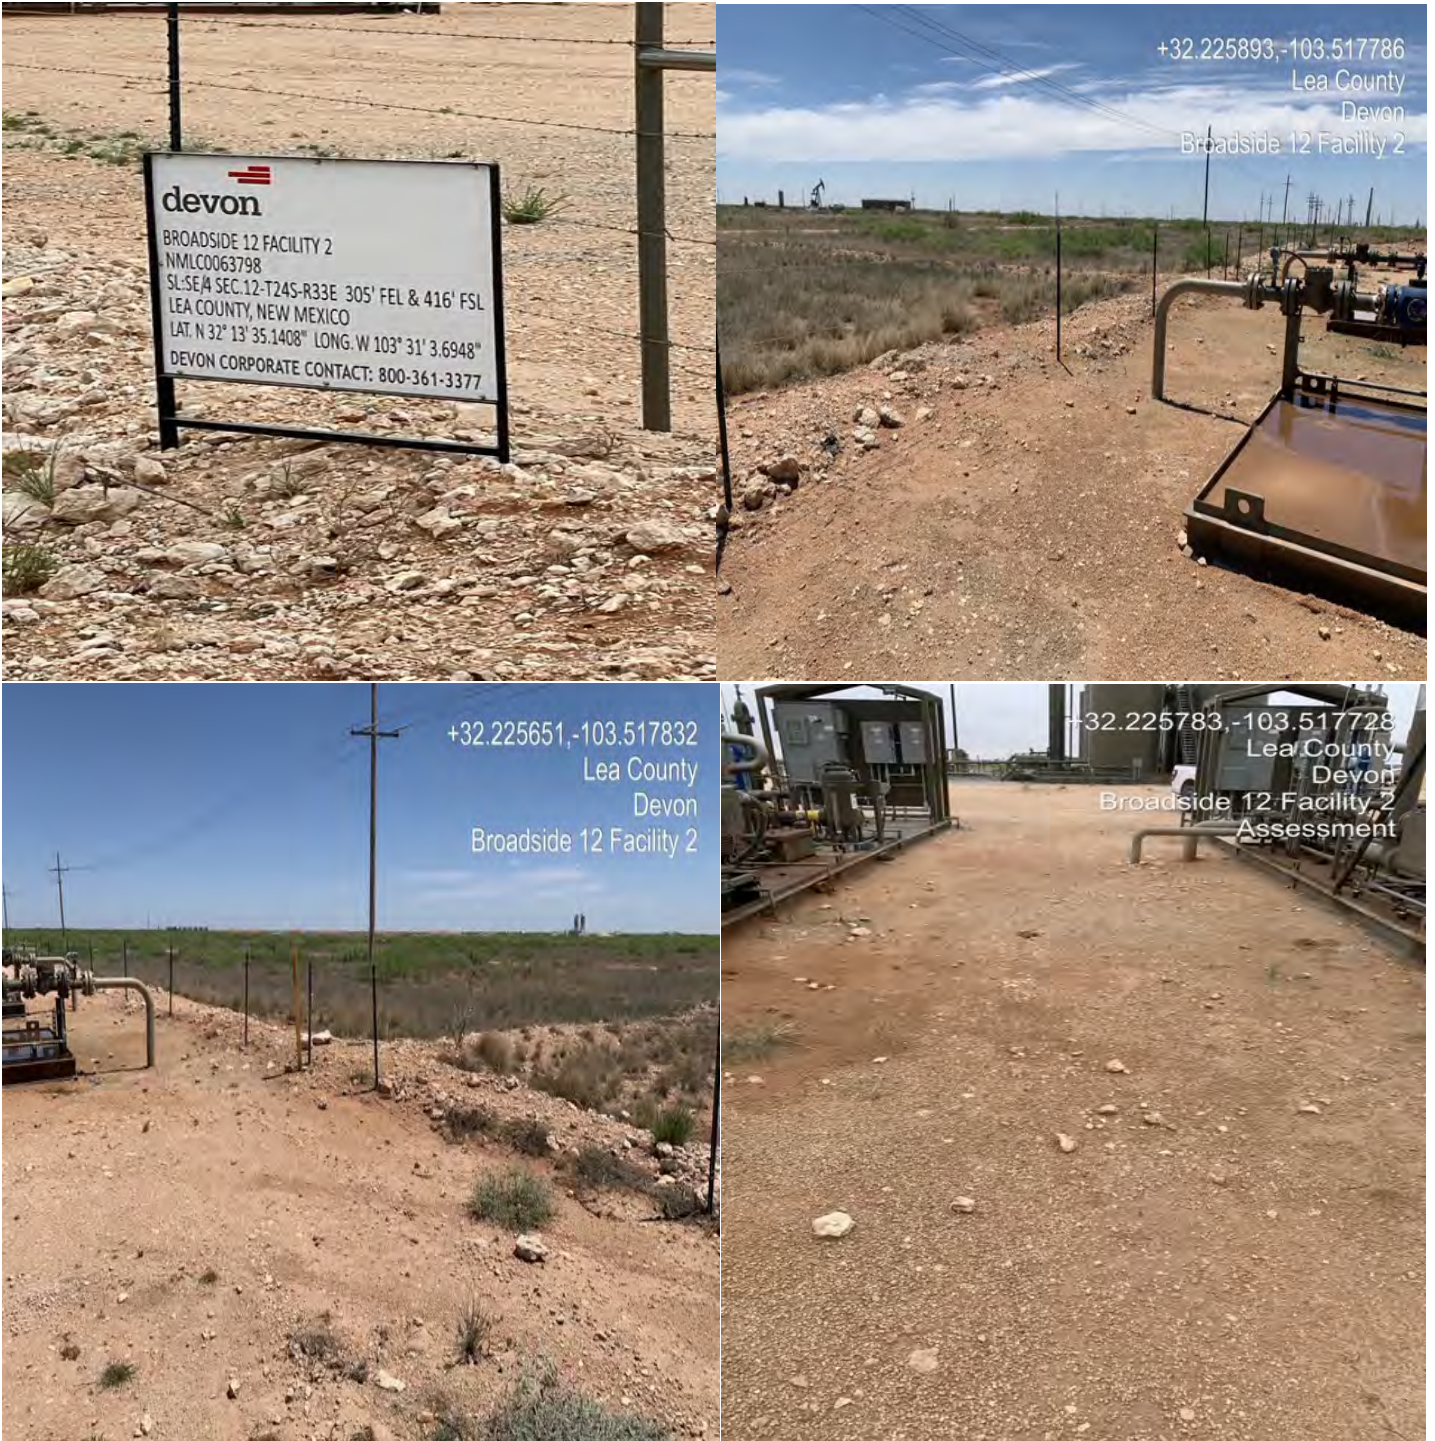
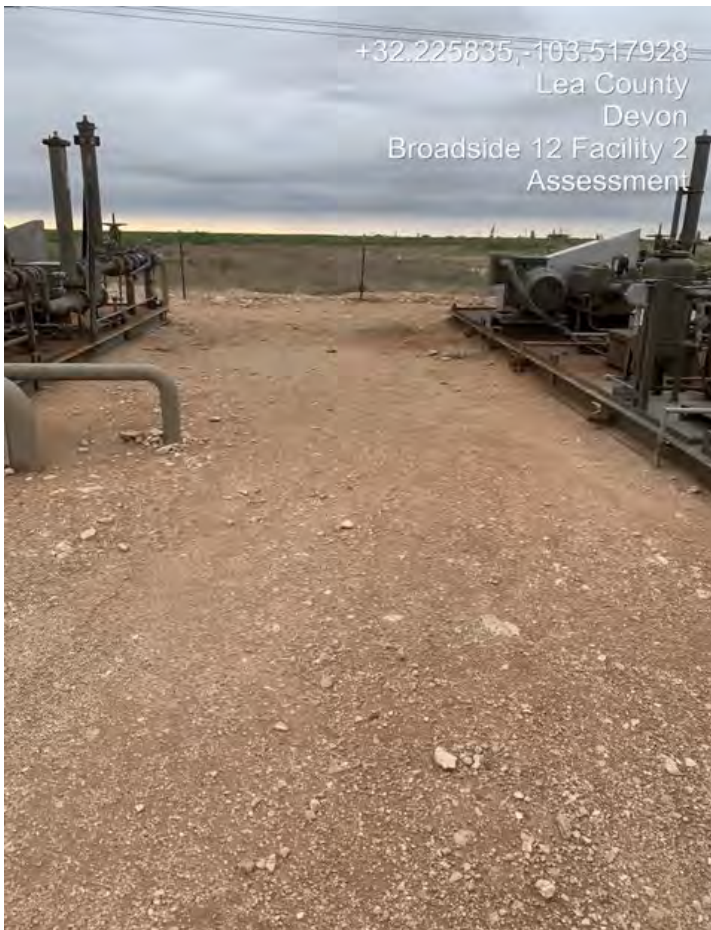
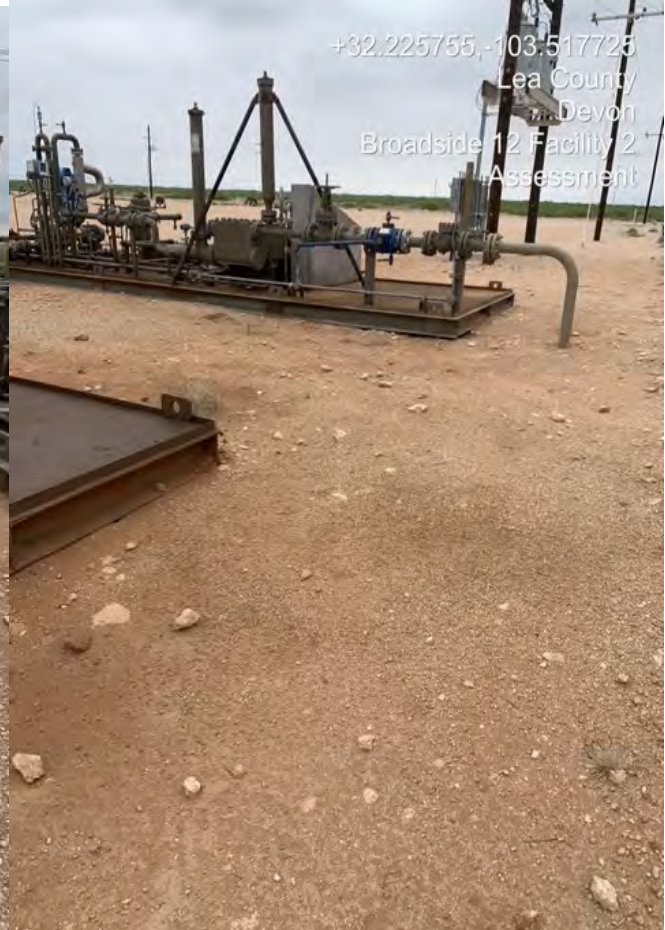
**Site Assessment**

**NAPP2312824558** On May 7, 2023, a 3<sup>rd</sup> party reported leaking and spraying from LACT pump skid, causing fluid to be released. The released fluids were calculated to be approximately 2 barrels (bbls) of crude oil, no fluids were able to be recovered.
