# Trinity Oilfield Services & Rentals, LLC

Re: **Remediation Plan Request**  
**Southeast Maljamar GB/SA Unit #909**  
**Tracking #: NAPP2414132464**

Trinity Oilfield Services (Trinity), on behalf of Cross Timbers Energy, LLC, hereby submits the following Remediation Plan Request in response to a release that occurred at the above-referenced location, and further described below.

Site Information	
Incident ID	NAPP2414132464
Site Name	Southeast Maljamar GB/SA Unit #909
Lease ID	B025160069
Company	Cross Timbers Energy, LLC
County	Lea
ULSTR	O-29-17S-33E
GPS Coordinates (NAD 83)	32.798783, -103.684236
Landowner	Private

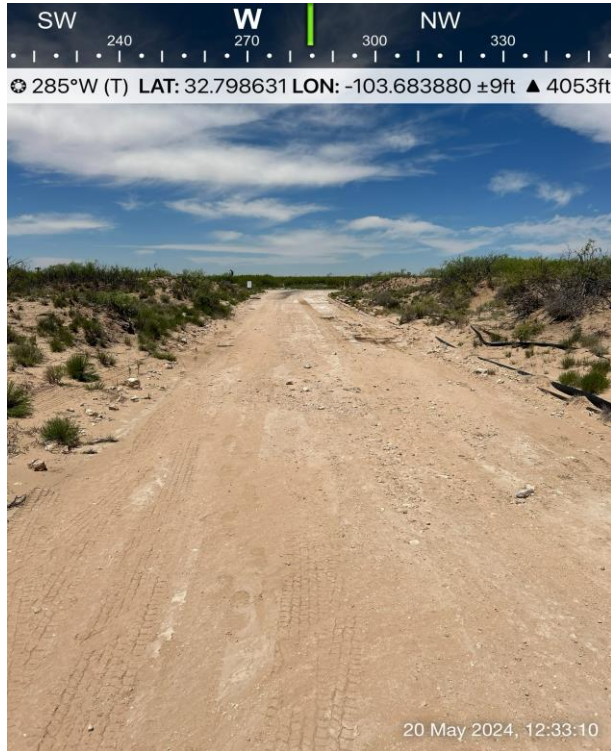
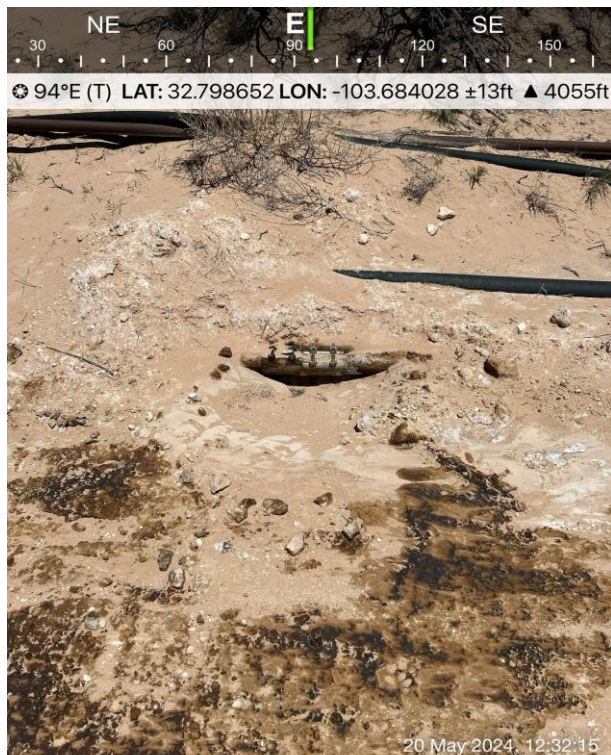
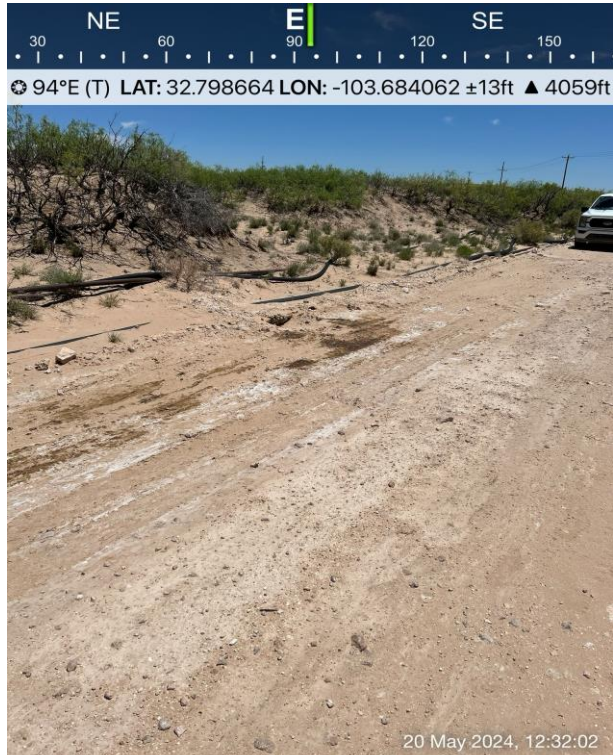
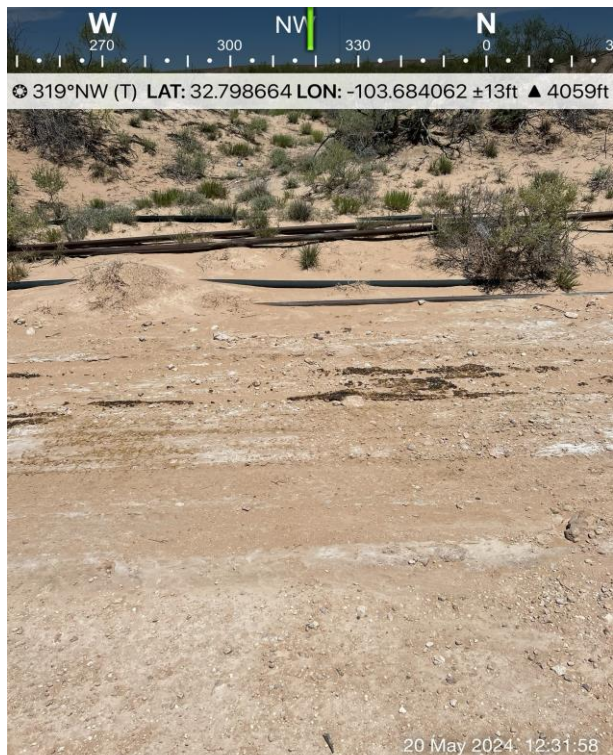
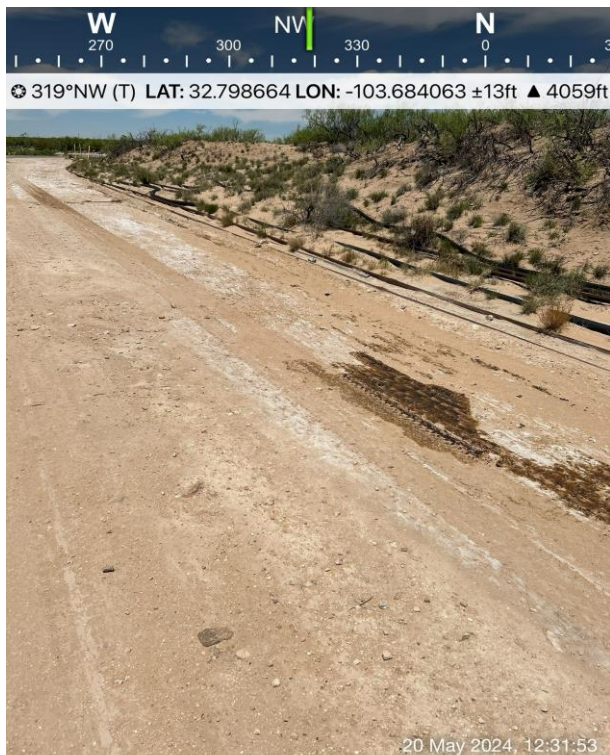
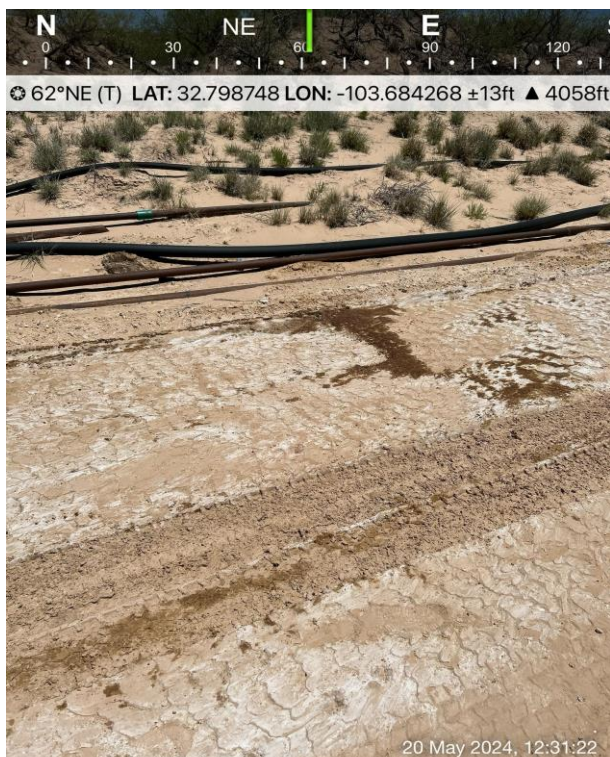
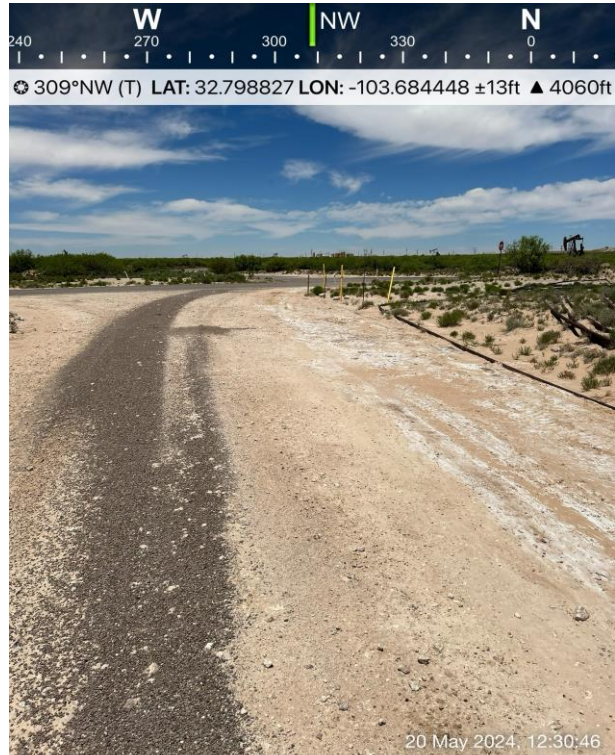
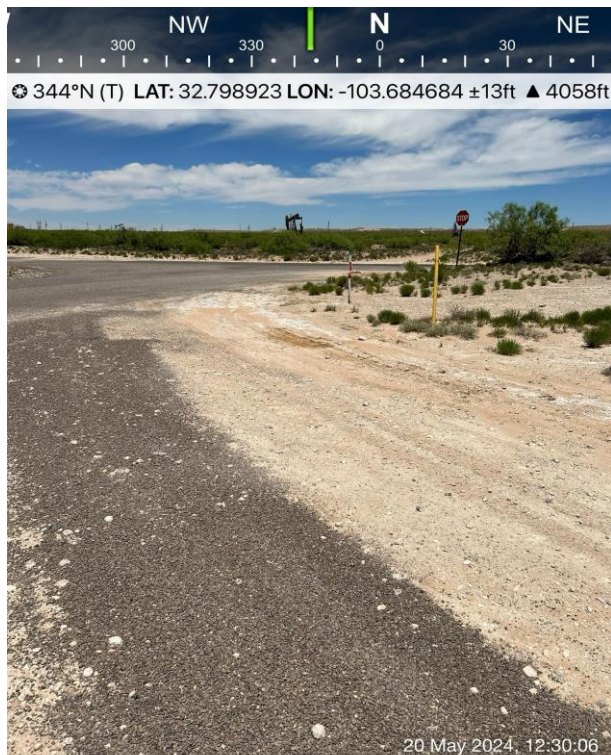
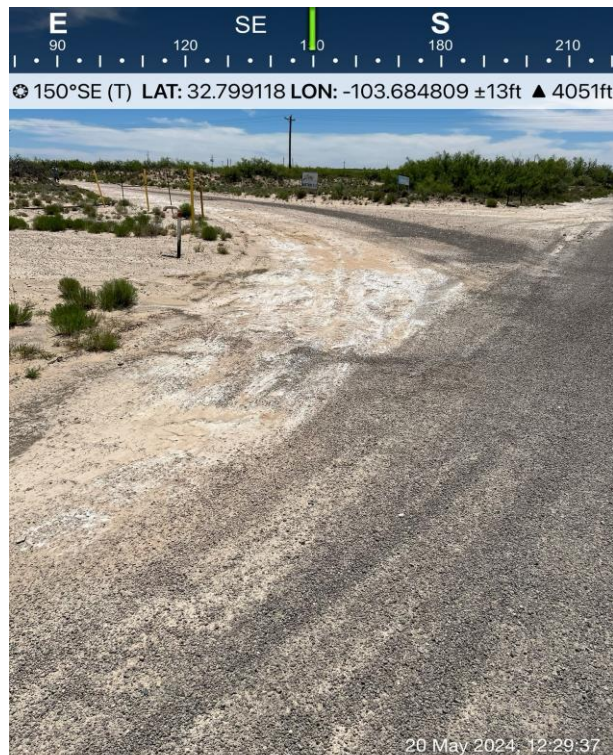
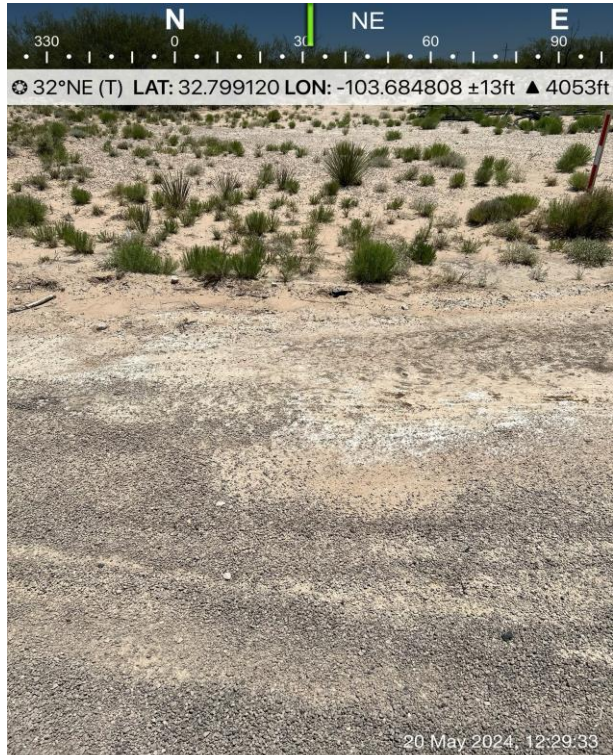
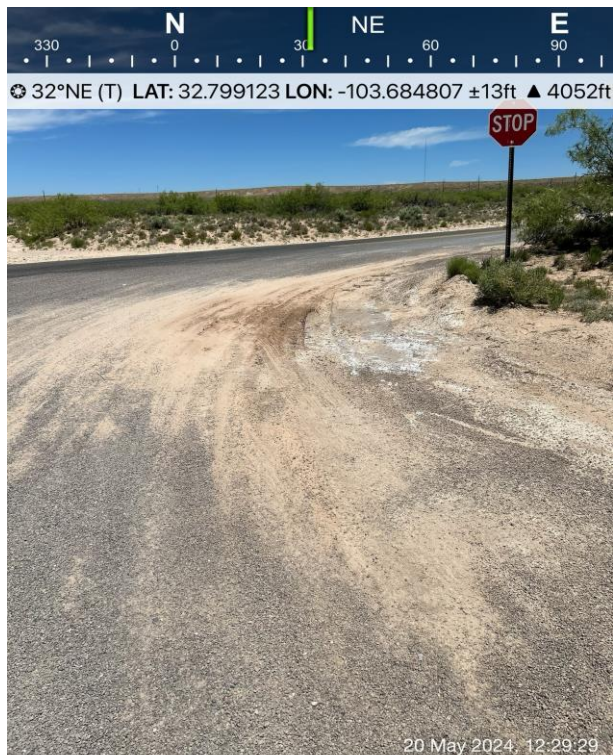
## Initial Release

On 05/20/2024, Cross Timbers Energy, LLC reported a release at the Southeast Maljamar GB/SA Unit #909. The release was caused by corrosion. Approximately 6,233 sqft. of the lease road was found to be damp upon initial inspection.

Areas affected by the release and the associated remediation activities will be restored to a condition that existed before the release to the extent practicable. The affected area will be contoured and/or compacted to provide erosion control, stability, and preservation of surface water flow. The area will be fenced off to mitigate grazing and soil compaction by cattle.
