Remediation Summary and Closure Request

Energex, LLC

Lucas Fee #1

NMOCD Incident # nAPP2411639976

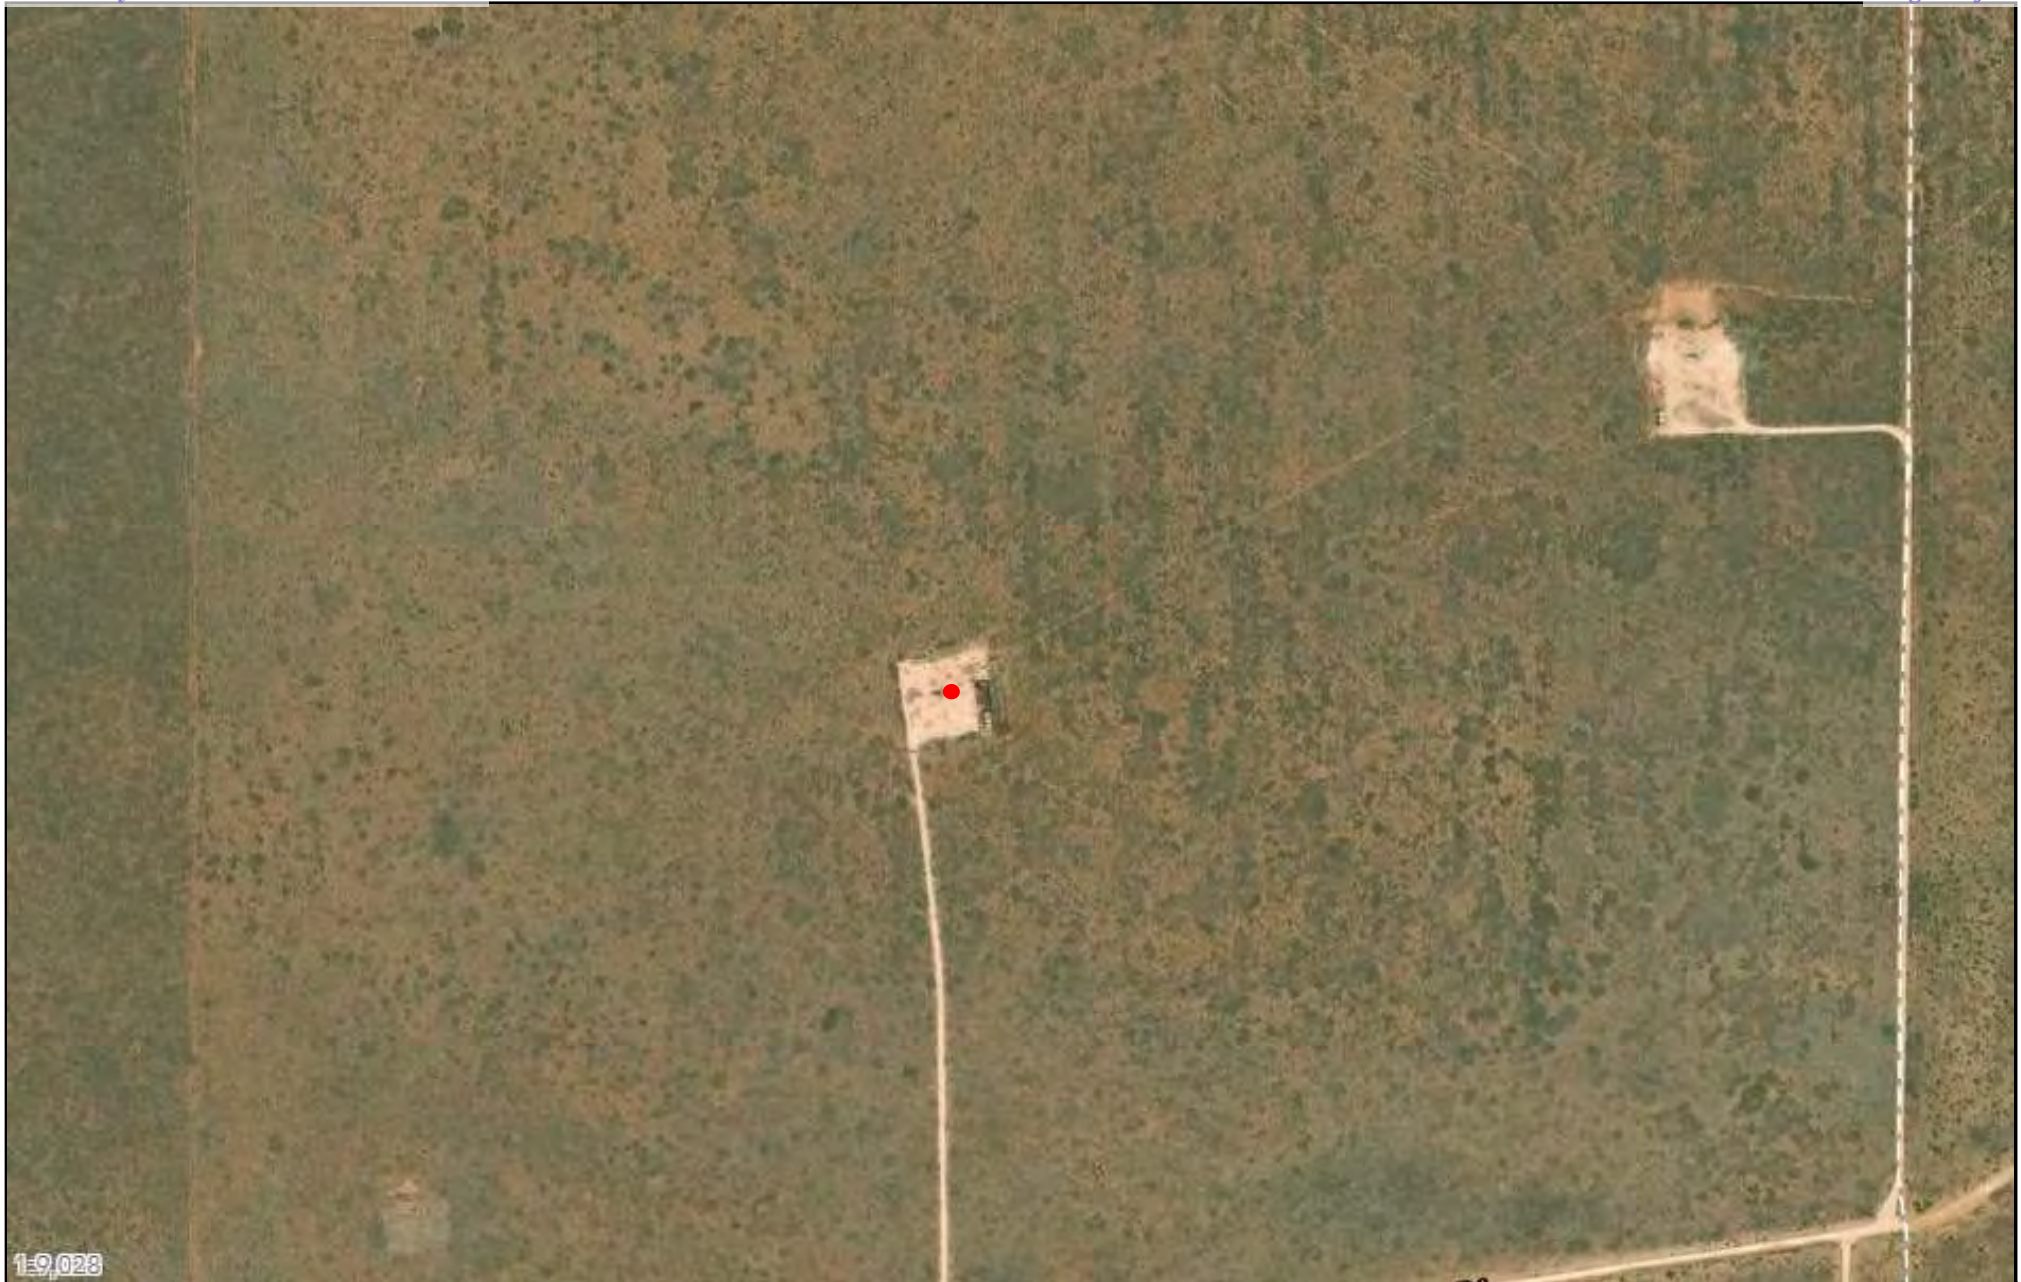
**Figure 2**

OSE POD Locations Map
Energex, LLC
Lucas Fee #1
GPS: 33.605541, -103.519656
Chaves County

The site is located in Unit Letter K (NE/SW), Section 24, Township 8 South, Range 33 East, approximately 27 miles Northwest of Tatum, in Chaves County, New Mexico. The property is located on private land. Topographic Map, OSE POD Locations Map, and USGS Well Locations Map are included as Figure 1, Figure 2, and Figure 3, respectively.

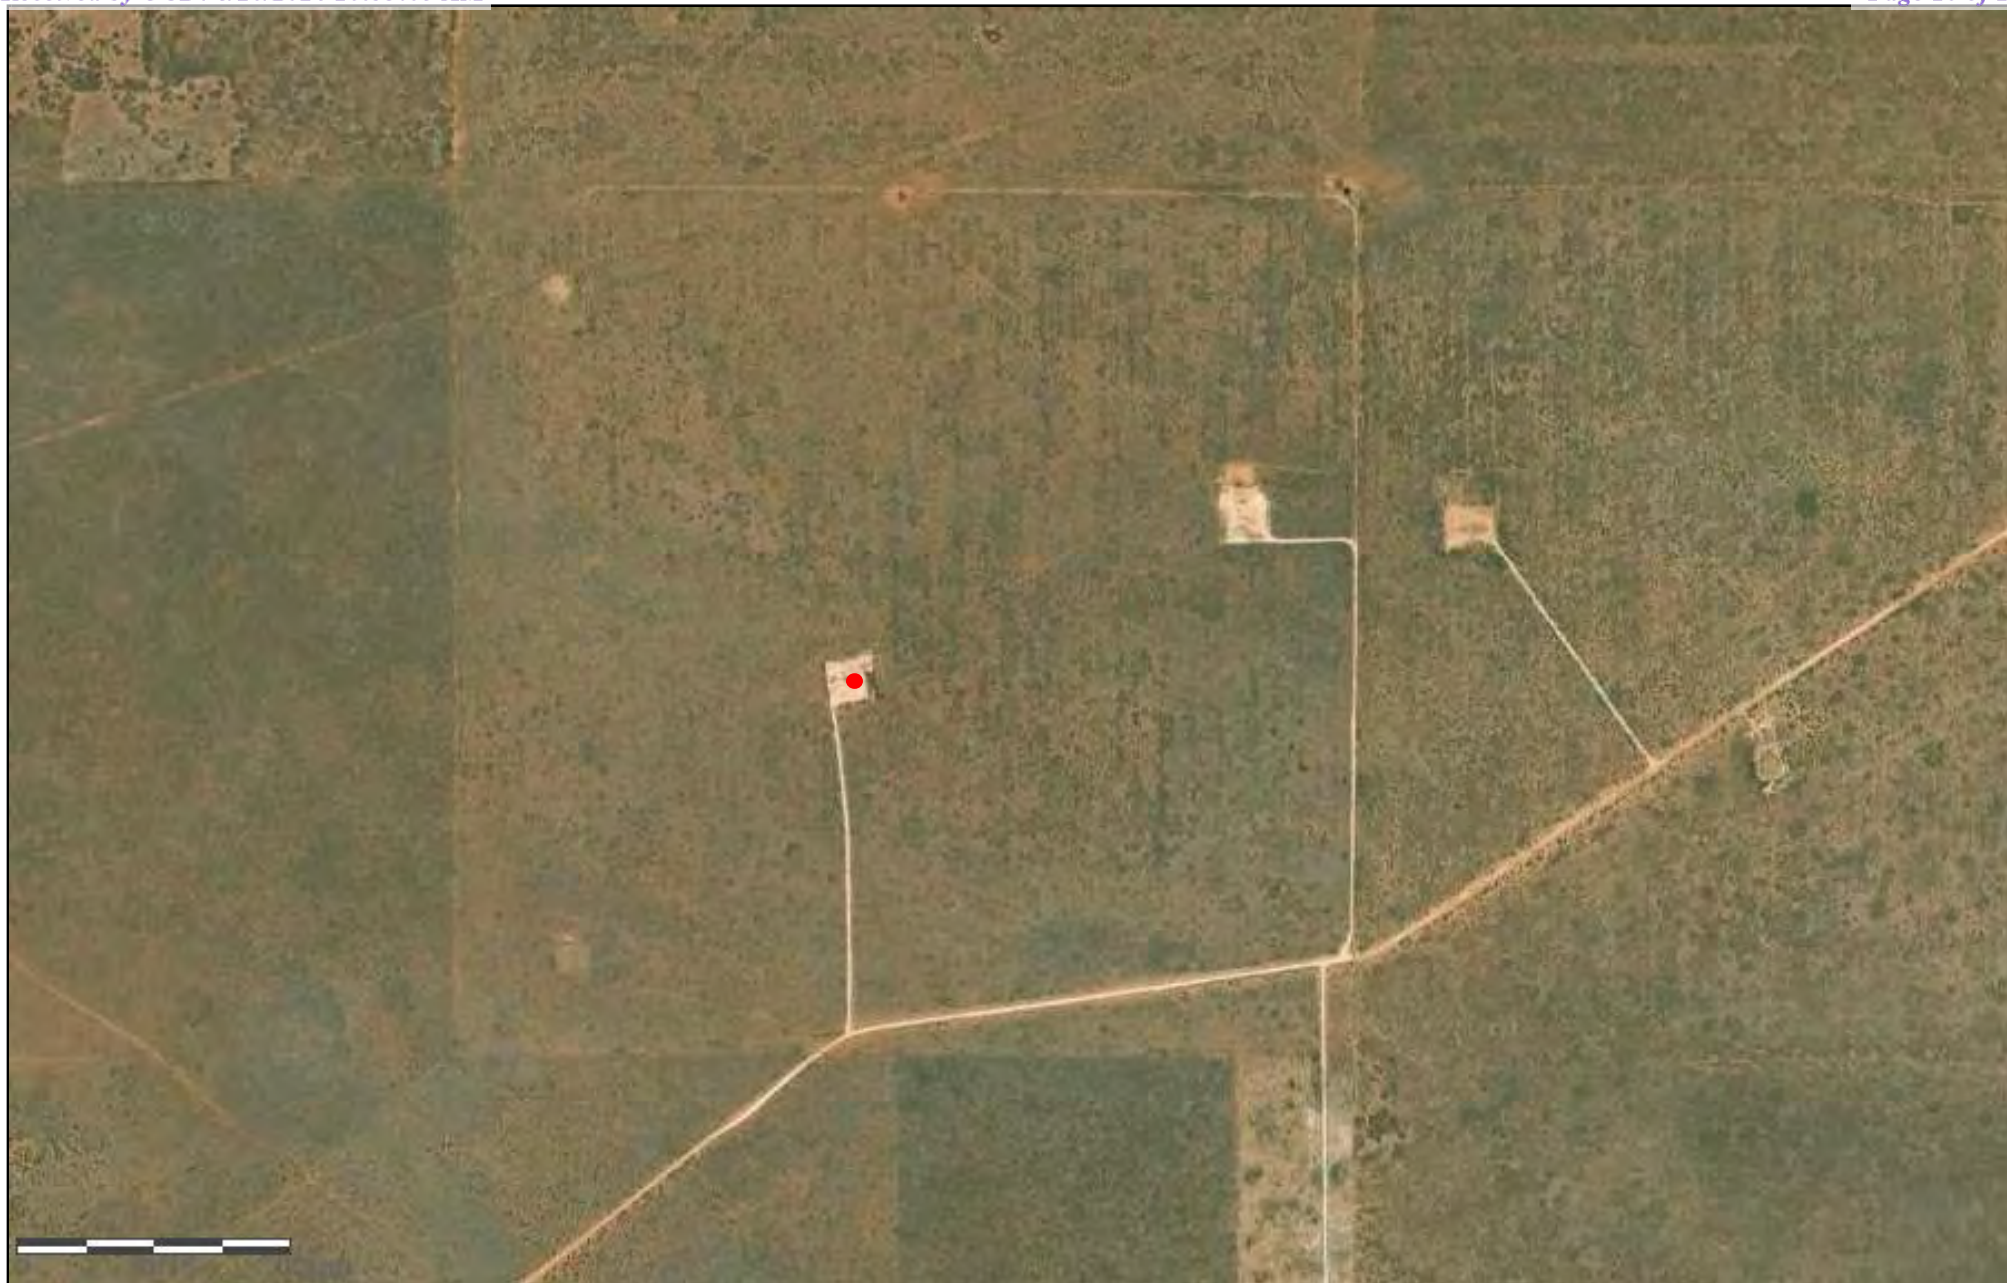
**Figure 3**

USGS Well Locations Map
Energex, LLC
Lucas Fee #1
GPS: 33.605541, -103.519656
Chaves County

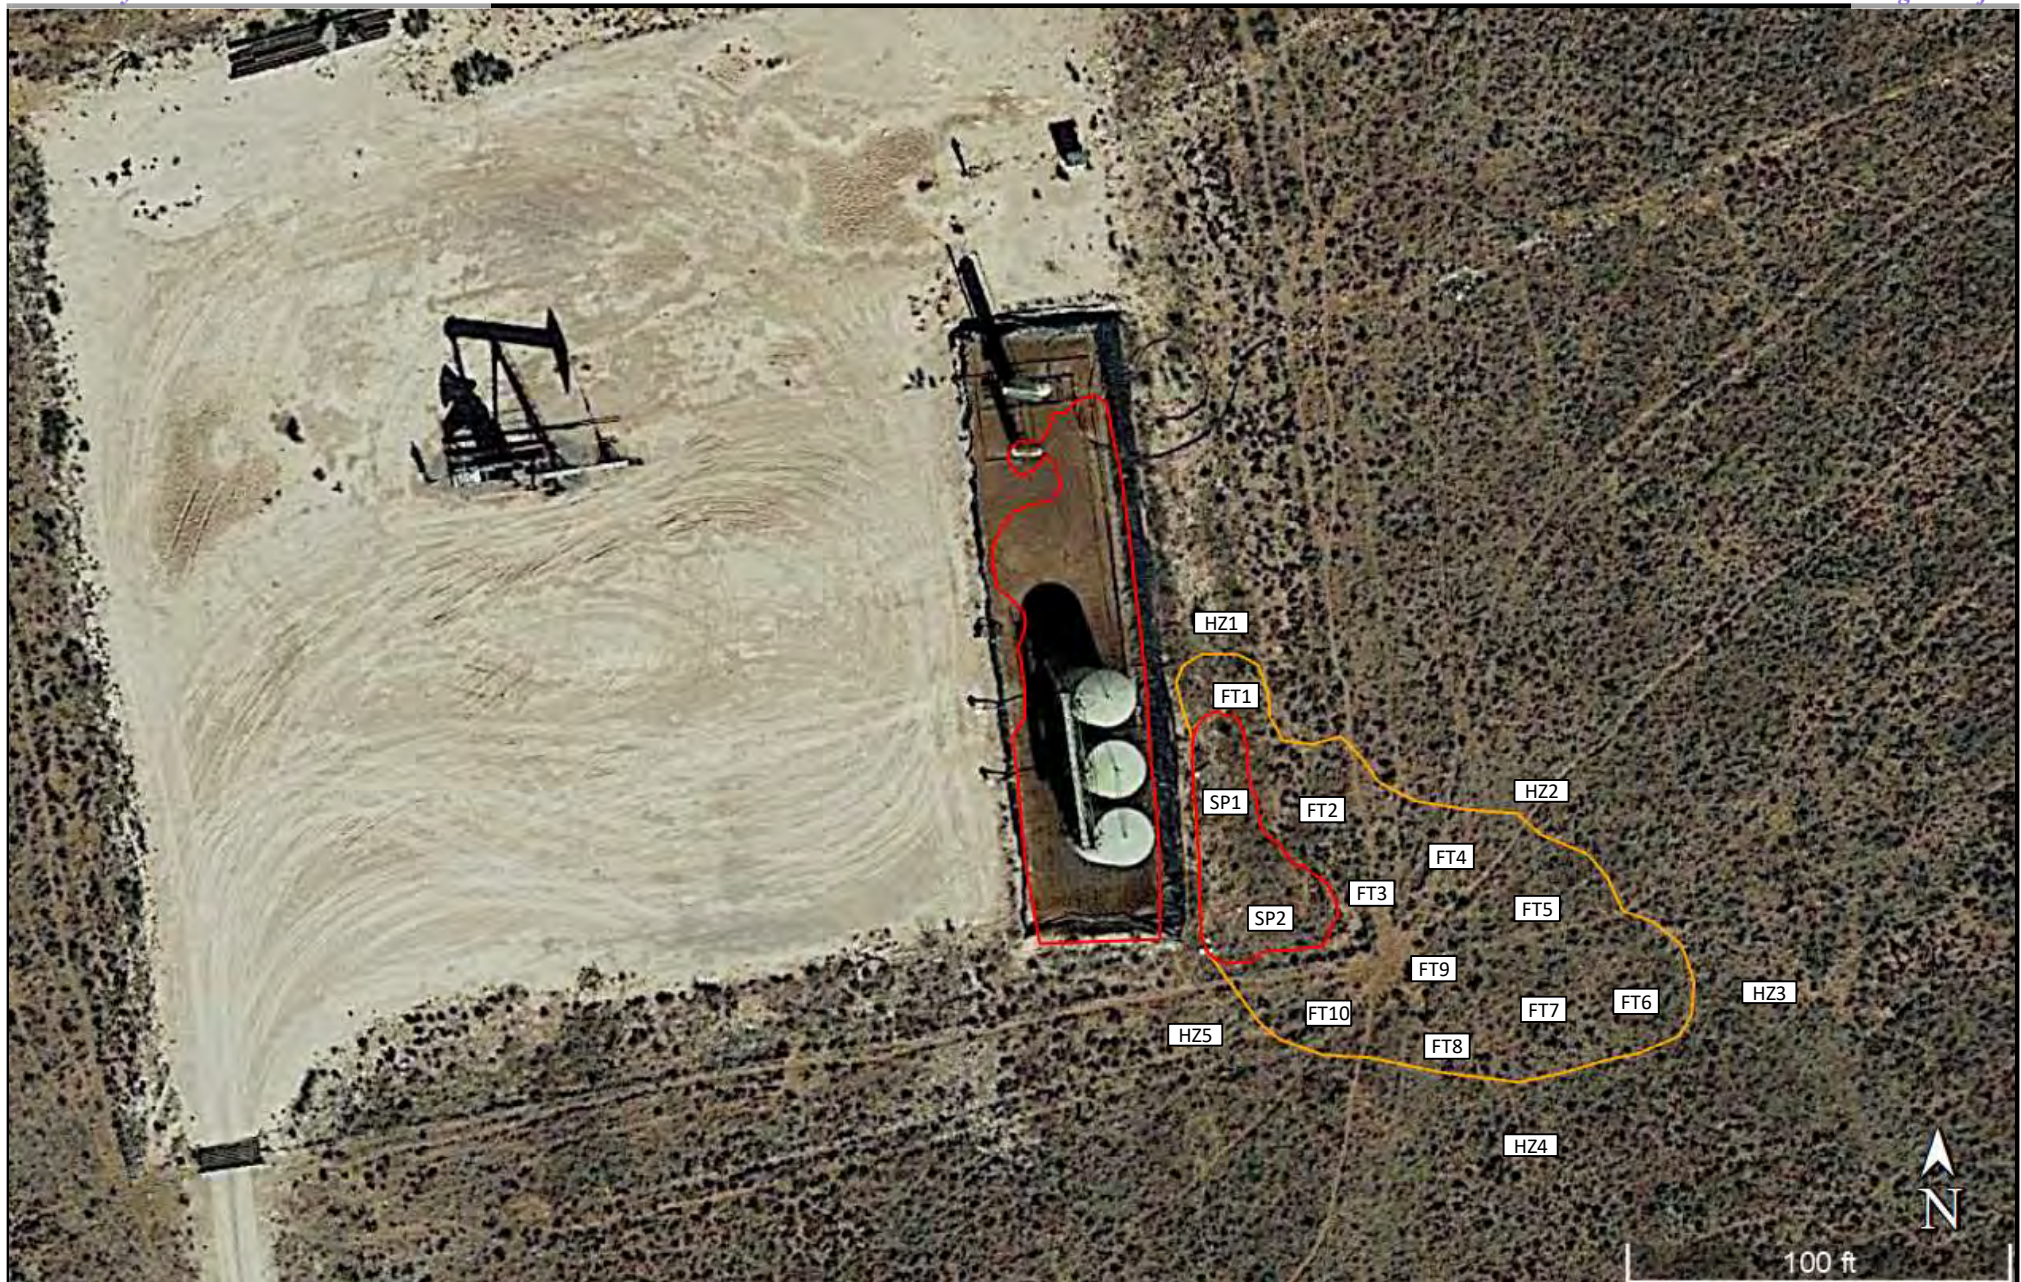
**Figure 4**

Proposed Delineation Sample Map
 Energex, LLC
 Lucas Fee #1
 GPS: 33.605541, -103.519656
 Chaves County

Based on field observations and field test data noted above and provided in Attachment V, fourteen representative soil samples were selected for laboratory analysis. Delineation soil samples SP1 and SP2, HZ1 through HZ5, were submitted to the laboratory for analysis of BTEX, TPH, and chloride. Laboratory analytical results indicated contaminant concentrations were below the NMOCD Closure Criteria in each submitted sample, with the exception of SP1 and SP2, each at Surface, which exhibited TPH concentrations in excess of NMOCD Closure Criteria.

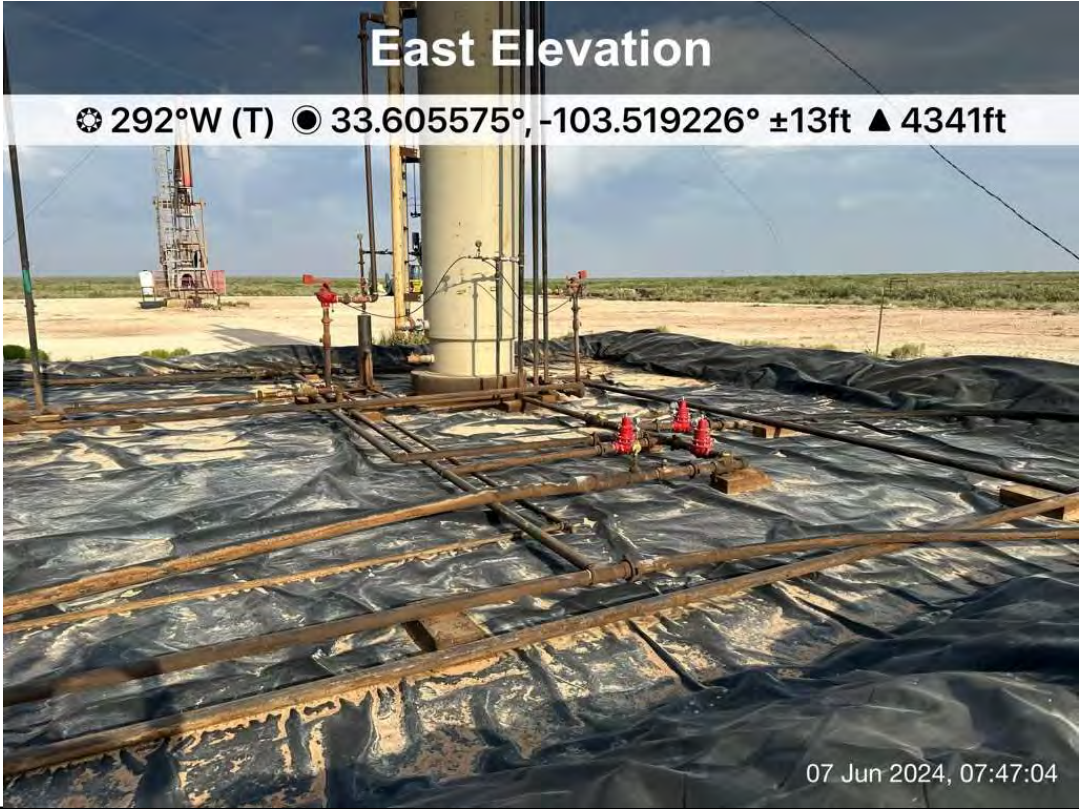
Photo:	23	Description: Liner Inspection
--------	----	-------------------------------

East Elevation

The liner was power washed on May 31, 2024. On June 3, 2024, Hungry Horse, LLC notified NMOCD that a liner inspection would be conducted on June 7, 2024. On June 7, 2024, Hungry Horse personnel arrived on location to inspect the liner. It was noted that it had rained the night before, leaving some standing water within the lined containment area. The liner and containment were thoroughly inspected from edge to edge, as well as around the tanks and process equipment installed on the liner itself. The liner was found to be in place, intact, with no visible breaks, or tears. There was no evidence of the release leaking through the lined containment area. Photographs are provided as Attachment III and a completed Liner Inspection Form as Attachment V.

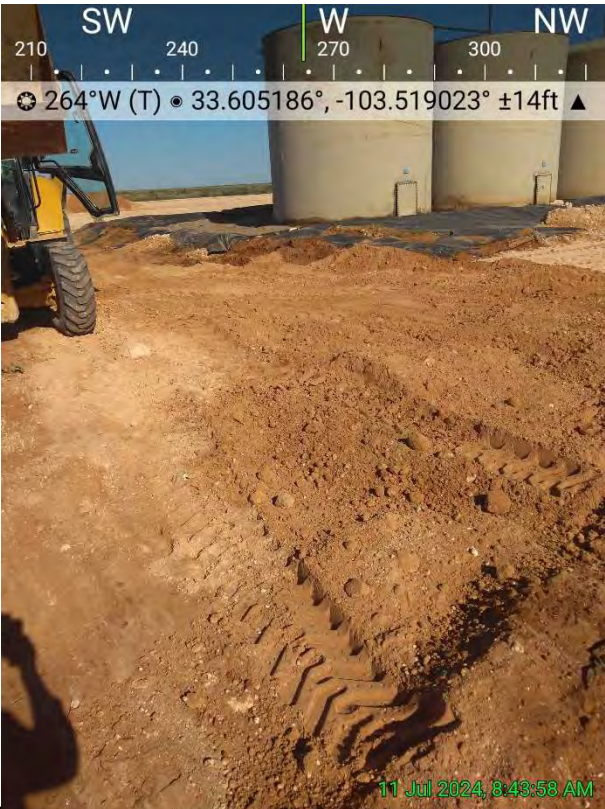
Photo:	33	Description: Backfilling top one foot layer with topsoil

The affected area was seeded, via hand broadcast at double the recommended rate, with landowner approved seed mixture, free of noxious weeds, on August 16, 2024. The reclaimed areas have been watered to aid in seed germination. A re-vegetation report will be submitted for approval when uniform vegetative cover has been established that reflects a life-form ratio of plus or minus fifty percent of pre-disturbance levels and a total percent plant cover of at least seventy percent of pre-disturbance levels, excluding noxious weeds.

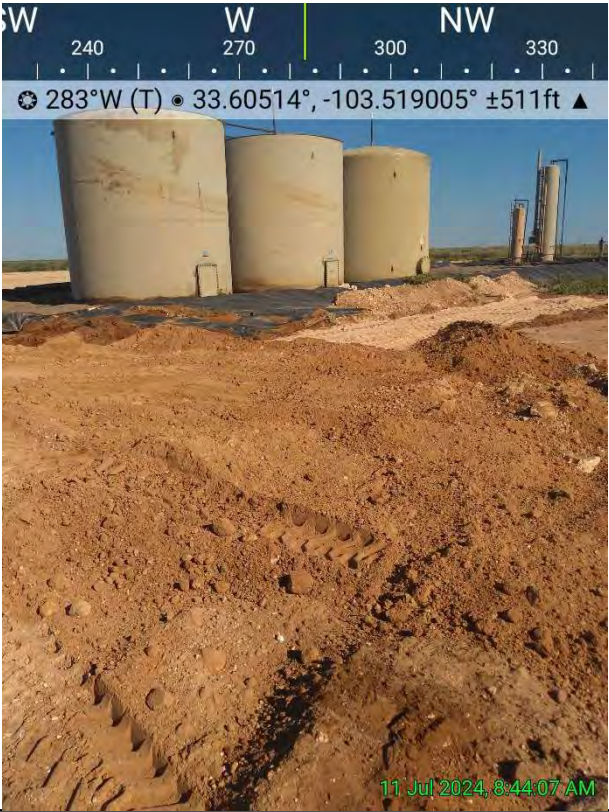
Photo:	34	Description: Backfilling top one foot layer with topsoil
