**Re: Closure Request  
Boundary Raider 7 CTB 2  
Incident Numbers nAPP2414543825 & nAPP2415972085  
Lea County, New Mexico**

Ensolum, LLC (Ensolum), on behalf of Devon Energy Production Company, LP (Devon), has prepared this *Closure Request* summarizing the response efforts and liner integrity inspection activities performed at the Boundary Raider 7 CTB 2 (Site) in Unit A, Section 18, Township 23 South, Range 32 East, in Lea County, New Mexico (Figure 1). The purpose of the liner integrity inspection was to determine if the lined secondary containment was capable of containing two separate produced water releases that occurred on May 24 and June 7, 2024, and whether impacts to soil in the areas immediately surrounding the containment liner were present or absent. Based on field observations during the liner integrity inspection, Devon is submitting this *Closure Request* and requesting closure for Incident Numbers nAPP2414543825 & nAPP2415972085.

Boundary Raider 7 CTB 2

### Photographic Log

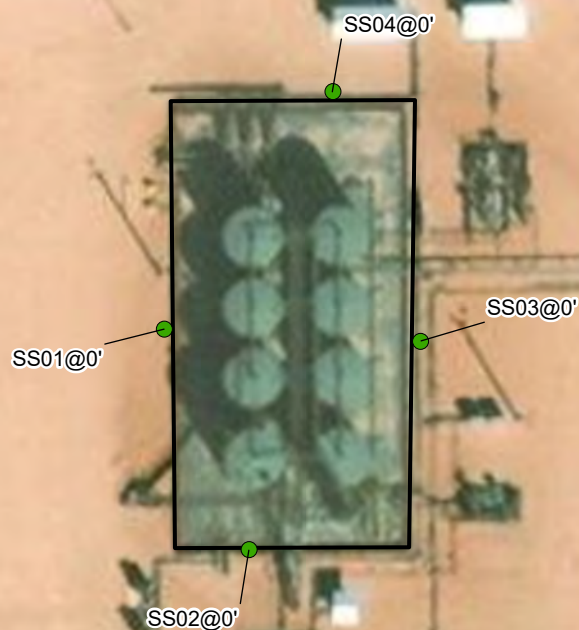
**Delineation Soil Sample Locations**

On June 3, 2024, Ensolum personnel arrived onsite to collect lateral surface samples associated with incident number nAPP2414543825. Four lateral delineation sample points (SS01 through SS04) were collected on all sides of the lined containment at ground surface to verify the release remained inside the lined containment. Delineation soil samples were field screened for chloride and TPH utilizing Mohr's titration method and a PetroFLAG® Soil Analyzer System, respectively. The delineation sample locations were mapped utilizing a handheld Global Positioning System (GPS) unit and are depicted on Figure 2.

On July 1, 2024, Ensolum personnel returned to the Site to collect lateral surface samples associated with incident number nAPP2415972085. Four lateral delineation sample points (SS01 through SS04) were recollected in the same locations as incident number nAPP2414543825 on all sides of the lined containment at ground surface to verify the release remained inside the lined containment. Delineation soil samples were analyzed and handled in the same manner previously described and the sample locations are depicted on Figure 2.

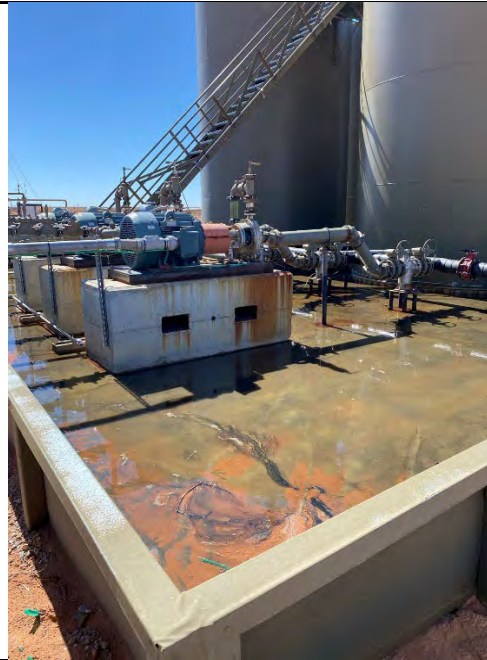
Photograph 2

On May 24, 2024, a ¼-inch plug washed out on a transfer pump, which resulted in the release of 40 barrels (bbls) of produced water inside the lined secondary containment. A vacuum truck successfully recovered all 40 bbls of produced water. Devon reported the release to the New Mexico Oil Conservation Division (NMOCD) via web portal on May 24, 2024. The release was assigned Incident Number nAPP2414543825. A 48-hour advance notice of liner inspection was provided via web portal to the NMOCD on June 3, 2024. A liner integrity inspection was conducted by Ensolum personnel following fluid recovery and upon inspection, the liner was determined to be intact and had the ability to contain the release in question.

Description: Spill Area - nAPP2414543825

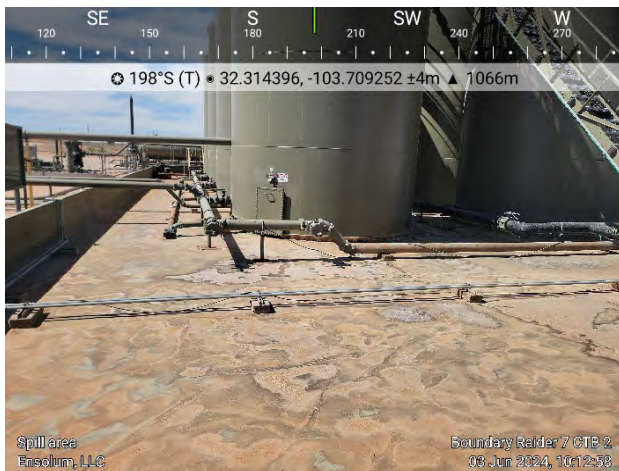
Photograph 3

Description: Spill area - nAPP2414543825

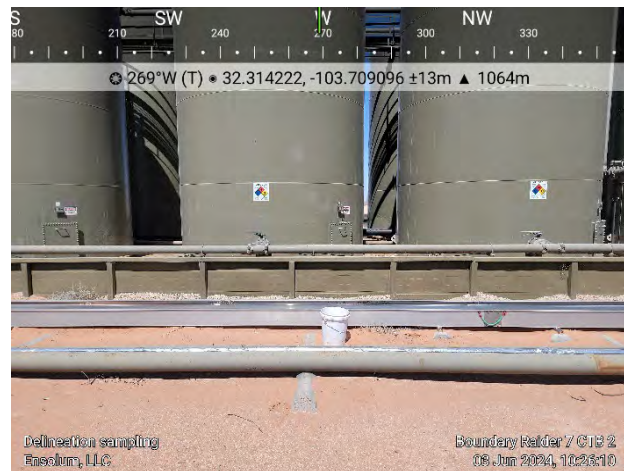
Photograph 4

Description: Delineation Sampling - nAPP2414543825

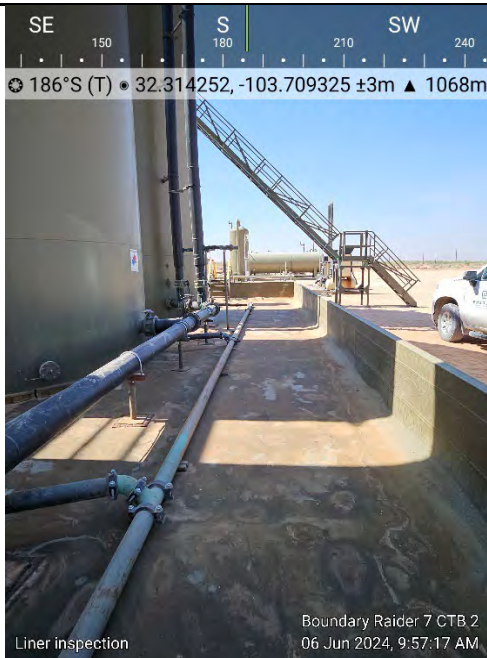
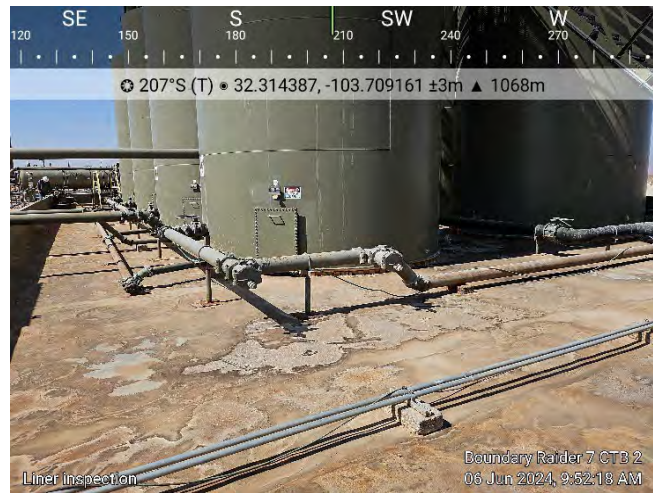
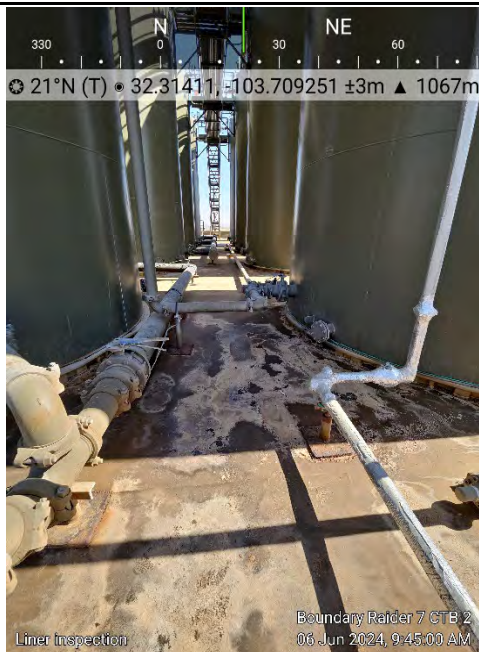
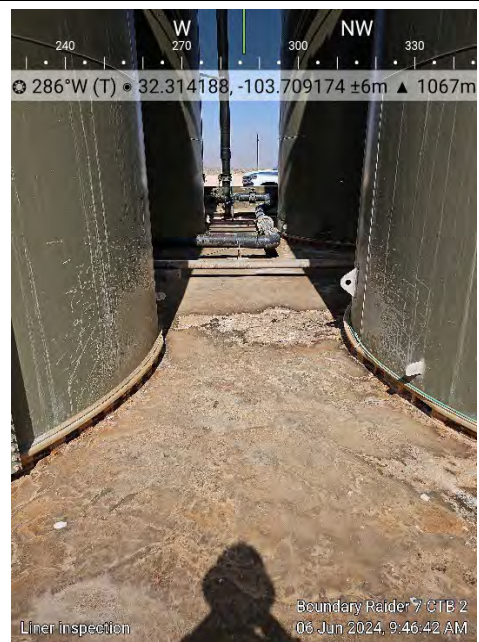
On June 6, 2024, Ensolum personnel competent in conducting liner inspections, returned to the Site to visually inspect the integrity of the containment liner associated with incident number nAPP2414543825. Prior to conducting the inspection, NMOCD was provided with a 48-hour liner inspection notification via email on June 3, 2024 (Appendix B). Ensolum personnel verified there was no visual evidence of a breach in the lined containment or any visible staining in the areas immediately surrounding the

containment walls. It was determined the liner remained intact and had to the ability to contain the release in question. Photographs taken during the liner inspection are included in Appendix C.

Photograph 5 Date: 6/6/2024  
Description: Liner Inspection - nAPP2414543825  
View: South

Photograph 6 Date: 6/6/2024  
Description: Liner Inspection - nAPP2414543825  
View: South

Photograph 7 Date: 6/6/2024  
Description: Liner Inspection - nAPP2414543825  
View: North

Photograph 8 Date: 6/6/2024  
Description: Liner Inspection - nAPP2414543825  
View: West

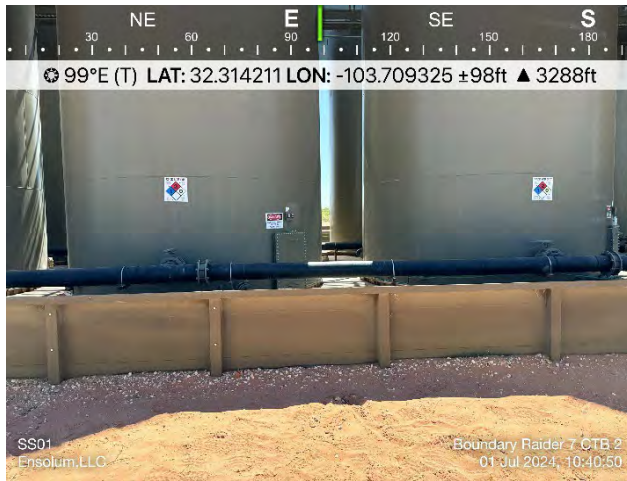
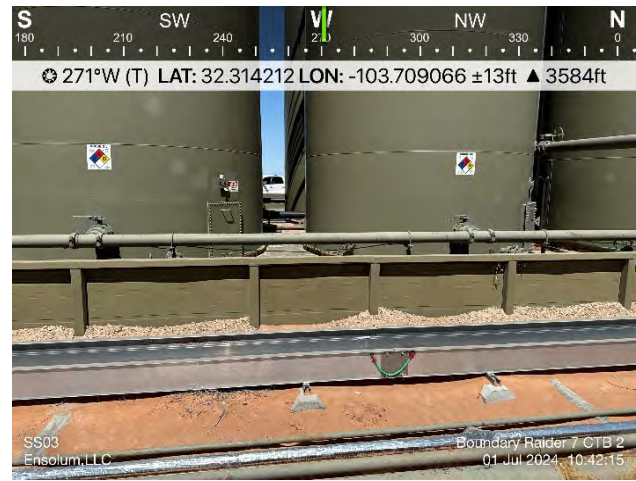
Photograph 9 Date: 7/1/2024  
Description: Delineation - nAPP2415972085  
View: East

Photograph 10 Date: 7/1/2024  
Description: Delineation - nAPP2415972085  
View: West

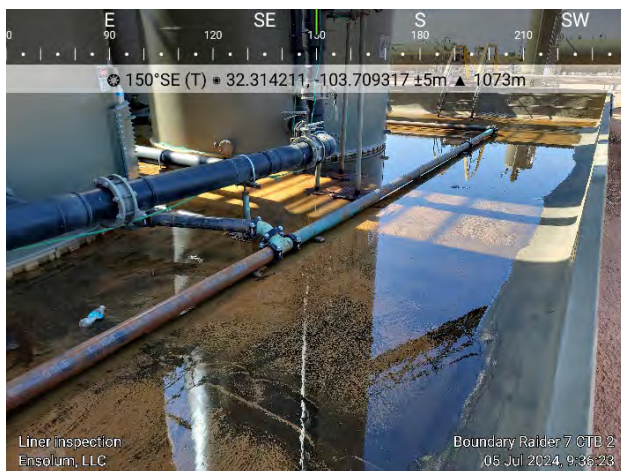
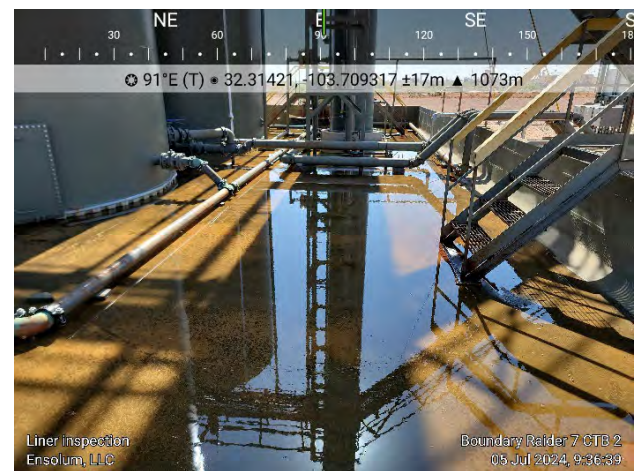
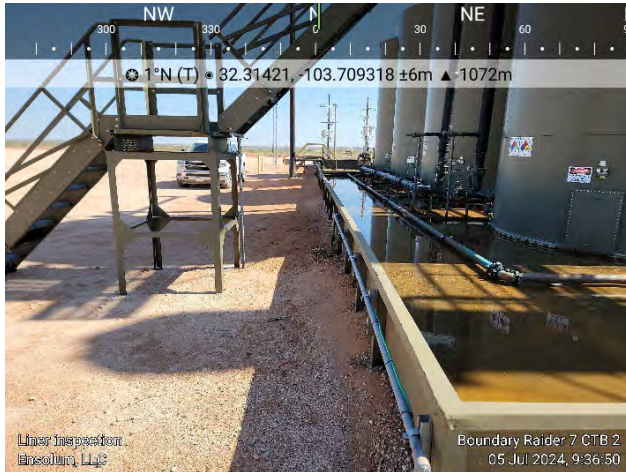
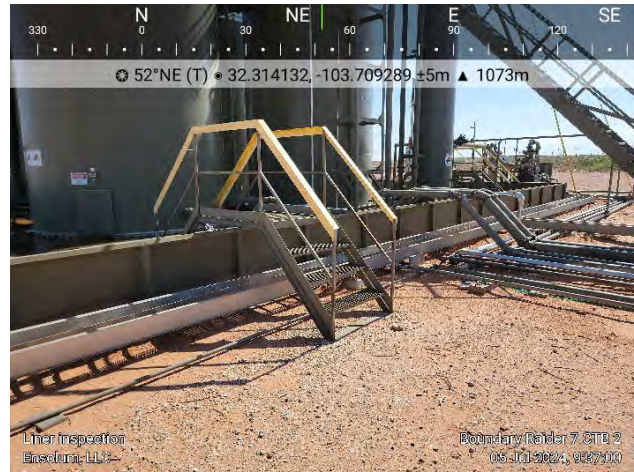
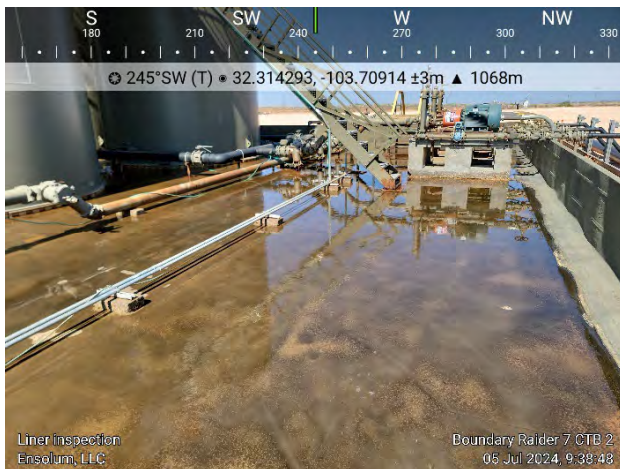
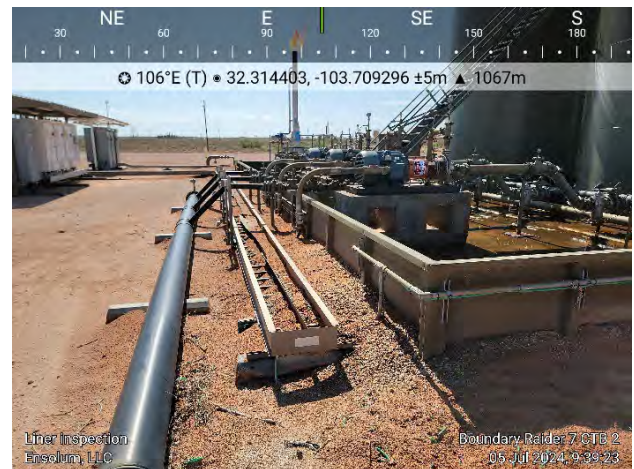
On July 7, 2024, Ensolum personnel competent in conducting liner inspections, returned to the Site to visually inspect the integrity of the containment liner associated with incident number nAPP2415972085. Prior to conducting the inspection, NMOCD was provided with a 48-hour liner inspection notification via email on July 2, 2024 (Appendix B). Due to heavy rains on July 4, 2024, an inch of water was present in the containment during the inspection on July 5, 2024, however the water was clear, and the liner inspection was still possible. Ensolum personnel verified there was no visual evidence of a breach in the lined containment or any visible staining in the areas immediately surrounding the containment walls. It was determined the liner remained intact and had to the ability to contain the release in question.

Photograph 11 Date: 7/5/2024  
Description: Liner Inspection - nAPP2415972085  
View: Southeast

Photograph 12 Date: 7/5/2024  
Description: Liner Inspection - nAPP2415972085  
View: East

Photograph 13 Date: 7/1/2024  
Description: Liner Inspection - nAPP2415972085  
View: North

Photograph 14 Date: 7/1/2024  
Description: Liner Inspection - nAPP2415972085  
View: Northeast

Photograph 15 Date: 7/5/2024  
Description: Liner Inspection - nAPP2415972085  
View: Southwest

Photograph 16 Date: 7/5/2024  
Description: Liner Inspection - nAPP2415972085  
View: East
