**Re: Closure Request
MCA Unit #184
Incident Number NSAP0230953082
Lea County, New Mexico**

Ensolum, LLC (Ensolum), on behalf of Maverick Permian, LLC (Maverick), has prepared the following *Closure Request* to document historical remediation activities performed at the MCA Unit #184 (Site). The remediation activities completed during 2013/2014 for Incident Number NTO1419639129 encompassed the release area for the subject Incident Number NSAP0230953082. Based on the historical remediation activities and subsequent closure approval for Incident Number NTO1419639129, Maverick is requesting closure for Incident Number NSAP0230953082.

CONOCOPHILLIPS MCA 2F HEADER

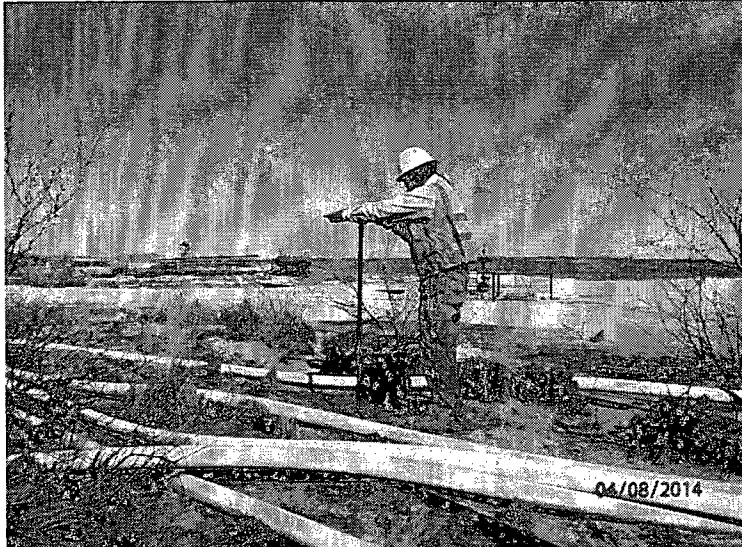
Hand auguring Point 4, facing northwest 4/8/14

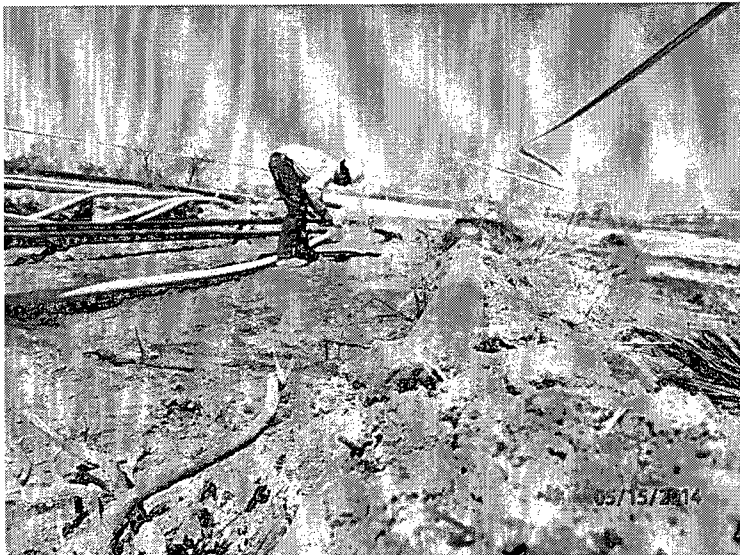
Sampling the hand shoveled scrape, facing west 5/15/14

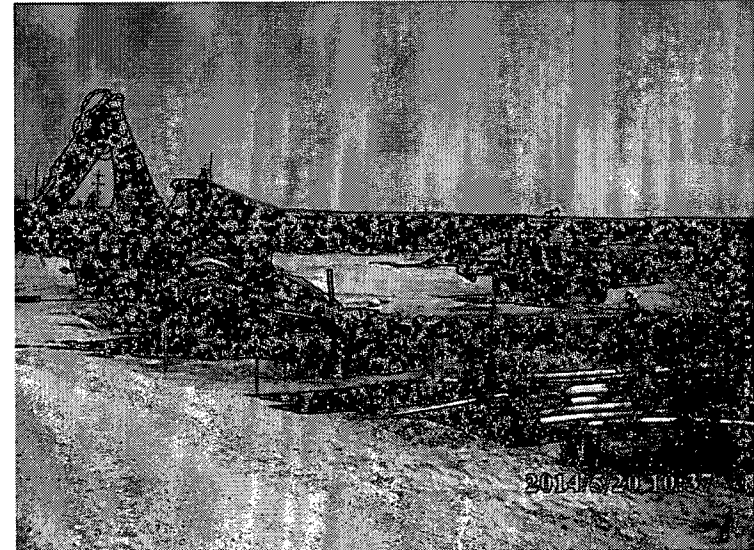
Excavating site, facing northeast 5/20/14

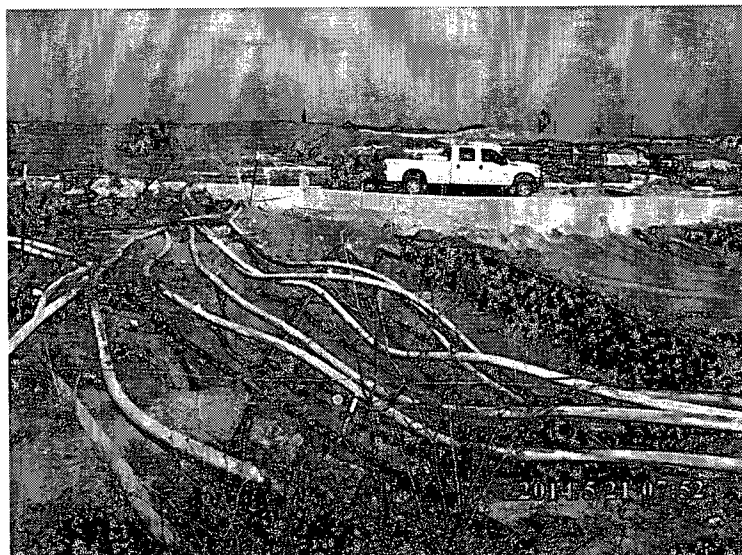
Excavation completed, facing west

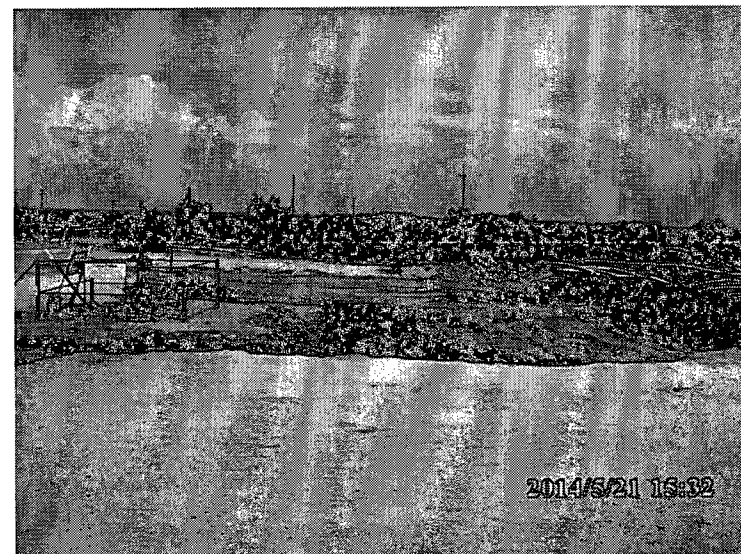
Excavation completed, facing east

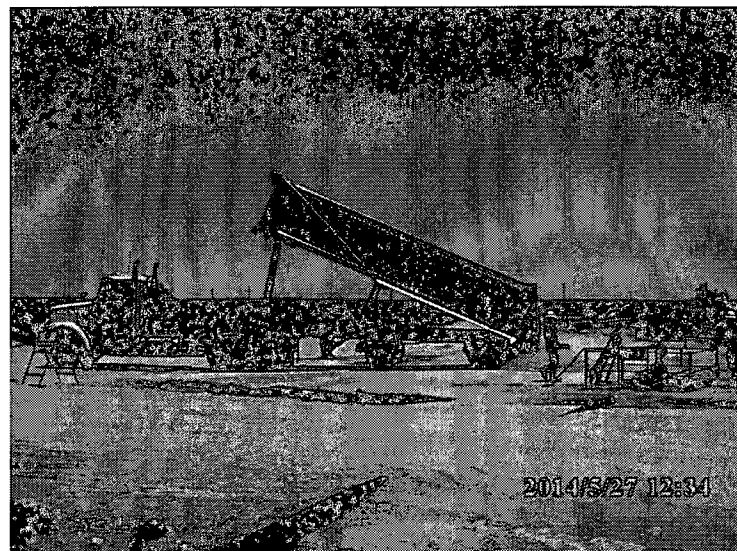
Importing caliche, facing northeast

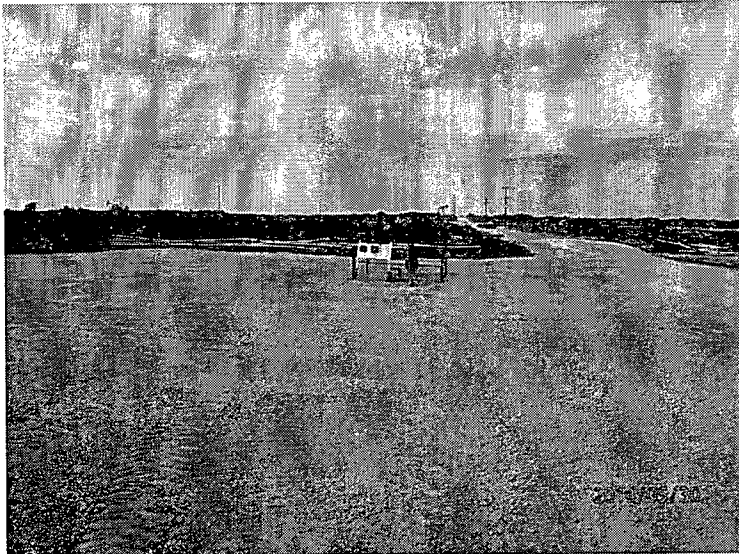
Backfill completed, facing east

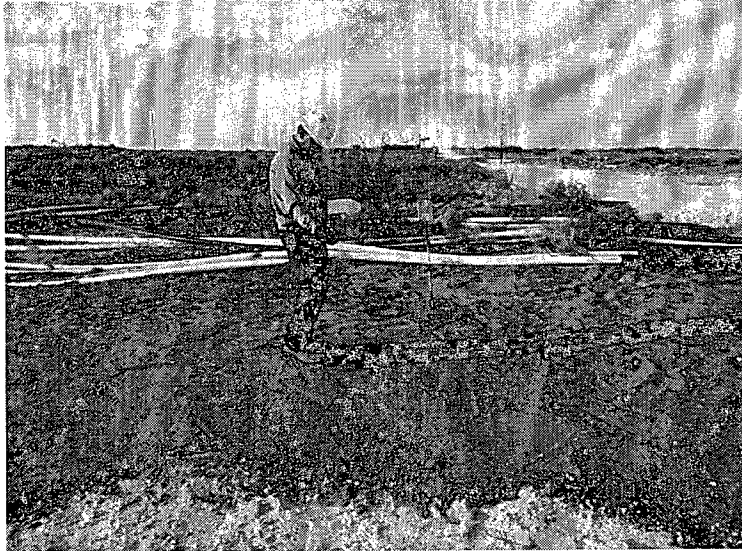
Seeding site, facing south

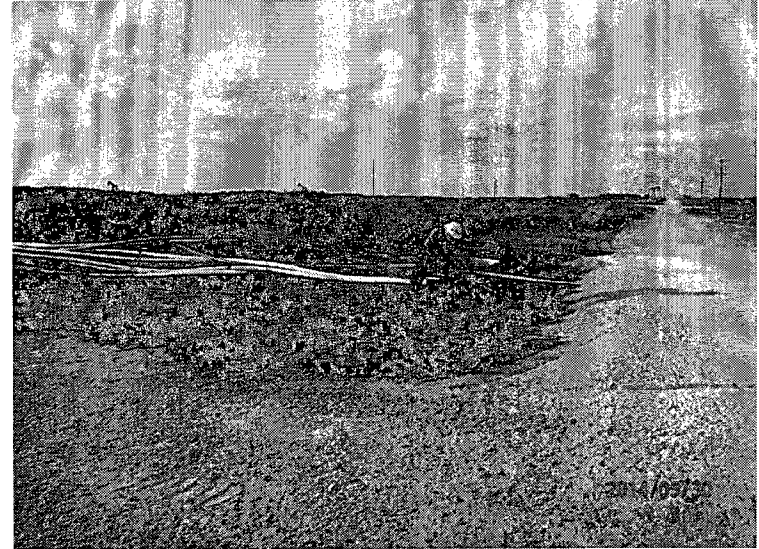
Raking the seed into the site, facing south

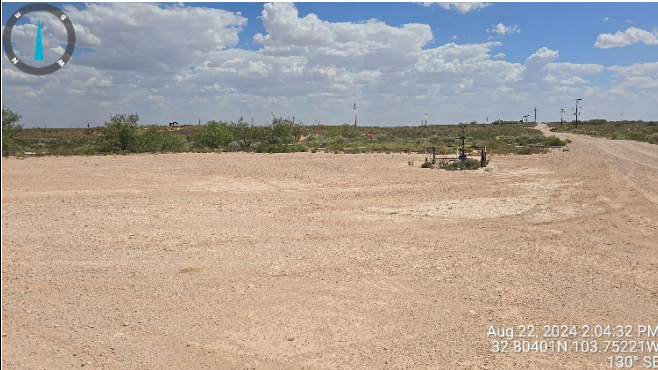
Photograph 1
Date: 8-22-2024
Description: Historical release area
View: Southeast

A Site visit was completed on August 22, 2024, to evaluate current Site conditions. No surface staining or visible indications of the historical releases were identified at the Site and vegetation was establishing in the affected pasture area south of the well pad. A photographic log from the Site visit is included as Appendix C.

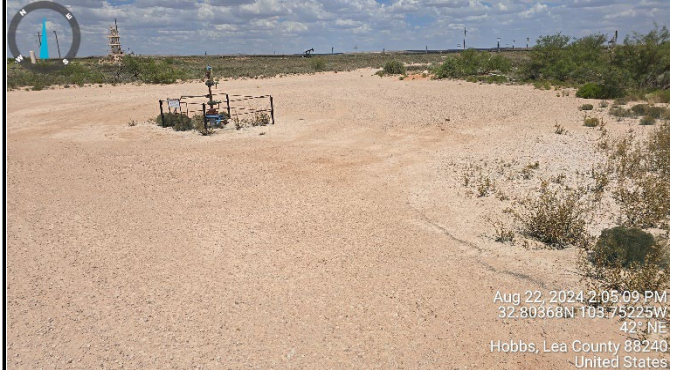
Photograph 2
Date: 8-22-2024
Description: Historical release area
View: Northeast

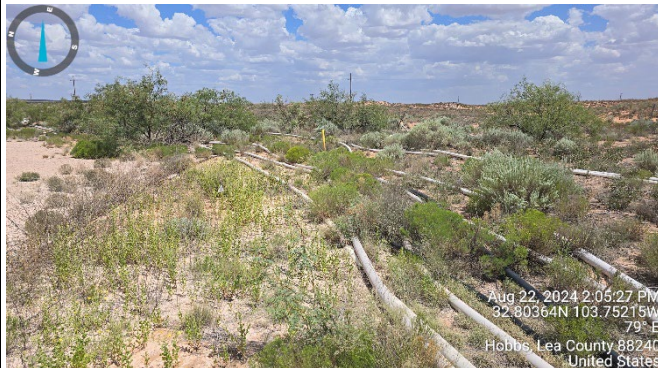
Photograph 3
Date: 8-22-2024
Description: Historical release area
View: East

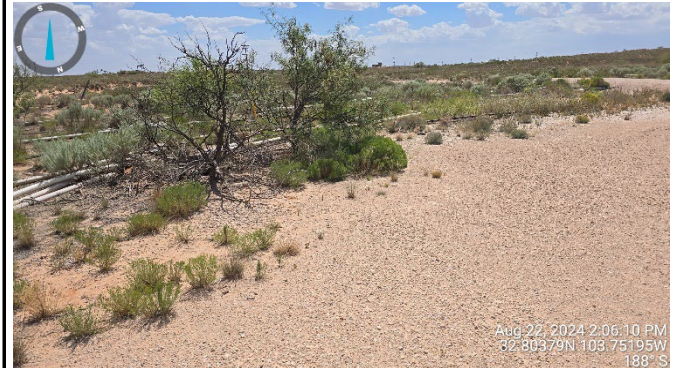
Photograph 4
Date: 8-22-2024
Description: Historical release area
View: South
