Release Notification and Corrective Action

Name of Company	Energen Resources Corporation	Contact	Andy Cobb
Address	3510 N A Street, Midland, TX 79705	Telephone No.	432-686-3599
Facility Name	State B	Facility Type	Oil and Gas Production Facility
Surface Owner	Dan Field/Branch Ranch	Mineral Owner	State of New Mexico
		API No.	3002502709

ATTACHMENT #7
Photographic Log

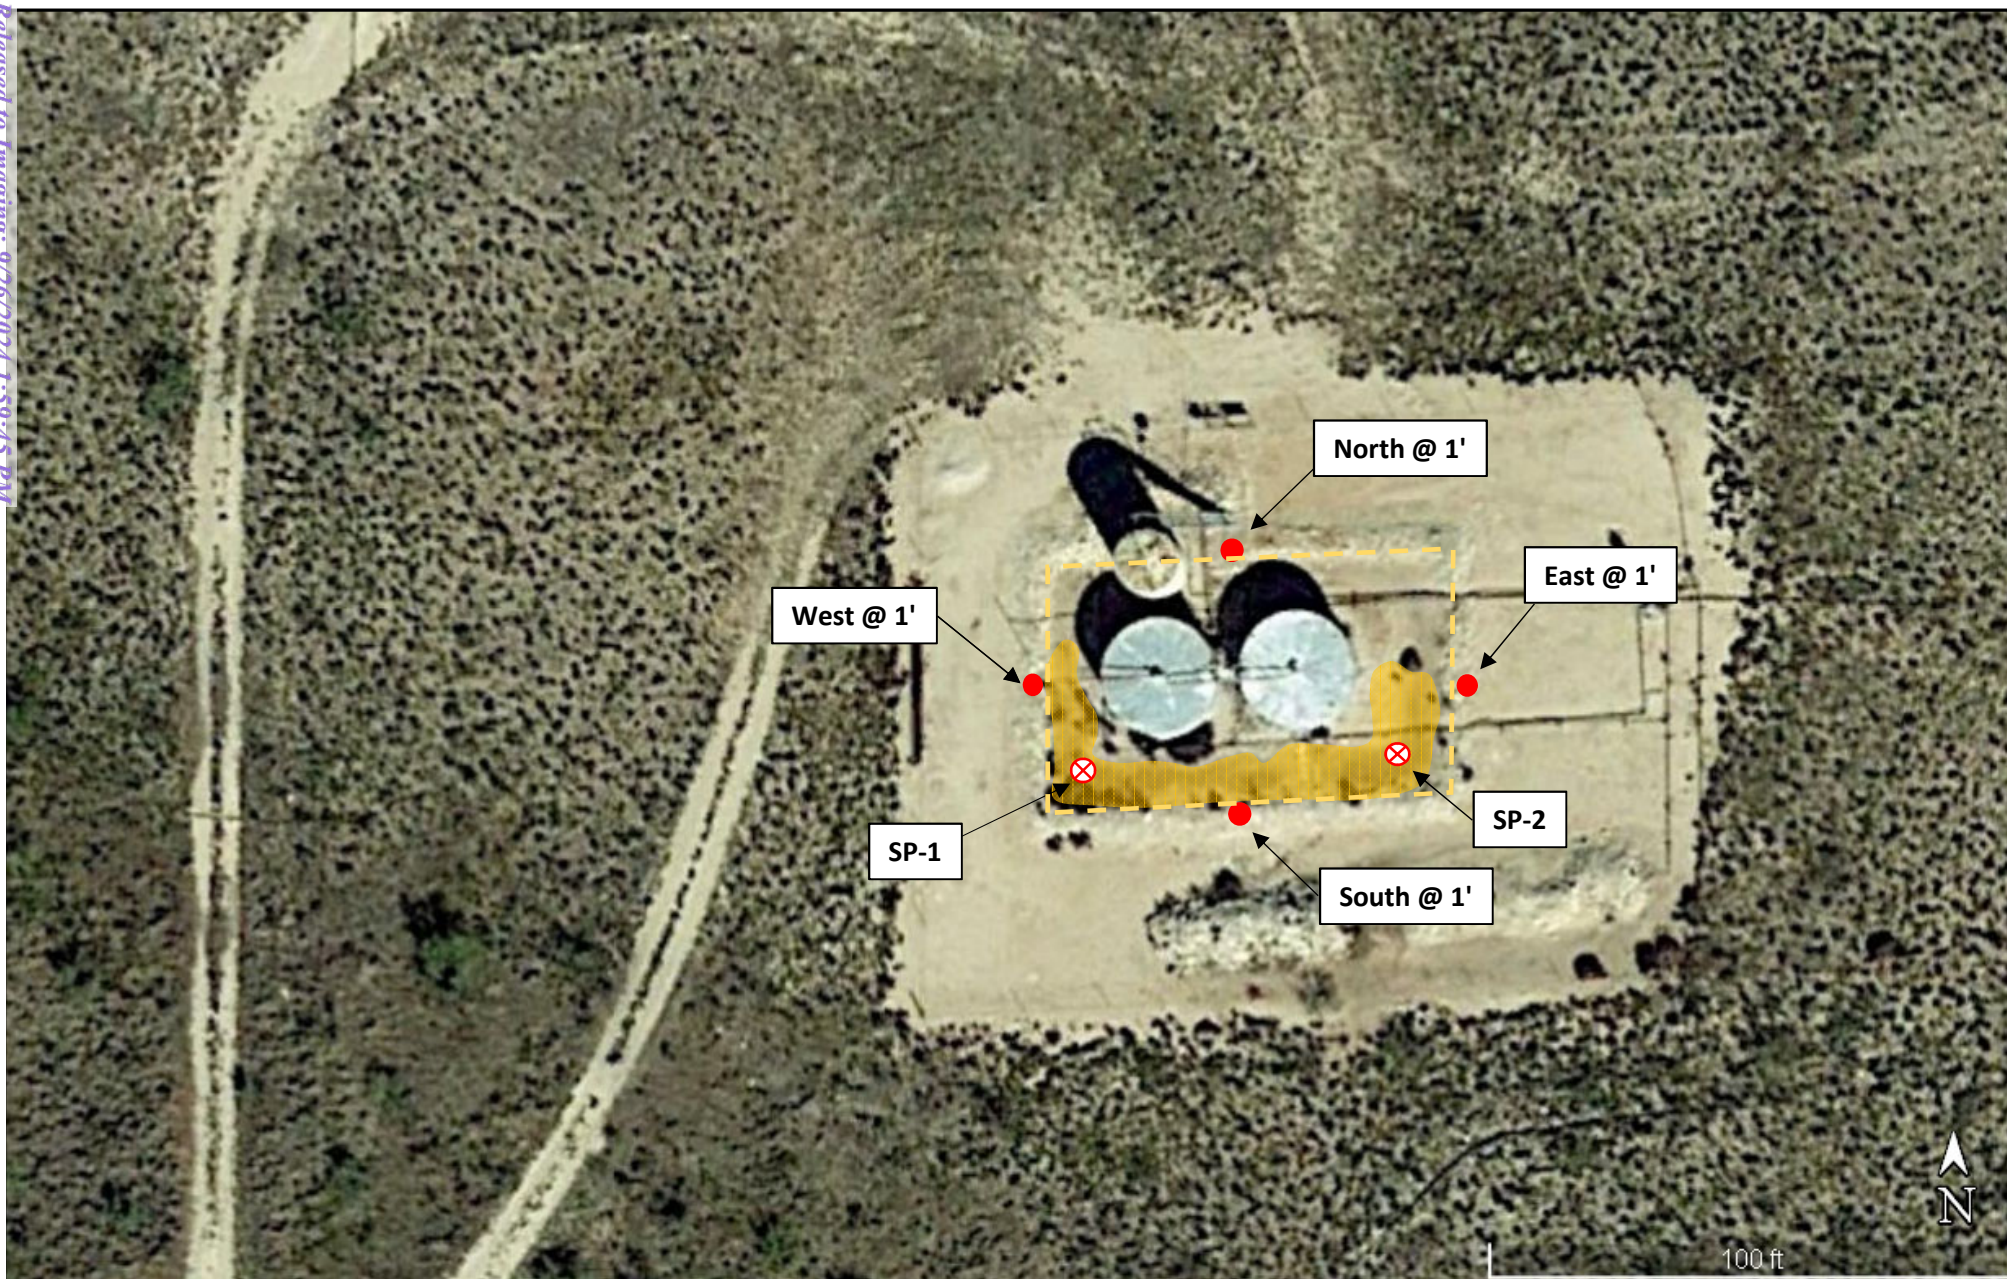
Figure 3 - Site & Sample Location Map

- Sample Location
- ⊗ Soil Boring
- Affected Area
- Earthen Berm

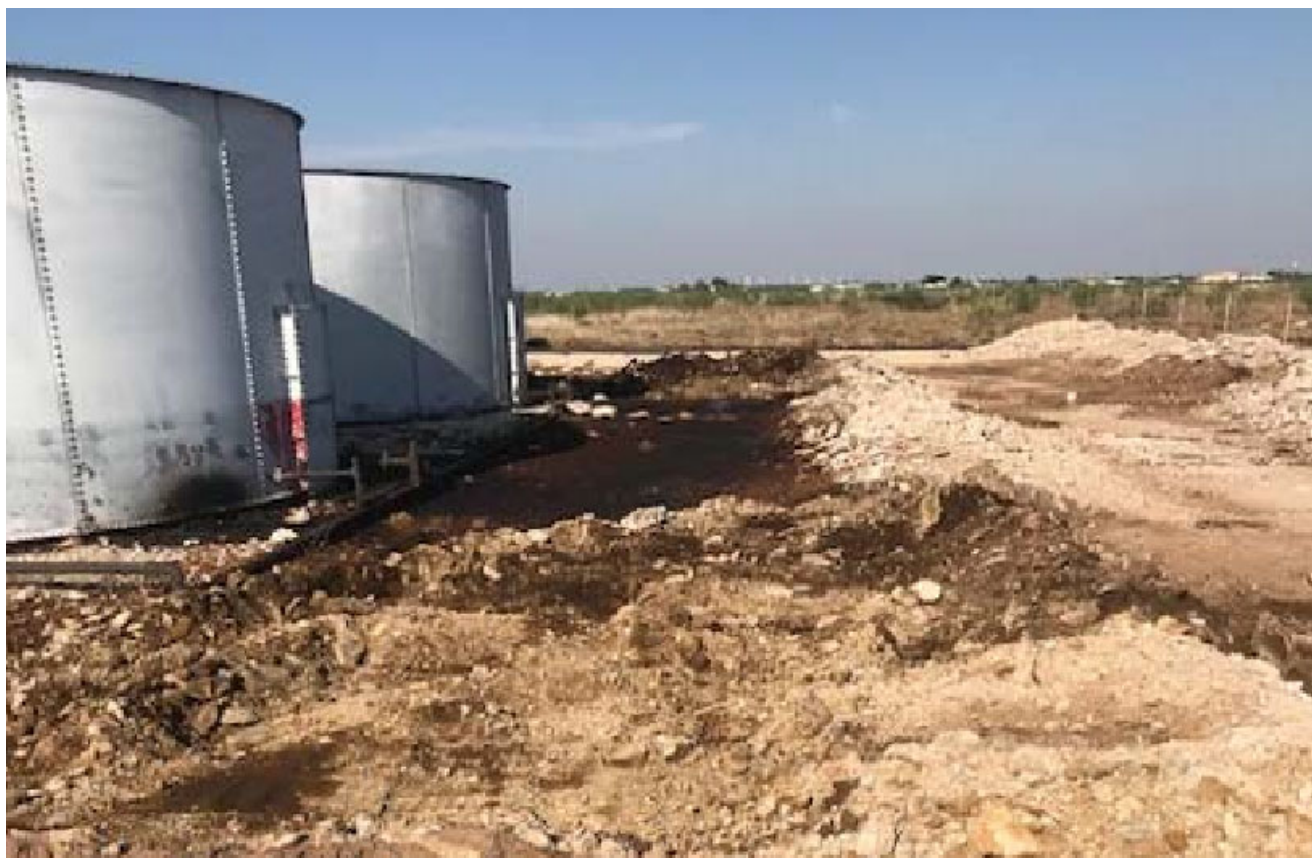
Figure 1 View of surface staining from the initial release, facing East.

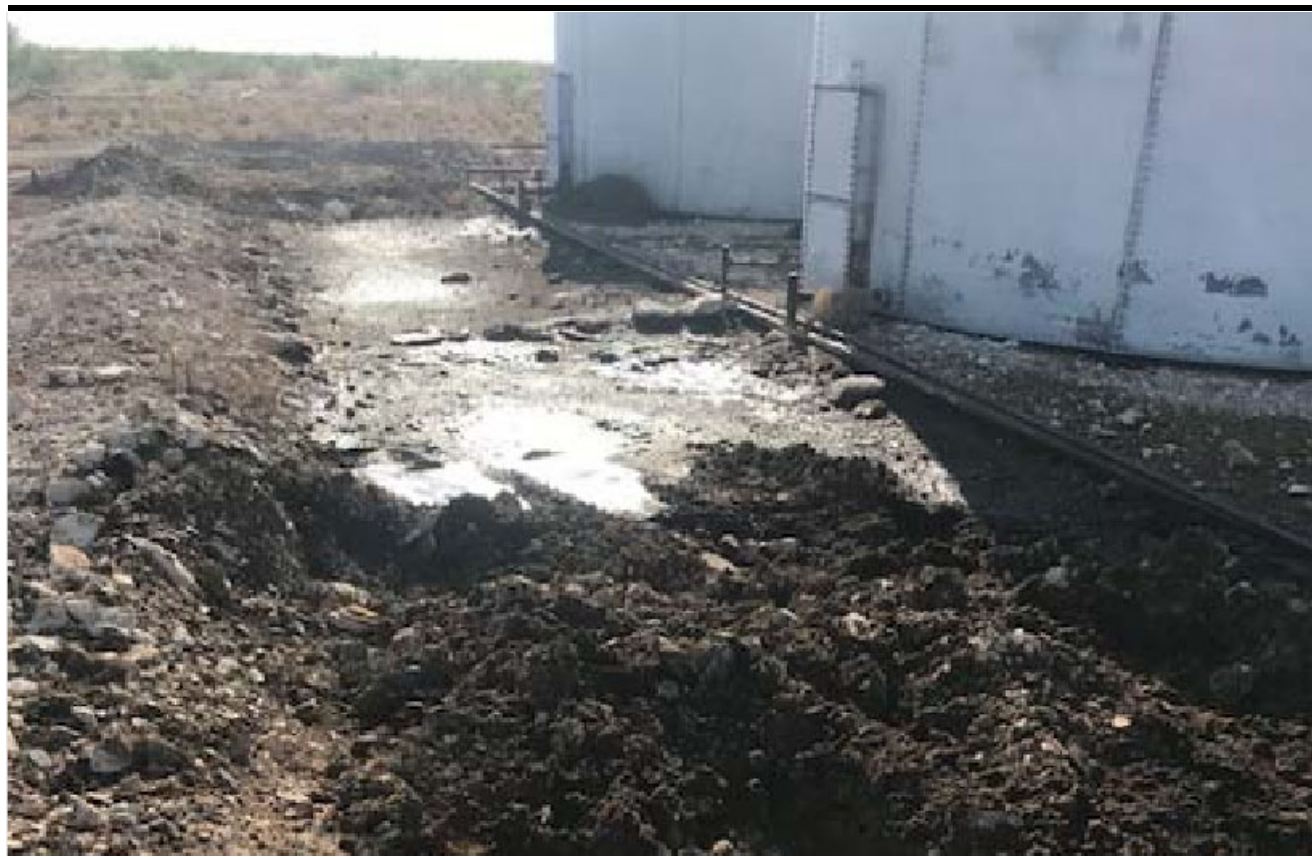
Figure 2 View of surface staining from the initial release, facing Northwest.

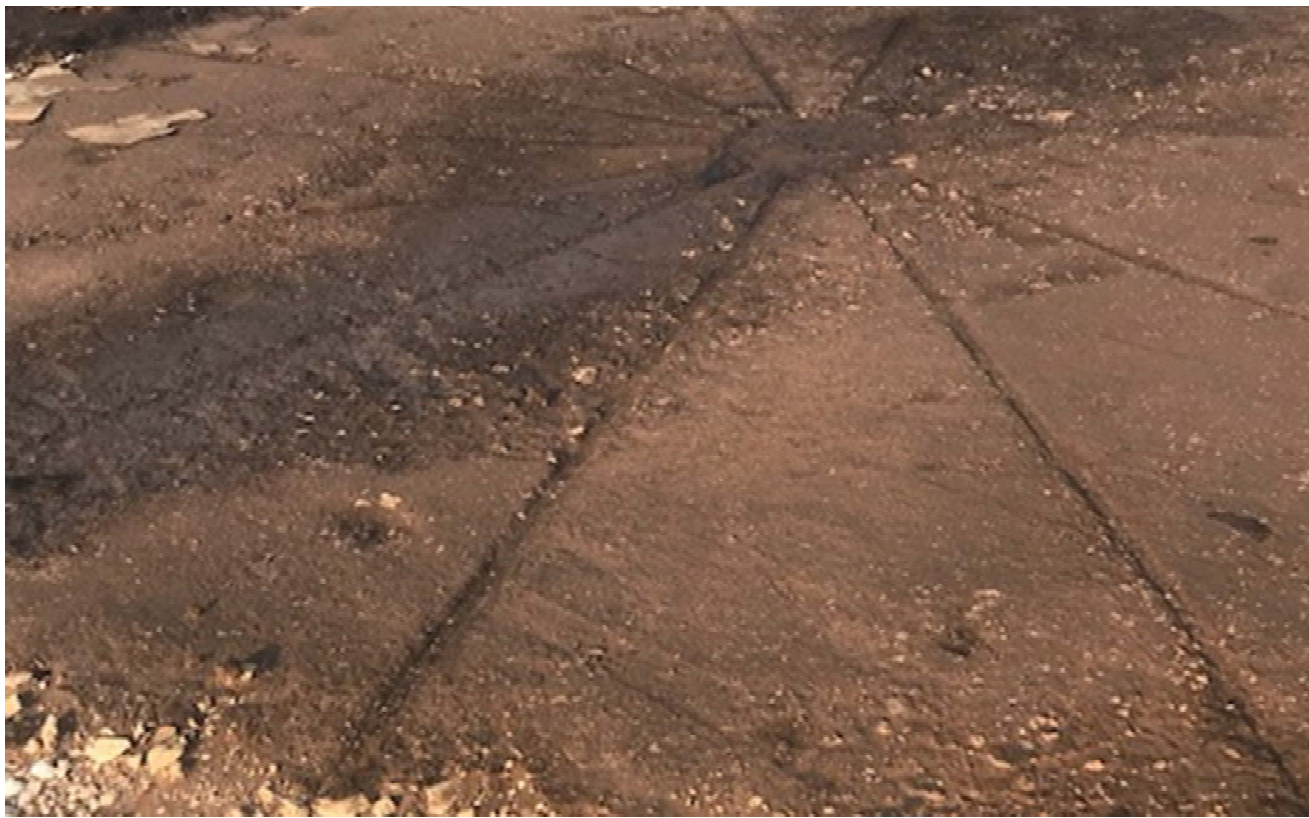
Figure 3 View of the affected area upon removal of the above-ground tanks.

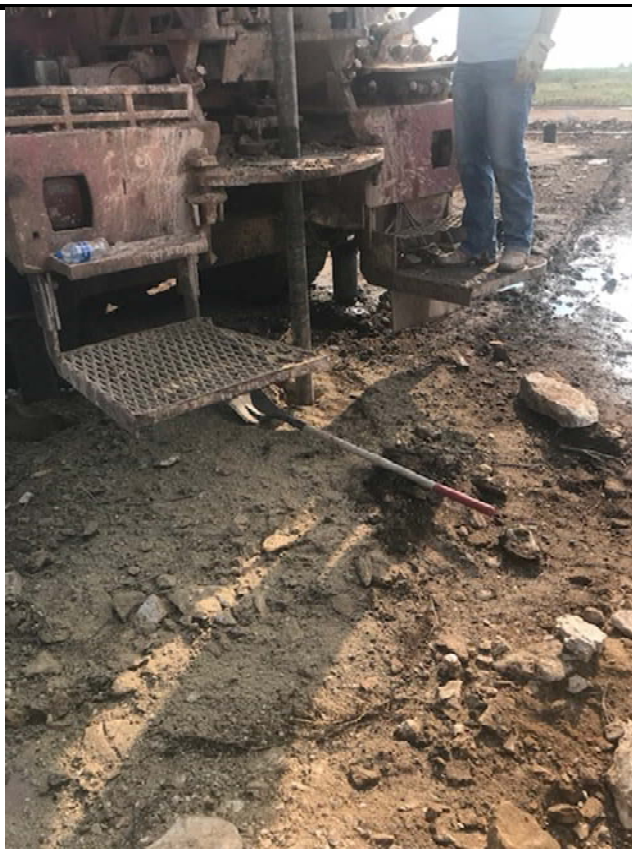
Figure 4 View of drilling activities.

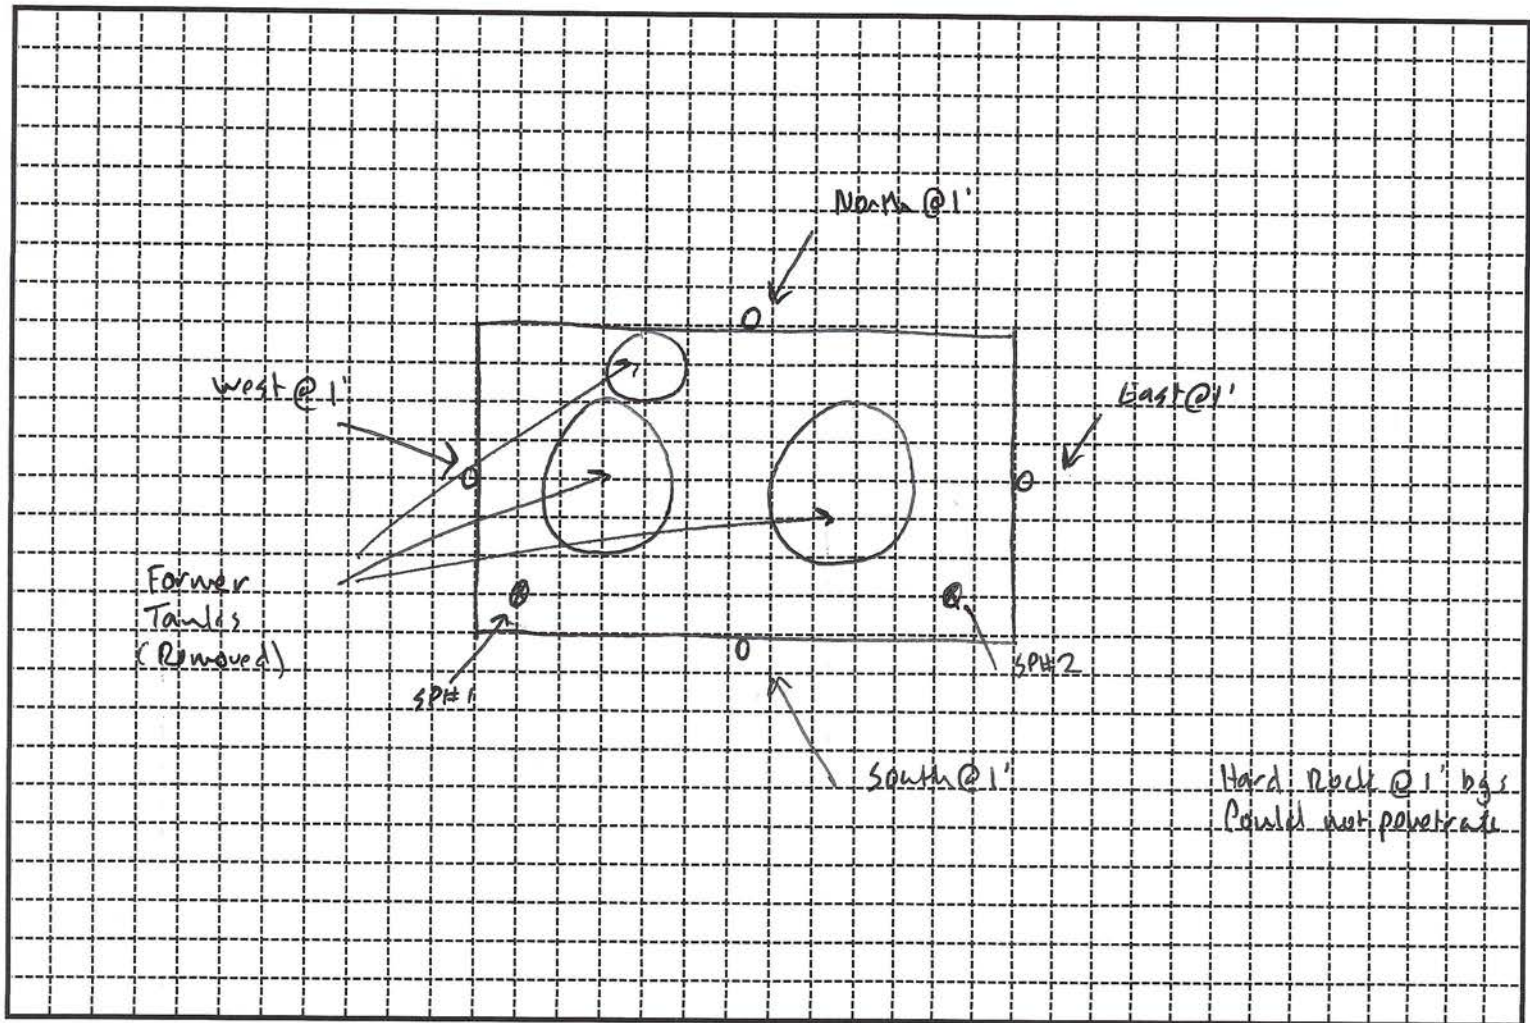
Hard Rock @ 1' bgs. Could not penetrate

Field ID	Odor/PID	Chloride
North @ 1'	None	330
East @ 1'	Slight	<120
South @ 1'	None	2,652
West @ 1'	None	942

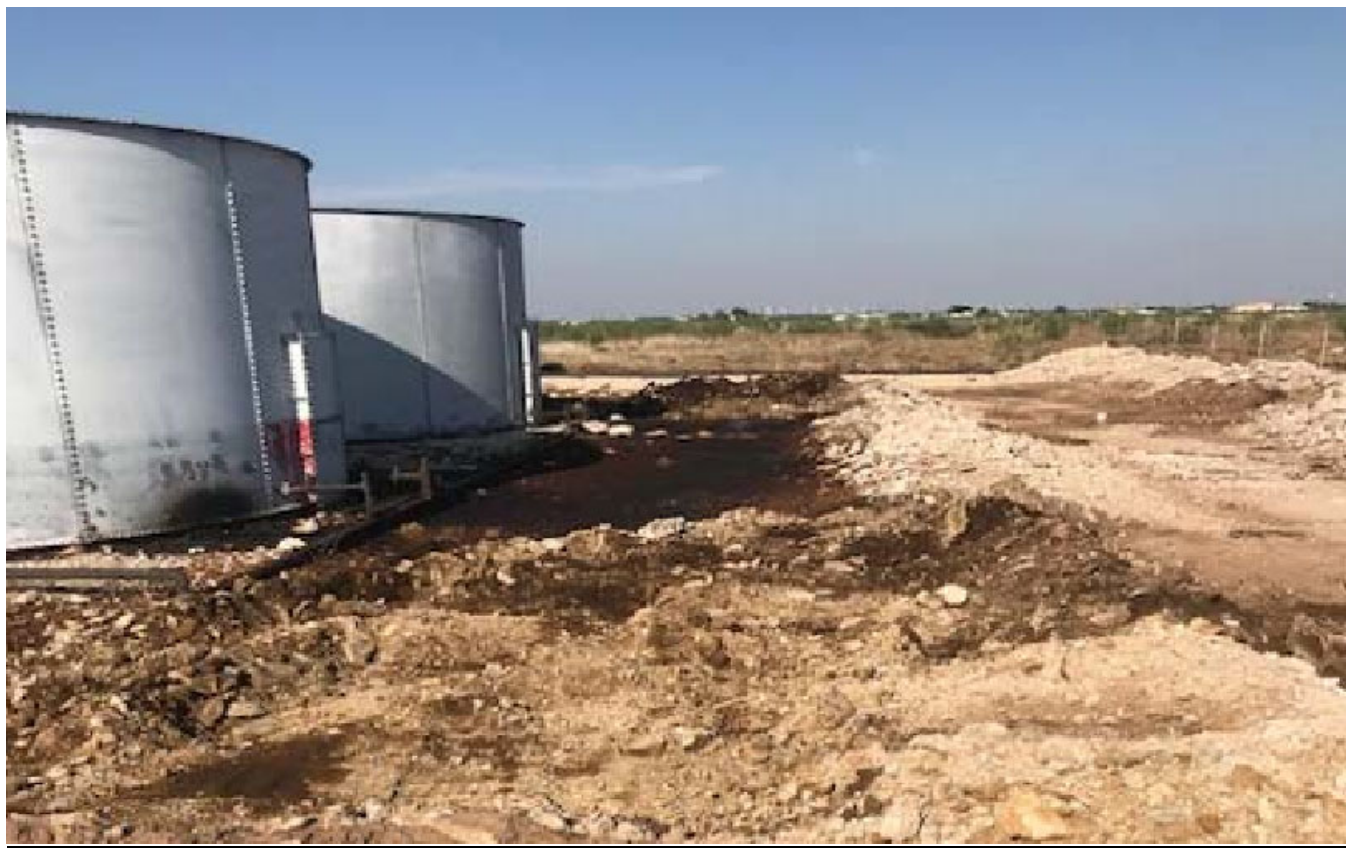
Figure 1 View of surface staining from the initial release, facing East.

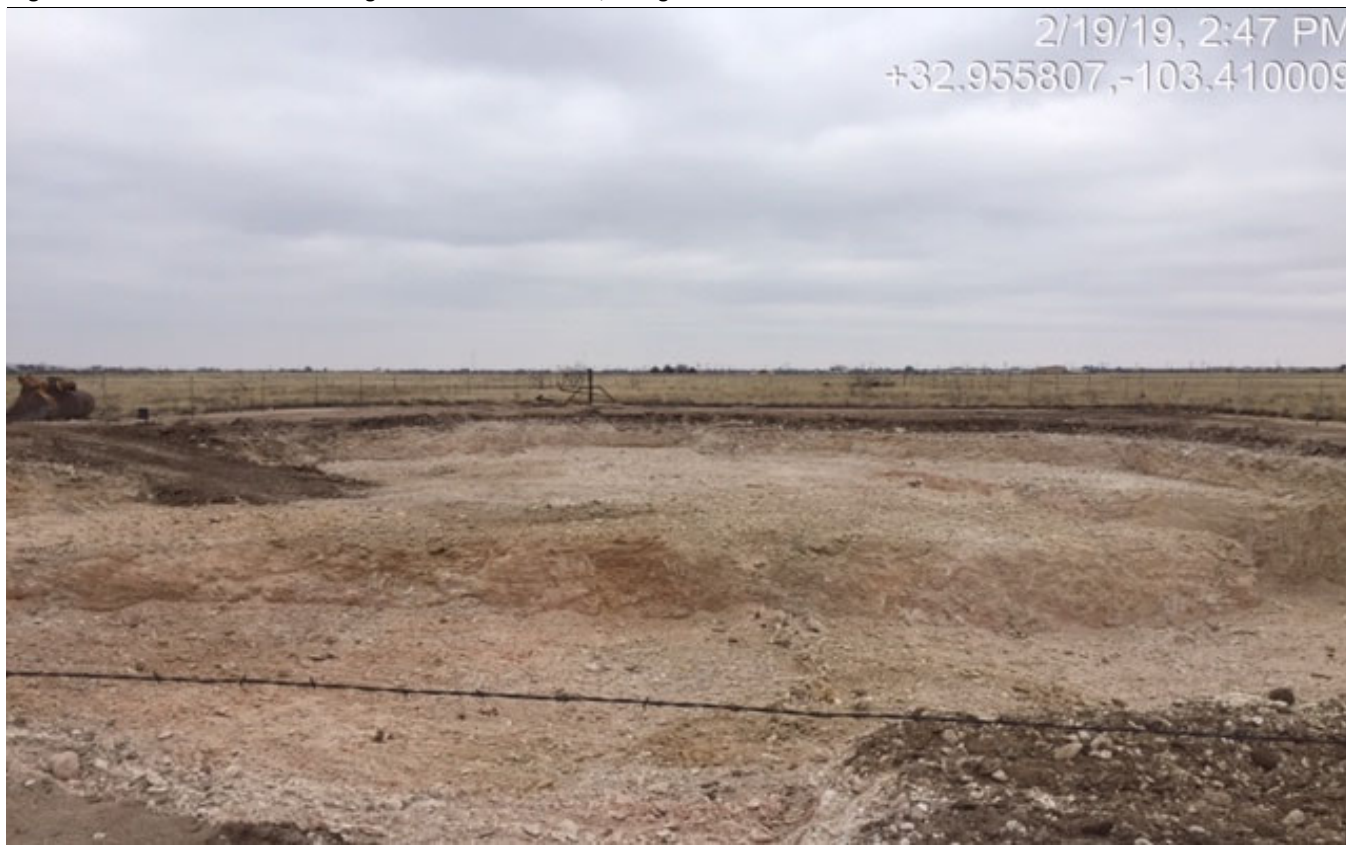
Figure 2 View of excavation activities, facing Southeast.

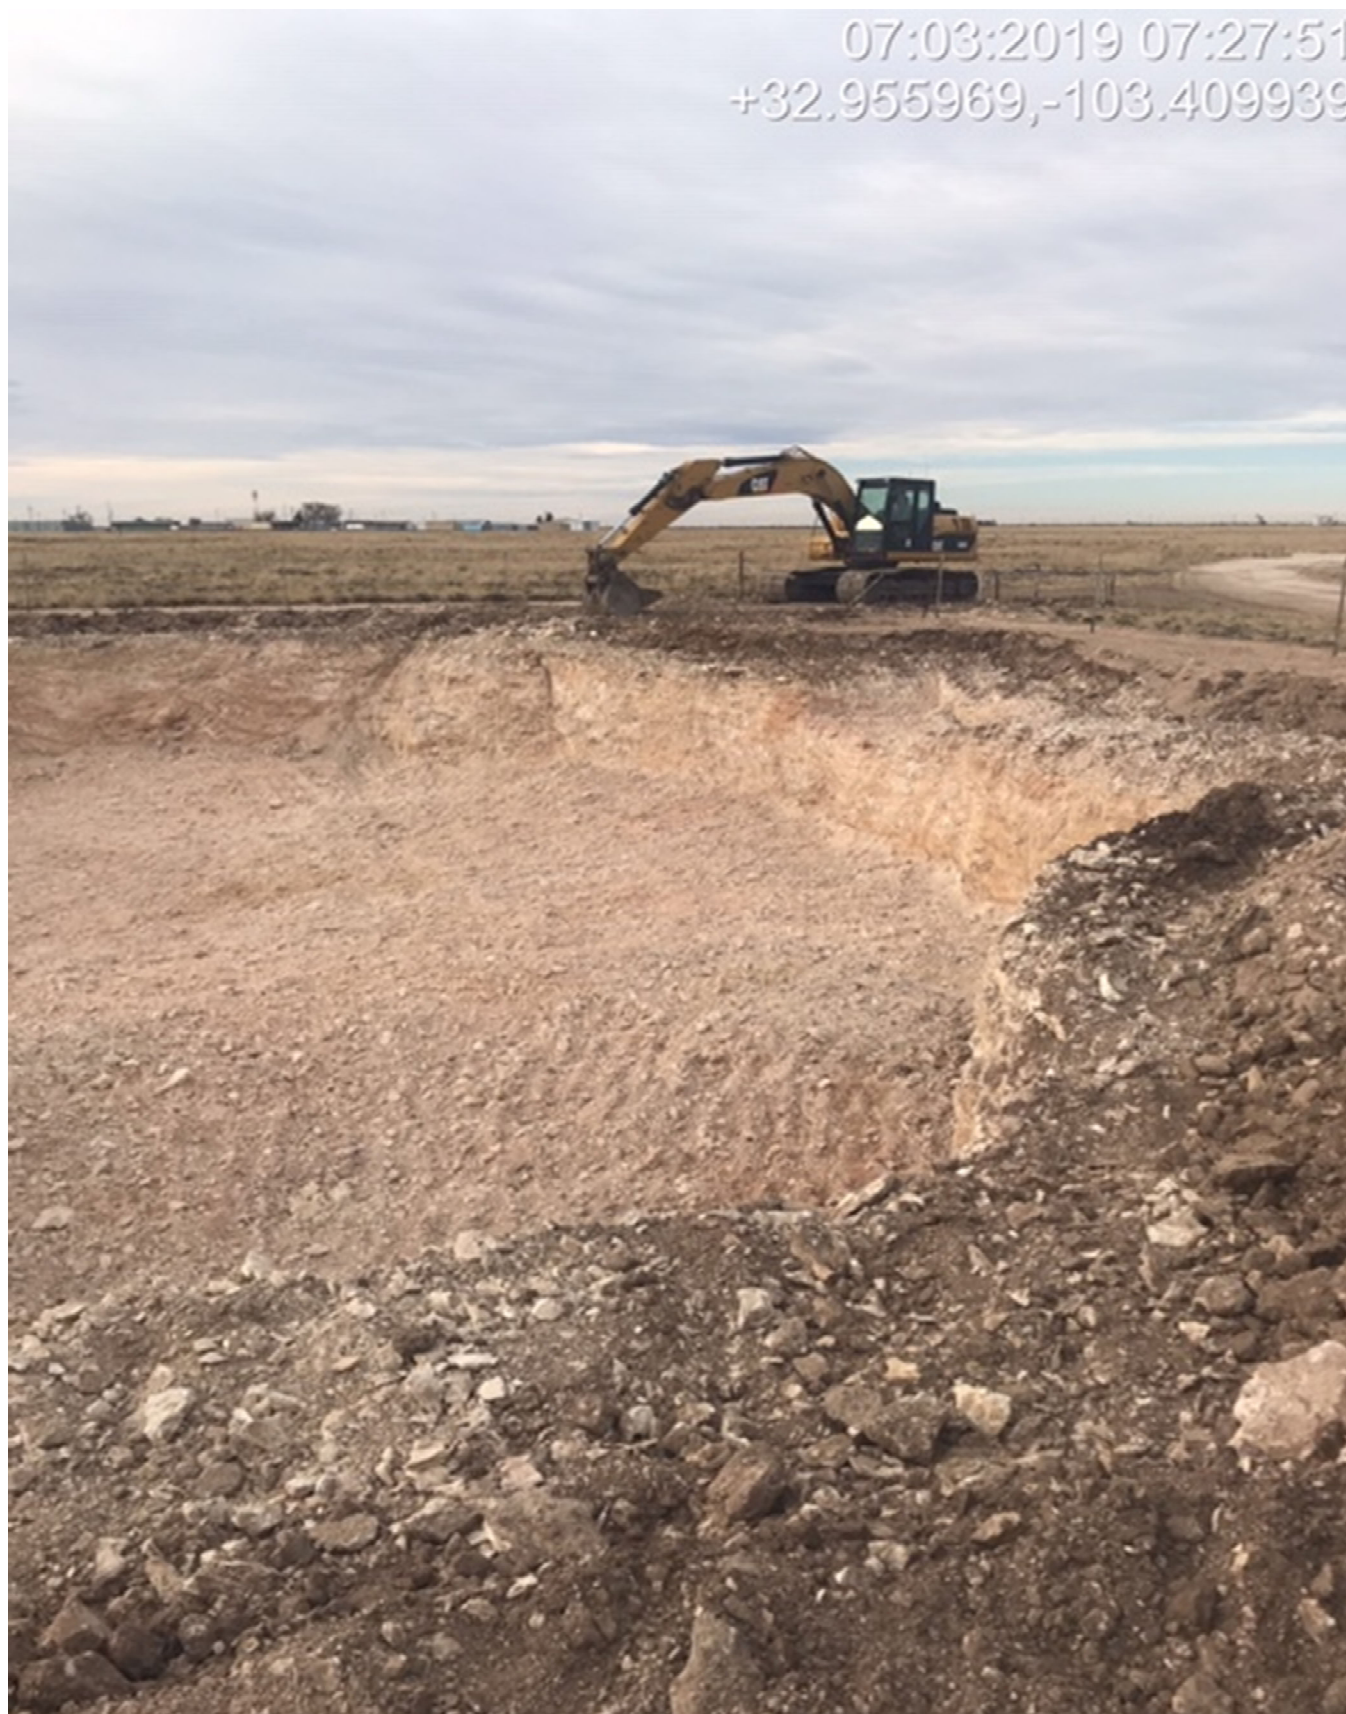
Figure 3 View of excavation activities, facing West.

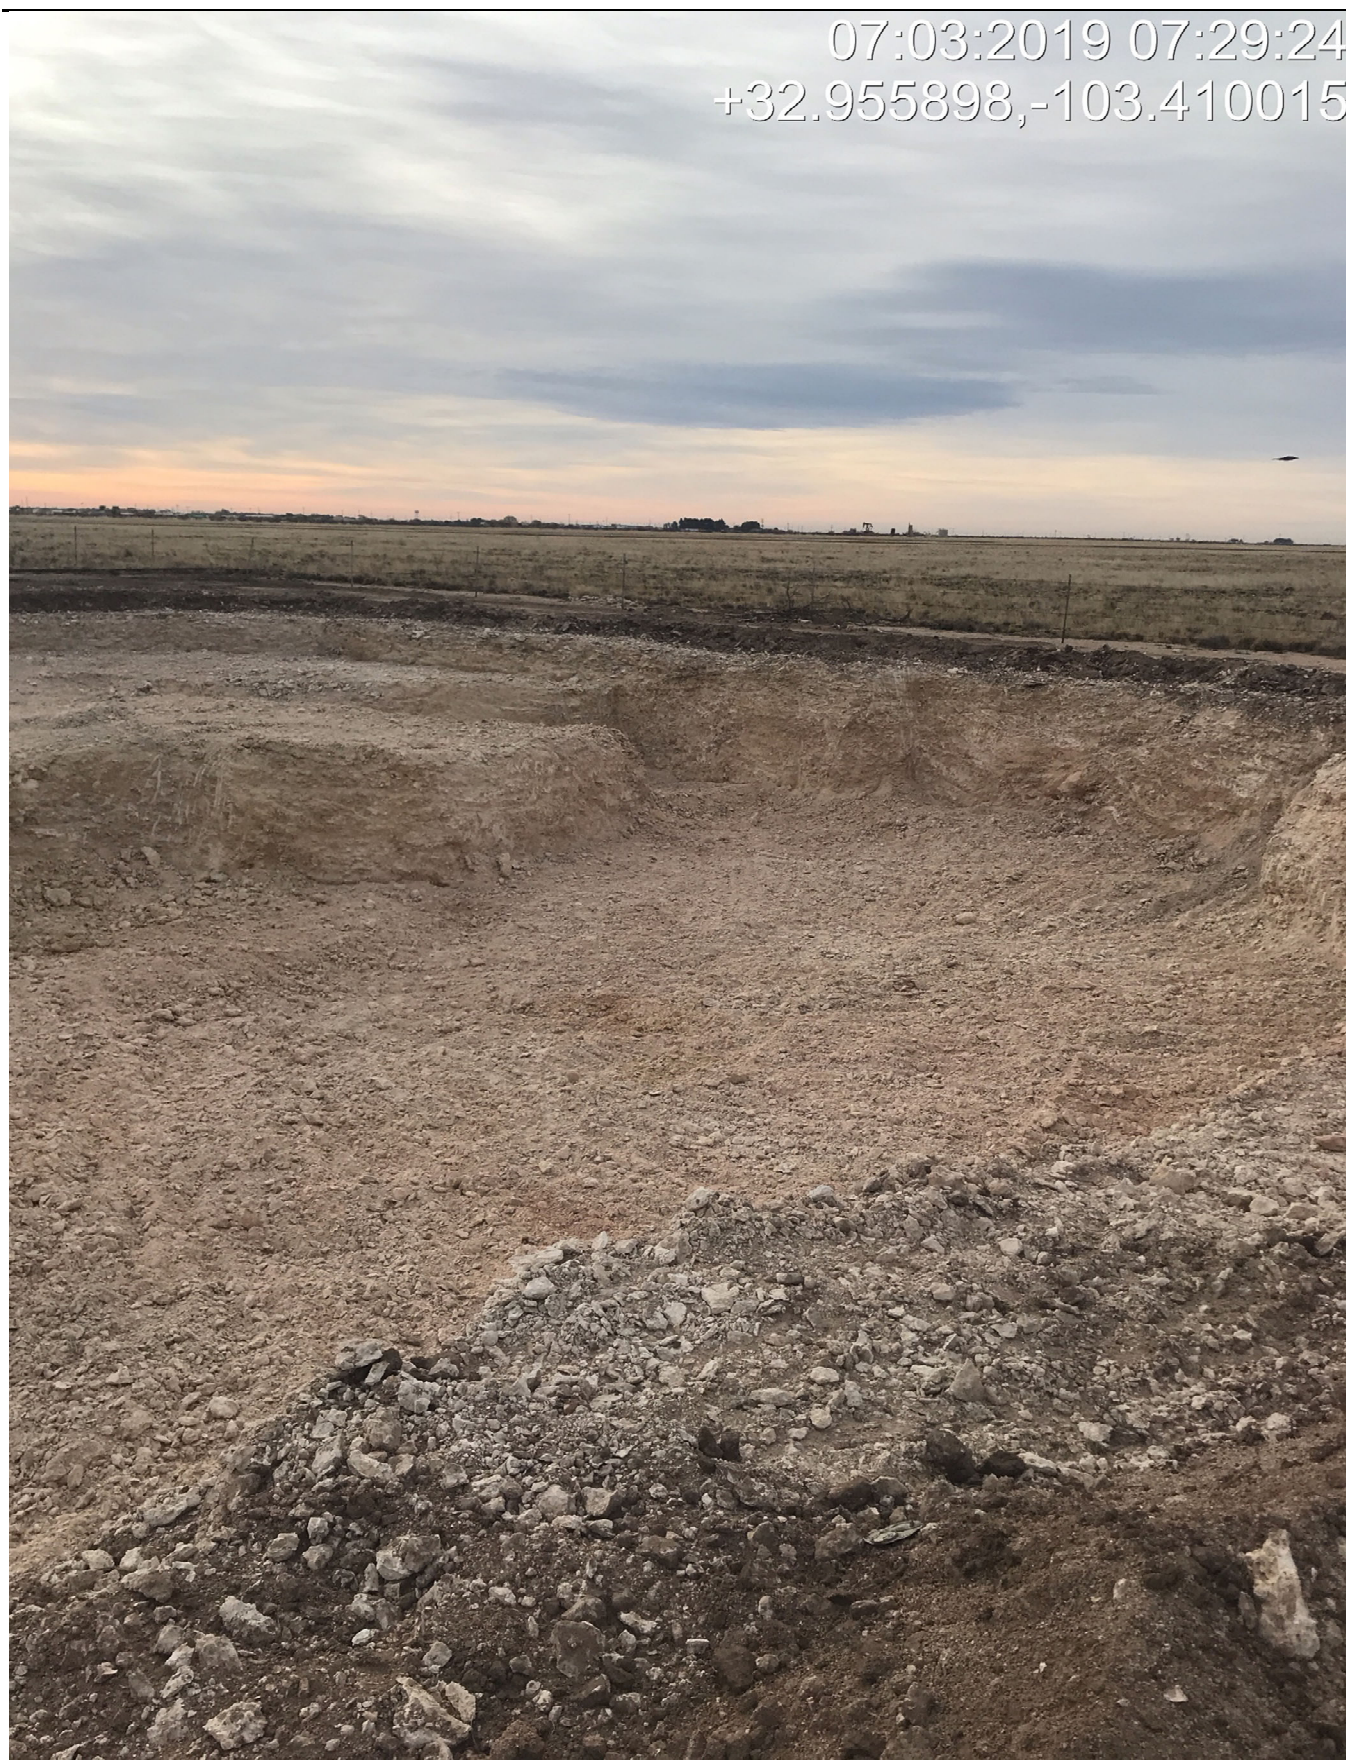
Figure 4 View of portion of the excavated area, facing Southeast.

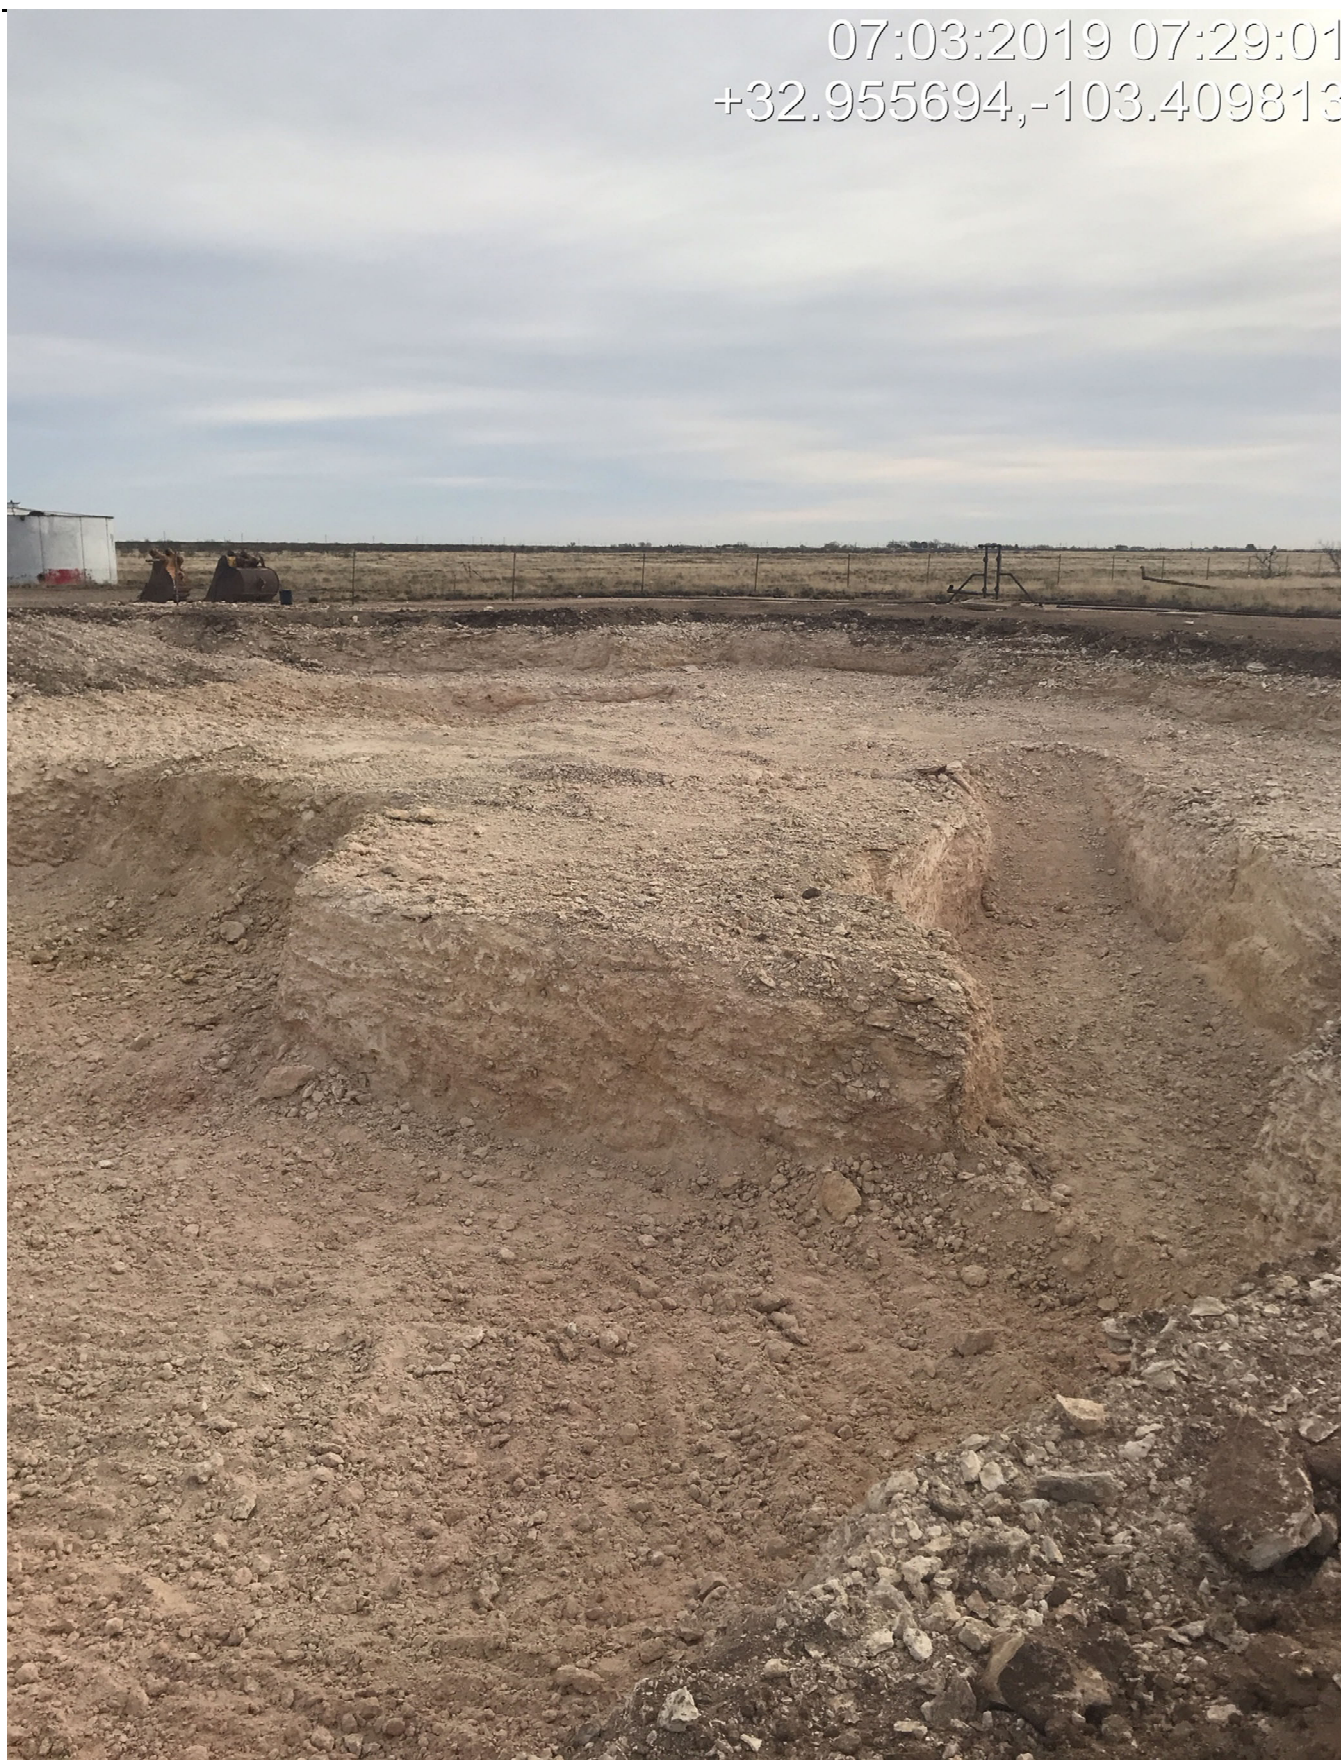
Figure 5 View of portion of the excavated area, facing Northeast.

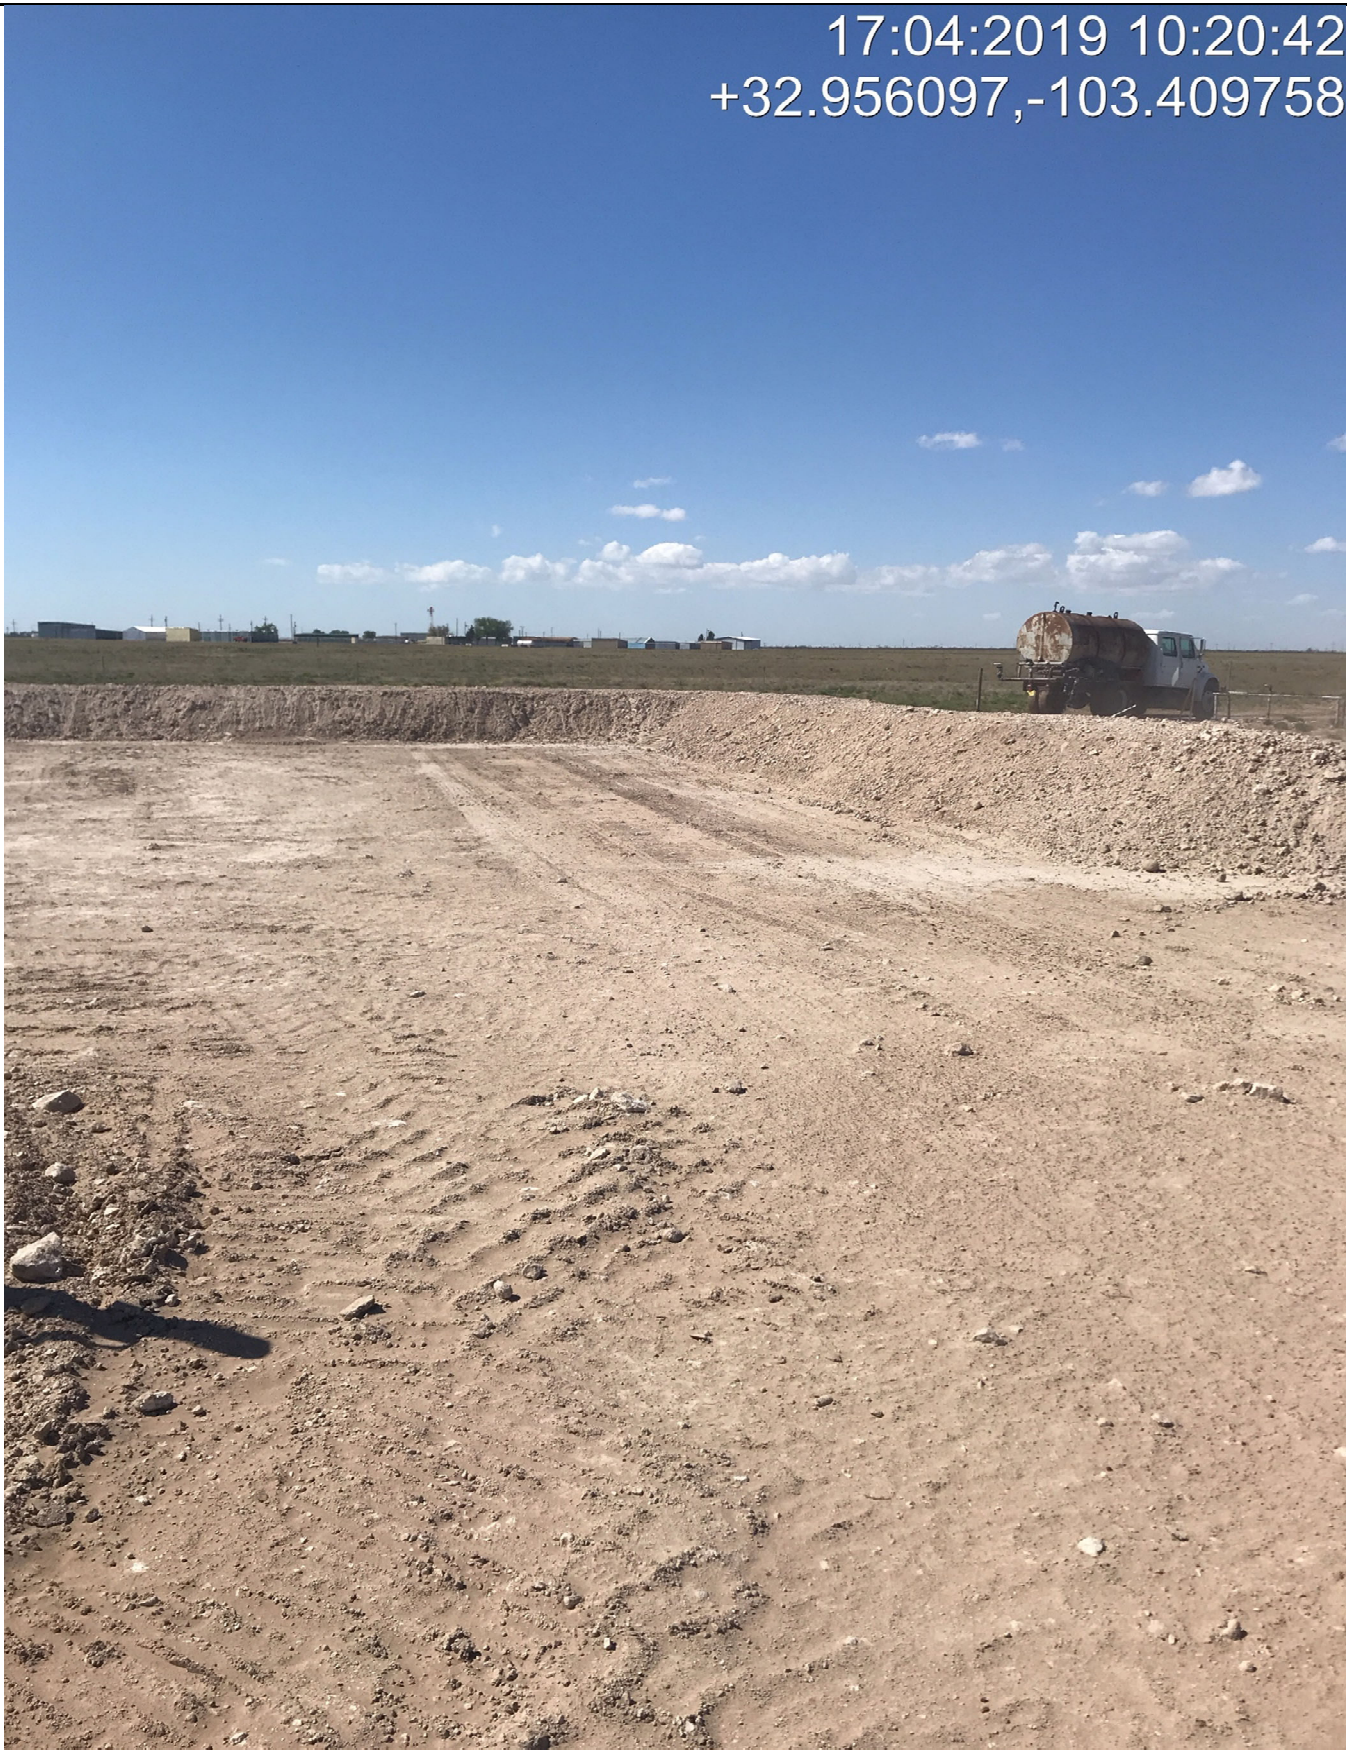
Figure 6 View of the affected area after remediation activities, facing South.

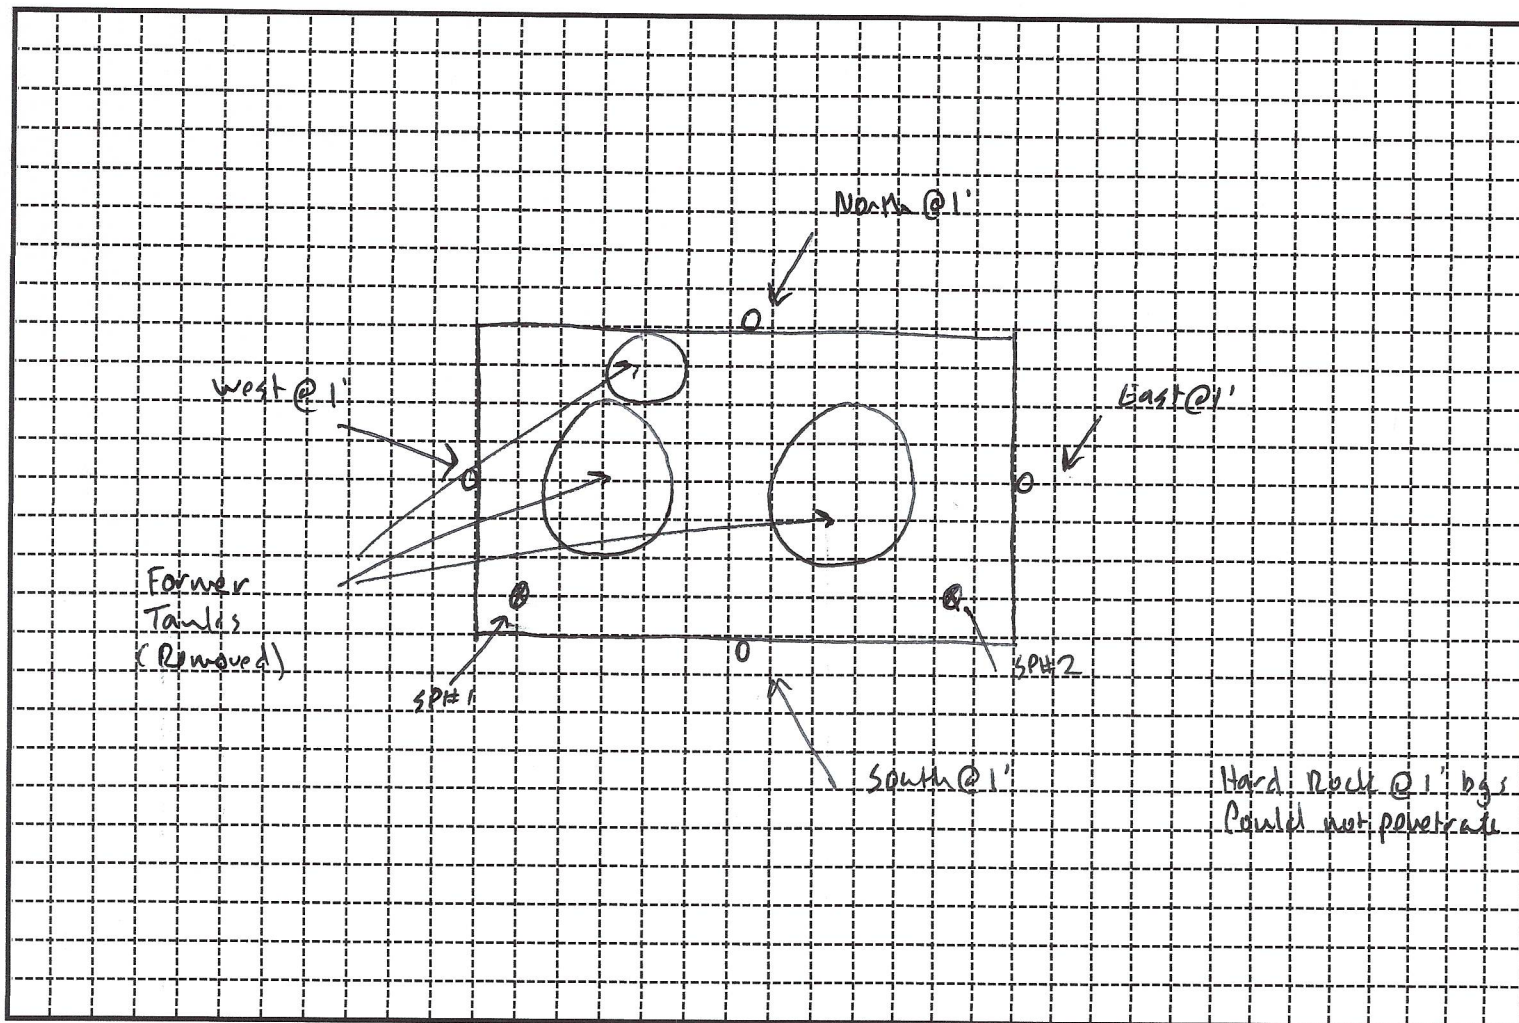
Hard Rock @ 1' bgs. Could not penetrate

Field ID	Odor/PID	Chloride
North @ 1'	None	330
East @ 1'	Slight	<120
South @ 1'	None	2,652
West @ 1'	None	942
