**Re: Deferral Request Report Addendum  
Charlie Sweeney Fed TB  
Incident Number nAPP2332849245  
Eddy County, New Mexico**

Ensolum, LLC (Ensolum), on behalf of Matador Production Company (Matador), has prepared this *Deferral Request Report Addendum (DRRA)* to document excavation and soil sampling activities at the Charlie Sweeney Fed Tank Battery (TB; Site). The purpose of the Site assessment and soil sampling activities was to address impacts to soil following a release of produced water at the Site. Based on the excavation activities and analytical results from the soil sampling events, Matador is submitting this *DRRA*, describing remediation and confirmation sampling activities that have been completed and requesting deferral for Incident Number nAPP2332849245 until the pad is well is plugged and abandoned or the Site is reclaimed.

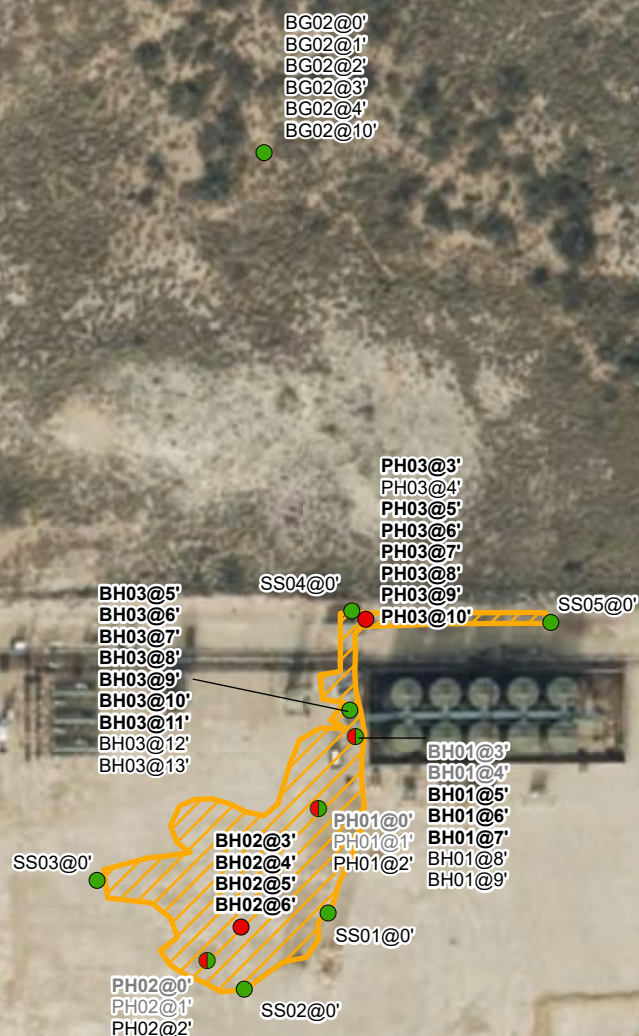
Notes:  
 Sample ID @ Depth Below Ground Surface.  
 Samples in bold indicate sample exceeded applicable closure criteria.  
 Grey text indicate soil sample was removed during excavation activities.

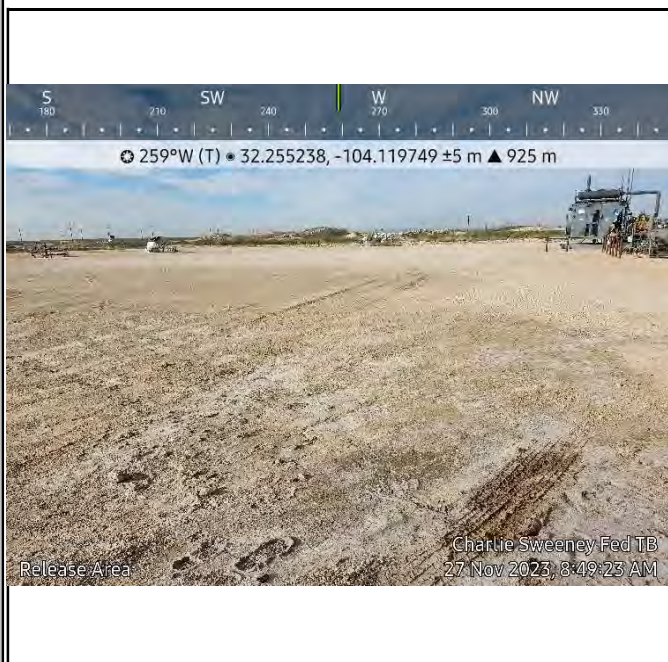
Photograph 1

Description: Spill Area

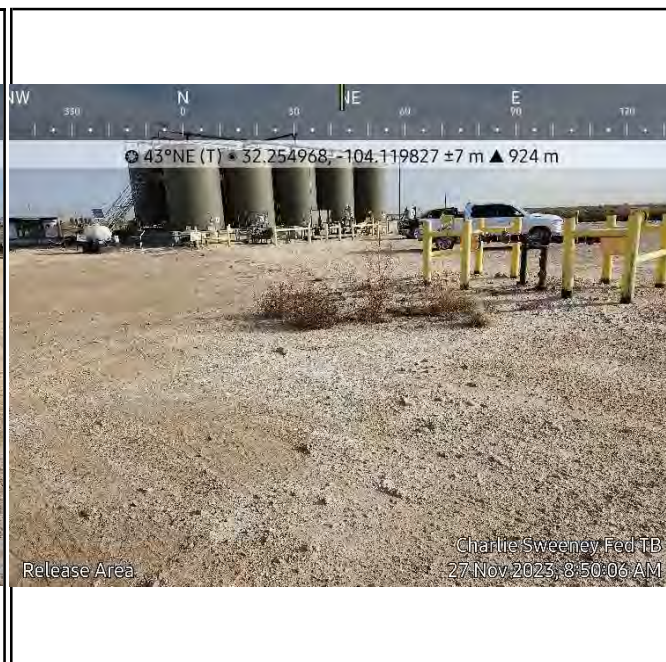
Photograph 2

Description: Spill Area

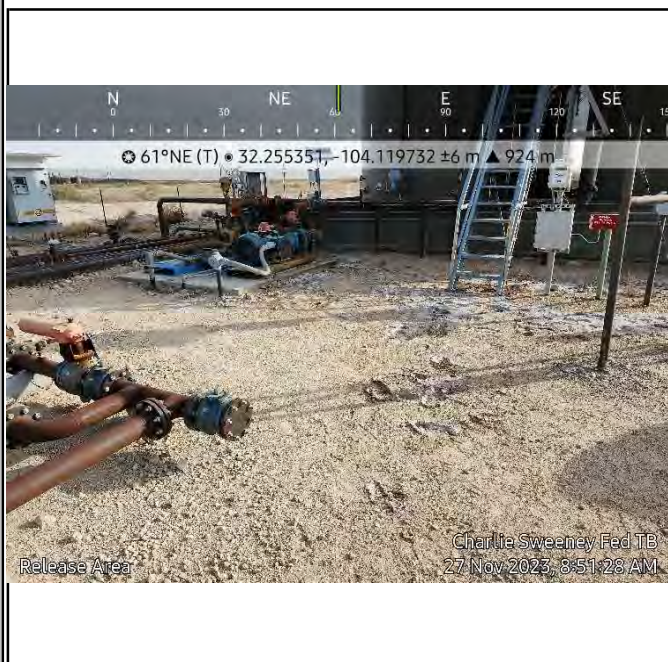
Photograph 3

Description: Spill Area

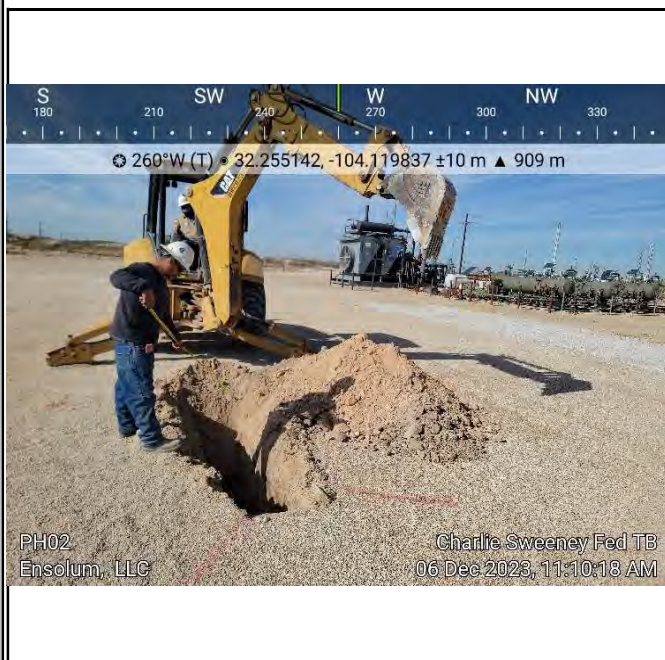
Photograph 5

Description: Delineation

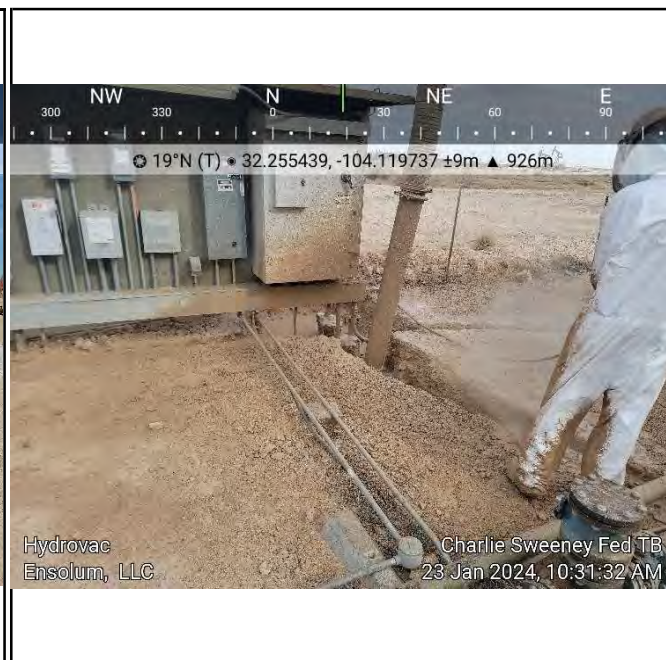
Photograph 6

Description: Hydro-vac lines

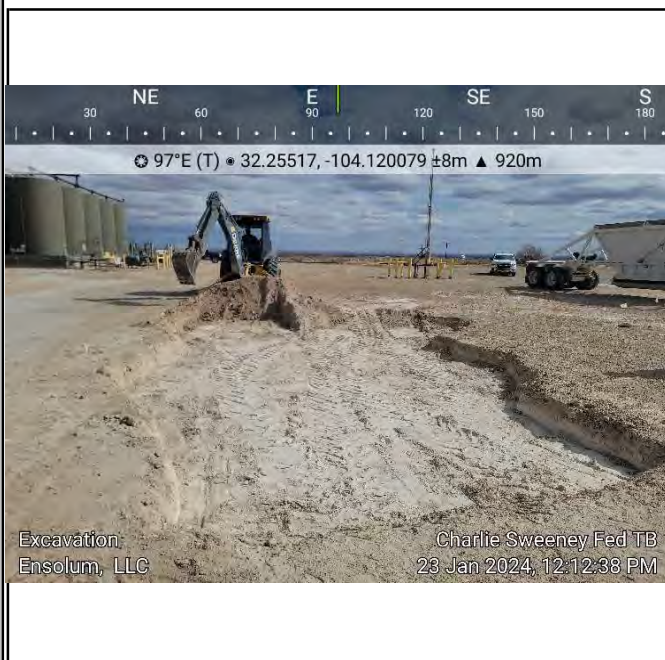
Photograph 7

Description: Excavation

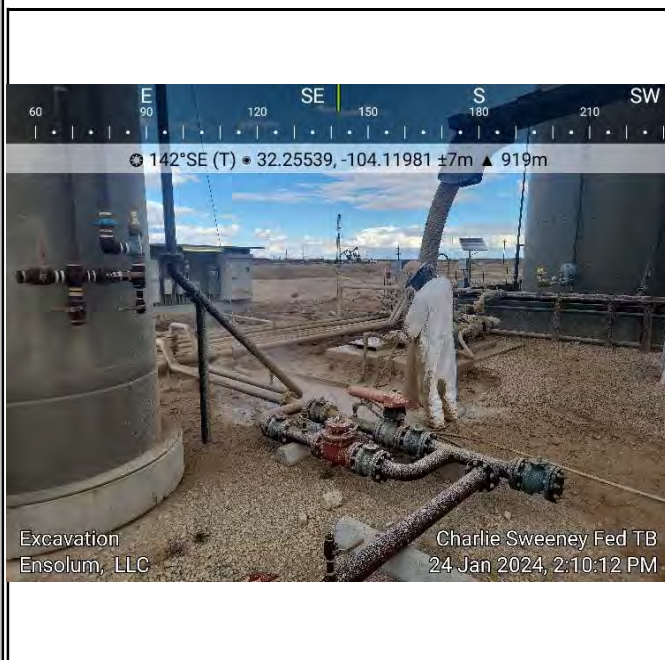
Photograph 9

Description: Hydro-vac around lines

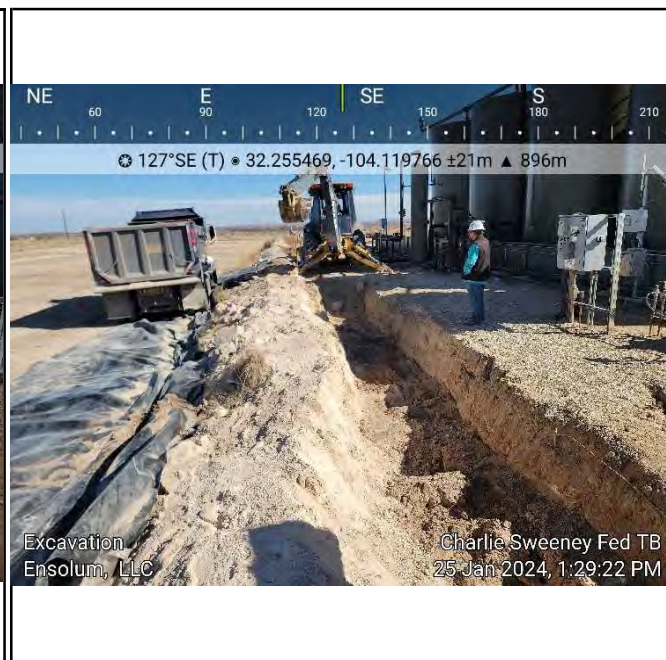
Photograph 10

Description: Excavation

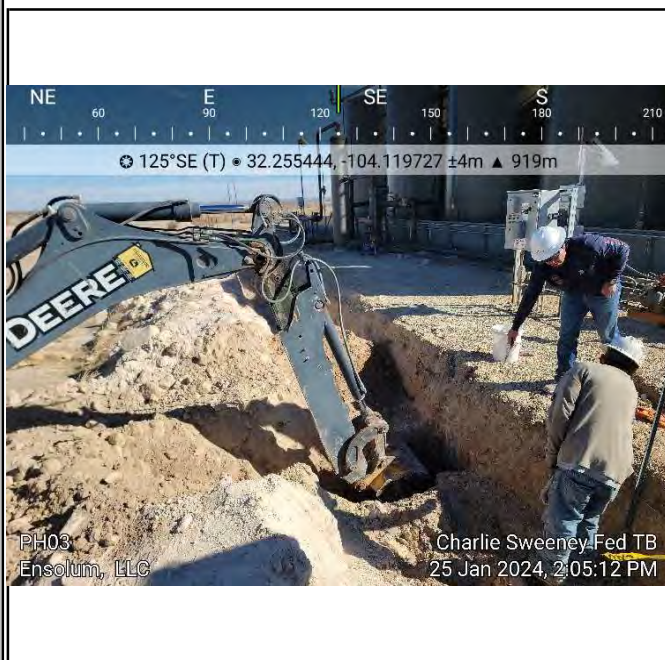
Photograph 11

Description: PH03 delineation

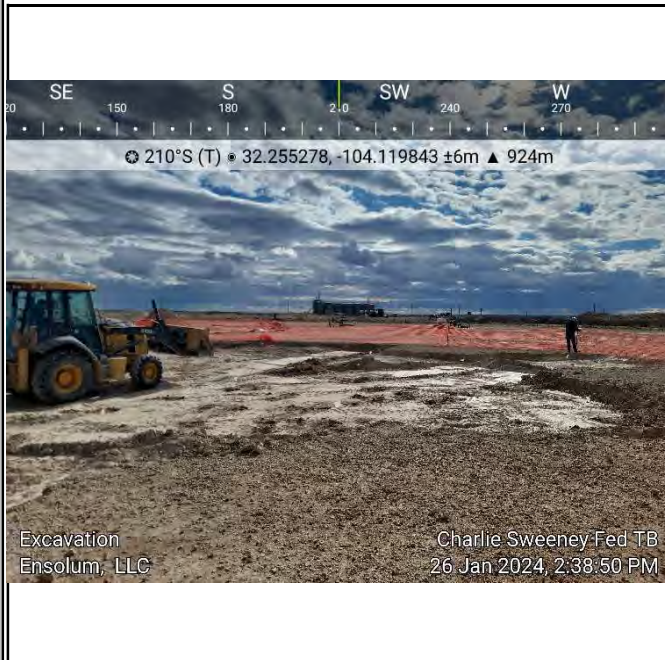
Photograph 13  
Description: Excavation  
View: South

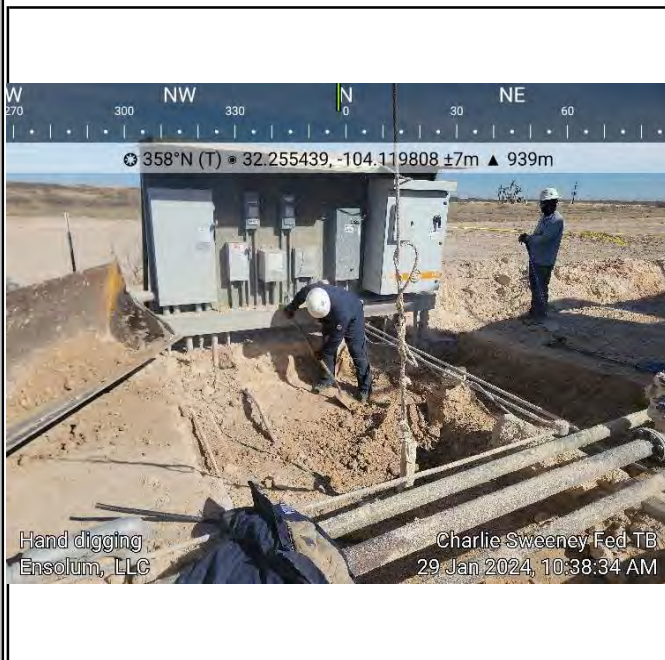
Photograph 15  
Description: Hand digging  
View: North

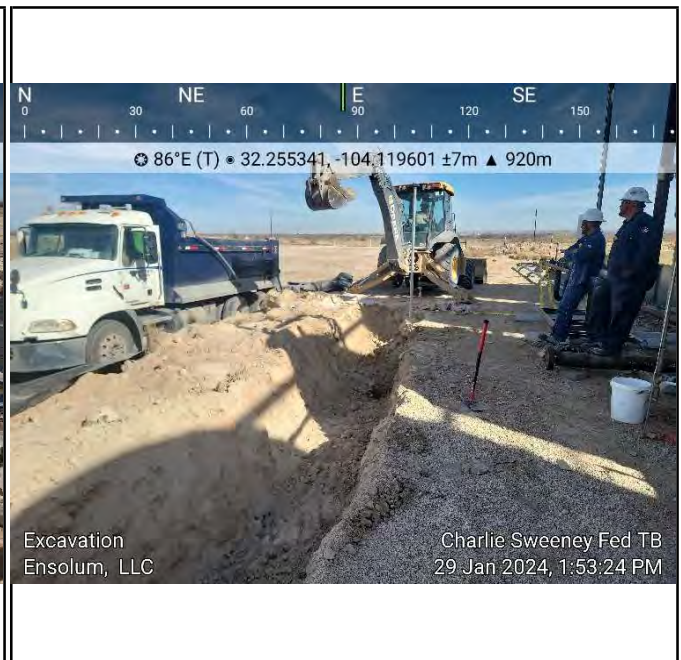
Photograph 16  
Description: Excavation  
View: East

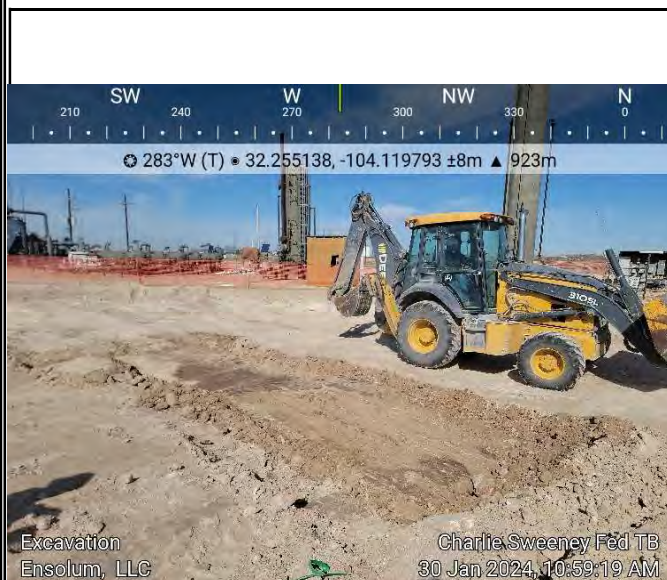
Photograph 17  
Description: Excavation  
View: Northwest

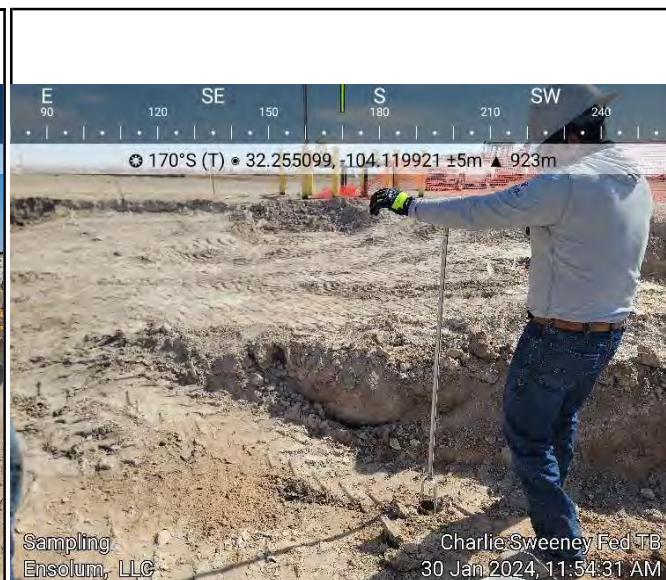
Photograph 18  
Description: BH02  
View: South
