## **Copper Ridge Resources, LLC**

**Re: Remediation Work Plan**

HALE STATE 001Y WELL SITE AND BATTERY (WELL API 30-025-26773)  
Copper Ridge Resources, LLC  
Incident: nAPP2425946348

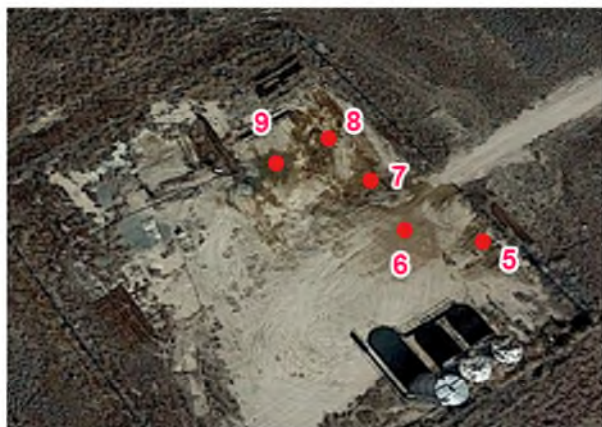
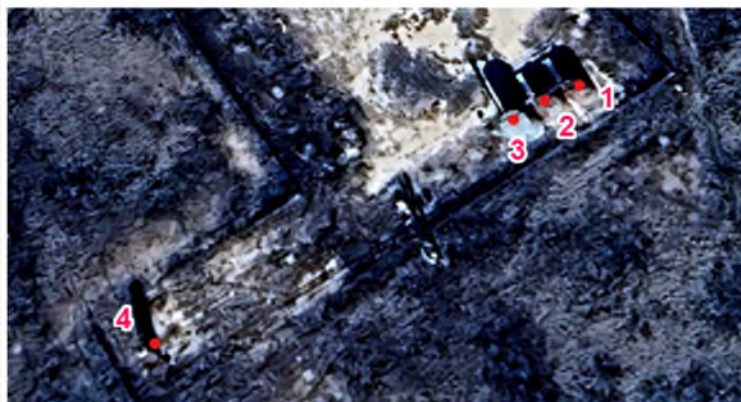
**Sample Map - Hale State 001Y Location**

Soil composition at the Site predominantly consisted of silty or loamy sand. Groundwater and/or saturated soil was not observed in any of the borings during drilling. Soil Sample 1, located in the middle of the footprint of the furthest southeast tank, contained GRO+DRO and BTEX concentrations of 188.7 mg/kg which exceeds the NMOCD Closure Criteria of 100 mg/kg found in Table 1 above.

Samples 1, 2, and 3, located in the footprint of the three storage tanks, which were recently removed, had chloride concentrations of 160, 416, and 304 mg/kg, respectively. These levels fall below the threshold limit of 600 mg/kg found in Table 1 above. There was no evidence of chloride contamination nor hydrocarbons with any of these samples. The sample odor of all these samples was consistent with fresh moist dirt with zero indication of hydrocarbons or chlorides.

**Samples taken at a depth on 1 foot on 8/1/2024 by Mark Burkett, witnessed by NM SLO Representative Mr. Deon David**  
**The number above corresponds to the sample number on the report from Cardinal Laboratories H244603**

Copper Ridge proposes to excavate impacted soil resulting from the release at the Site to achieve NMOCD Table I Closure Criteria. Soil will be excavated and transported off-Site for disposal. Following removal of the impacted soil, 5-point composite soil samples will be collected at least every 200 square feet from the floor and sidewalls of the excavation. The 5-point composite samples will be collected by placing five equivalent aliquots of soil into a 1-gallon, resealable plastic bag and homogenizing the samples by thoroughly mixing. Soil samples will be submitted for laboratory analysis of TPH, BTEX, and chloride in the manner described above.
