O-LOOP LINE LEAK (09.09.23)

Remediation Summary & Closure Report

NMOCD Incident No. nAPP2325748815
UL "I&J", Sec. 23, T17S, R32E
32.515113°, -103.325036°
Lea County, New Mexico

August 15, 2024

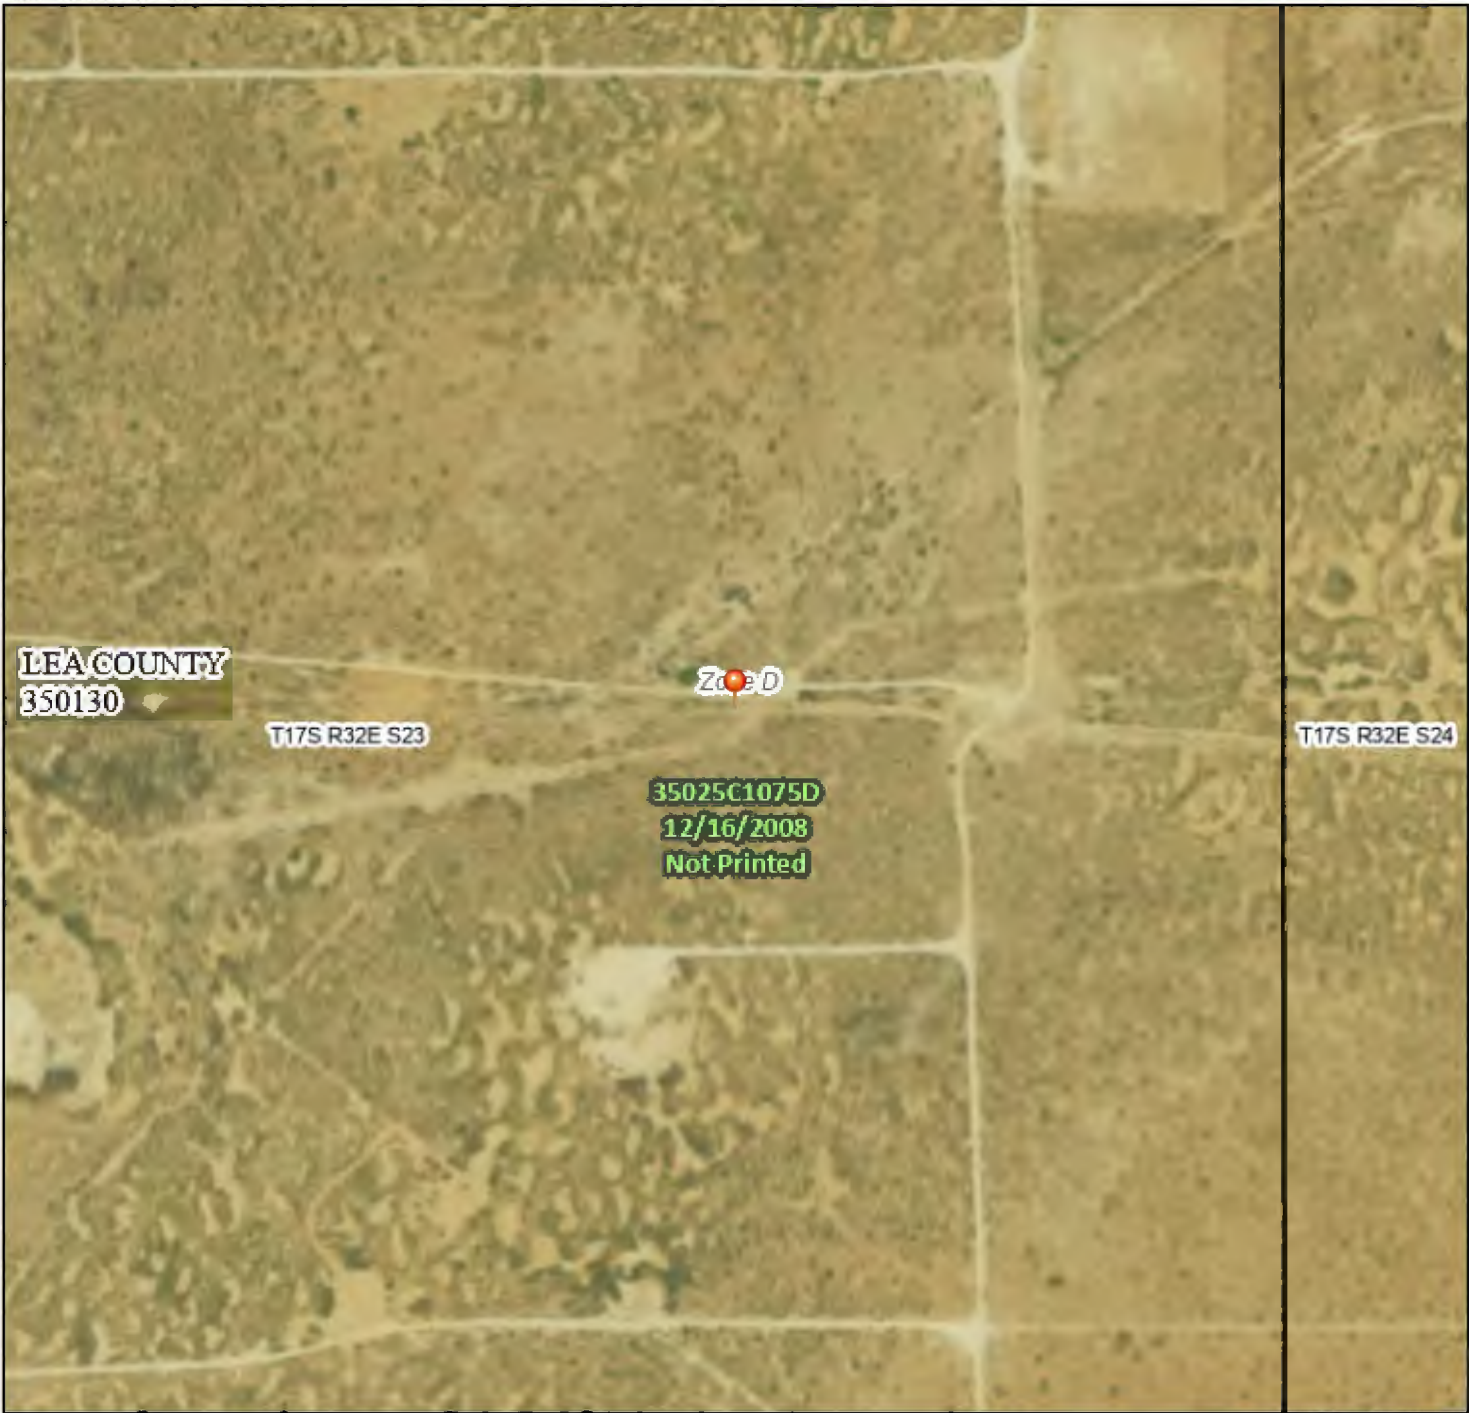
Figure 4

National Flood Hazard Layer FIRMette

Review of flood map data published by the Federal Emergency Management Agency (FEMA) indicates the site is not located within a 100-year floodplain. A copy of the FEMA FIRMete Map can be found attached as Figure 4.
