**Re: Closure Request
Remuda 100 Battery
Incident Number nAPP2418050972
Eddy County, New Mexico**

Ensolum, LLC (Ensolum) on behalf of XTO Energy, Inc. (XTO), has prepared this *Closure Request* to document site assessment, excavation, and soil sampling activities at the Remuda 100 Battery (Site). The purpose of the site assessment and soil sampling activities was to assess the presence or absence of impacts to soil following a release of produced water. Based on field observations, field screening activities, and soil sample laboratory analytical results, XTO is submitting this *Closure Request*, describing delineation and excavation activities that have occurred and requesting no further action for Incident Number nAPP2418050972.

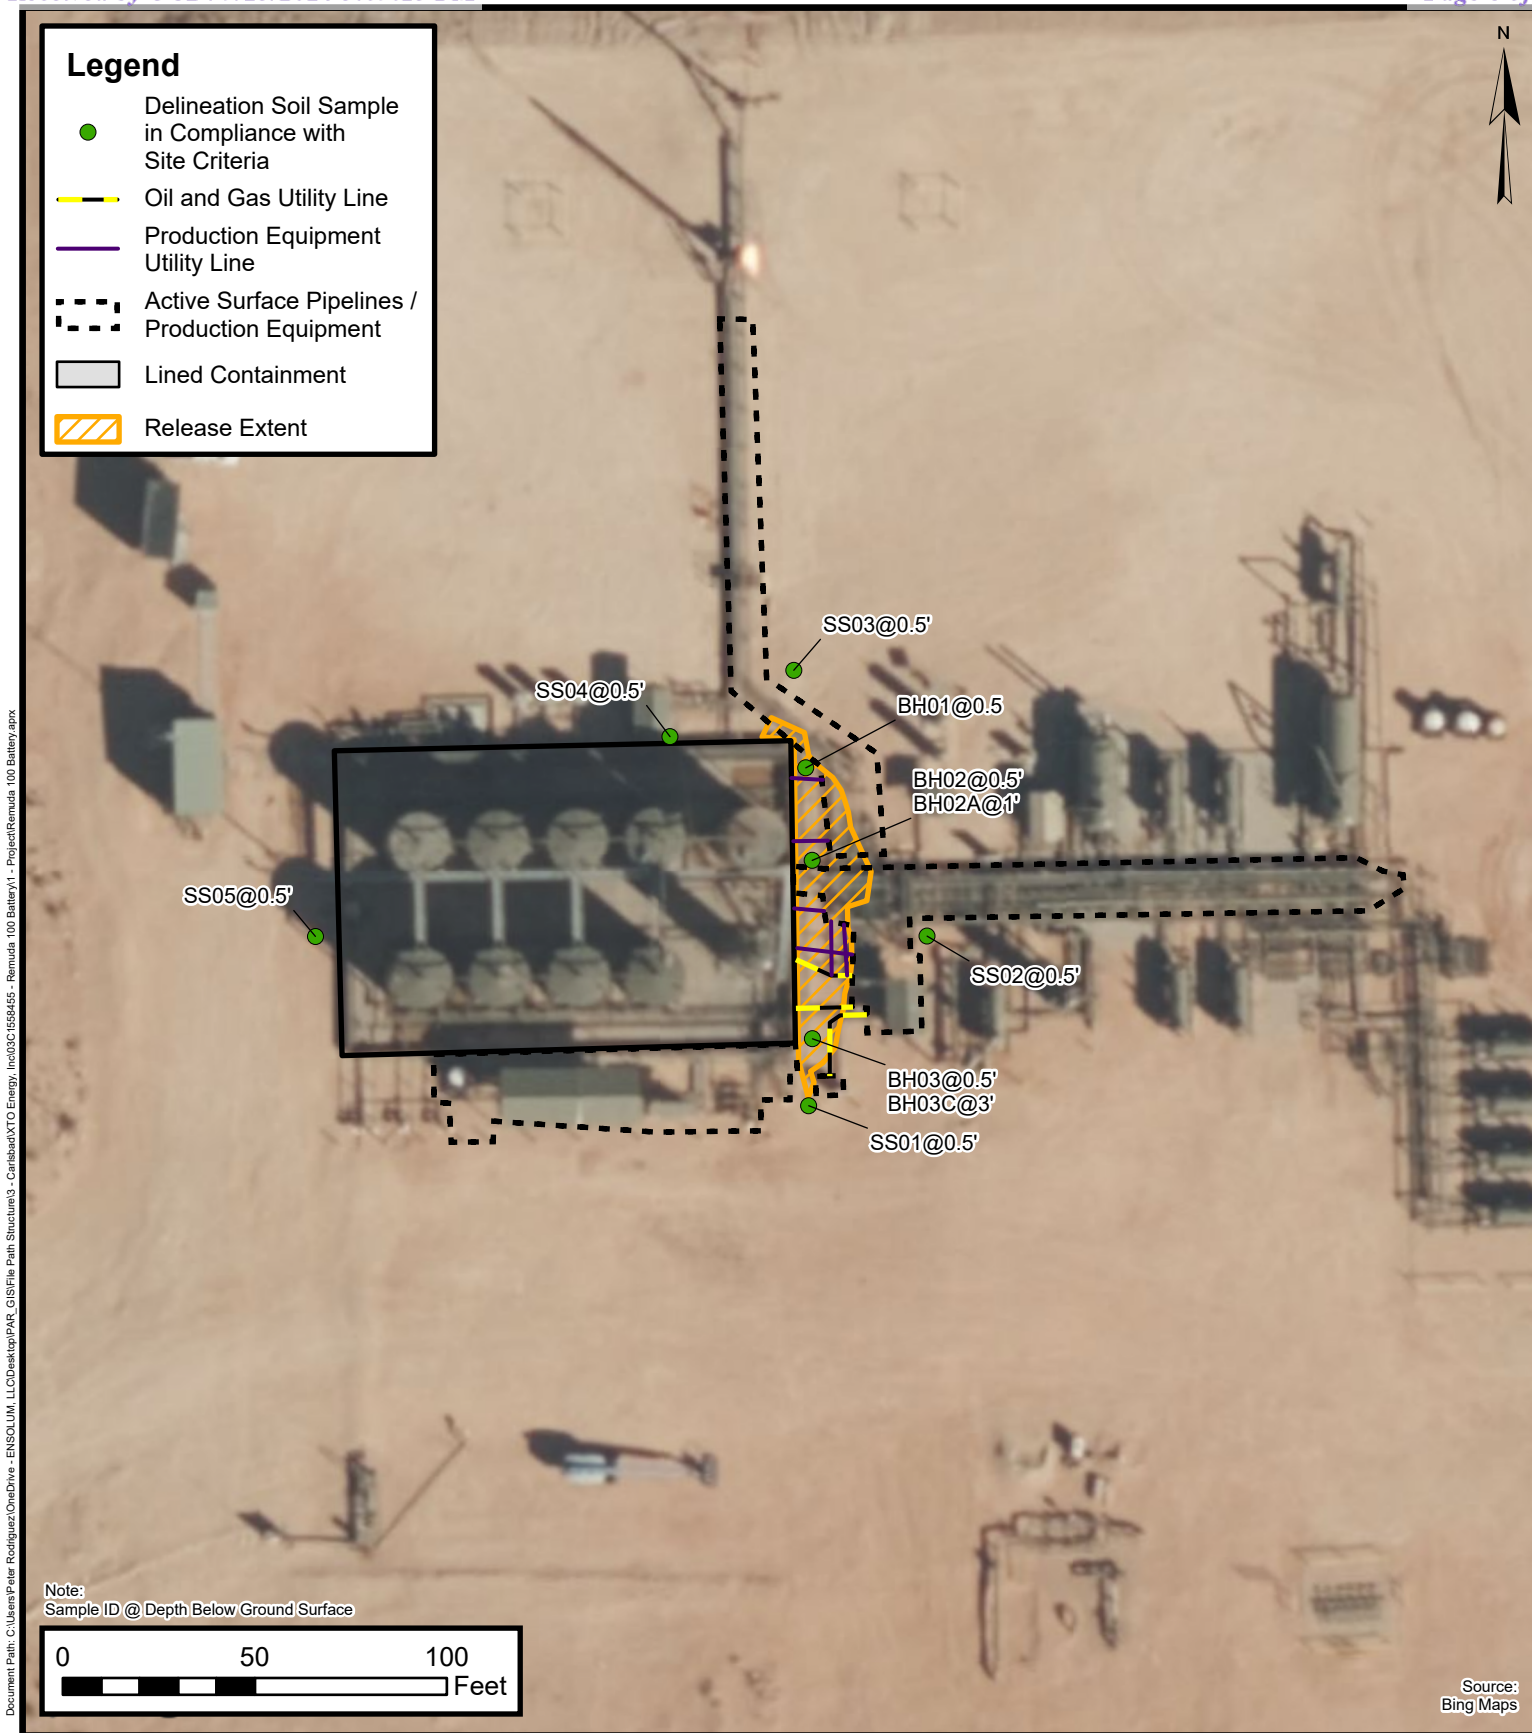
FIGURE
2

Delineation Soil Sample Locations

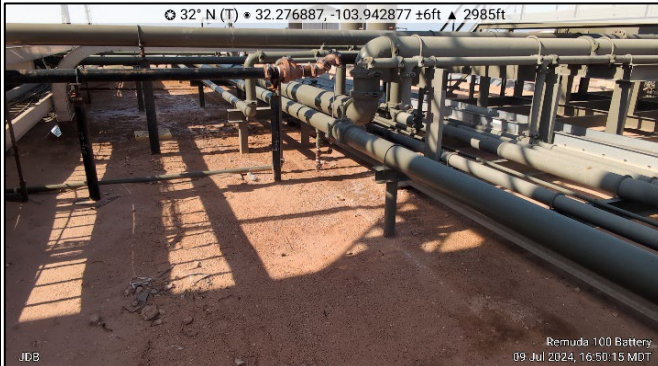
Photograph: 1 Date: 7/09/2024
Description: Initial soil staining
View: North

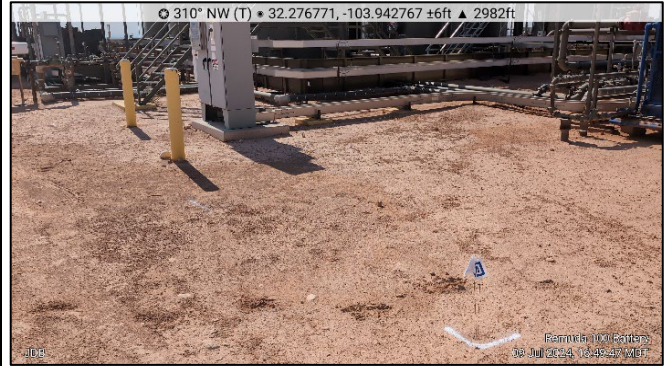
Photograph: 2 Date: 7/9/2024
Description: Initial soil staining
View: Northwest

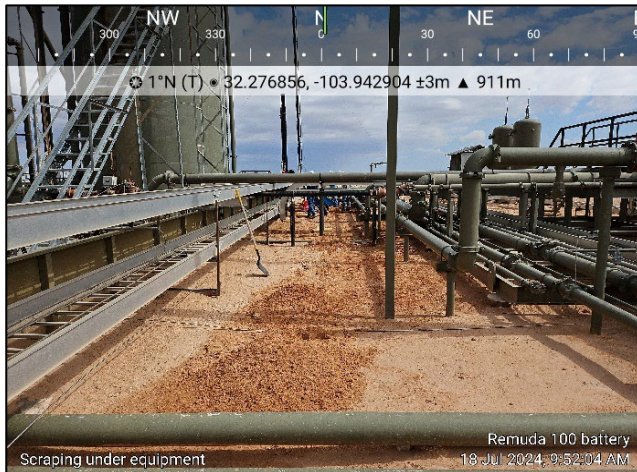
Photograph: 3 Date: 7/18/2024
Description: Final excavation extent
View: North

I am reviewing the submitted remediation closure report for the following release NAPP2418050972 REMUDA 100 BATTERY and have a question regarding the photos submitted. Photograph 3 in the report says final excavation extent but shows a patch of stained soil. Did the stained soil get removed?

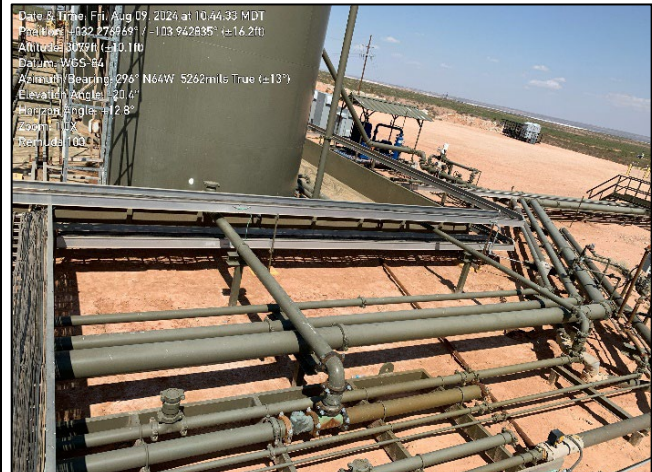
Photograph: 4 Date: 8/9/2024
Description: Final excavation extent
View: Northwest

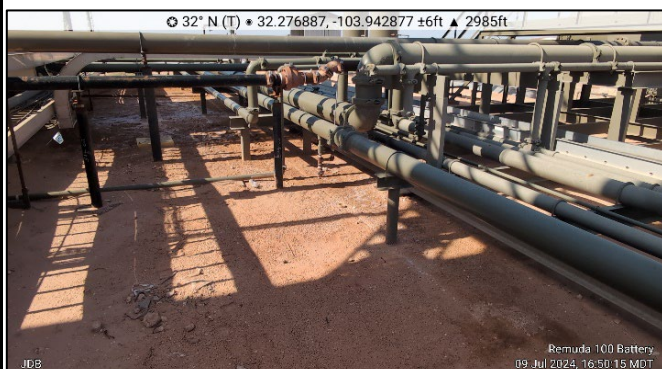
Photograph: 1 Date: 7/09/2024
Description: Initial soil staining
View: North

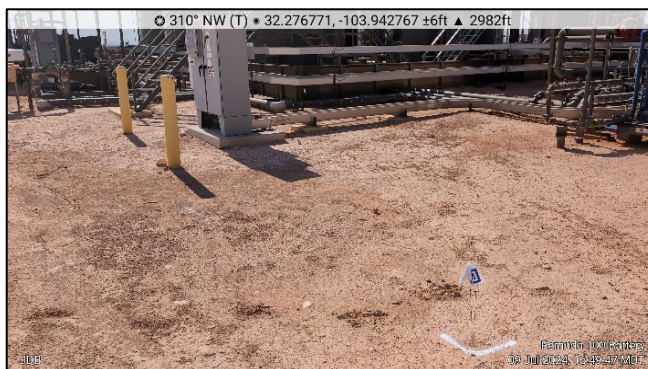
Photograph: 2 Date: 7/9/2024
Description: Initial soil staining
View: Northwest

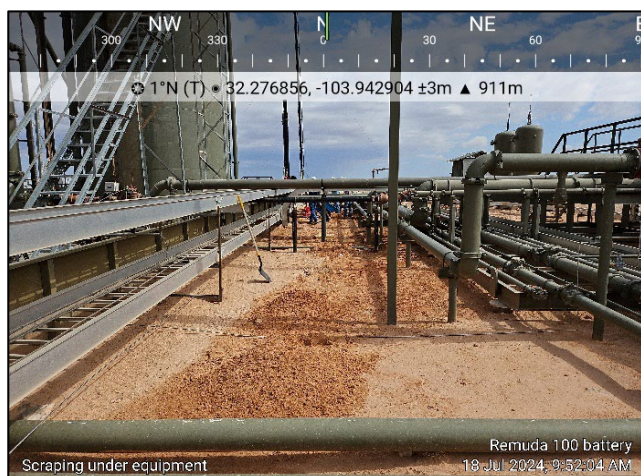
Photograph: 3 Date: 7/18/2024
Description: Excavation Activities
View: North

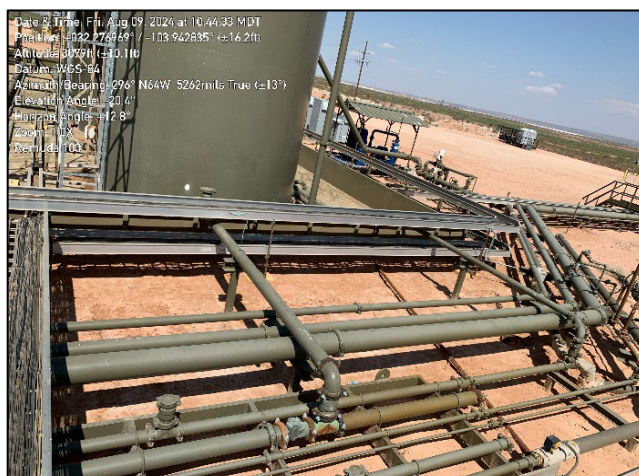
Photograph: 4 Date: 8/9/2024
Description: Final excavation extent
View: Northwest
