**Re: Closure Request  
Gem 4, 5, 7, 10 Battery, 8705 JV-P  
Incident Number nCH1903263128  
Lea County, New Mexico**

Ensolum, LLC (Ensolum) on behalf of BTA Oil Producers, LLC (BTA), has prepared this *Closure Request* to document excavation and soil sampling activities performed at the Gem 4, 5, 7, 10 Battery, 8705 JV-P (Site). The purpose of excavation and soil sampling activities, conducted in accordance with an approved *Remediation Work Plan (Work Plan)*, was to address impacts to soil resulting from a release of produced water at the Site. BTA is submitting this *Closure Request*, describing excavation activities that have occurred and requesting no further remediation for Incident Number nCH1903263128.

BTA Oil Producers, LLC  
Closure Request  
Gem 4, 5, 7, 10 Battery, 8705 JV-P

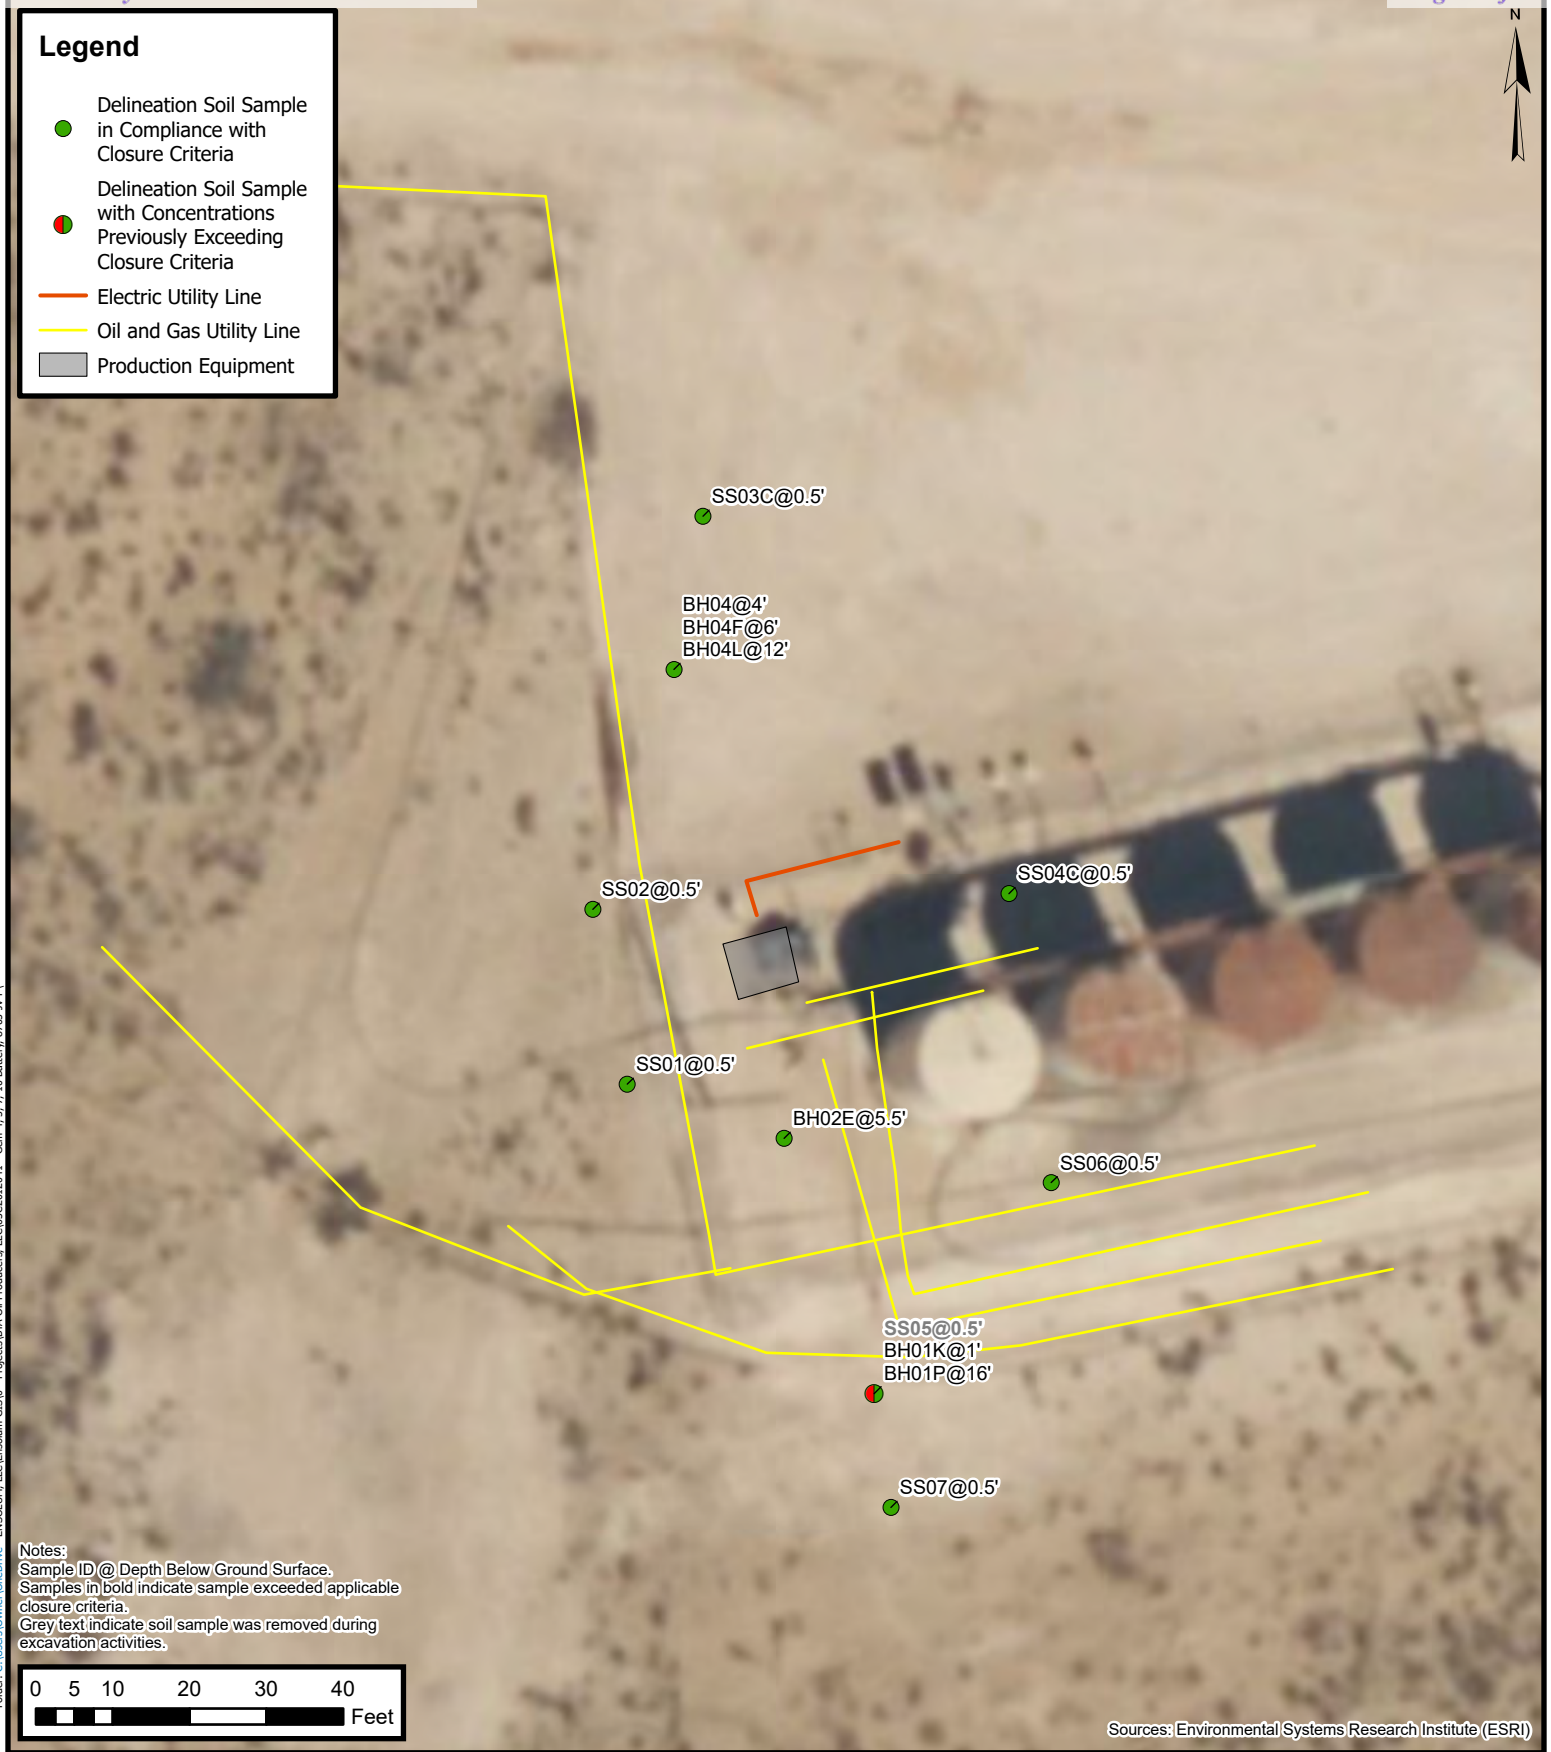
## Delineation Soil Sample Locations

To adequately define the lateral extent of the release, soil samples from the locations described above and depicted on Figure 2 will be collected at 0.5 feet bgs confirm the release did not extend past the footprint previously identified. It should be noted that the lateral delineation soil samples south of borehole SP-2 will be completed with a hand auger until an ARMS review determined the remediation area has been properly assessed for potential presence of culture resources.

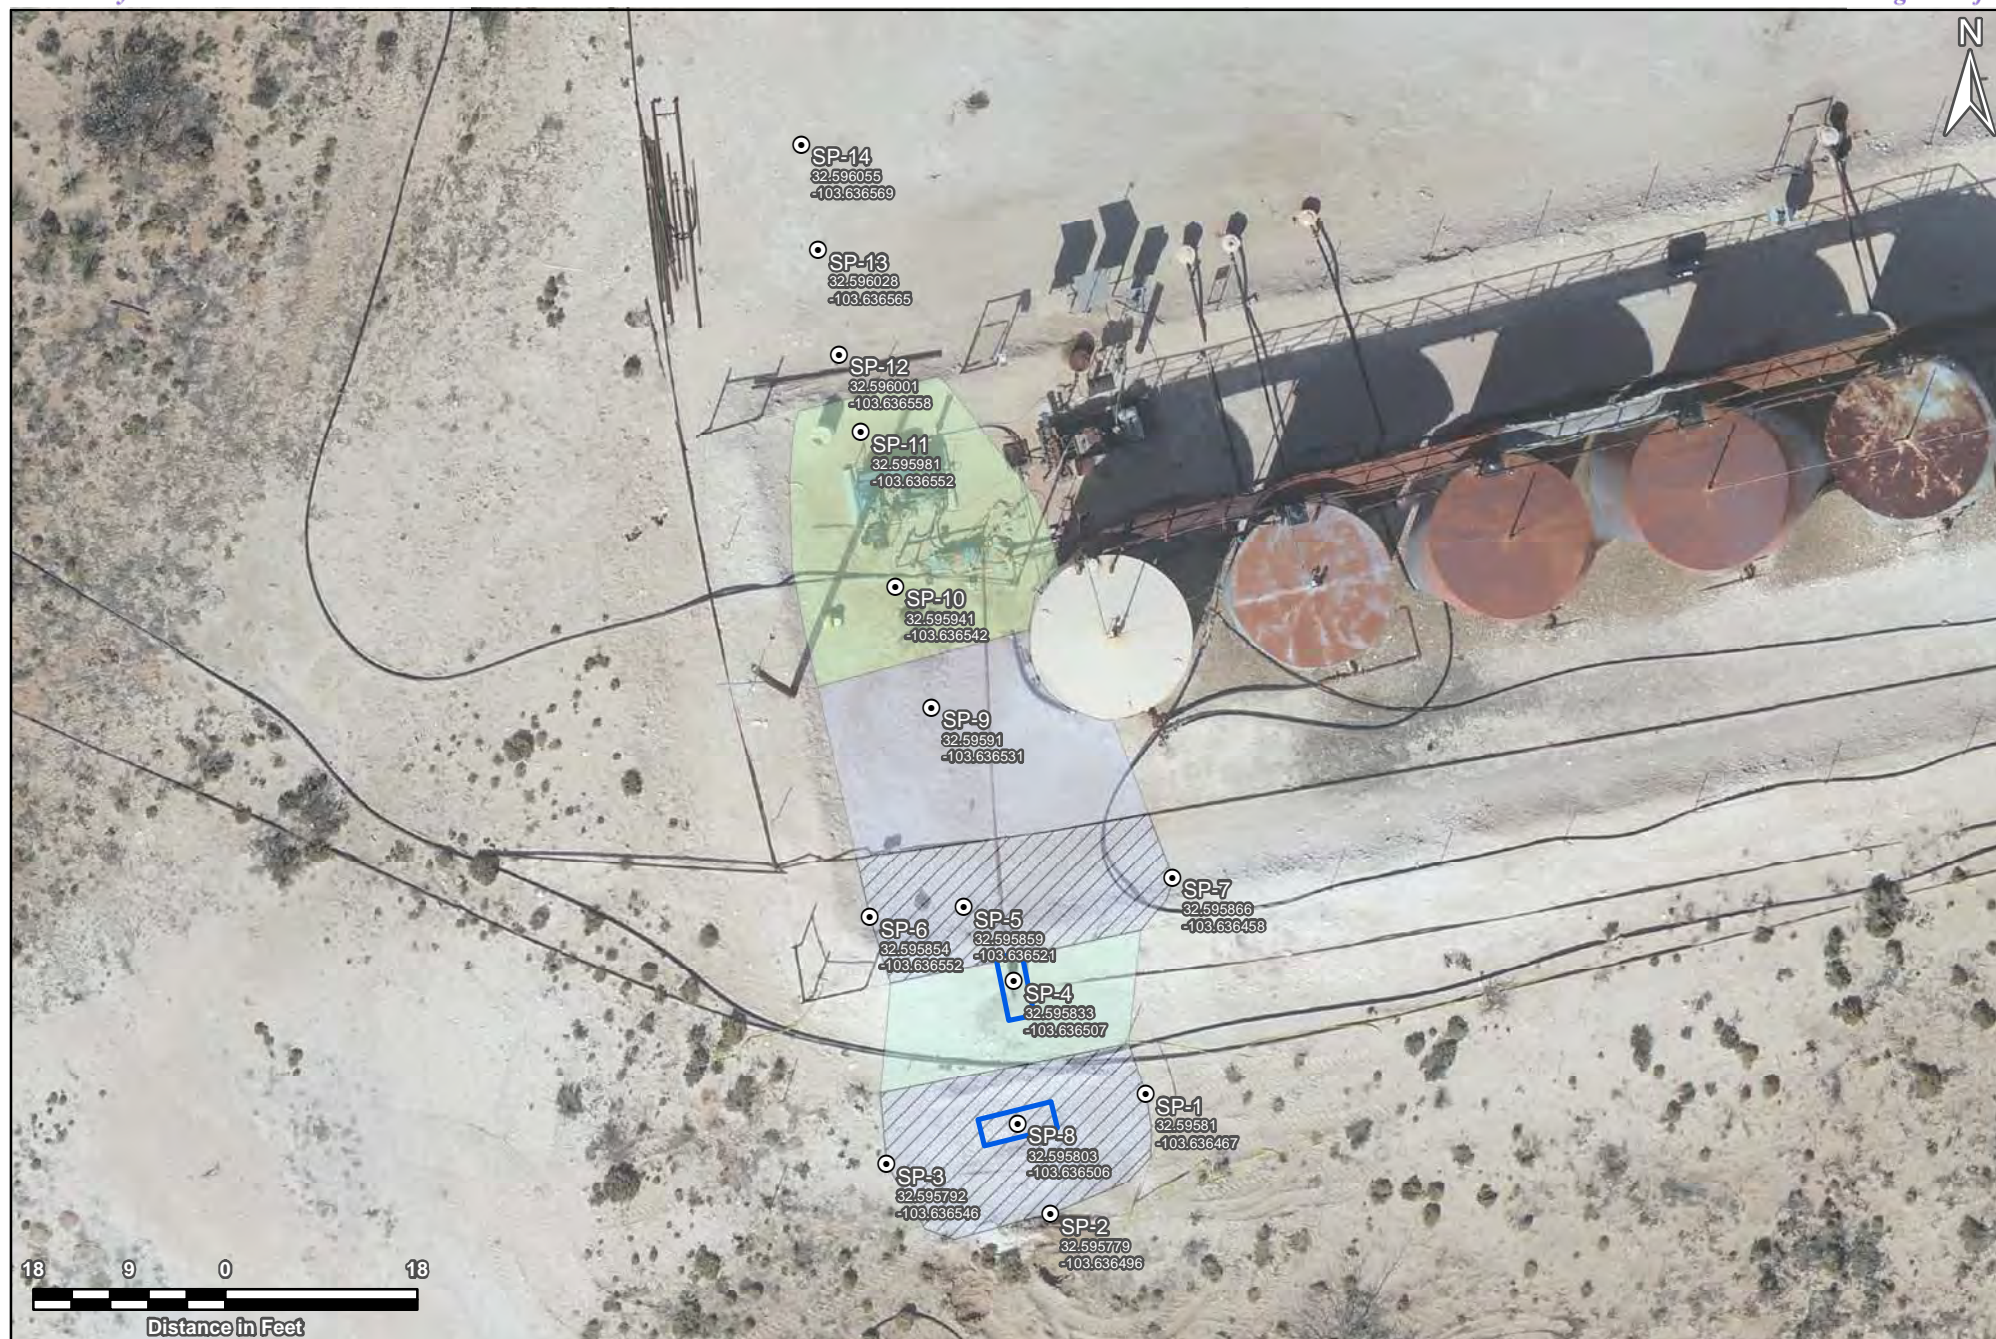
Proposed Excavation Depths

- The areas represented by auger holes SP-10 and SP-11 will be excavated to a total depth of 2 feet bgs.
- The area represented by auger hole/delineation trench SP-4 will be excavated as necessary to remove all visibly stained soil, with anticipated depths ranging from 2 to 4 feet bgs.

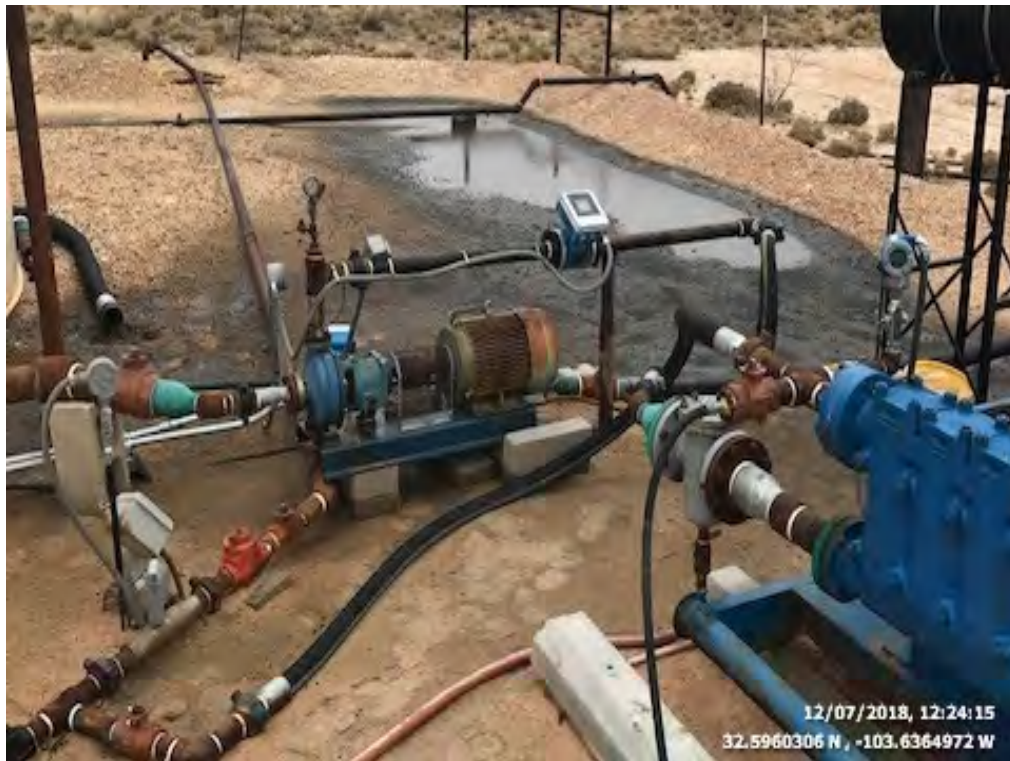
Release (Looking South-Southwest)

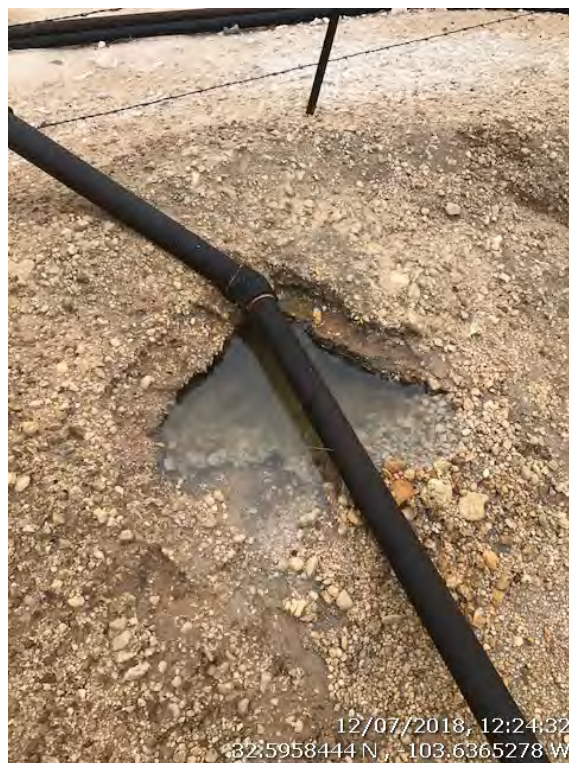
Release (Looking Southwest)

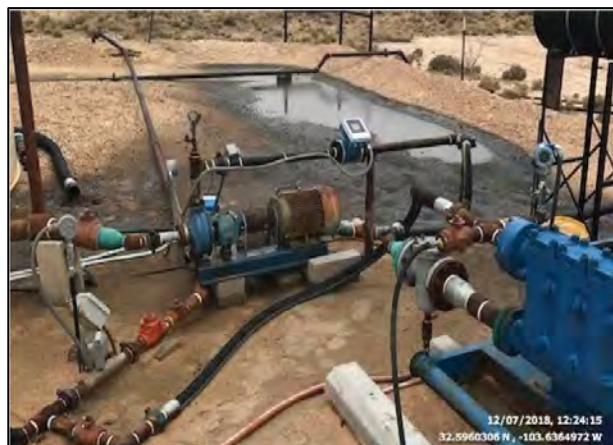
Photograph: 1 Date: 12/7/2018  
Description: Release footprint, overspray visible to south.  
View: South

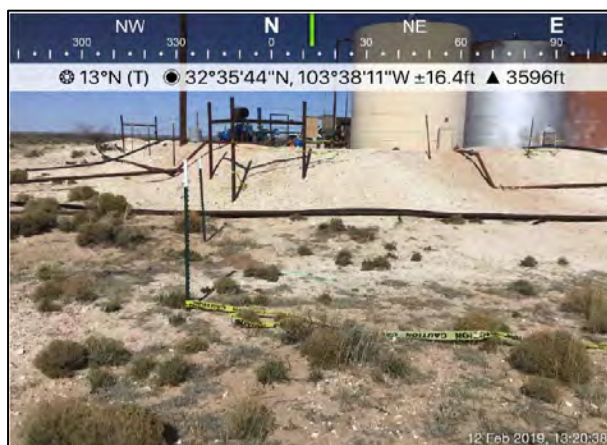
Photograph: 2 Date: 2/12/2019  
Description: Pasture and tank battery during Trinity delineation.  
View: North

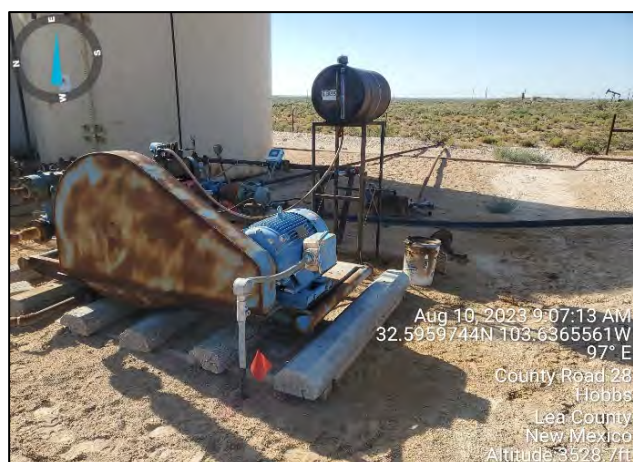
Photograph: 3 Date: 8/10/2023  
Description: Delineation activities near active production equipment.  
View: East

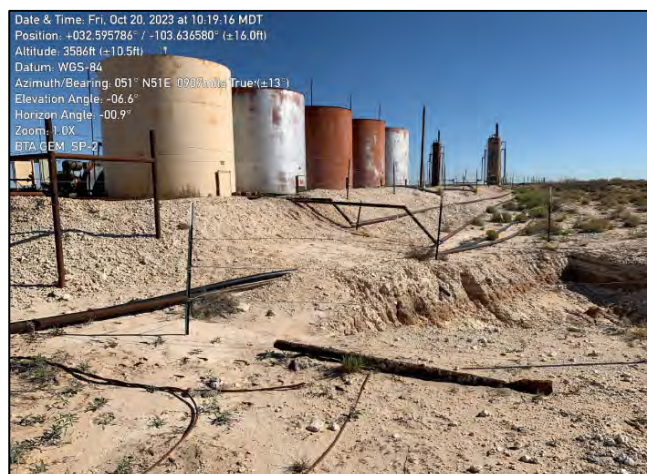
Photograph: 4 Date: 10/20/2023  
Description: Final excavation extent  
View: Northeast

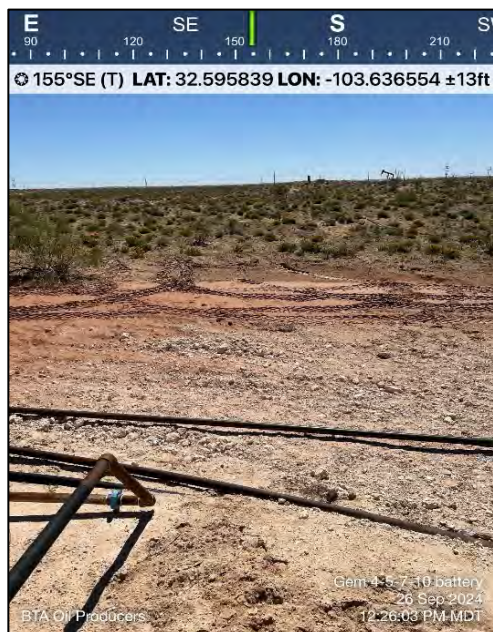
Photograph: 5  
Description: Backfill activities  
View: South

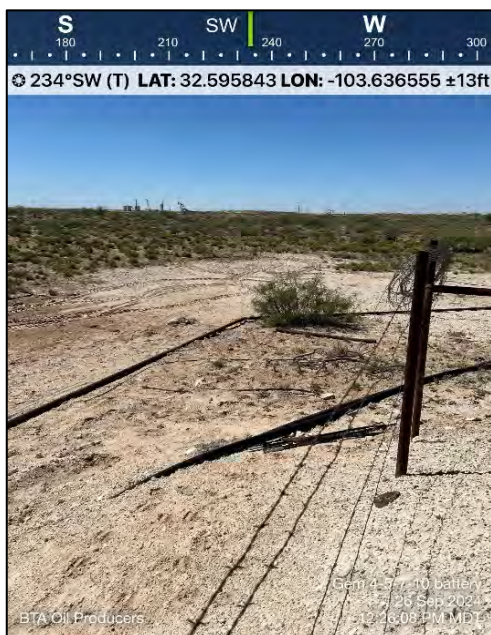
Photograph: 6  
Description: Backfill activities  
View: Southwest
